# ***Blue Palmetto Home Inspection***

## **Property Inspection Report**

Home Sweet Home

111 Dream street, Dream City, SC 29485

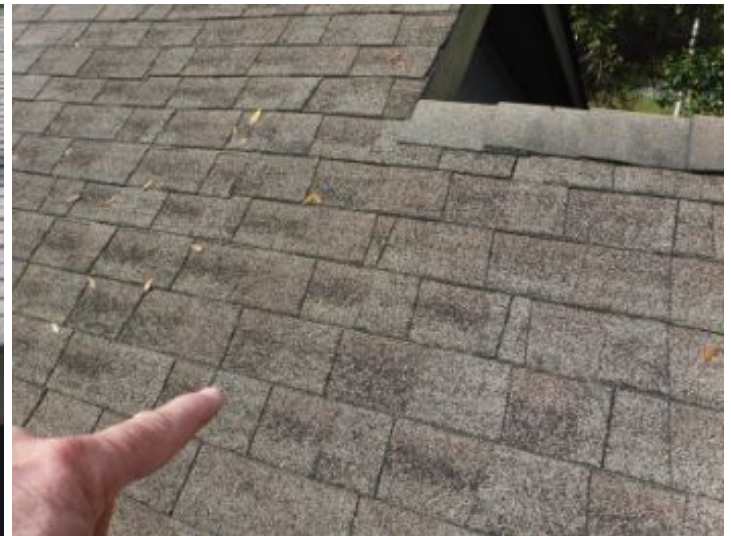
Area of concern- Area of concern pictured. - Probable leak under chimney area noted.

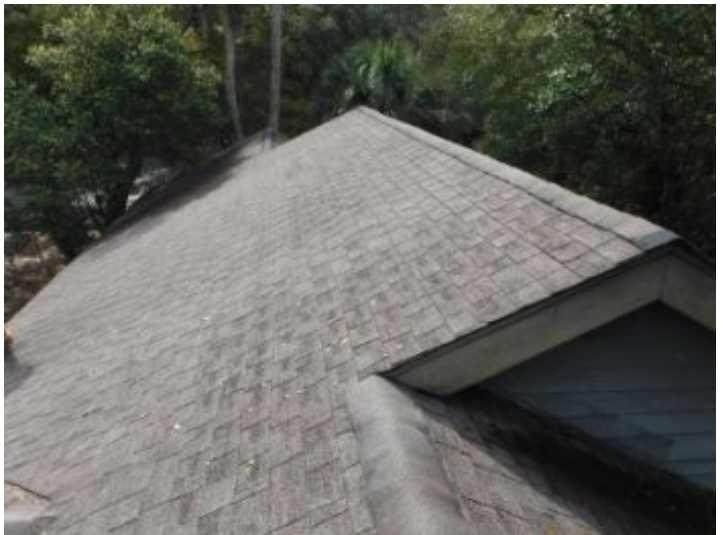
Broken or damaged shingles at overhang location/s shown. Repair as needed.

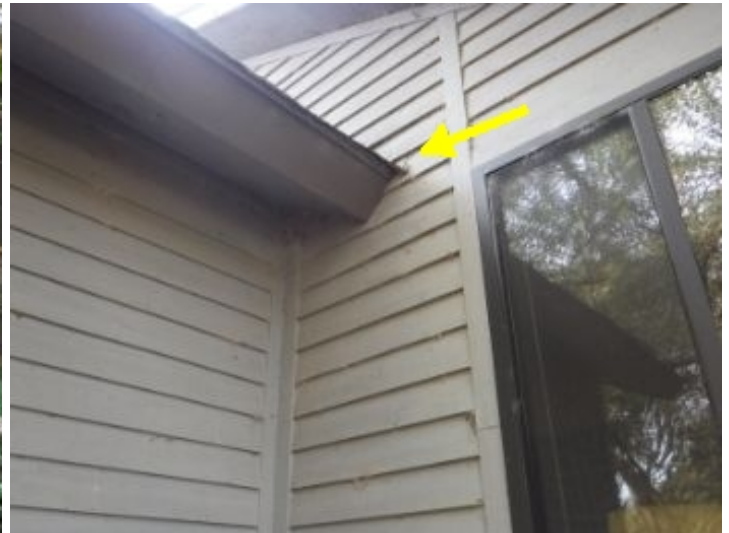
Kickout flashing is missing at the location pictured or other places . Kickout flashing is a piece of metal bent so as to divert water away from the house. It is used where a roof surface meets a wall. Lack of kickout flashing can allow moisture to enter behind the siding at that location and may cause damage. An example of kickout flashing can be found at <http://www.summerville-home-inspector.com/content/what-kickout-flashing> . There is frequently moisture penetration where kickout flashing is missing. Recommendation is to add the kickout flashing where needed. Note that it appears that there is flashing here but it isn't bent to deflect water away from home. Recommend improve.

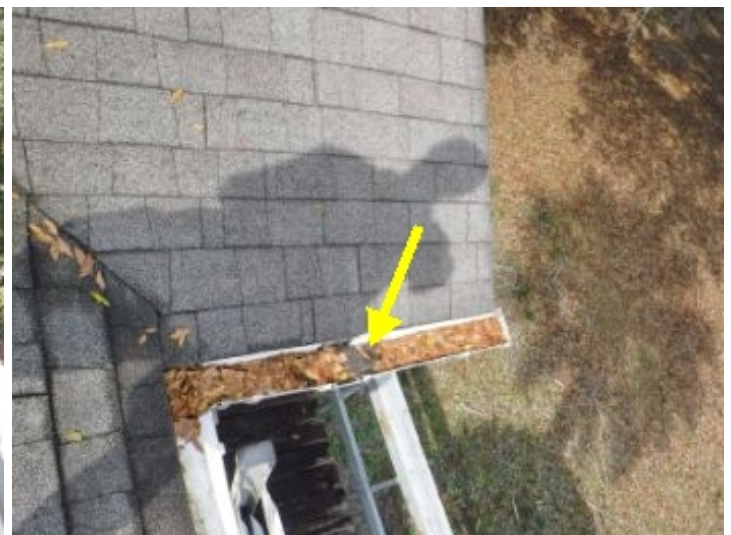
- Clean gutters: Significant amounts of debris and blockage evident.
- Gutters are in disrepair along back porch area with clogged, missing sections. Also drainage exit under home is improper. Water should flow to the exterior away from the house. Recommend improve.

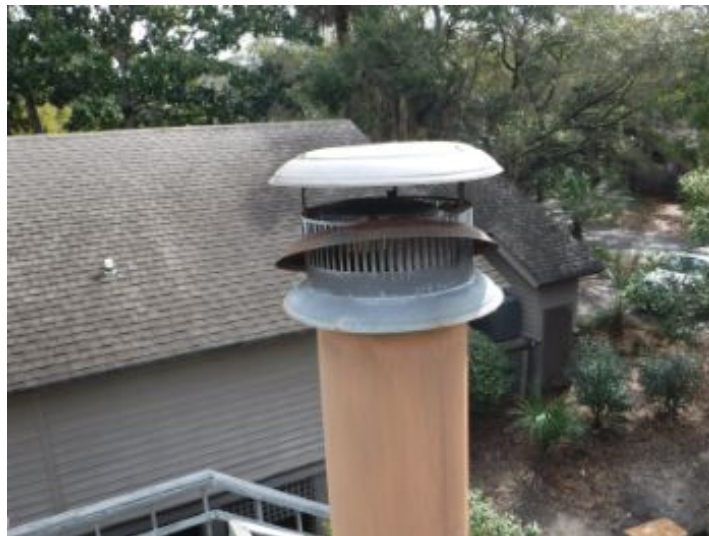
• **Cap Disrepair-** Chimney cap is in disrepair and does not hold the center pipe securely. Spark screen is missing so vermin could enter. Recommend have a qualified chimney sweep or fireplace professional repair.

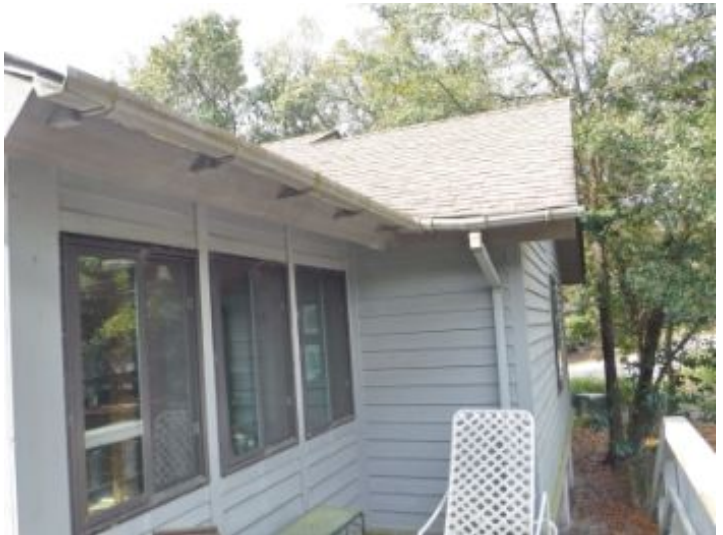
Decay (pictured)- Decay at pictured location.  
Repair as needed. In corner of deck.

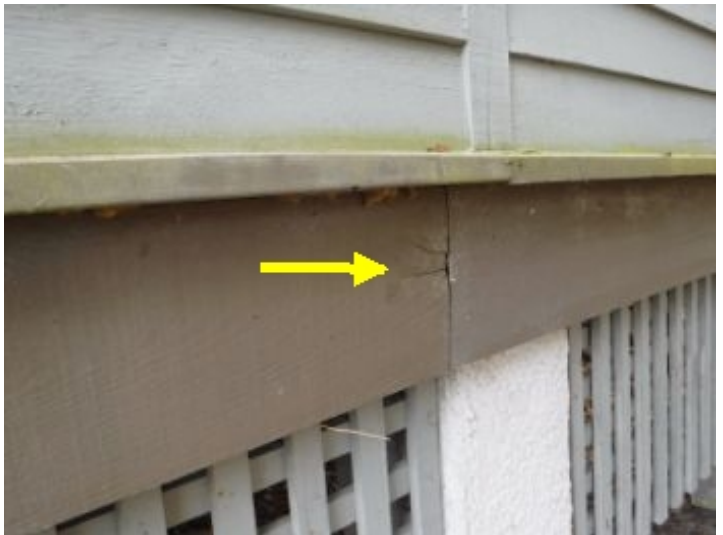
rodent chewed trim shown- improve flashing here  
at next re- roof

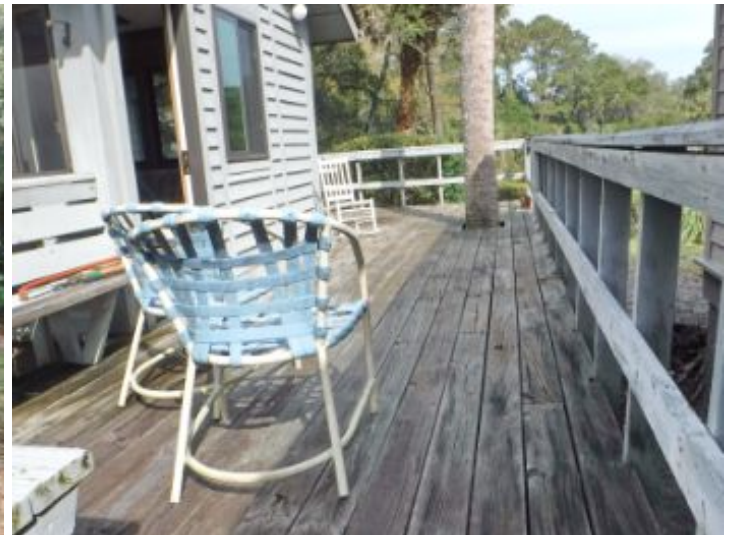
- The walking surface deck boards are nearing their useful life. Consider replacement soon. Note\* Replacing the deck surface is an inexpensive way to breath new life into an existing deck as the surface boards tend to age faster than the floor support structure.

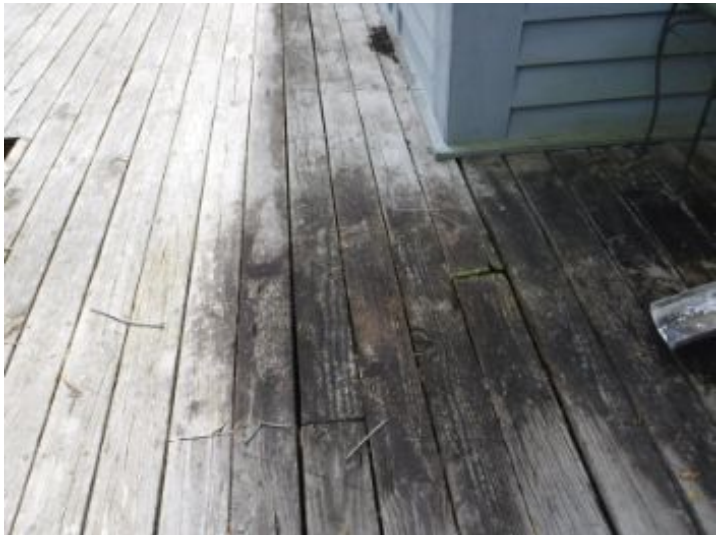
Noted there were missing or insufficient guards in the screened porch area. Modern safety rules require that raised floor surfaces over 30" in height above ground have guards 36" in height. These guards must not permit passage of a 4" sphere and be strong enough to resist a 200 lb load. Also existing guards are in poor shape with flimsy loose connections. Recommend consider improvement for safety.

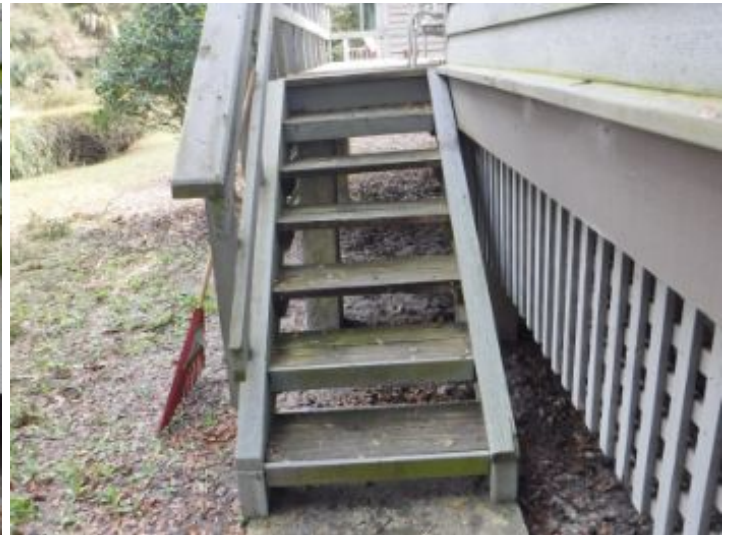
Modern safety rules require a graspable handrail for safety on all stairs of 4 or more risers or over 30" in height. A graspable handrail is about 2" in diameter. In addition raised floor surfaces over 30" in height require guards 36" in height. These guards must not permit passage of a 4" sphere (4 3/8" for stair guards) and be strong enough to resist a 200 lb load. Recommend consider improvement for safety.

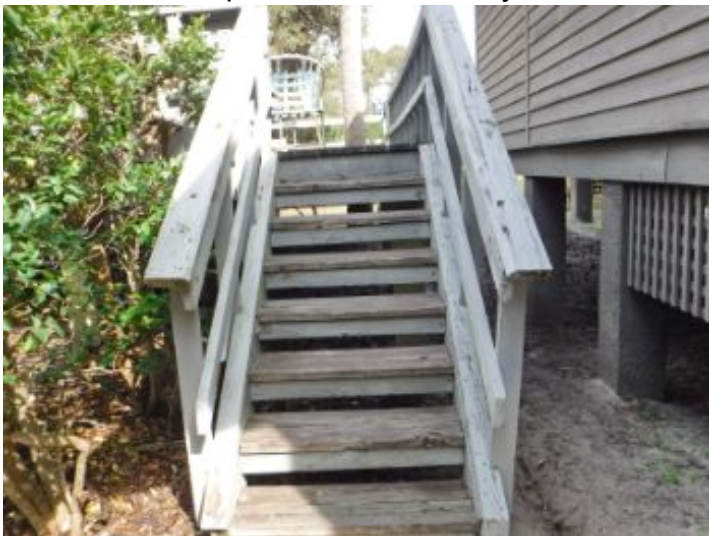
Modern safety rules prohibit open risers on stairs over 30" or 4 risers high. Recommend improve for safety.

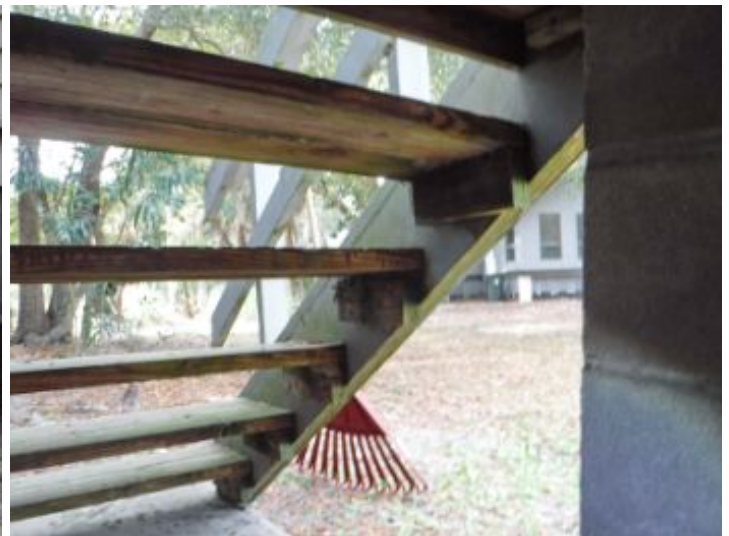
Center Stringer- The steps on the sides side of the deck does not have a center stringer. A stringer is the notched part of stairs that support the treads. A center stringer is needed for proper support. Recommend improve. Have a qualified carpenter review the deck and steps as maintenance has been deferred.

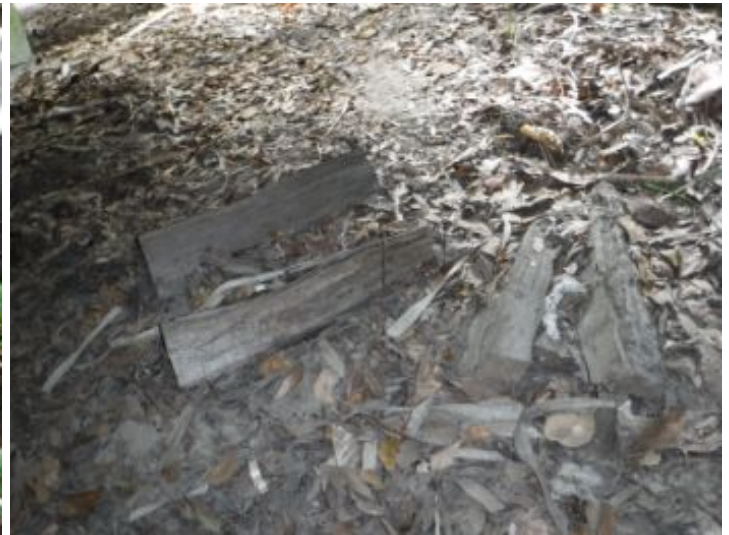
The under floor lattice was in disrepair in a few places (some are pictured) and we suggest review and repair all. Actually we recommend extending the lattice to the ground to discourage entry by vermin. Recommend repair all as needed.

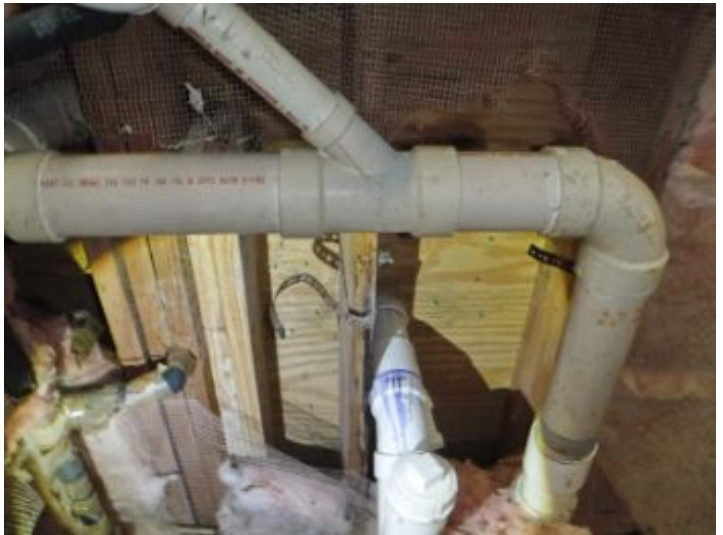
Insulation (support)-There is some insulation falling down in various areas. This can be due to improper attachment. Install more insulation supports rods where needed or netting to retain the insulation in place. Note that open netting is marginal at keeping out rodents. Consider alternatives such as house wrap or plywood.

missing insulation shown

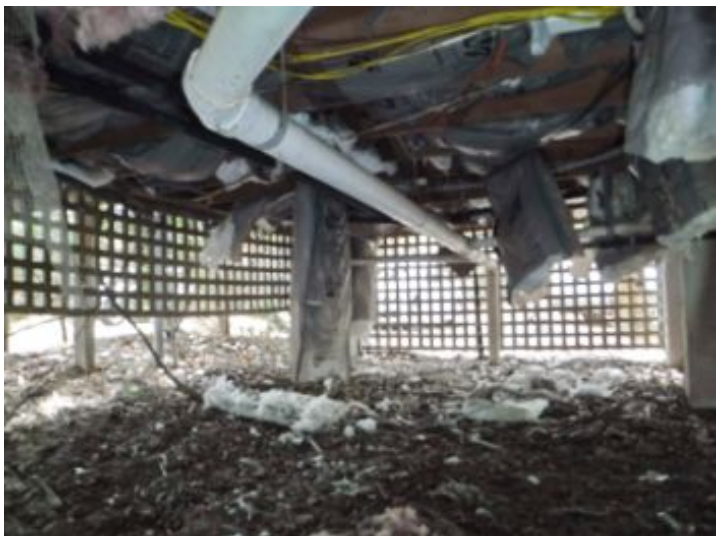
Insulation (support)-There is some insulation falling down in various areas. This can be due to improper attachment. Install more insulation supports rods where needed or netting to retain the insulation in place. Note that open netting is marginal at keeping out rodents. Consider alternatives such as house wrap or plywood.

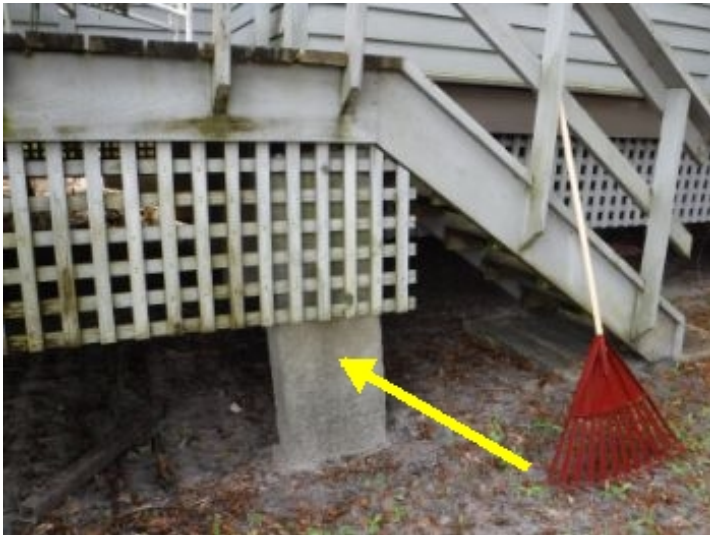
Pier by back deck stairs is leaning, is not filled with concrete and is open at top. Open cells are not allowed. Have it repaired.

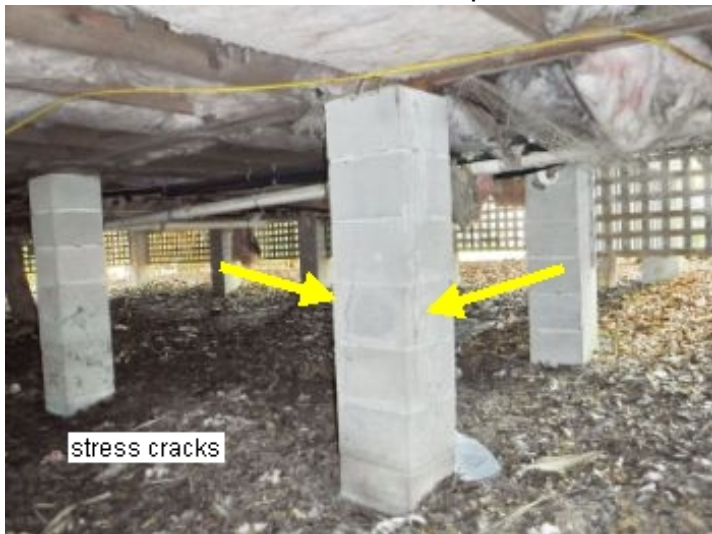
stress cracks

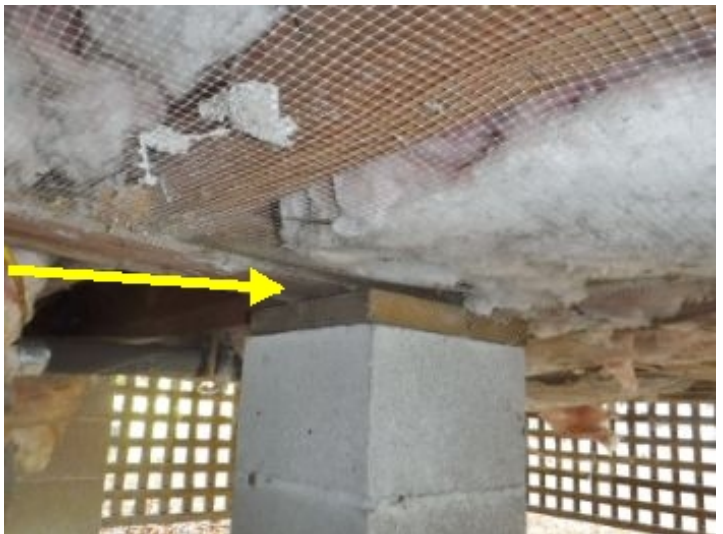
needs shimming

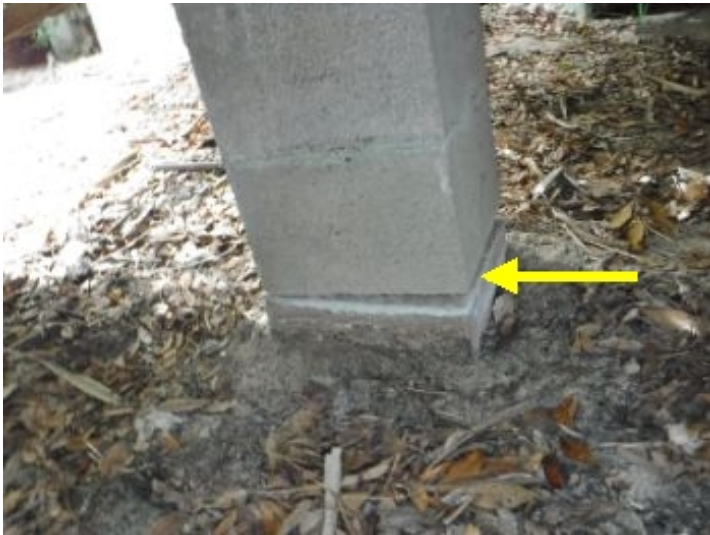
Pier (leaning)- Pier as pictured is leaning and structurally deficient. (at least three noted) Repair as needed.

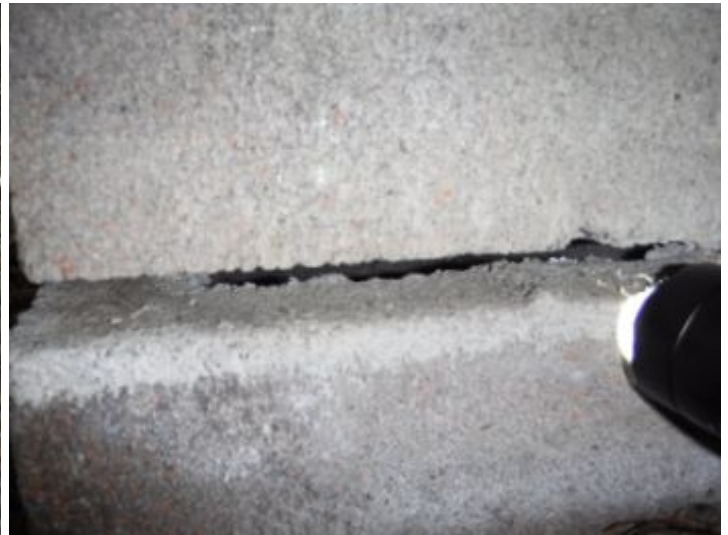
close up view of crack at bottom of pier reveals no reinforcing concrete or steel

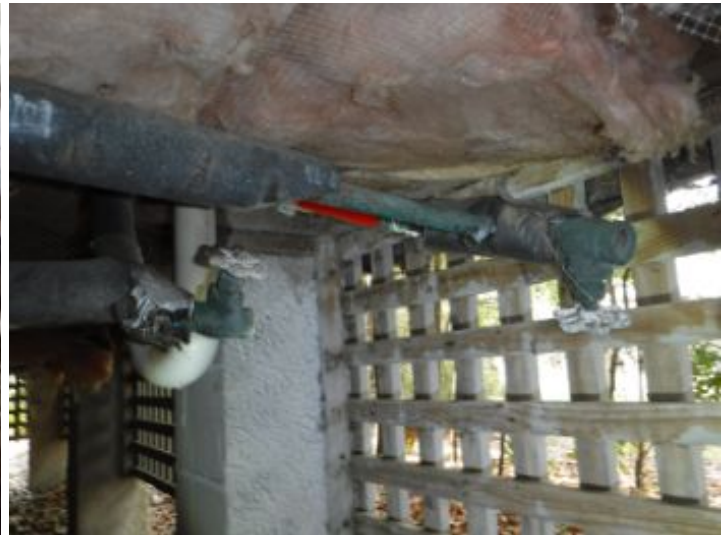
piping needs a little support here

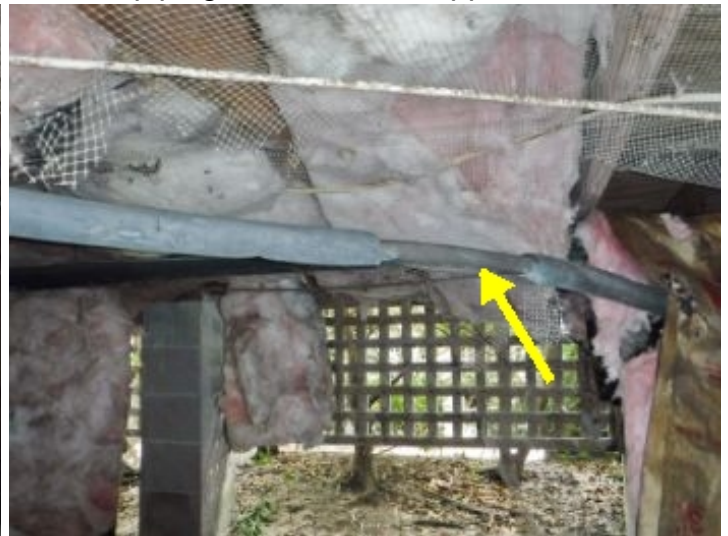
The refrigerant line (from the air conditioner) has gaps in the insulation in places in the crawlspace. Insulation is required. A line which is not insulated will suffer a performance loss and condensation will form on piping causing moisture issues in the crawlspace which is undesirable. Recommend improve.

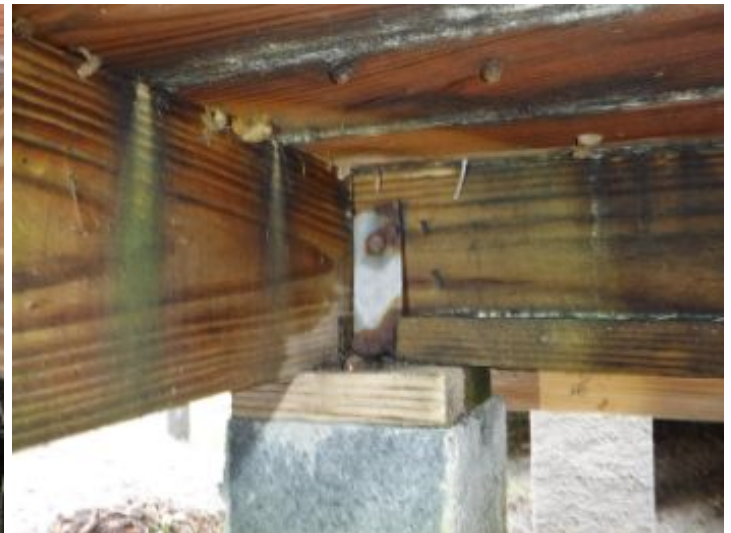
severely rusting anchor

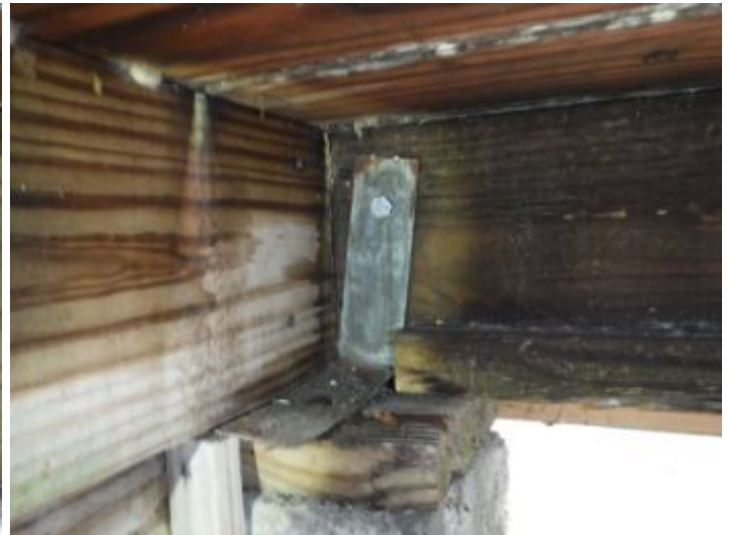
General Comments and Analysis- Although it appeared that metal strapping was inside the piers in the ones I checked it was not the case. It appears in the few I checked that a short piece was bent into an L shape and only bolted to the band. Effectively useless as far as wind uplift resistance is concerned. Recommend have an engineer or a contractor who specializes in foundation repair review and advise.

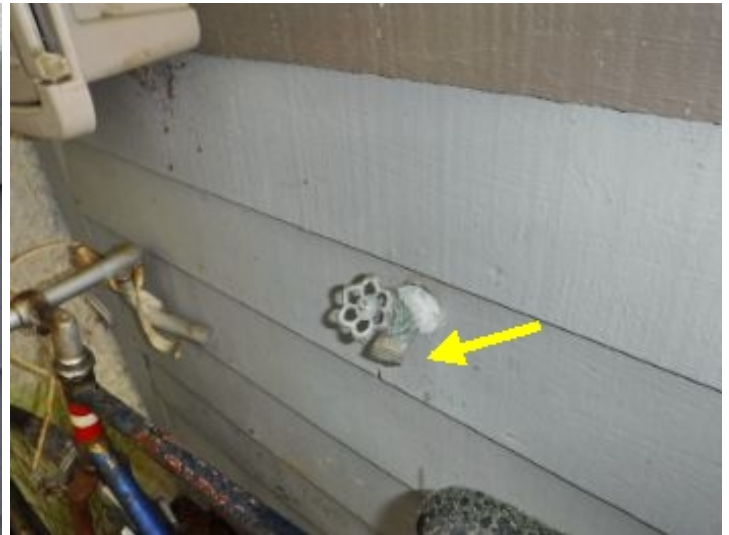
Hose bib (attachment)- Hose bib is not firmly attached. Repair as needed.

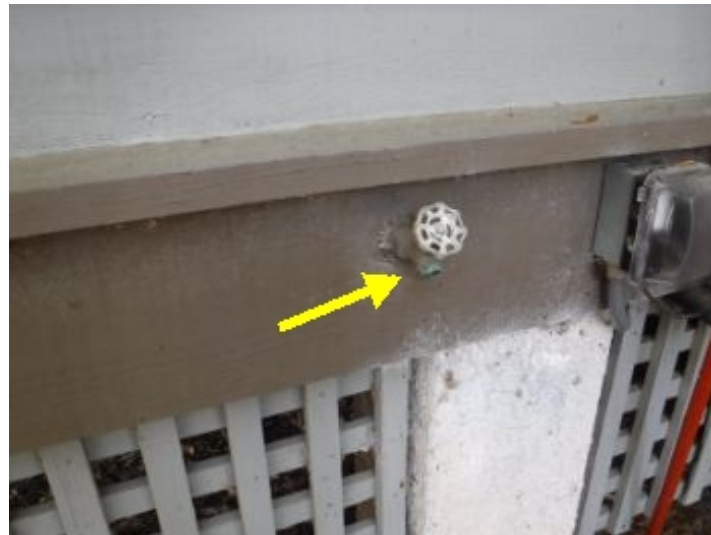
Absent (all)- Noted not present on hose bibs.(anti backflow devices) Recommend improve.

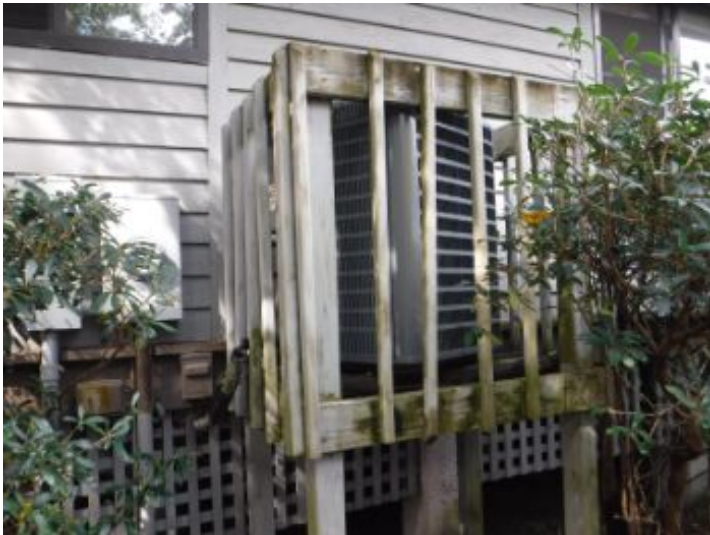
AC Support- Support deck is in need of minor repairs. Recommend improve.

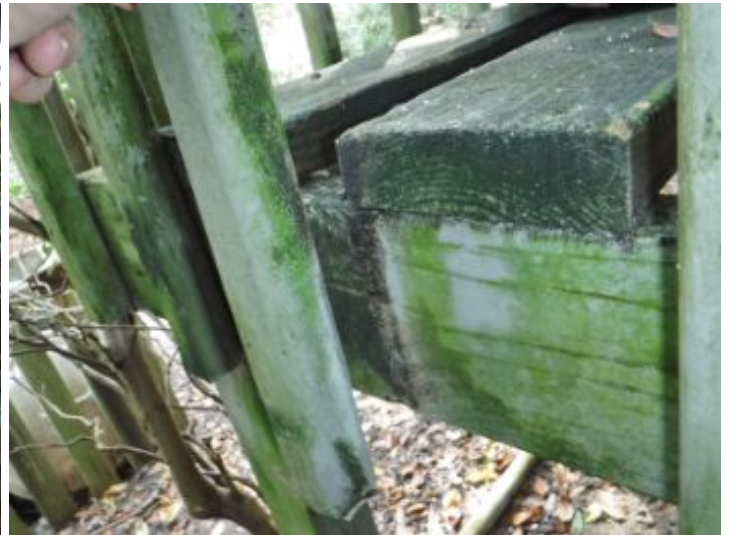
shows loose pickets on AC stand from rusting fasteners.

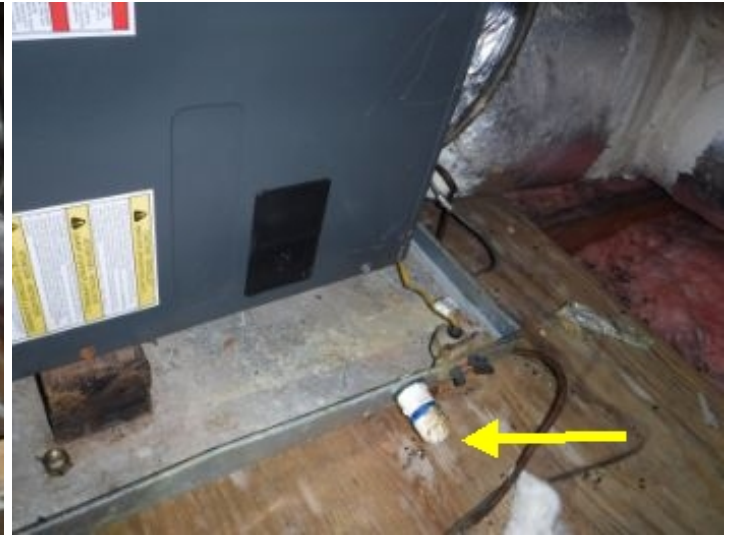
Pan Drain Line (absent) Pan drain line is absent or capped. This is allowed if an automatic (float switch) disconnect device is present. However should the primary drain line fail the overflow pan will be full of water which will be difficult to remove even if a capped fitting is present. Recommend that the pan drain be extended to the exterior of the home for optimum performance.

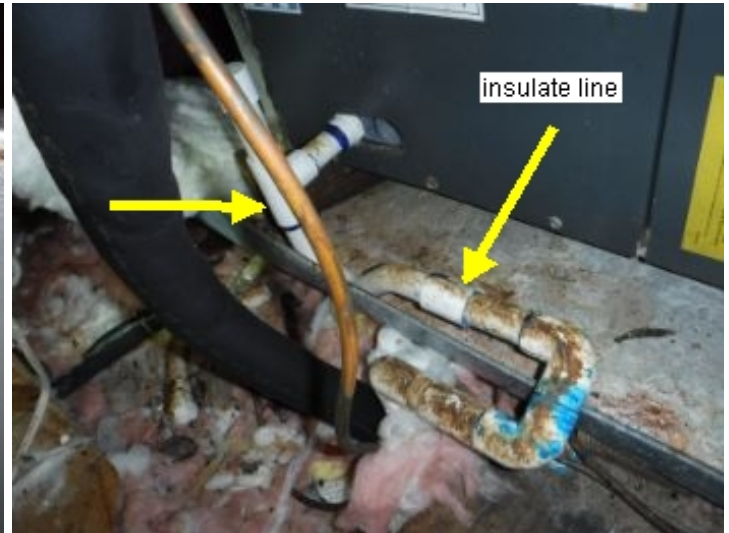
\*Gunk or other buildup noted in the condensate trap. When traps clog a backup will happen. Recommend cleaning.

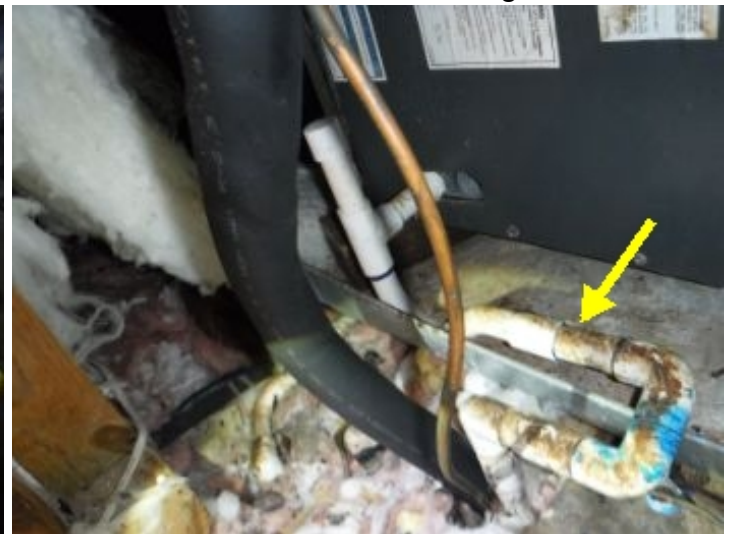
Insulation- Primary condensate line is not insulated. Line should be insulated in the attic areas to prevent condensation from forming on pipe. Condensation can damage building materials. Recommend improve.

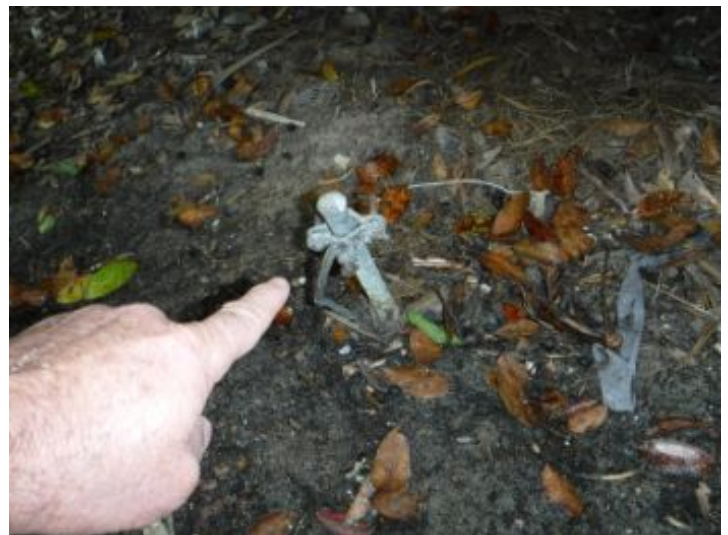
Grounding clamp at the ground rod is loose. Repair as needed for safety. Grounding clamps must be torqued to specifications (good and tight) and driven flush to grade.

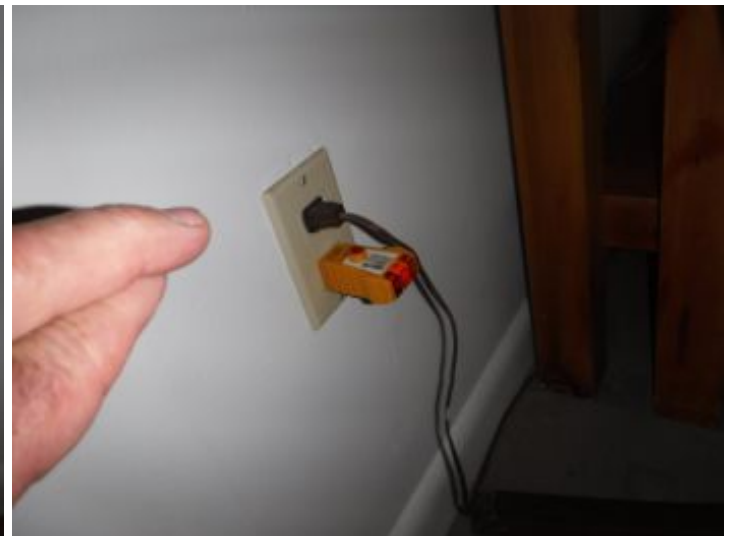
\*Outlets- An electrical outlet/s as pictured showed an - hot, neutral reversed (reversed polarity) - condition. Repair as needed.

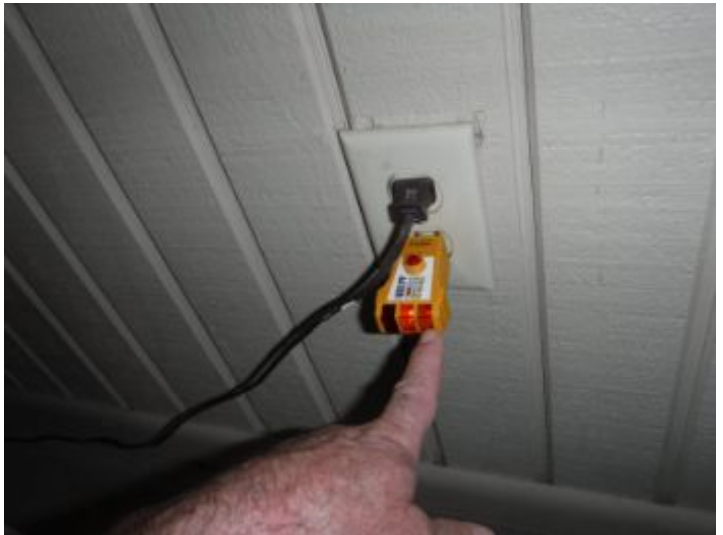
\*Outlets- An electrical outlet/s as pictured showed an - loose connection - condition. Repair as needed.

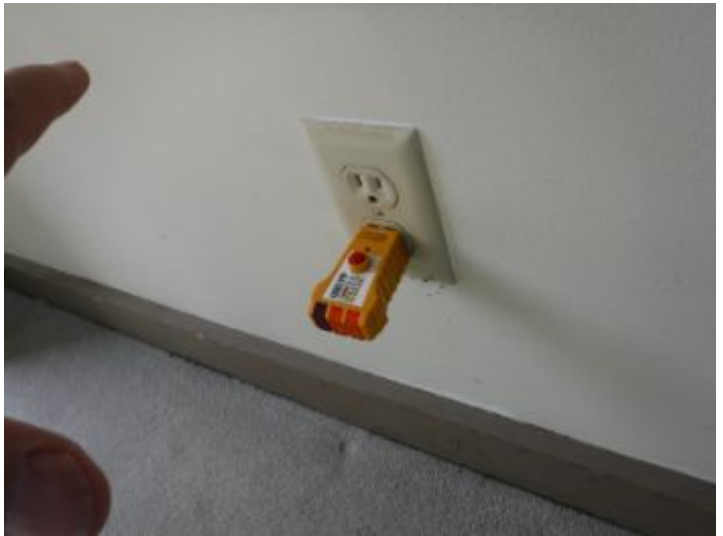
\*Outlets- An electrical outlet/s as pictured showed an - loosely mounted in box - condition. Repair as needed. More than several noted.

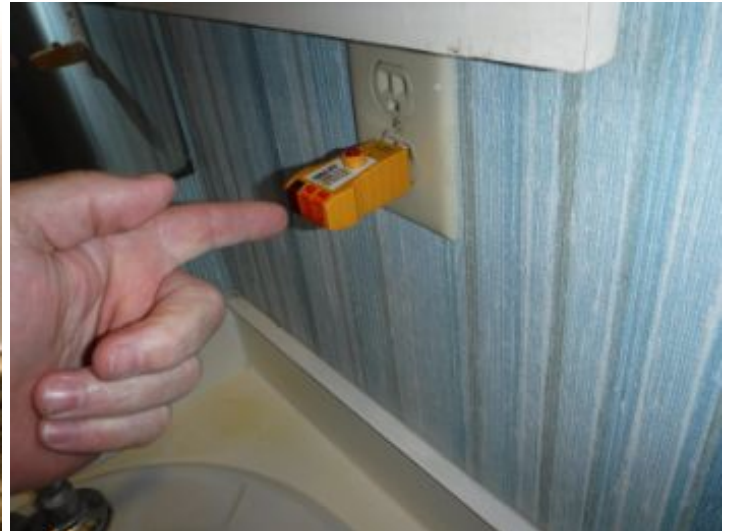
Not Protected- The bathroom receptacles did not test positive for GFI protection. Recommend improve for safety.

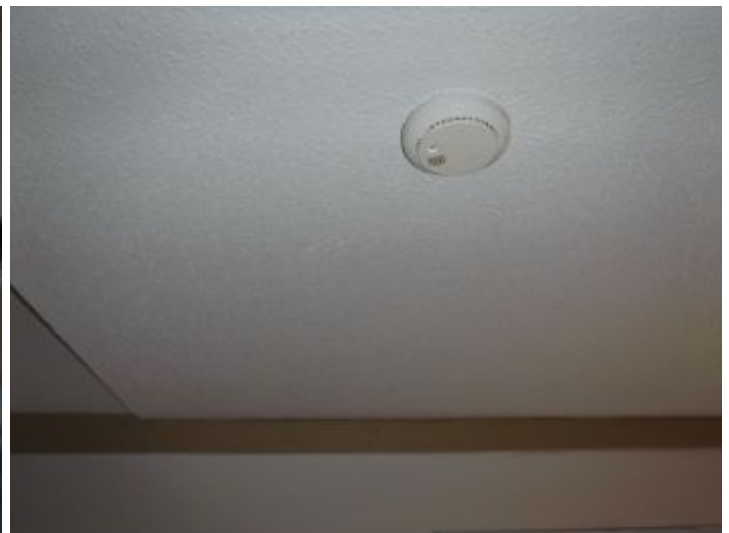
Testing (device failed)- Note at least one smoke/CO detector failed. (pictured) Probable battery issue. Repair as needed.

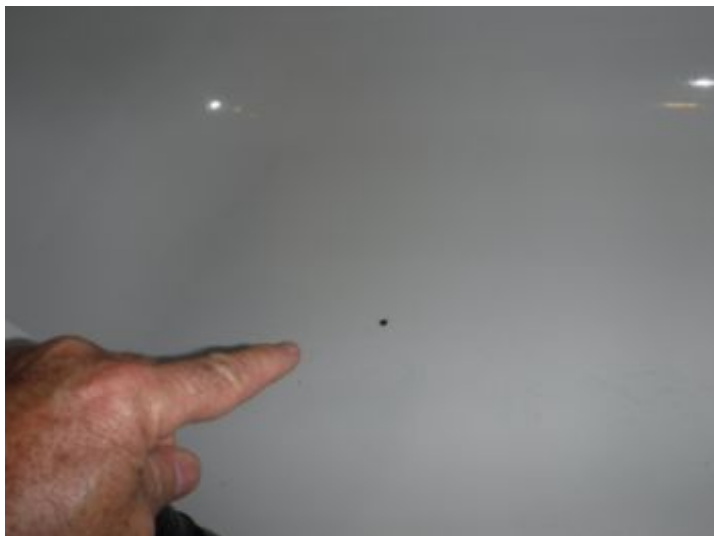
Minor chips noted in finish. Chips and scratches can be refinished by a professional.  
(Recommended)

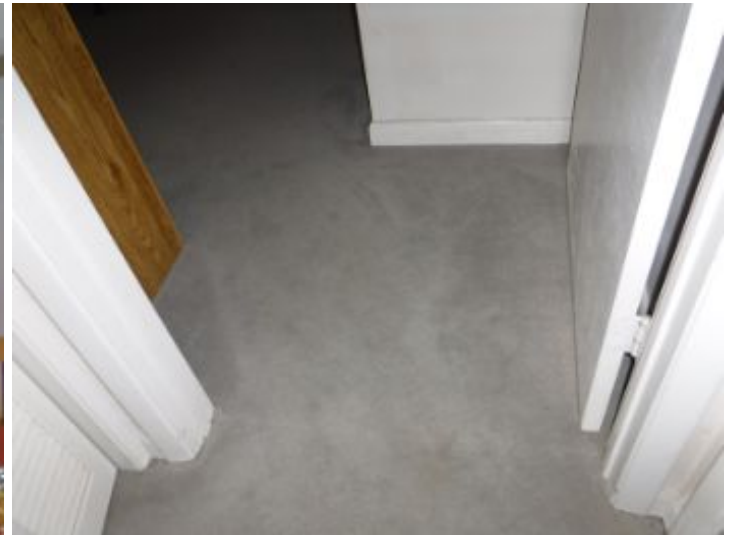
Floor felt spongy here- probably improper subfloor attachment

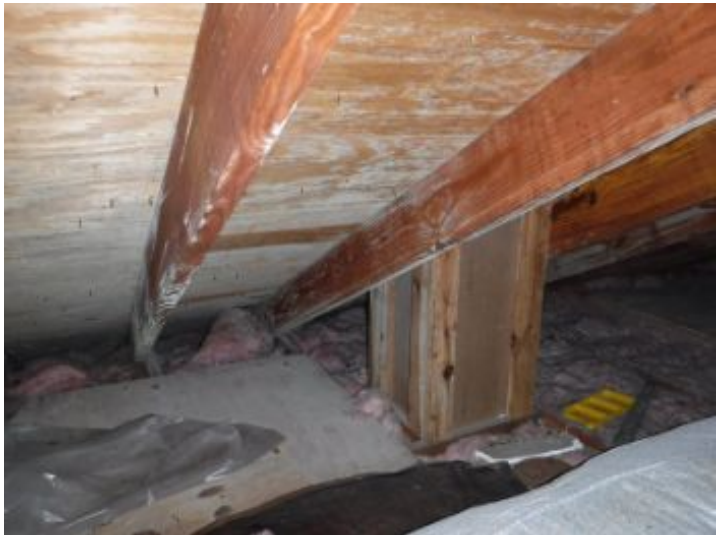
Microbial Growth- Some microbial growth observed on some framing components in the attic. Some areas are pictured. Although generally it was a modest amount it was not insignificant. Recommend improve attic ventilation. Some remediation is suggested (removal and treatment) especially if sensitive individuals.

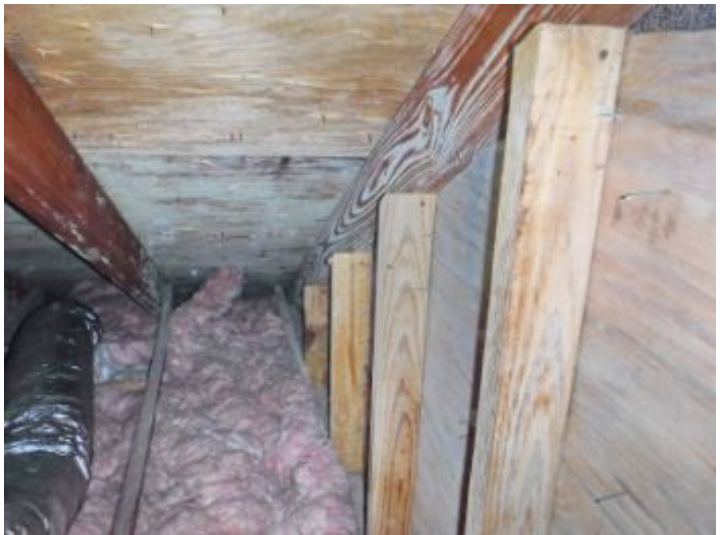
Microbial Growth- Some microbial growth observed on some framing components in the attic. Some areas are pictured. Although generally it was a modest amount it was not insignificant. Recommend improve attic ventilation. Some remediation is suggested (removal and treatment) especially if sensitive individuals.

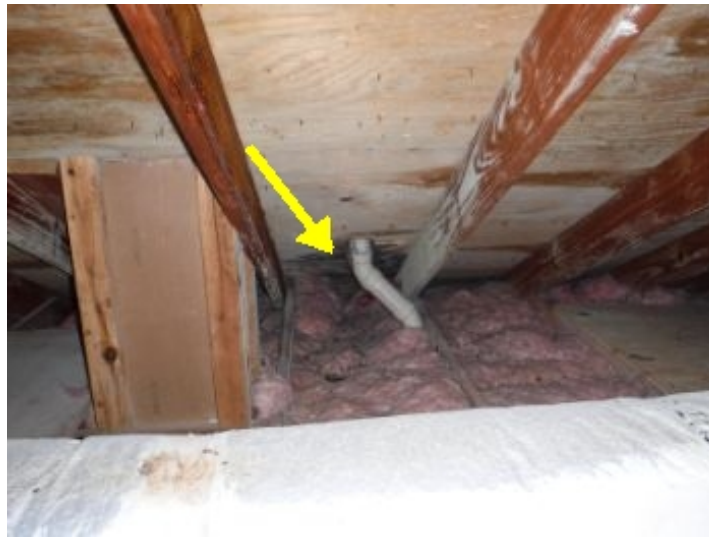
Vent Stack (past/current leak)- There was some evidence of past or current leak around a vent pipe. Recommend repair as needed.

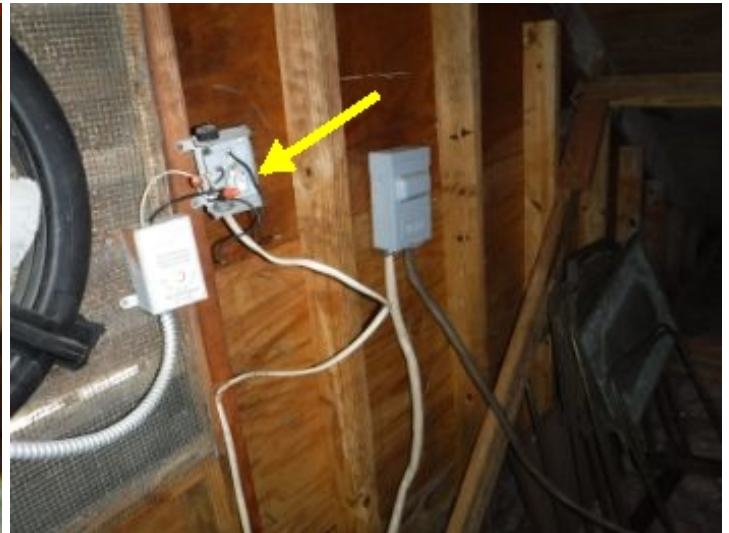
J Boxes, connections- Connections made outside of a junction box is not allowed and pose a safety hazard. Connections need to be made inside of a listed box with a suitable cover properly attached to framing as required. Recommend repair as needed.

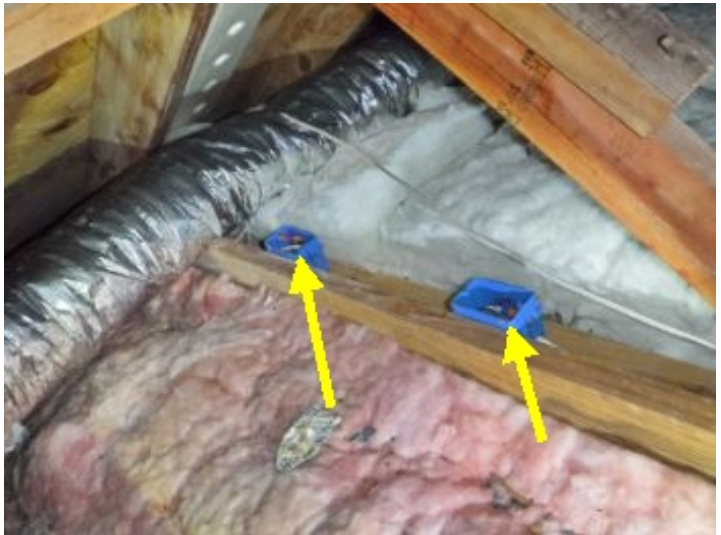
J Box Covers- Noted more than several junction boxes without a suitable cover, which is a safety concern. Some are pictured. Recommend installing proper covers, as needed, for safety. In addition boxes need to be properly attached to framing as required. Recommend repair all as needed.

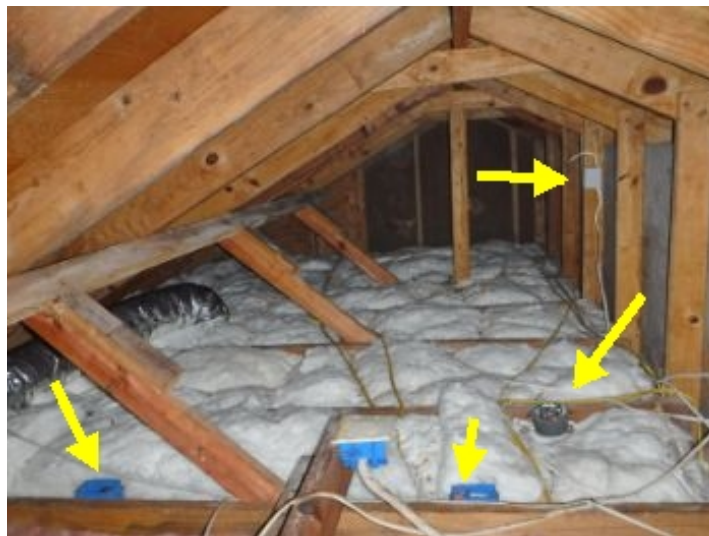
J Box Covers- Noted more than several junction boxes without a suitable cover, which is a safety concern. Some are pictured. Recommend installing proper covers, as needed, for safety. In addition boxes need to be properly attached to framing as required. Recommend repair all as needed.

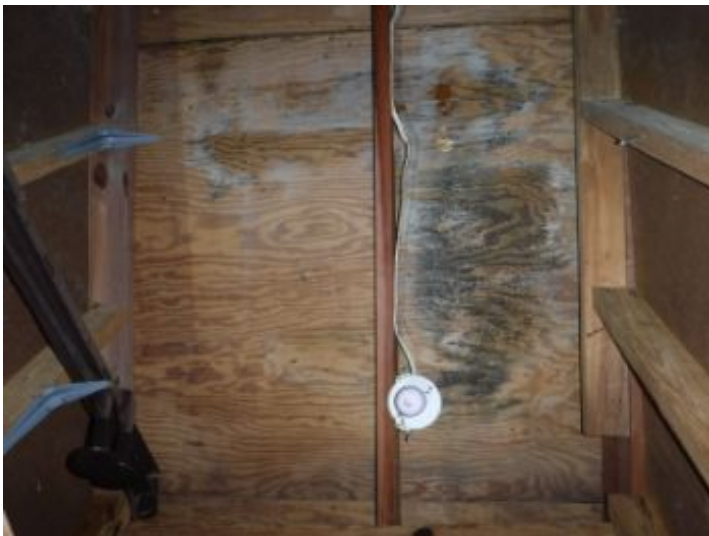
microbial growth on utility room ceiling- possible leak or insufficient ventilation in this area.
