## Diagnostic Result

ACTROS 930.0 - 934.3

FR

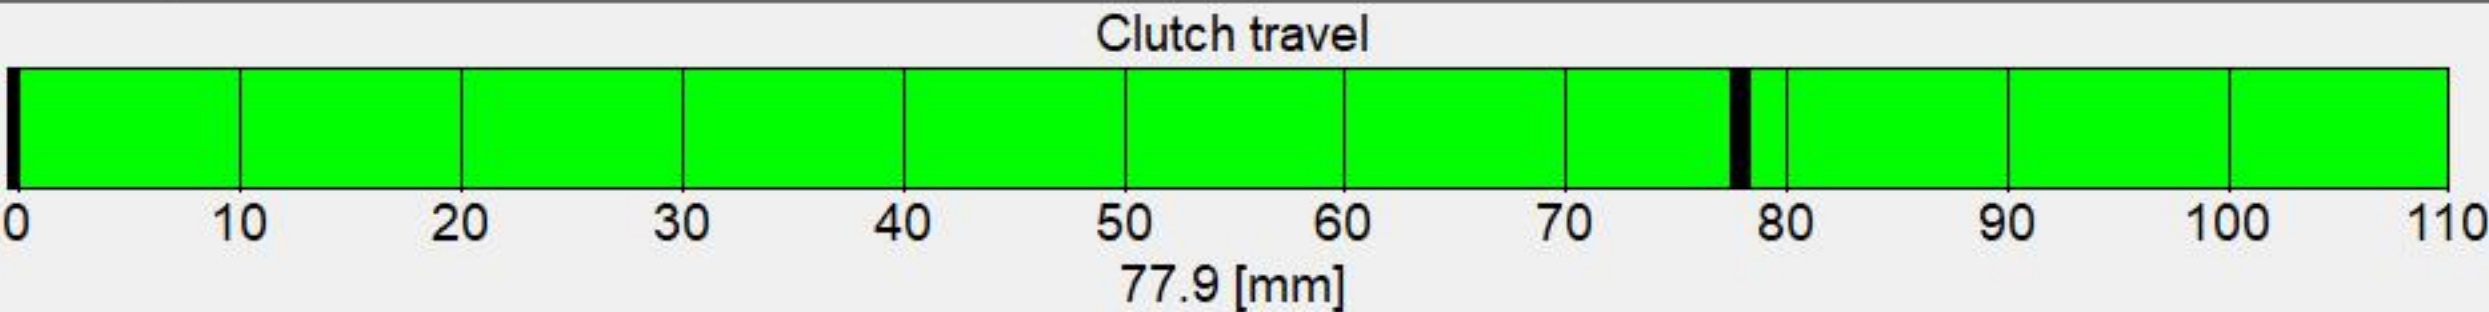
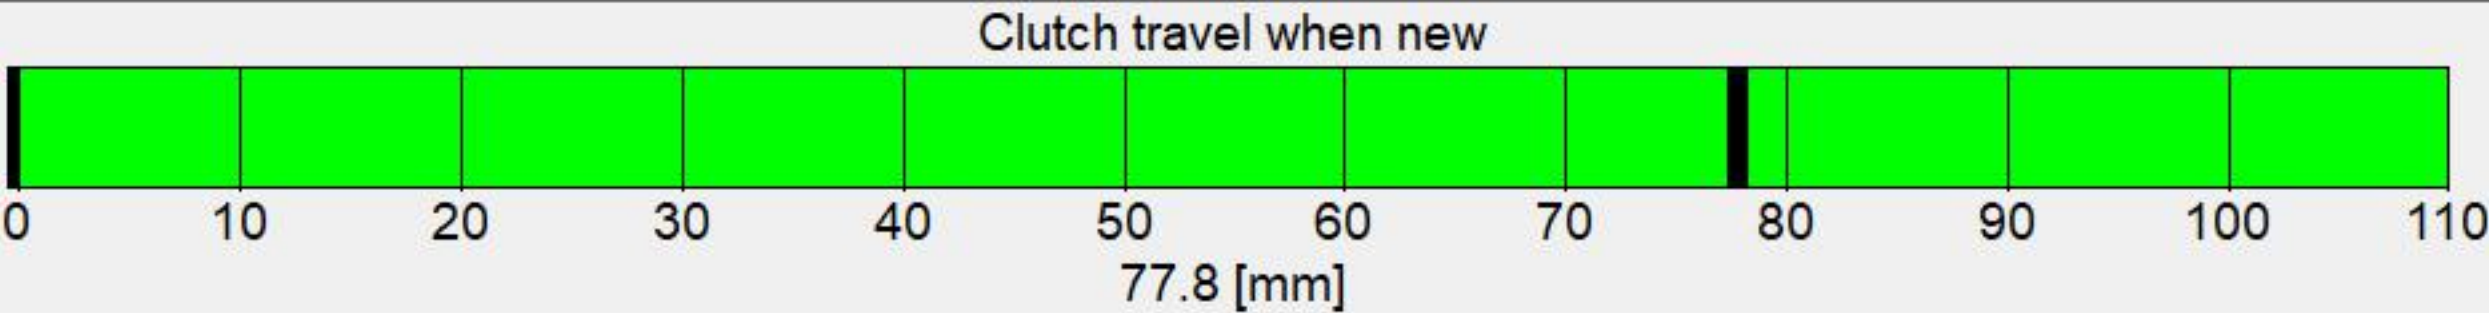
Clutch pedal is learned.

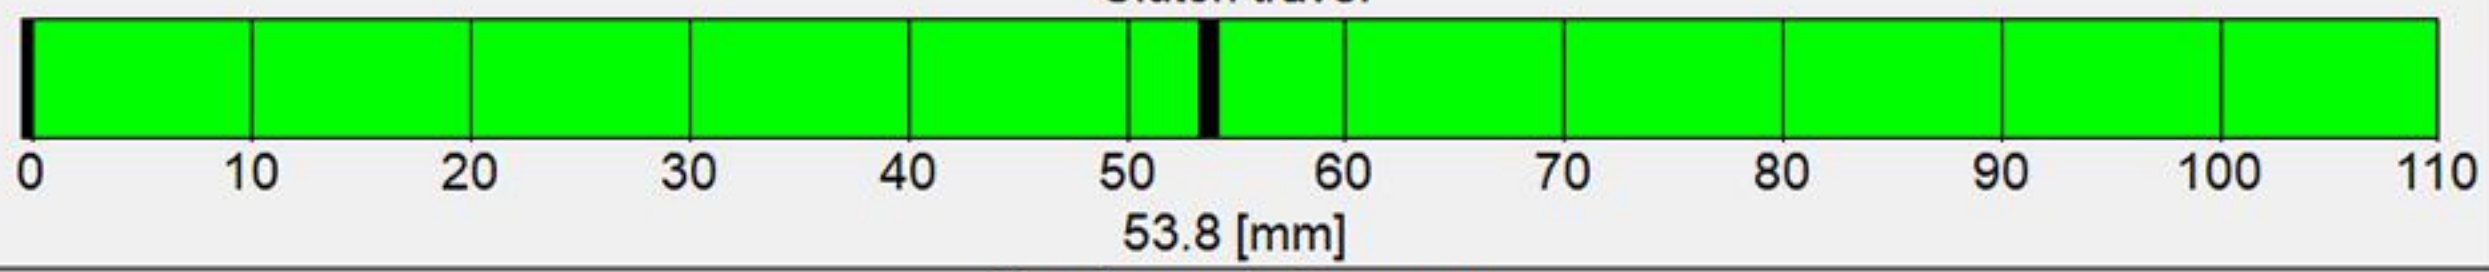
Clutch travel

Clutch pedal is learned.
