## HMAS Sydney II Commission of Inquiry

### Report on Technical Aspects of the Sinking of HMAS *Sydney* and HSK *Kormoran*

DSTO-GD-0559

This report describes the technical findings of the battle and sinking of HMAS Sydney and HSK Kormoran based on historical and archeological evidence. The battle occurred on the 19<sup>th</sup> of November, 1941 off the West Australian coast. The wrecks of the two ships were discovered in March 2008 and their subsequent underwater exploration has shed light on the events that took place during and after the battle.

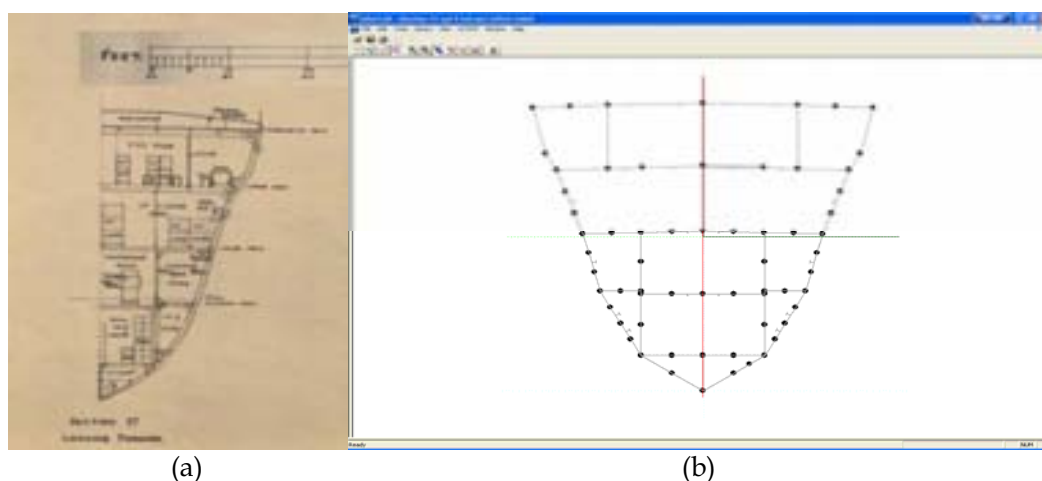
ROV footage analysis from the *Geosounder* expedition identified that there was visible damage caused by a torpedo hit on *Sydney* at approximately frame 27 (see description of evidence from the wreck site in Chapter 6). The geometry and longitudinal stiffener arrangement of frame 27 was input using the sections design drawing [23], shown in Figure 9a. The shell expansion [24] was used for the outer shell plating thicknesses and the ULTSTR model set up using a combination of stiffened panels and hard corners. The ULTSTR model of frame 27 is shown in Figure 9b.

Figure 9: Frame 27 arrangement (a) and ULTSTR model (b)

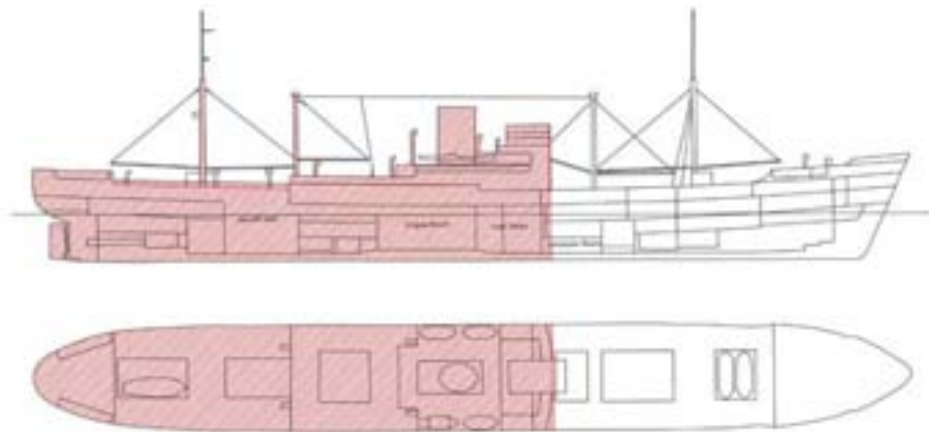
Figure 97: Extent of damage to *Kormoran* as it lies on the ocean floor [159]

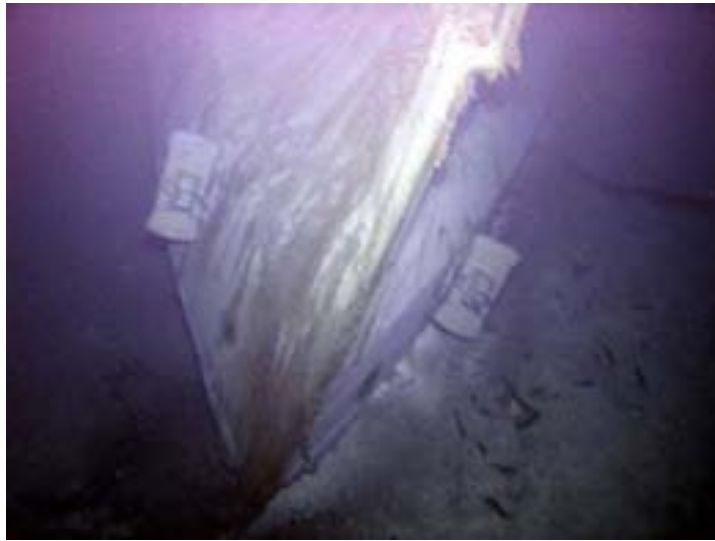
Figure 113: Forward section of the inverted bow resting on the ocean floor [171]

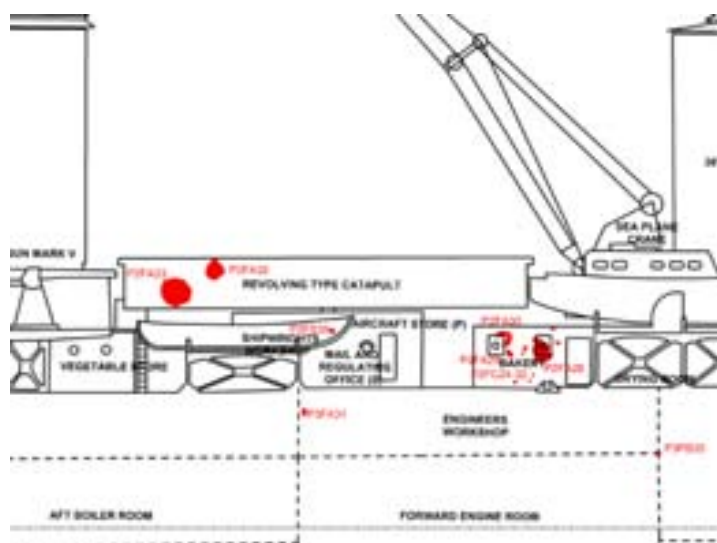
Figure 127: Location of weapon damage to port side around catapult

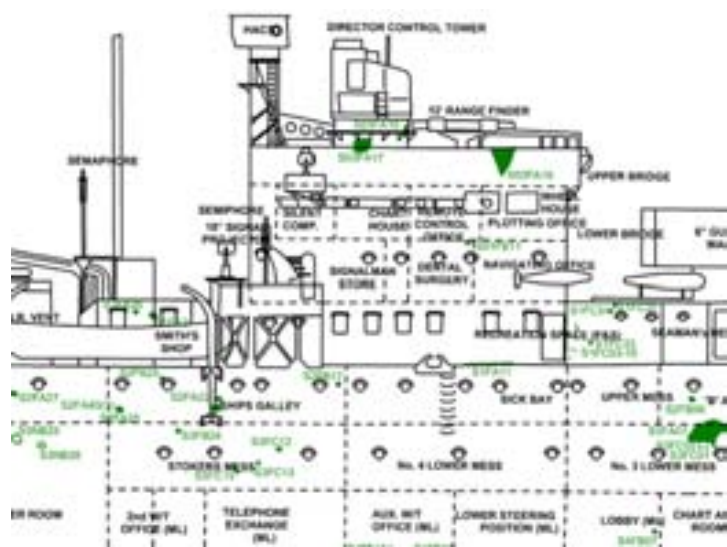
Figure 130: Location of weapon damage to starboard side around the bridge

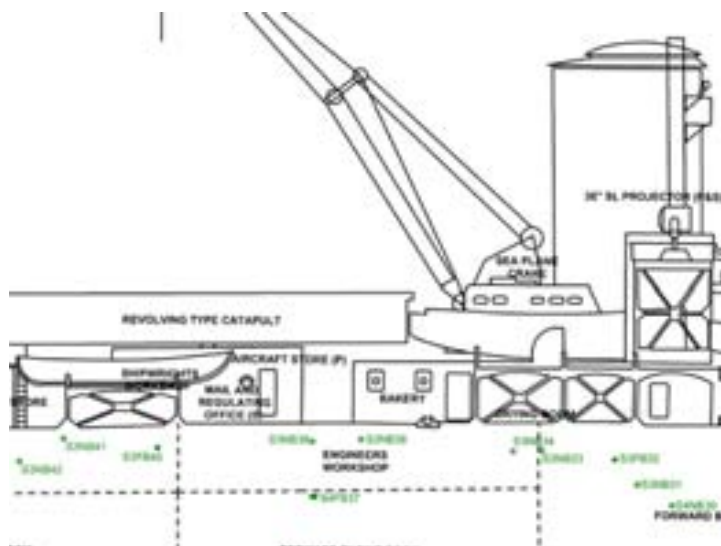
Figure 131: Location of weapon damage to starboard side around the bakery

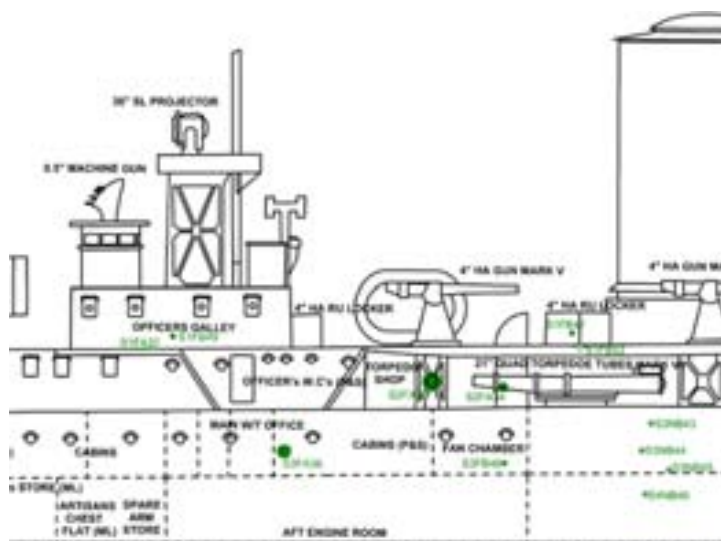
Figure 132: Location of weapon damage to starboard side around the 4" HA guns

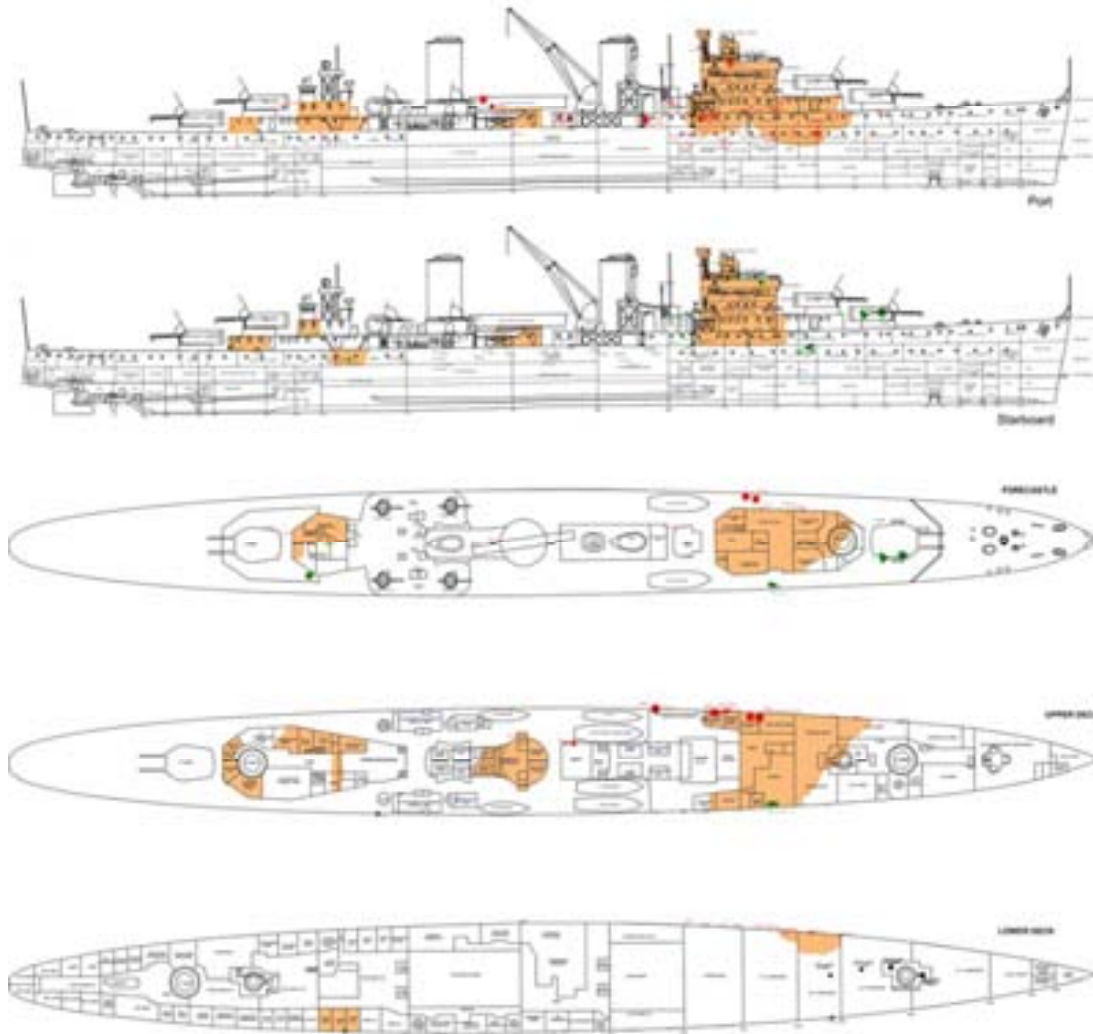
- Midships below the aircraft platform and across the upper deck.
- The aft superstructure and upper deck on the port side and aft superstructure on the starboard side, below the aft control position. The upper deck is also burnt below X turret. The starboard hull (lower deck) is burnt around a shell impact/penetration.

Figure 146: The areas of Sydney that were affected by fire damage are shaded in orange

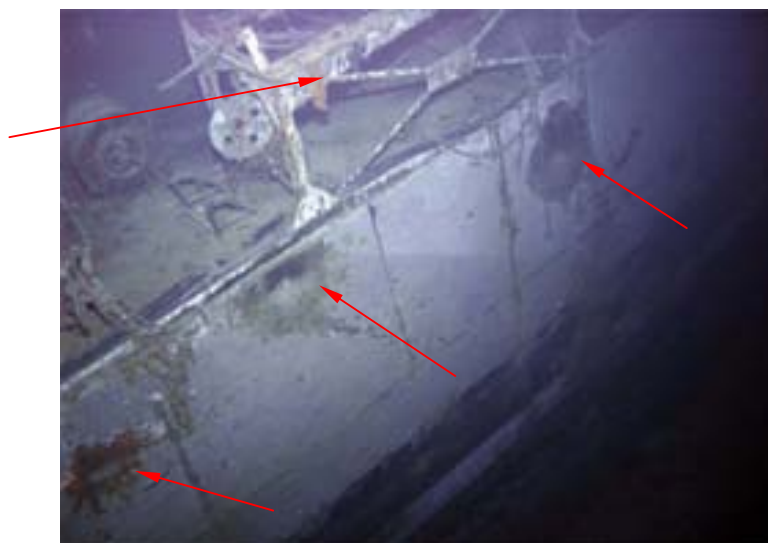
*Figure 152: Starboard side, end of 27' Whaler cradle – note fragment damage to front of cradle frame and weapons damage to the hull which would have caused major fragmentation [246]*

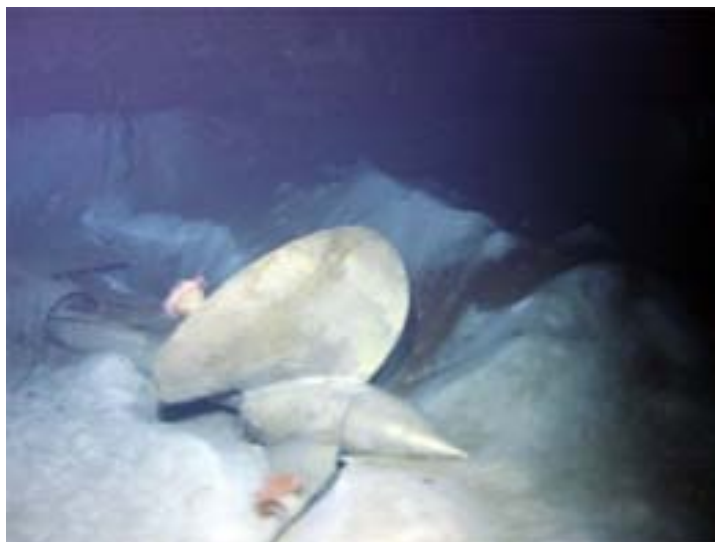
Moving further forward along the seabed there is evidence that the impact with the seabed caused major damage to the propellers, shafts and the associated supporting structure. One of three-bladed highly-pitched propellers is shown in Figure 165. This is the port inner propeller and the shaft has been partly withdrawn by about 8-10'. The shaft bracket has separated from the hull and the fractured top arm is also visible. The propeller is partly buried in the sand or silt on the seabed.

*Figure 165: One of the ship's port propellers on the seabed [258]*

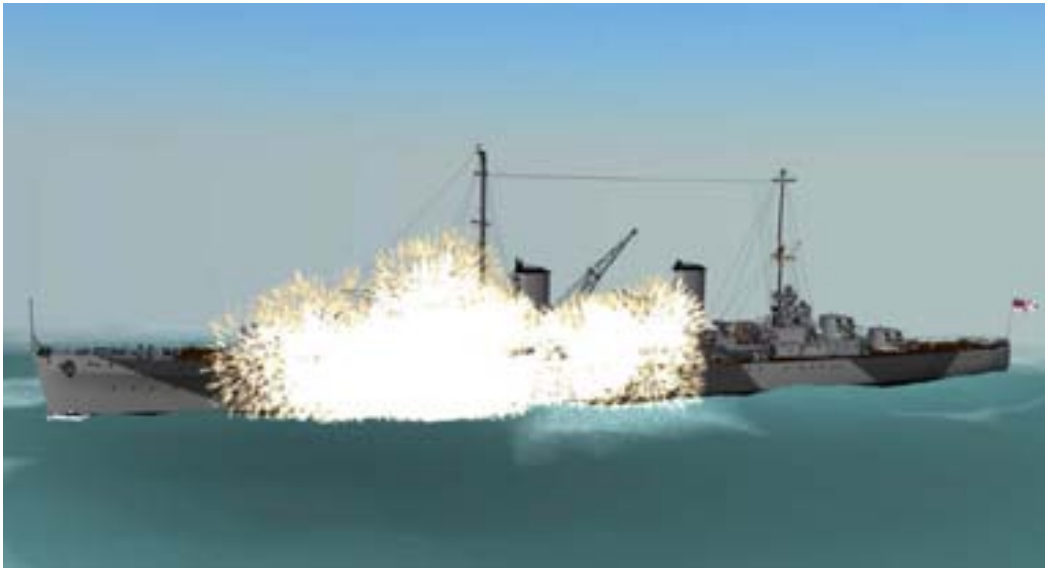
The location of the port side 15 cm hits to *Sydney* are shown in Figure 125 to Figure 128. These hits are primarily concentrated around the forward part of the ship, superstructures, and the upper and Lower Decks below the forward superstructure. Another concentration of hits is midships in the region of the catapult. All these shell hits are shown in Figure 209.

Figure 209: Shell detonations on the port side of Sydney occurring simultaneously

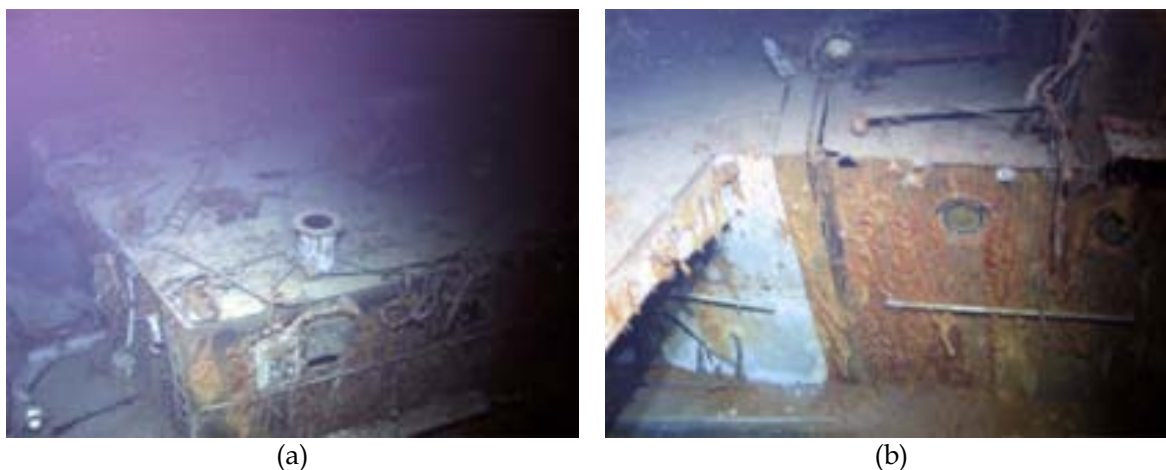
There was fire damage to many of the areas close to the Carley floats. For example, Figure 258 shows the Officers Galley and WCs on the port side at the aft end of the 4" gun deck. The Carley floats attached to the wood storage rack would have been close to this area and could have been affected by the fire.

Figure 258- Fire damage to the port side aft upper deck in the vicinity of the 4" gun deck [254, 312]

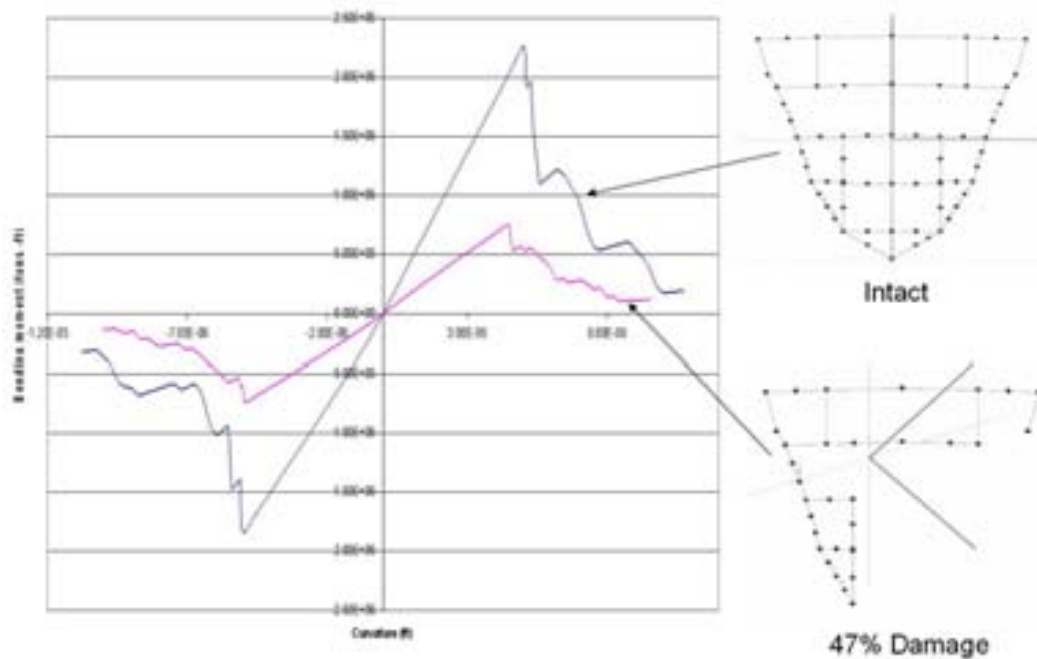
Figure 260: Comparison of Ultimate strength curves for frame 27 intact and frame 27 with 47% of structure removed due to damage

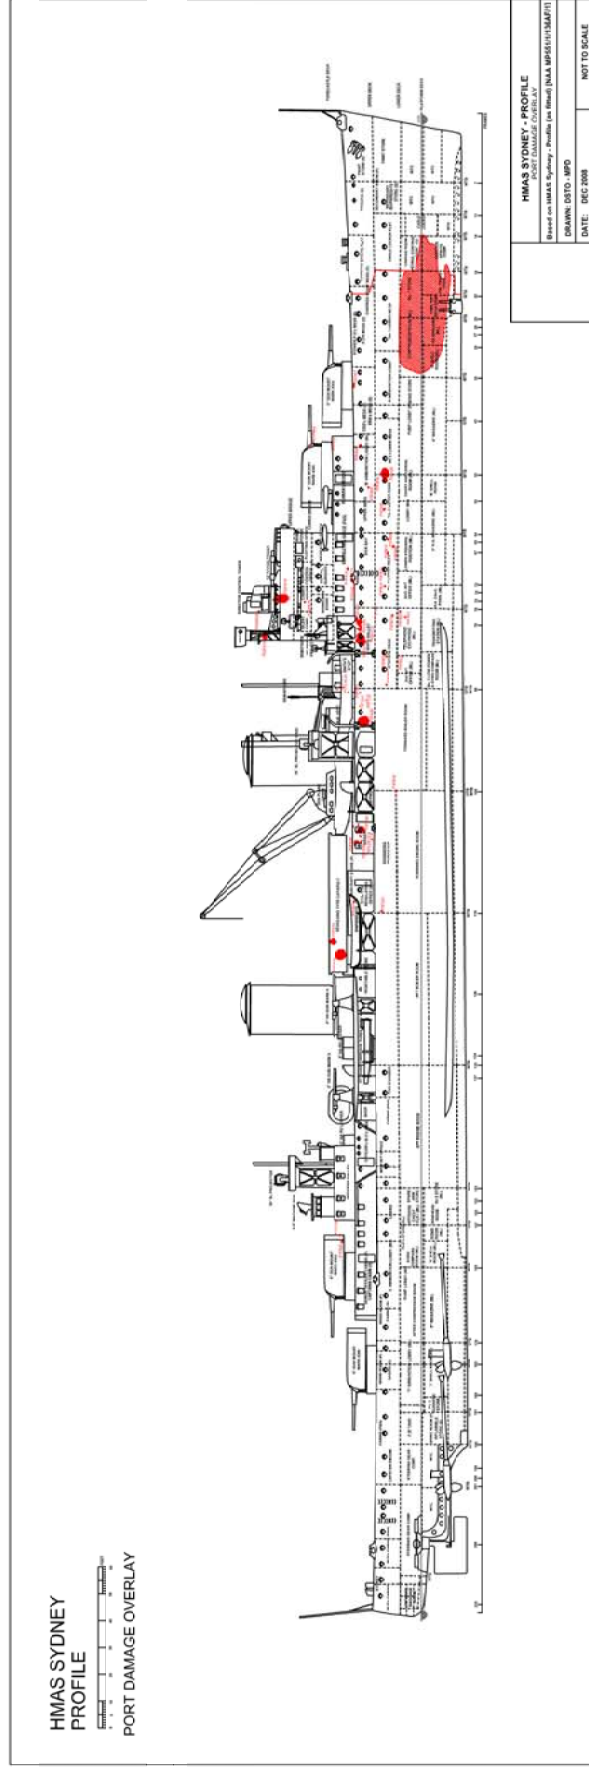
Figure 284: Damage to HMAS Sydney on port side

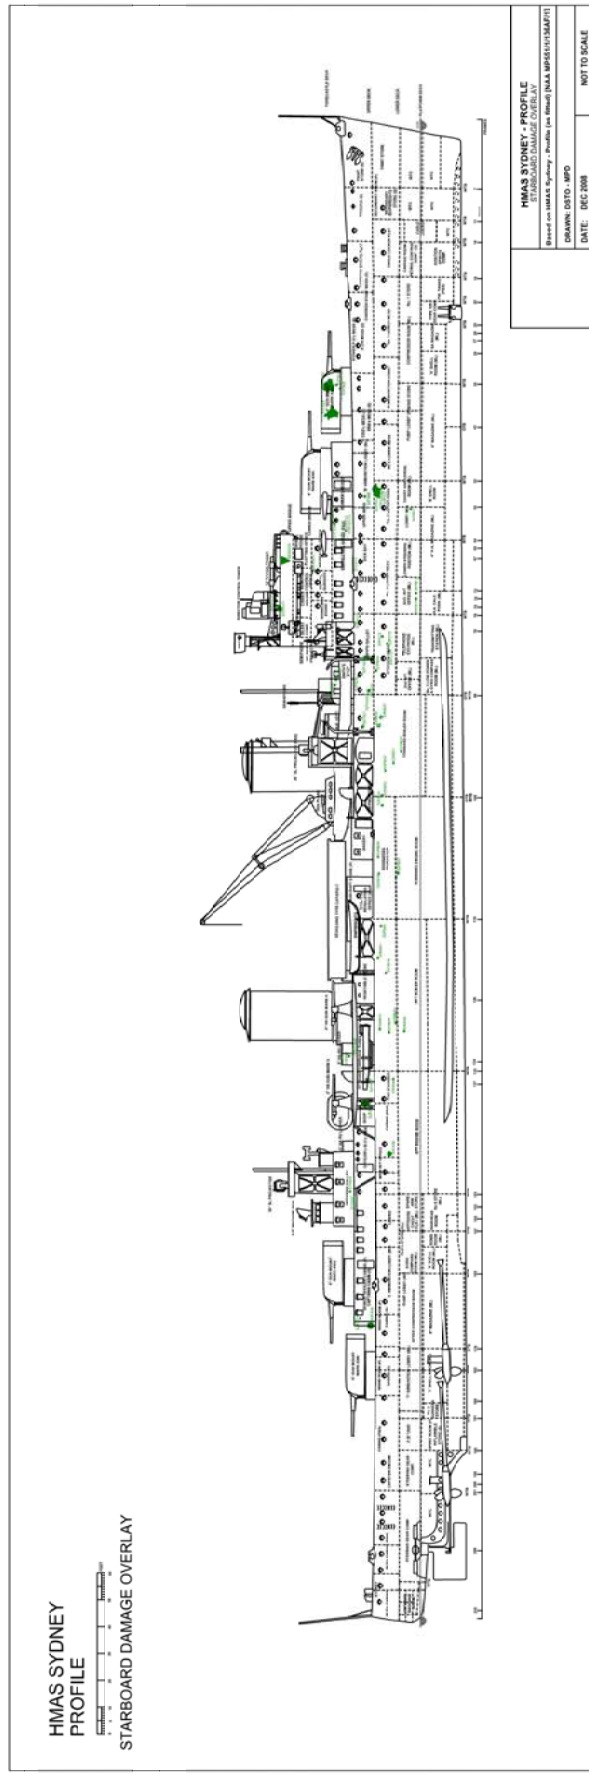
Figure 285: Damage to HMAS Sydney on starboard side

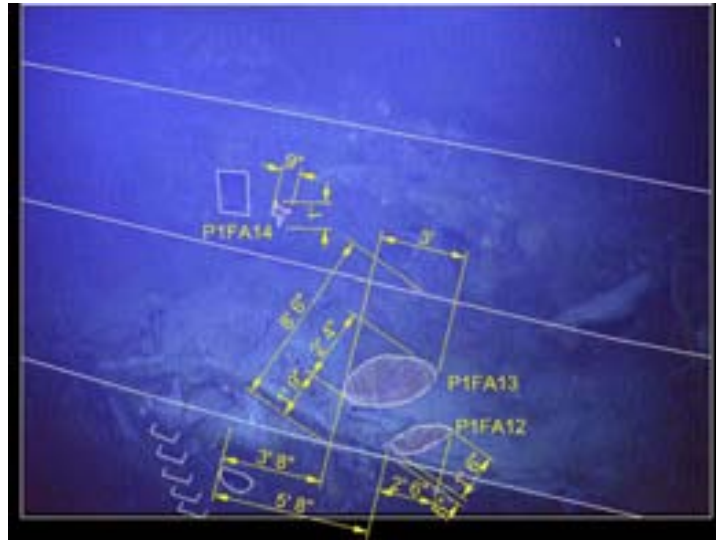
Figure 291: Damage to Forecastle deck. Into General Store and Victualling Store, upper deck [340].
