## Diagnostic Result

ACTROS 930.163

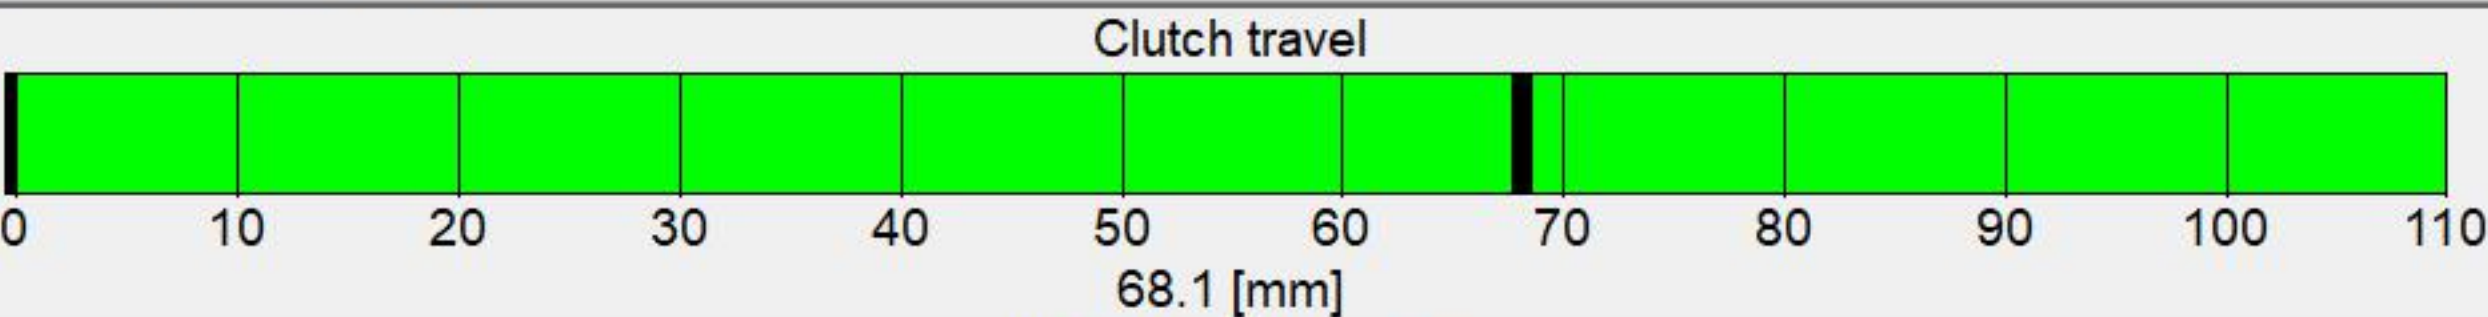
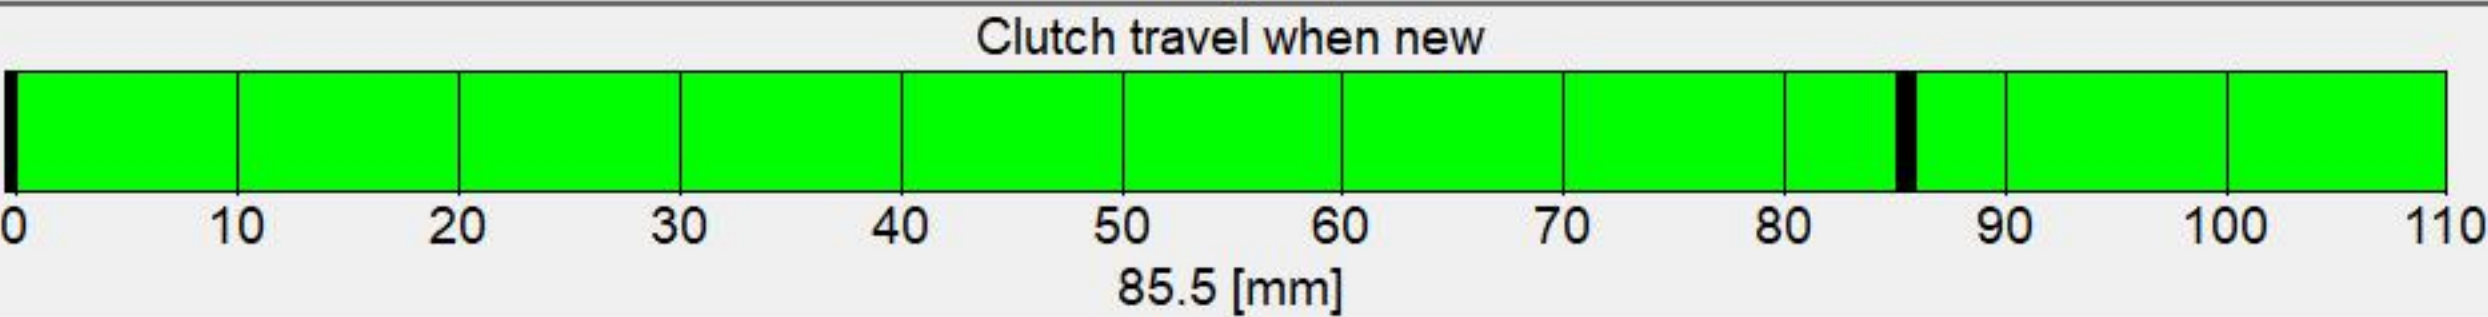
Clutch pedal is learned.

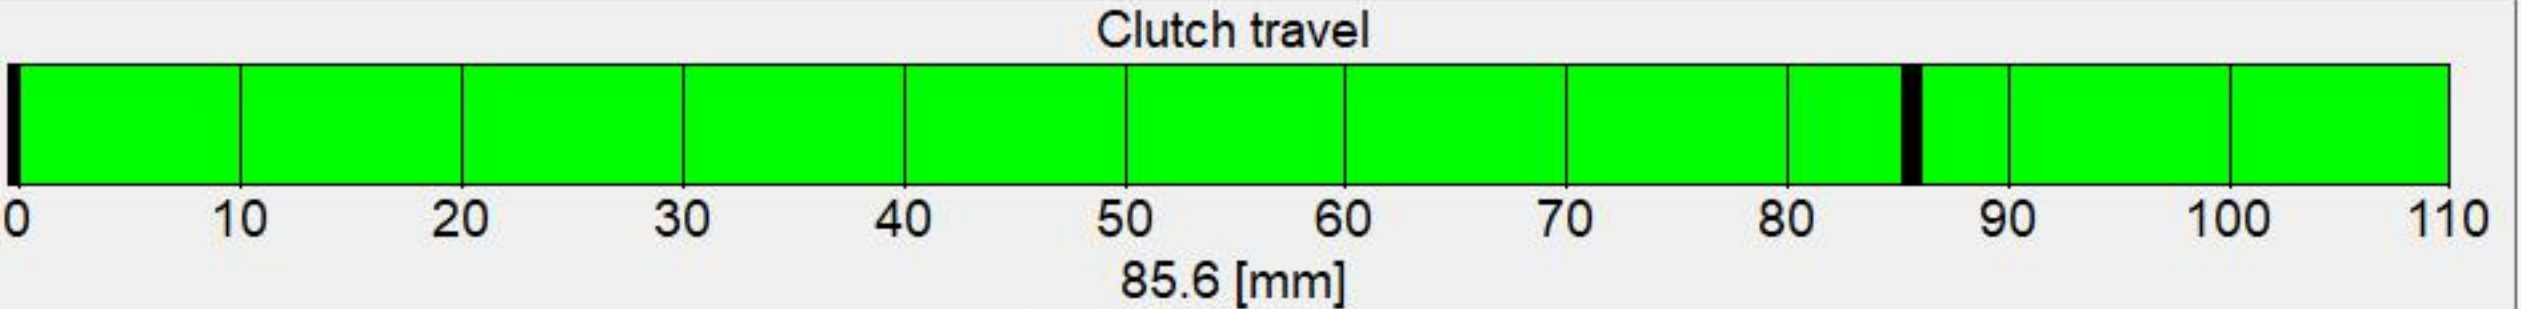
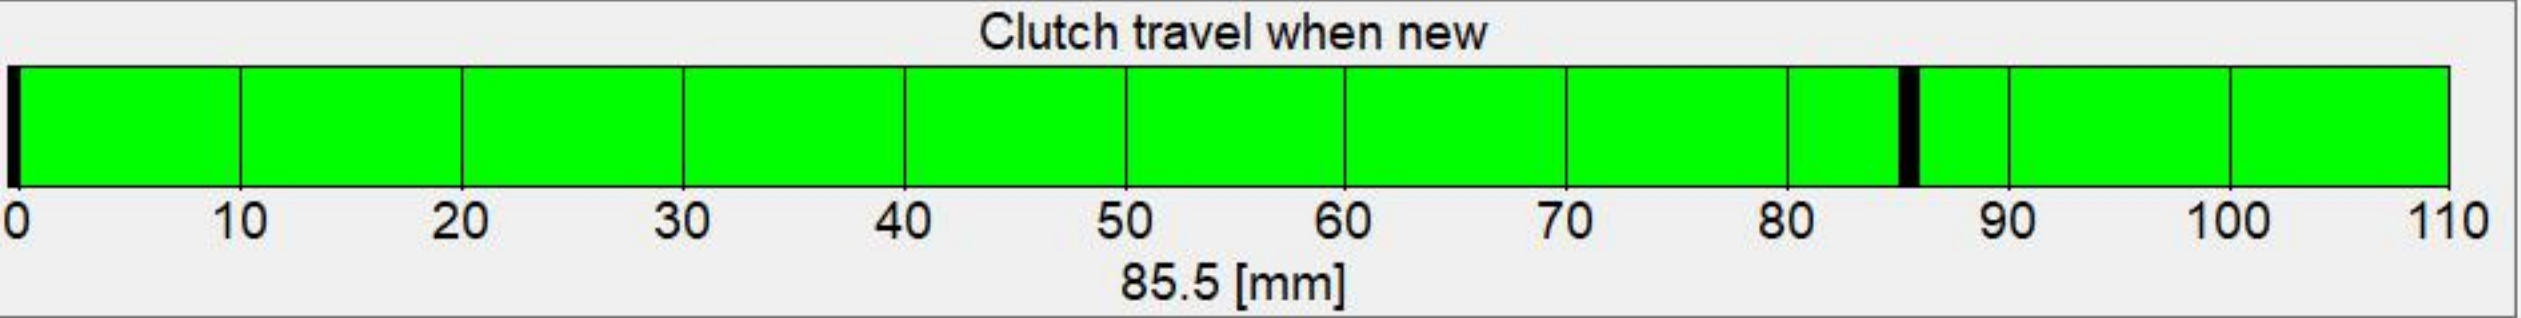
Clutch pedal is learned.
