# In-flight engine malfunction – Boeing 747-438, VH-OJH

100 km south-east of Bali International Airport, Indonesia | 9 May 2011

**ATSB Transport Safety Report**  
Aviation Occurrence Investigation  
AO-2011-062  
Final

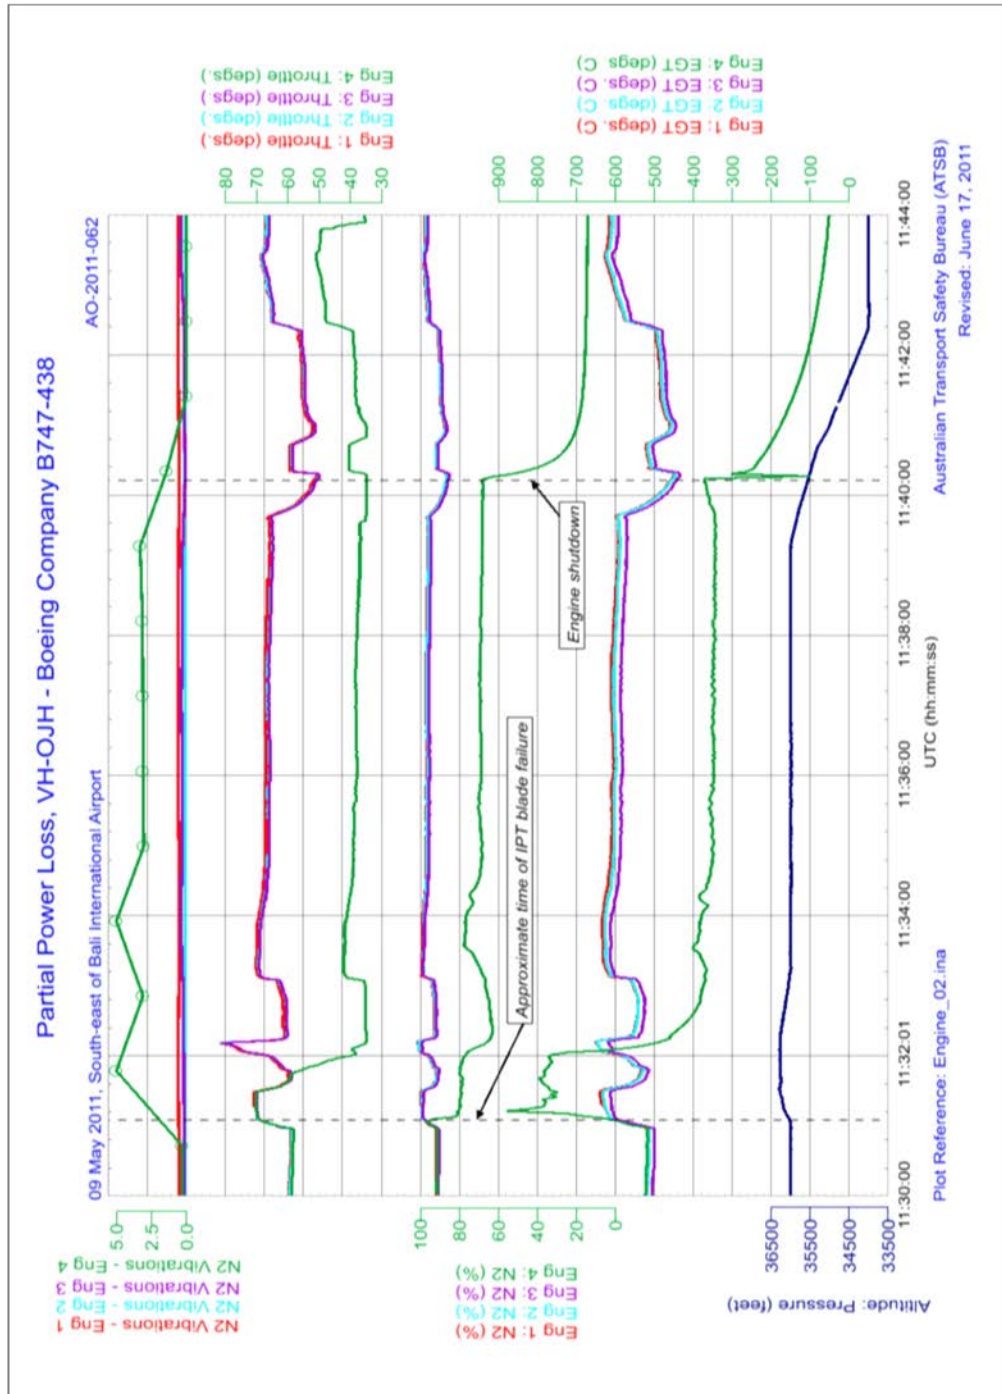
Figure 1: FDR plot showing increase in No.4 engine EGT and N2 vibrations

- Shortly after, at 1131:07 the N1, N2 and N3 values for the No.4 engine started to decrease with no associated change to the thrust lever movement, while the EGT continued to increase at a faster rate than the other engines.

- The EGT for engine No.4 reached its peak value of 880 °C at 1131:14.
- The aircraft levelled off at 36,250 feet pressure altitude at approximately 1131:30. At 1131:48, and for a duration of approximately 24 seconds, the No.4 engine thrust lever was reduced to flight idle while the other engine thrust levers were advanced to 80°.

- No.4 engine vibrations were recorded at 5 units (full scale) at 1131:49 and high vibrations continued to be recorded for the following 7 samples (recorded at intervals of 64 seconds)

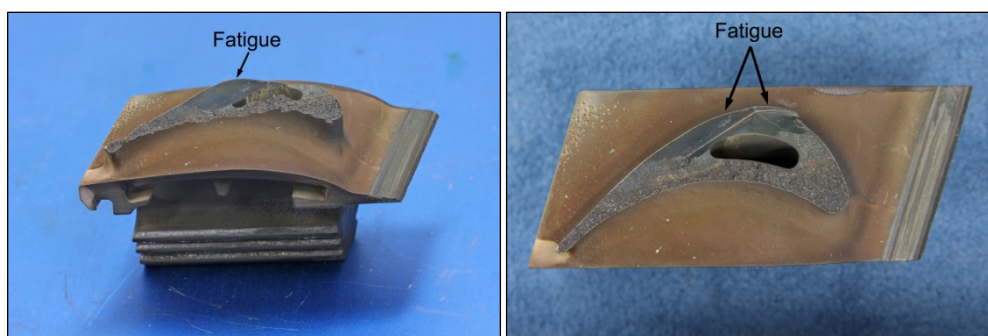
**Figure 4: Root section of fractured IP turbine blade no. 24**

The fractured IP turbine blade, manufactured in May 1989, was identified as blade No.24 (disc post position), with serial number A01630-7 and part number UL21701. The blade had fractured approximately 5 mm (0.2 in) from the root platform.

Fractographic analysis showed that the blade had failed following the growth of a low stress/high cycle fatigue crack that had originated on the convex (suction) side of the aerofoil (Figure 3) and propagated across a significant portion of the cross section prior to final release in tensile rupture (Figure 4). There were no discontinuities or other localised stress-raising defects identified in the crack origin areas.

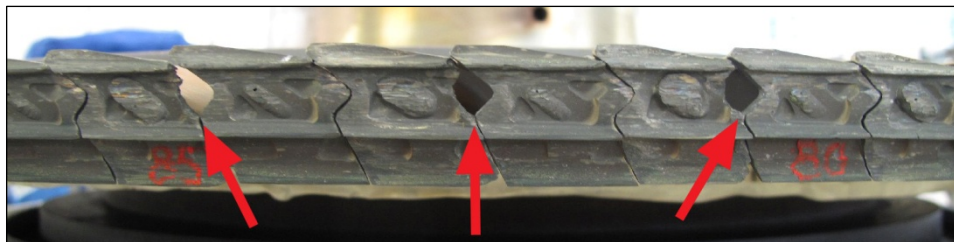
- Most of the repaired blades had lost material from the outer shroud interlock feature where they had been rebuilt with weld metal.
- The shrouds and interlocks on the new blades were considered to be satisfactory.

- Significant loss of the rear interlock shroud was identified on blades 14, 81, 83, 85 and 106 (Figure 5).

**Figure 5: Outer shrouds of blade 80 – 85 showing significant loss of material from the interlock feature (arrowed) [image supplied by the manufacturer]**

The outer interlocking shrouds are an integral feature of the blade design and serve to dampen blade motion during engine running. As the shrouds wear, the blades can become more susceptible to excitation (resonant vibration) in the flap and torsional modes.

Of the five IP turbine blades that showed significant wear and loss of the interlocking shroud feature, three (blades 81, 83 and 85) were located diametrically-opposite the failed blade 24.

Following the occurrence, the engine manufacturer issued non-modification service bulletin, NMSB 72-G739, on 6 October 2011. The NMSB directed a borescope inspection of the IP turbine blades to confirm that the interlocks were in an acceptable condition. It was recommended that the inspections be carried out before 30 June 2012. The service bulletin was re-issued on 11 July 2012 to include crack acceptance and re-inspection criteria.
