Design of Safe Timber Structures - How Can we Learn from Structural Failures in Concrete, Steel and Timber?

Frühwald, Eva; Serrano, Erik; Toratti, Tomi; Emilsson, Arne; Thelandersson, Sven

2007

Report TVBK-3053
ISSN 0349-4969
ISNR:LUTVDG/TVBK-3053-SE (228)

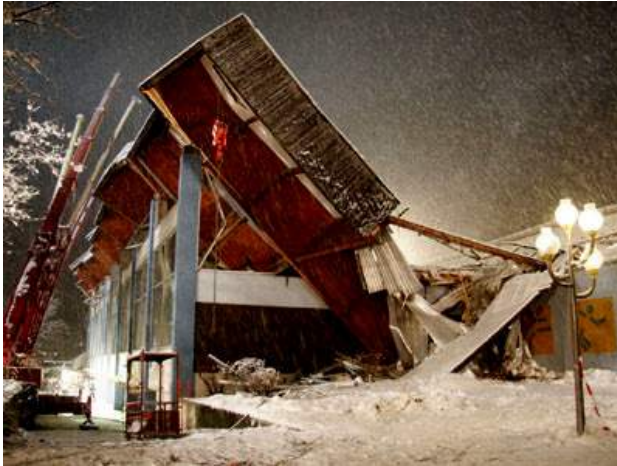
trusses fell down in spite of the fact that there was no snow load at all on the roof [14, 15]. The investigation [14] of the failure revealed that the main cause was multiple errors related to the structural analysis and conceptual modelling of the primary structure. This event created a heated debate in Denmark concerning quality assurance and control systems in the building process. Minor quality deficiencies of the glulam used in the structure were also revealed in the investigation, but these were found to be irrelevant for the occurrence of failure.

Fig. 1. Collapse of wooden roof for ice skating arena in Bad Reichenhall, Germany

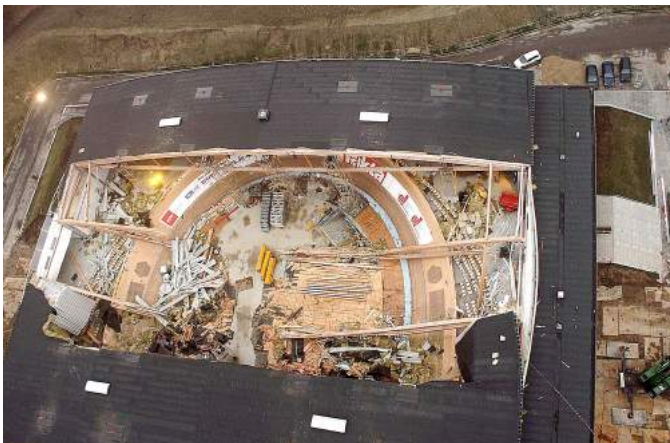
Fig. 2. Photo taken from above after the failure of the Ballerup arena roof.

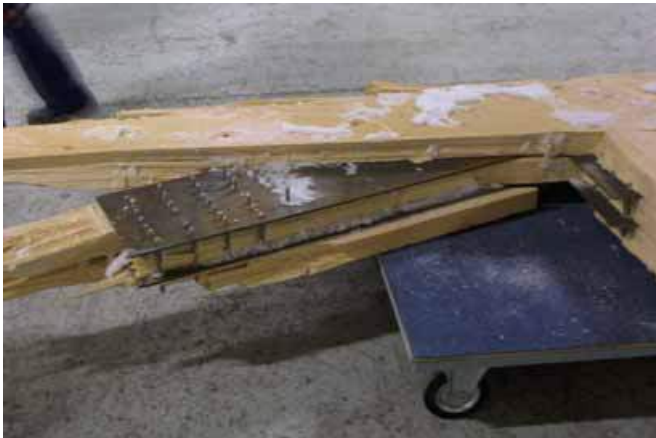
The same winter 2003 another structural collapse took place in Finland. Four main roof trusses for exhibition hall B2 of Jyväskylä Paviljonki collapsed two weeks after the hall was opened for the public [15,16]. The snow load at the time of failure was about 50 kg/m² and there was no wind. The design snow load at this location is 200 kg/m² according to the Finnish code. The primary cause of failure was manufacturing errors leading to malfunctioning slotted-in steel plate joints in the main glulam trusses, see Fig. 3. The failure was initiated in a joint where only 7 out of 33 dowels were in place.

Fig. 3. Slotted-in steel plate joint where dowels were not mounted as intended.

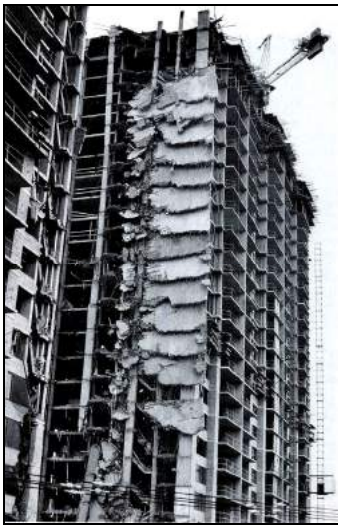
Fig. 4. Progressive failure of multi-storey concrete building due to premature removal of shoring, 1973, Virginia, USA.

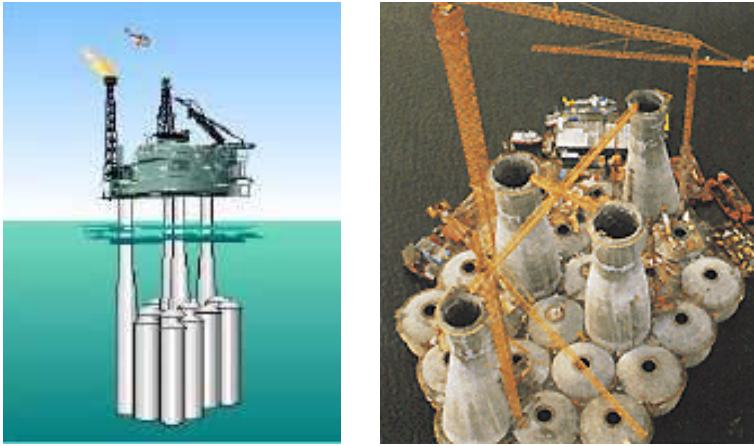
total base area of 16000 m². Errors in detailing of the reinforcement in the vertical joints between the concrete cells lead to shear failure during the operations to sink the platform to the seabed, see e.g. [30]. The economical loss from this detailing error was estimated to 700 Million US\$, the most expensive shear failure in history.

Fig. 5. The Sleipner A offshore platform

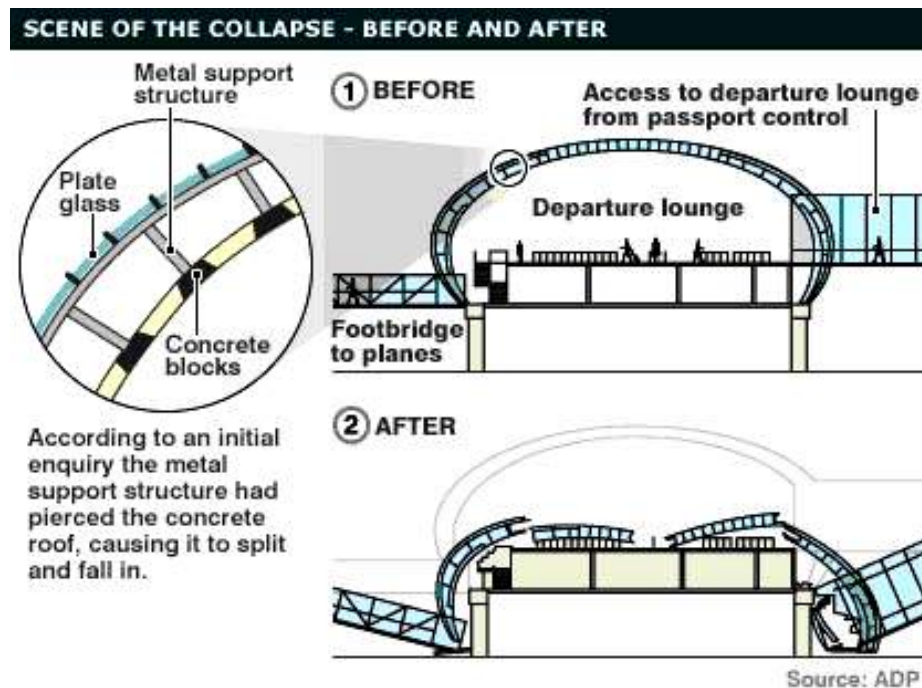
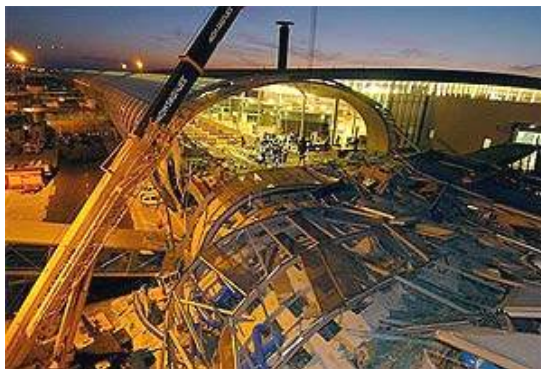
An example of an innovative concrete structure is the terminal building at Charles de Gaulle airport in Paris, which was built with an elliptical reinforced concrete shell roof. The roof suddenly collapsed in May 2004, 11 months after it was opened, killing four people, see Fig. 6. The official investigation identified four errors in design and construction of the unusual type of structure.

Fig. 6. Collapse of terminal roof at Charles de Gaulle airport in Paris

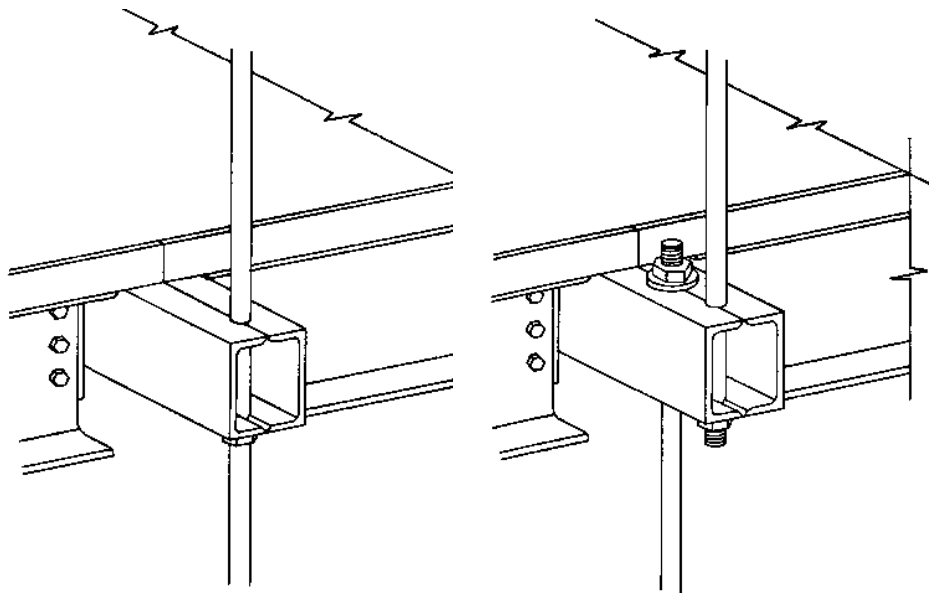
a) Original design of detail

Failures caused by incorrectly designed or constructed steel connections are quite common. A well known example of structural failure of a steel structure due to errors in detailing of steel connections is the collapse of the walkway in the Hyatt Regency hotel in Kansas City in 1981. The walkway, which was suspended on steel rods in the lobby of the hotel, collapsed suddenly leading the death of 113 persons and injury of many others. The reason for the failure was incorrect design and construction of the connection between the steel rod and the cross beam in the walkway structure. The original design of this detail is shown in Figure 7, together with the as-built detail. Even the original design can be criticised, since the flanges of the channel profiles are too weak to resist the pressure from the nut carrying the load from the walkway. The actual as-built arrangement means that the contact pressure in the detail is doubled compared to the original design, which had been overlooked when the change was made. According to [6] the actual capacity of the connection was only slightly higher than the dead load from the structure. The collapse occurred when the walkway was crowded by people watching a dancing competition on the lobby floor beneath the walkway.

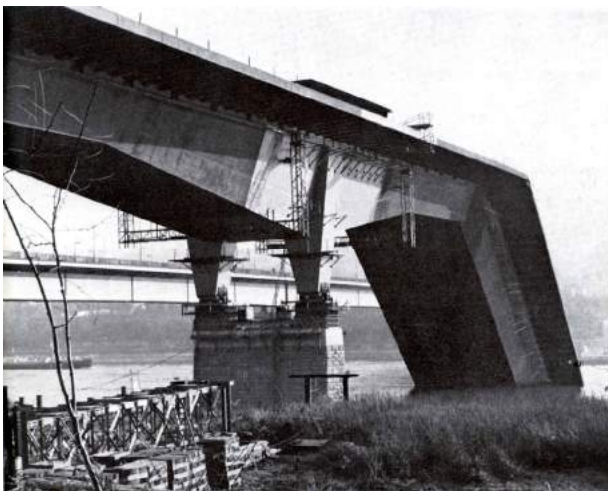
Fig. 8. Collapse of steel box girder during cantilever construction, Rheinbrücke, Koblenz, 1971, Source: Ref. [31].

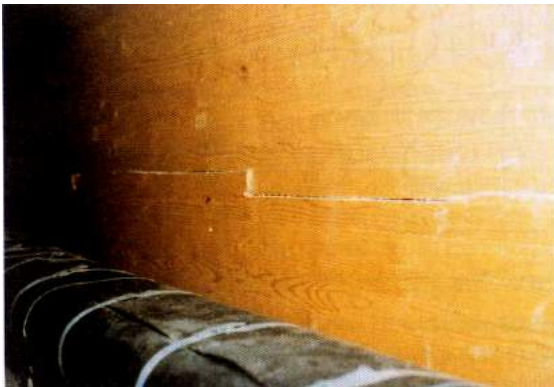
when the building (sport hall) was 2 years old. The cracks were mainly caused by rapid drying of the wood after it was finished. Particularly heavy cracking took place in that part of the roof where installations of hot water tubes were present. The cracks led to increased and nonuniform deflection of the flat roof, which in turn led to ponding during a heavy rain. The roof did not collapse but had to be temporarily supported for safety reasons.

Fig. 9. Longitudinal through crack in glulam roof girder due to shrinkage effects. Hot water piping in the vicinity of the girder contributed to fast drying. Source: Ref. [7].

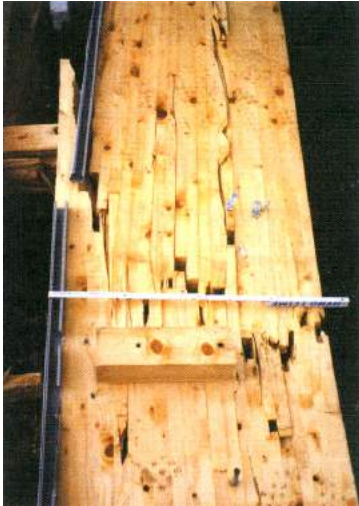
Fig. 10. Failed glulam beam due to low quality finger joints. The failure line is staggered and coincides with the finger joints. Source: Ref. [9].

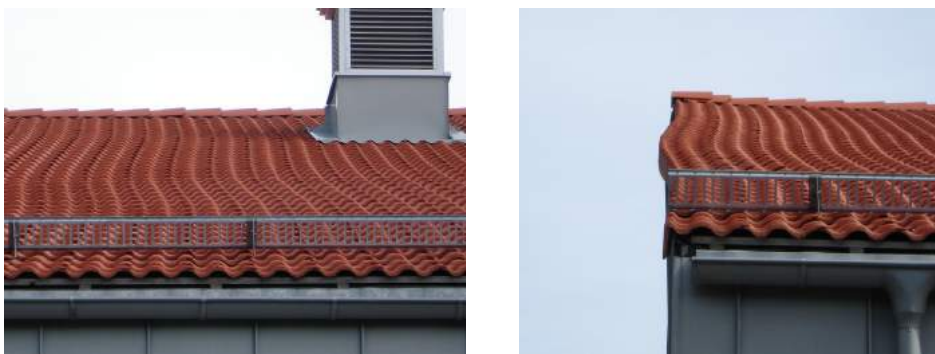
Instability failure due to insufficient bracing is also quite frequent after the building is completed. A typical example is case 114, which is a timber truss roof with span of more than 20 m, which was built with insufficient lateral bracing of the top chord. This led to lateral buckling of the top chord as shown in Figure 17, with large lateral deformations. The tiling battens connecting the trusses with each other fell down between the trusses in several positions, which worsened the situation. A number of similar cases have occurred in Sweden, where the current structural code does not have any quantitative guidelines for design of lateral bracing. However, any engineer responsible for a structure of this type should be competent enough to realise that lateral bracing is necessary for the top chord of slender trusses.

Figure 17. Deformations in roof due to lateral buckling of top chord of roof trusses.

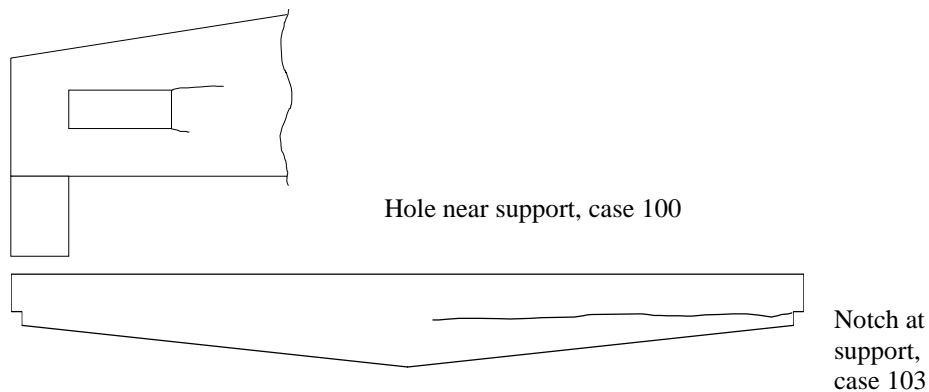
Figure 18 shows cracking patterns from two cases, 100 and 103, with inappropriate design of holes and notches respectively, which led to perpendicular to grain failure.

Figure 18. Schematic illustrations of perpendicular to grain failures in connection with holes and notches in large glulam beams.

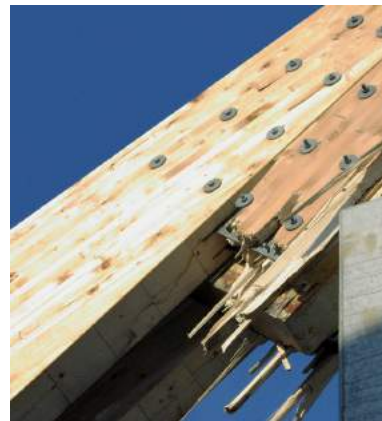
Failed heel joint

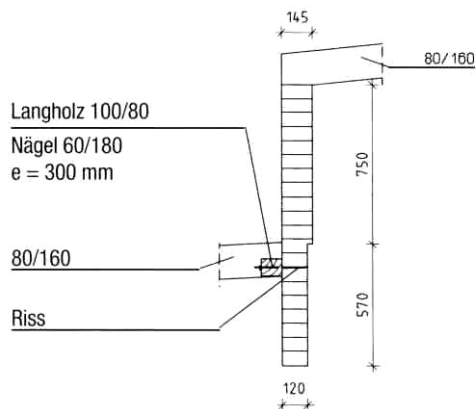
A sports hall (33.6m x 18m) is roofed in the central part by double-tapered glulam beams placed at 4.2 m centres. At the two gable ends of the building, the roof is on a lower level. Here, straight glulam beams with a depth of 1.32 m and a width of 145 mm in the upper part (h=750mm) and 120 mm in the lower part (h=570mm) carry the roof, see Figure 6-1. Structural timber 100 mm x 80 mm is nailed along the lower part of the glulam beam, to provide support for the lowered roof. The lowered roof is carried by structural timber (cross-section 80 mm x 160 mm). At the support, the glulam beam is notched, with a notch height equal to the lower part of the beam, i.e. 570 mm.

Figure 6-1: Glulam beam with support of lowered roof. Picture from Dröge G. & Dröge T.: *Schäden an Holztragwerken, Schadenfreies Bauen, Band 28*, Fraunhofer IRB Verlag, 2003.

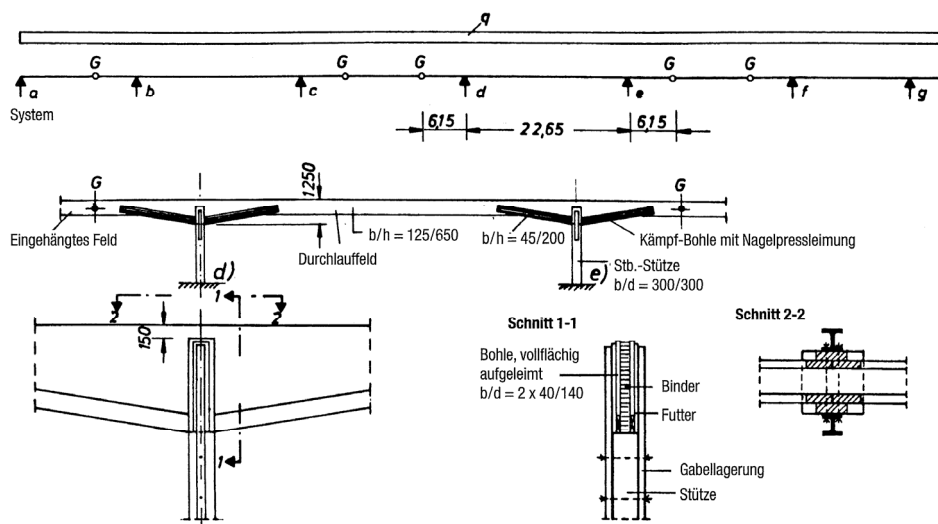
A 125 m wide industrial building is covered by continuous glulam beams with Gerber type hinges in every second span (span 22.6 m), see figure 7-1. Near the supports, the beam is tapered to increase the depth near the support. The roof is completely flat, leading to large water pools after rain. Glulam beams and purlins have been designed for uniform load comprised of dead load, extra load due to fixtures and fittings and snow load. The beams had been designed with full utilization both in the bays and at supports. As the support area is too small to transfer the support load with respect to compression perpendicular to the grain, standing boards were glued to both sides of the beam. The boards transfer the support load via their end grain to the concrete column.

Figure 7-1. Top: Continuous glulam beams of Gerber type with hinges in every second span. Middle: Strengthening with boards, glued to lower edge of beams in the tapered area, carried out after first failure. Bottom: Detail at support before first failure. Picture from Dröge G. & Dröge T.: Schäden an Holztragwerken, Schadenfreies Bauen, Band 28, Fraunhofer IRB Verlag, 2003.

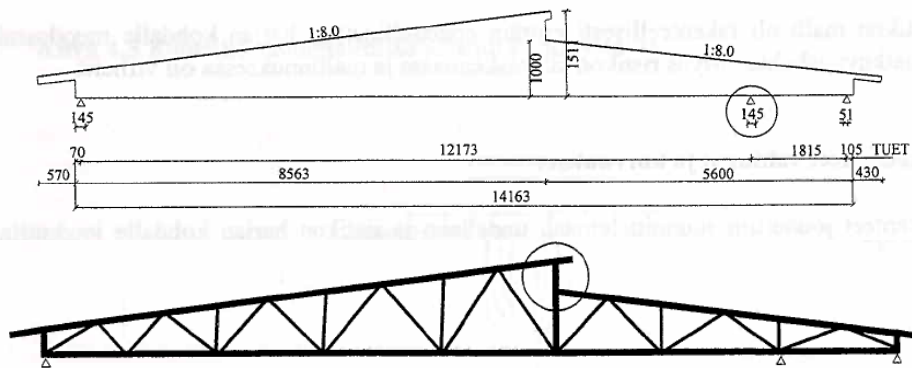
Figure 89-1: The top chord is not aligned at centre span causing a high bending load on the vertical member.

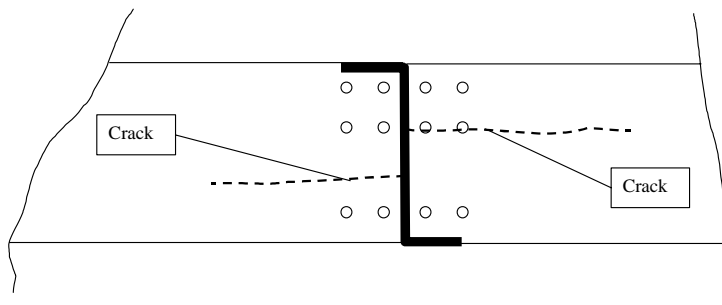
Figure 109-2. Schematic of beam connection and cracks found.

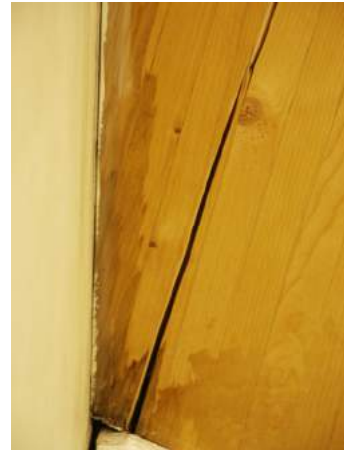
Figure 115-2. Crack at column fitting to the steel part.

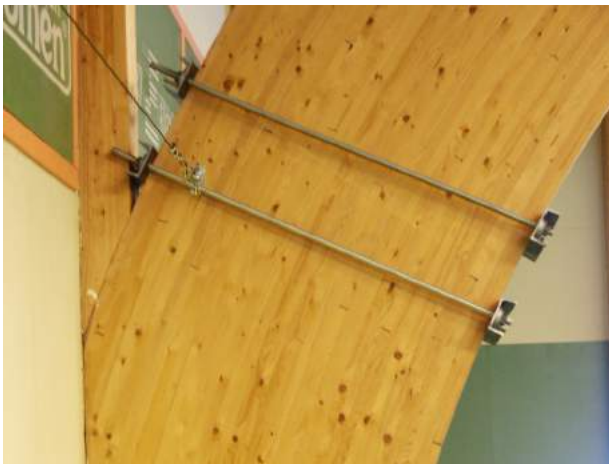
Figure 115-3. Temporary steel fixings attached to the column.

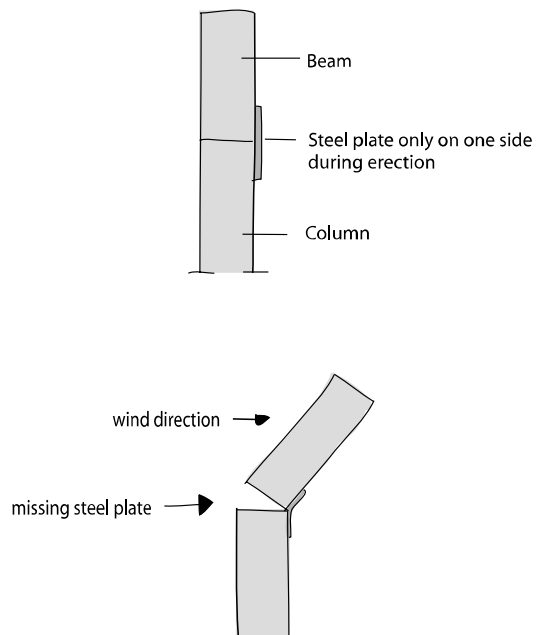
Figure 125-2: Joint between columns and beams. Left: joint as executed, right: failed joint.

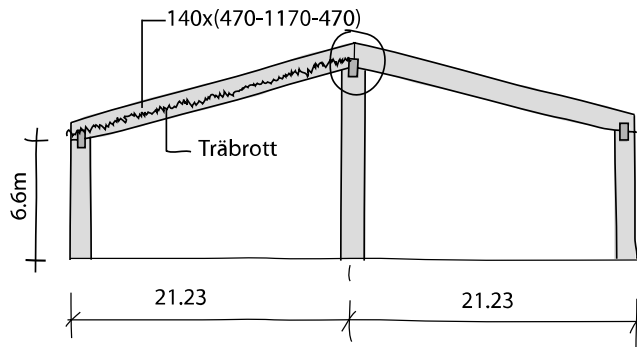
Figure 127-1: Storage building with glulam columns and glulam beams. Jagged line indicates timber failure.

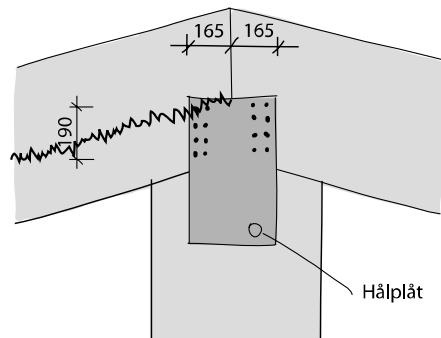
Figure 127-2: Detail of joint between beam and column at the centre of the building. Jagged line indicates timber failure.
