AN EVALUATION OF THE STRUCTURAL INTEGRITY OF PUREX STORAGE TUNNEL #1 (S-2-1)

**An Evaluation of the
Structural Integrity of PUREX Storage Tunnel # 1**

May 17, 1991

Los Alamos Technical Associates, Inc.

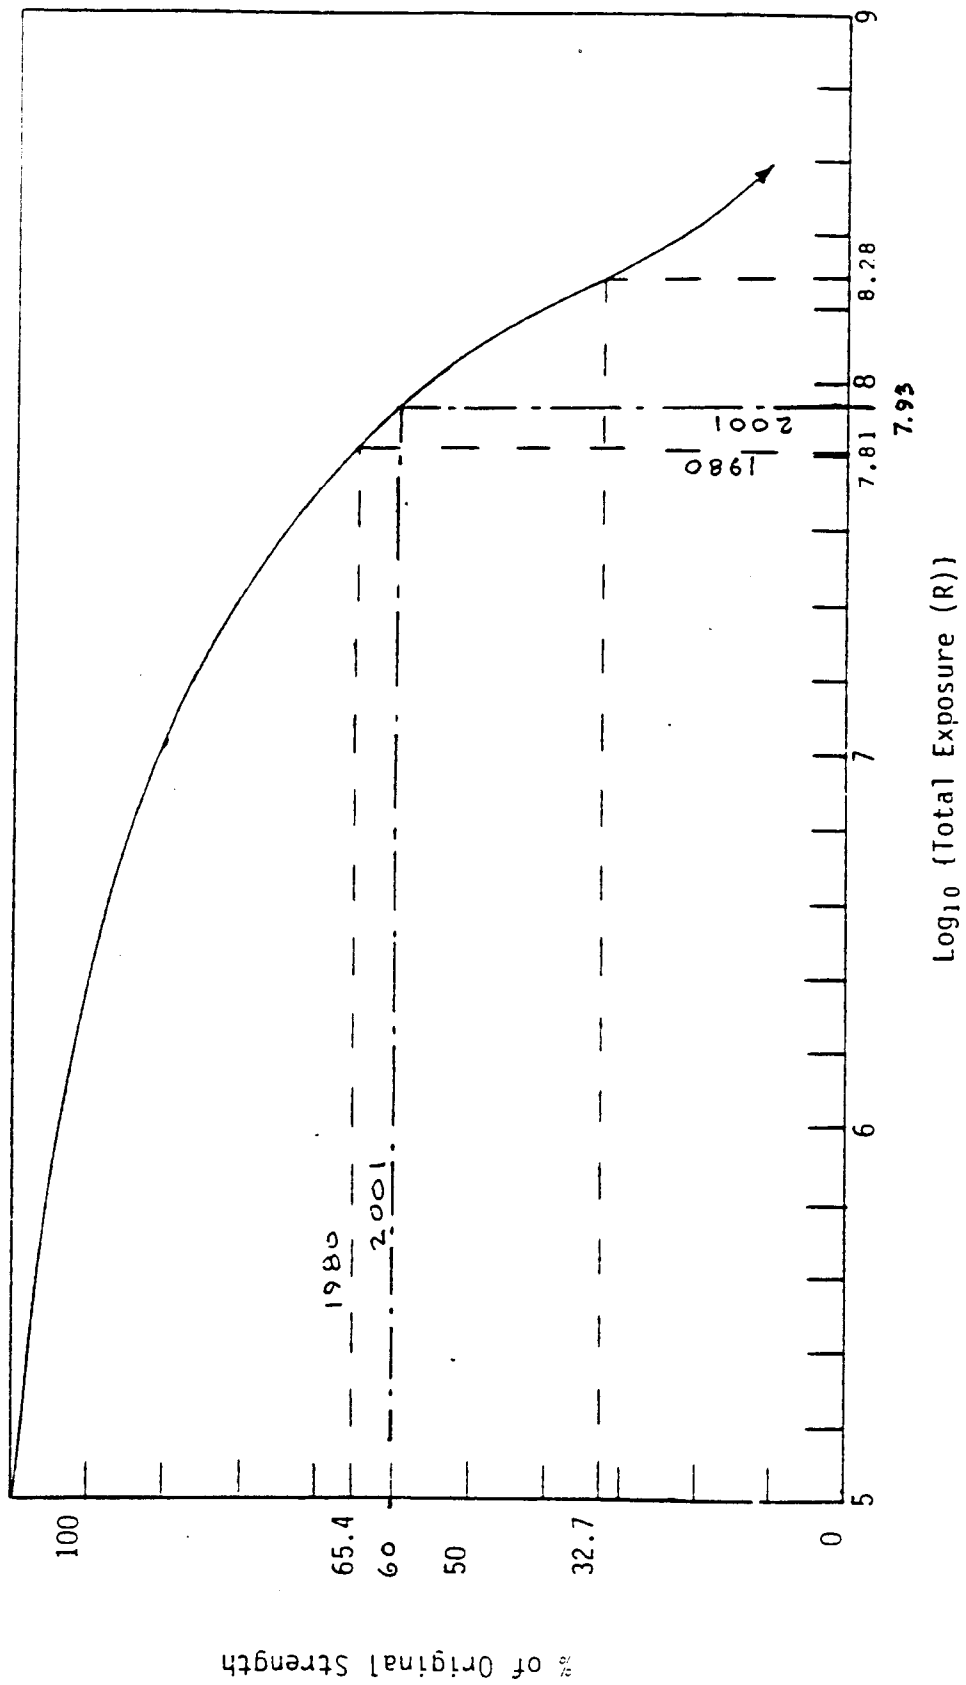
FIGURE A-1: EFFECT OF GAMMA RADIATION ON WOOD BENDING STRENGTH(1)

The percent of original integrity at any year can be estimated based on the same assumptions as made by Silvan (1980) in the Appendix of his report. By the year 2001, the

percent of original integrity is estimated to be 60%. The calculations that are the basis for the estimate are as follows:

Percent of Original Strength = 60% (from Figure A-1 of Silvan [1980], see the appendix for a copy of Figure A-1 with the new data superimposed).

The result of this additional loss of strength would be minimal.

The amount of gamma radiation induced strength loss required to reduce the safety factor of the tunnel to zero maybe determined. This load state would correspond to the degraded tunnel just reaching its ultimate load capacity and being in a state of incipient collapse. Using the numbers and procedures in Silvan, this critical state will be reached when the standard factor of safety (which is 1.65 per Silvan) is reduced to zero. The corresponding gamma radiation degraded stress value is 0.727 of the 1980 value. Silvan calculated the degraded stress at 65.4 percent of original value. An additional reduction of 0.727 of this value, or 47.5 percent of original value, is required for the safety factor to equal zero.

Therefore, it is recommended that the dangerous waste in the tunnel remain as is and that if a decision for final disposition is not made by the year 2001, that the structural integrity again be evaluated in light of any then available information including any further tests on wood preservation that may have been completed at that time. Further tests of the timbers in the tunnel, either destructive or non-destructive, are not indicated at this time.
