Electrical: Instruments

Volvo Maintenance FAQ for 7xx/9xx/90 Cars

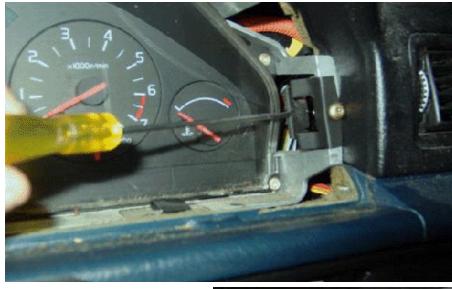
[Responses: Abe Crombie and IanB] Disconnect battery negative and place the turn signal and wiper stalks in the down position. Insert a narrow screwdriver through the

slot in the side of the metal bezel (see photo arrow). You will feel a spring clip as you push into slot. Hold the screwdriver at the angle shown in the photo. Push the clip hard while pulling toward you with the shank of driver; the clips are attached to the dash and are also robust, not easy to damage. Use a hooked dental pick to pull the cluster bezel while depressing the spring clip if it is stuck. The cluster mounting surround is alloy and is held by the cluster screws. There are lugs cast into the sides of the surround onto which the clips lock. Do one side

only, it should come out easily once you get one to let go. One clip each side, nothing else holds it in. After you get it out remove the cluster by taking out (4) Torx screws (DON'T DROP THEM) and it's free. Remove by pulling forward until you can see the rear electrical connectors. If it's turbo you have a gauge hose to disconnect at a joint about 8 or 10 inches from gauge. The latter is easier to do with the kickpanel above brake removed. Before you replace the bezel, grease the spring clips and the lugs to make future removal easier. To replace the bezel simply push it in and the clips lock onto the lugs

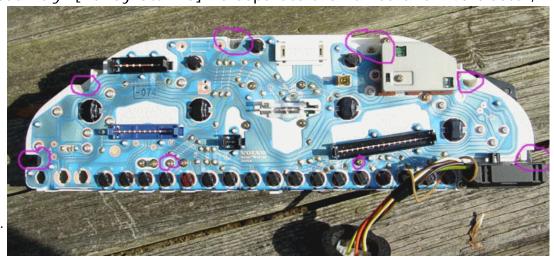
940 Cluster Disassembly. [Randy Starkie] To separate the halves of a 940 cluster,

remove the screws shown circled in the diagram. Be careful when doing this: once separated, the instrument faces are exposed and you can break off the zero stop posts very easily. Try placing the front of the

exposed panel on a piece of styrofoam to provide flexible support.

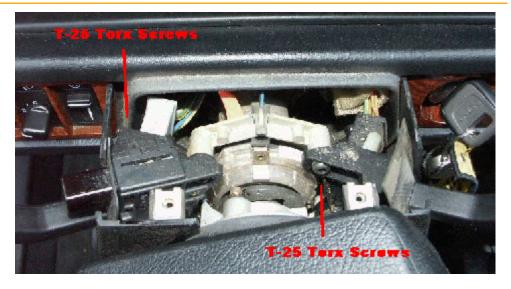
Replacing Turn
Signal or Wiper
Stalks.[Photos
Courtesy of Jurgen
Winkelvoss] [Tip from
Editor] My kid's 940
cruise control died
and I traced it to a
broken wire in the
turn signal stalk. The

Volvo manual instructs you to remove the air bag and steering wheel to replace the

stalks, a nightmare if there ever was one. After looking carefully at the assembly, here's an easier way to do it:

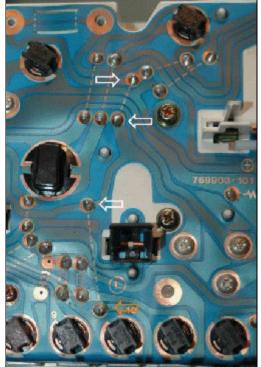
[Andrew Woods] I've had an intermittent fuel guage, warning lights, and a jumpy

tach, as well as an alternator that would not work till I revved the engine up past 2k rpm's, all due to faulty connections on the instrument cluster. I always thought it was bad connections where the wires connect to the cluster but I found out that it was bad solder joints that were cracking and losing conductivity. I resoldered all the connections and found at least 3 that where cracked where the solder was actually supposed to bond to the wires. The solder joints had cracked and were so loose that I could actually poke the piece of wire coming through the solder and see it move. The solder was still connected to the PCB, but not to the wire. After resoldering these, now my fuel gauge, my warning lights, and my alternator now work when I turn the car on and my tach is no longer jumpy. For anyone else having problems I suggest you try this. [Arthur Lambe] I too spent about a month chasing an intermittent gauge problem: fuel sender was fine, the gauge worked when cold, and guit after about 15 mins. Cleaned the screws, sandpapered the

connections, also the connectors to the back of the cluster. No joy. Then I examined all the printed circuit solder joints with a high power magnifier, and found a couple of bad ones, not near the gauge. Soldered them up (it is easy), and the gauge has worked well ever since (9 months now). Personally, I don't think the screws are much of a problem. Clean them up and if the

elsewhere.[Note] In my case, the failure was intermittent, occurring only when cold. I resoldered all four of the arrowed points in the photo but the failure was caused at the orange arrow. See your

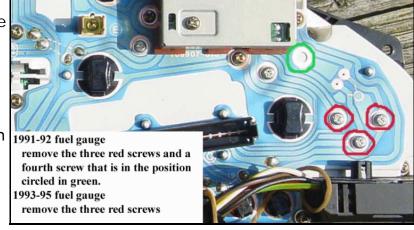
3. Poor Instrument Panel Contacts. [Response: Tom Irwin] My friend who is a

Master Volvo Tech told me that usually the comb connector in the back needs to be re-crimped. After I did that 3 times he told me that if the re-crimp doesn't fix it, then it is in the electrical interface between the 3 screws that hold the gauge in place, with the flexible PCB sandwiched in between. The flex PCB, while very environmentally friendly to manufacture, easily deforms and becomes brittle with time. Ask

ANYONE who has a 240 with tail light problems about these little beauties. In

addition, the retainer/conductor screws are supposed to be cadmium plated. But cadmium is bad-bad for the environment. So the 3 little screws are coated with some other shit that blooms into galvanic corrosion after a while even though they 'look' ok. I wire brushed them, straightened the pcb and hit em with DeOxIt. That repair actually lasted the longest: about 3 days. There is only one permanent repair in this case: the screws must be soldered. My buddy tells me to lay a small amount of solder, very quickly and VERY carefully to the contact points under each screw. Use a light iron with temp control. Try to hold ~700 degrees f. Use a normal 60/40 rosin core solder. Be very careful not to melt the plastic substrate as you heat up. I like to keep a can of electronic freeze spray to douse the hot spots immediately after flowing a bead of solder. In a pinch, a can of 'compressed air' turned upside down will achieve the same thing. Solder all 3 screws to the PCB traces and you are done. No more fuel gauge problems.
