<b>QUALITY ALERT HR.0001</b>
------------------------------

**Title:** Electronics Cover - 28990

**Part Number:** 28990

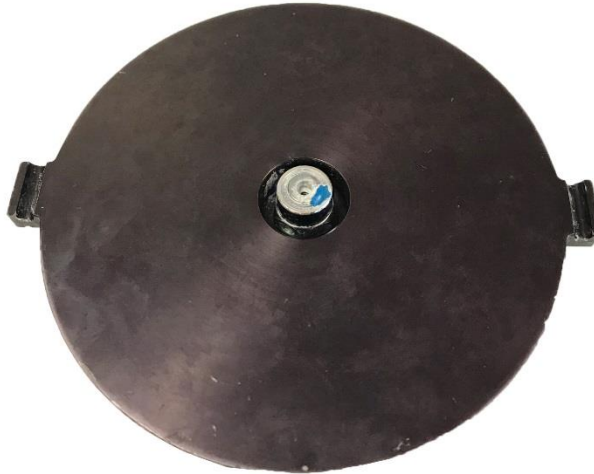
#### **1. Remove Old Battery Cover**

- a. Unhook both latches and remove old aluminum battery cover

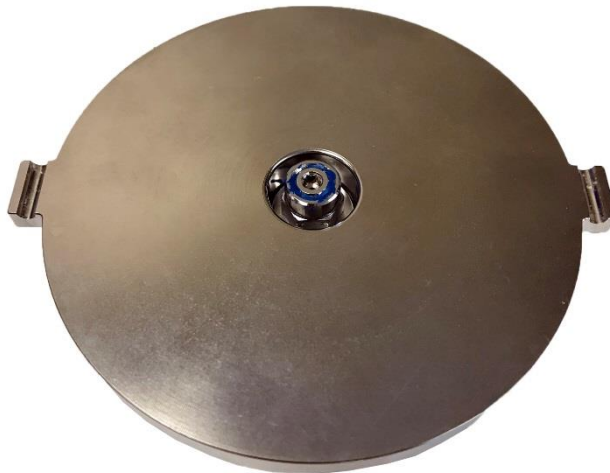
**3. Install New Stainless Battery Cover - 28990S.A**

- a. Secure both latches and ensure battery cover is seated properly
- b. Your Prism 2 electronics cover is now upgraded
- c. If you have any additional questions or concerns, please contact [service@hollisrebreathers.com](mailto:service@hollisrebreathers.com) or call 385.770.7430
