## Attachment B: Barn/Material Images

Images of the Littlerock Yellow Barn: Materials salvaged from deconstruction of this barn are available.

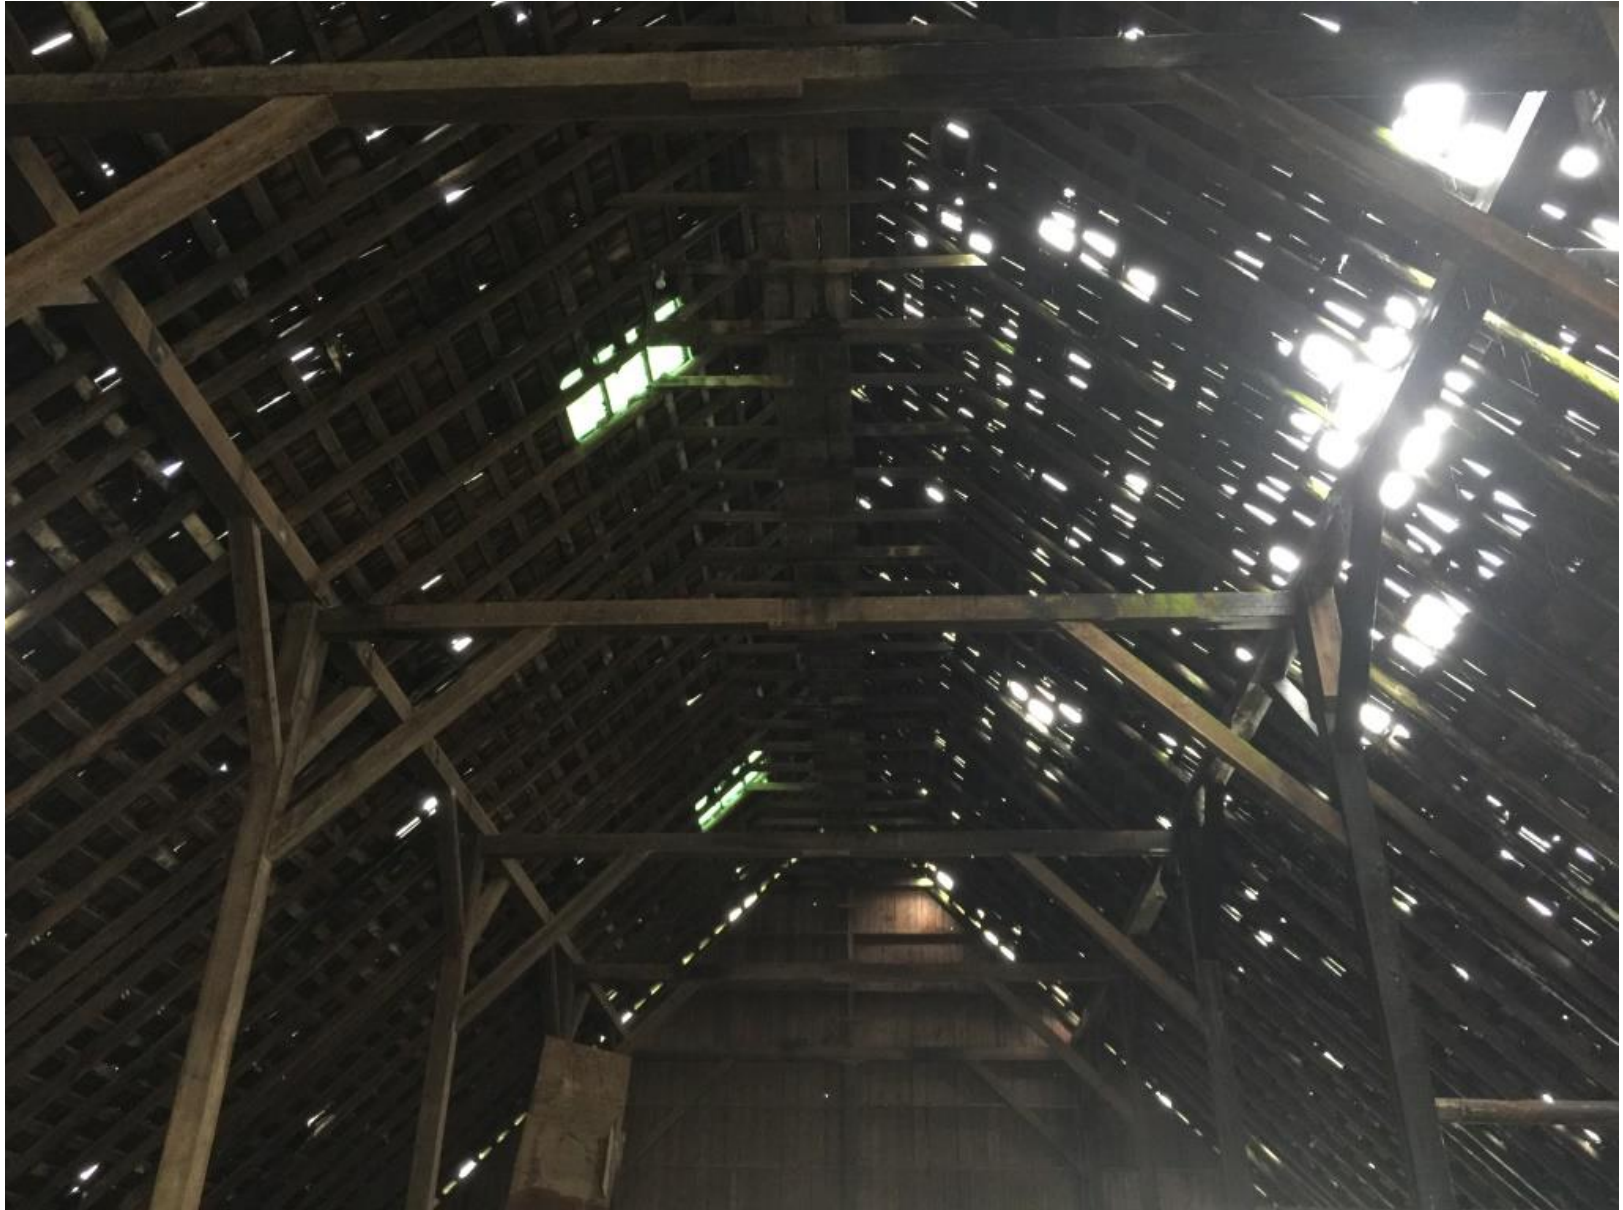
Image of structural system – all posts, beams, ties and braces to be deconstructed and available as salvage material.

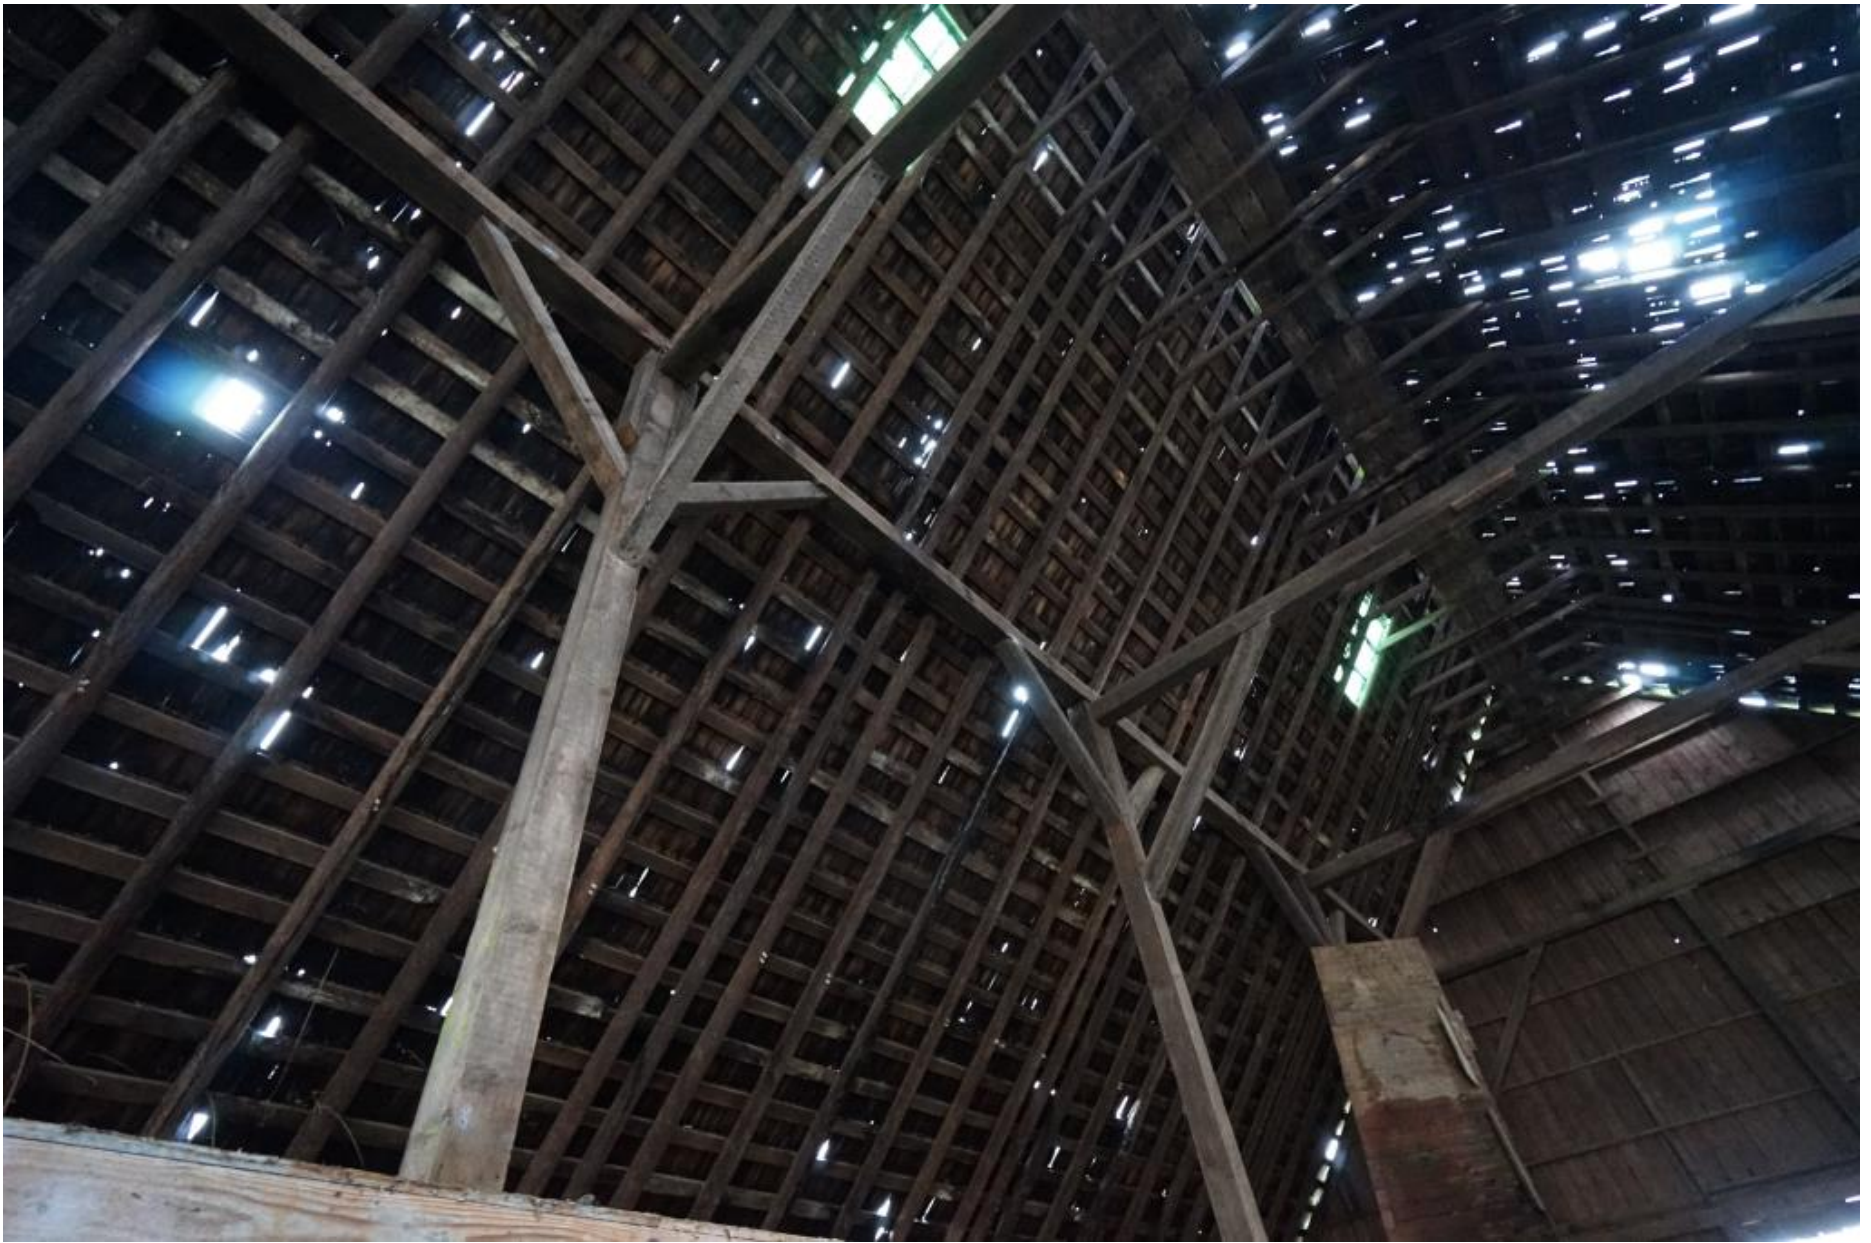
Image of post-beam connections.

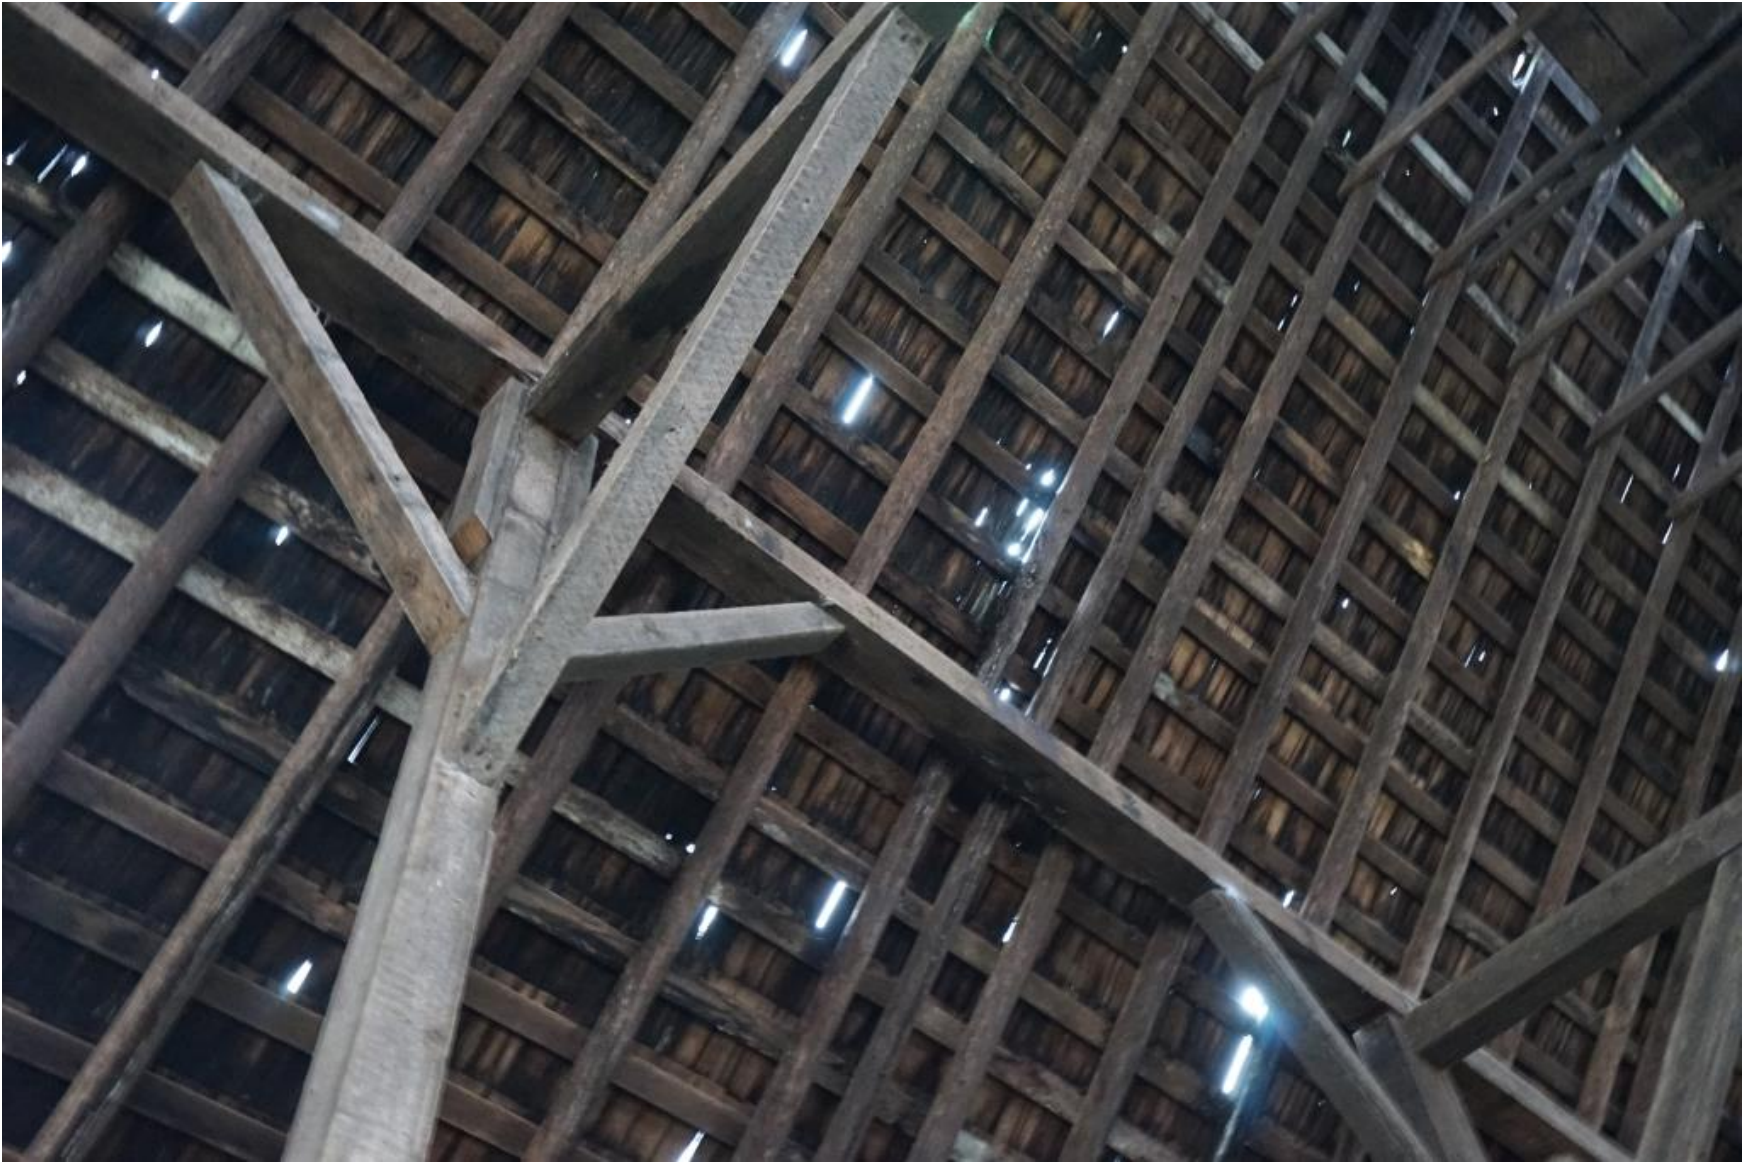
Detail of post-beam connection, showing round-log purlins in roof structure.

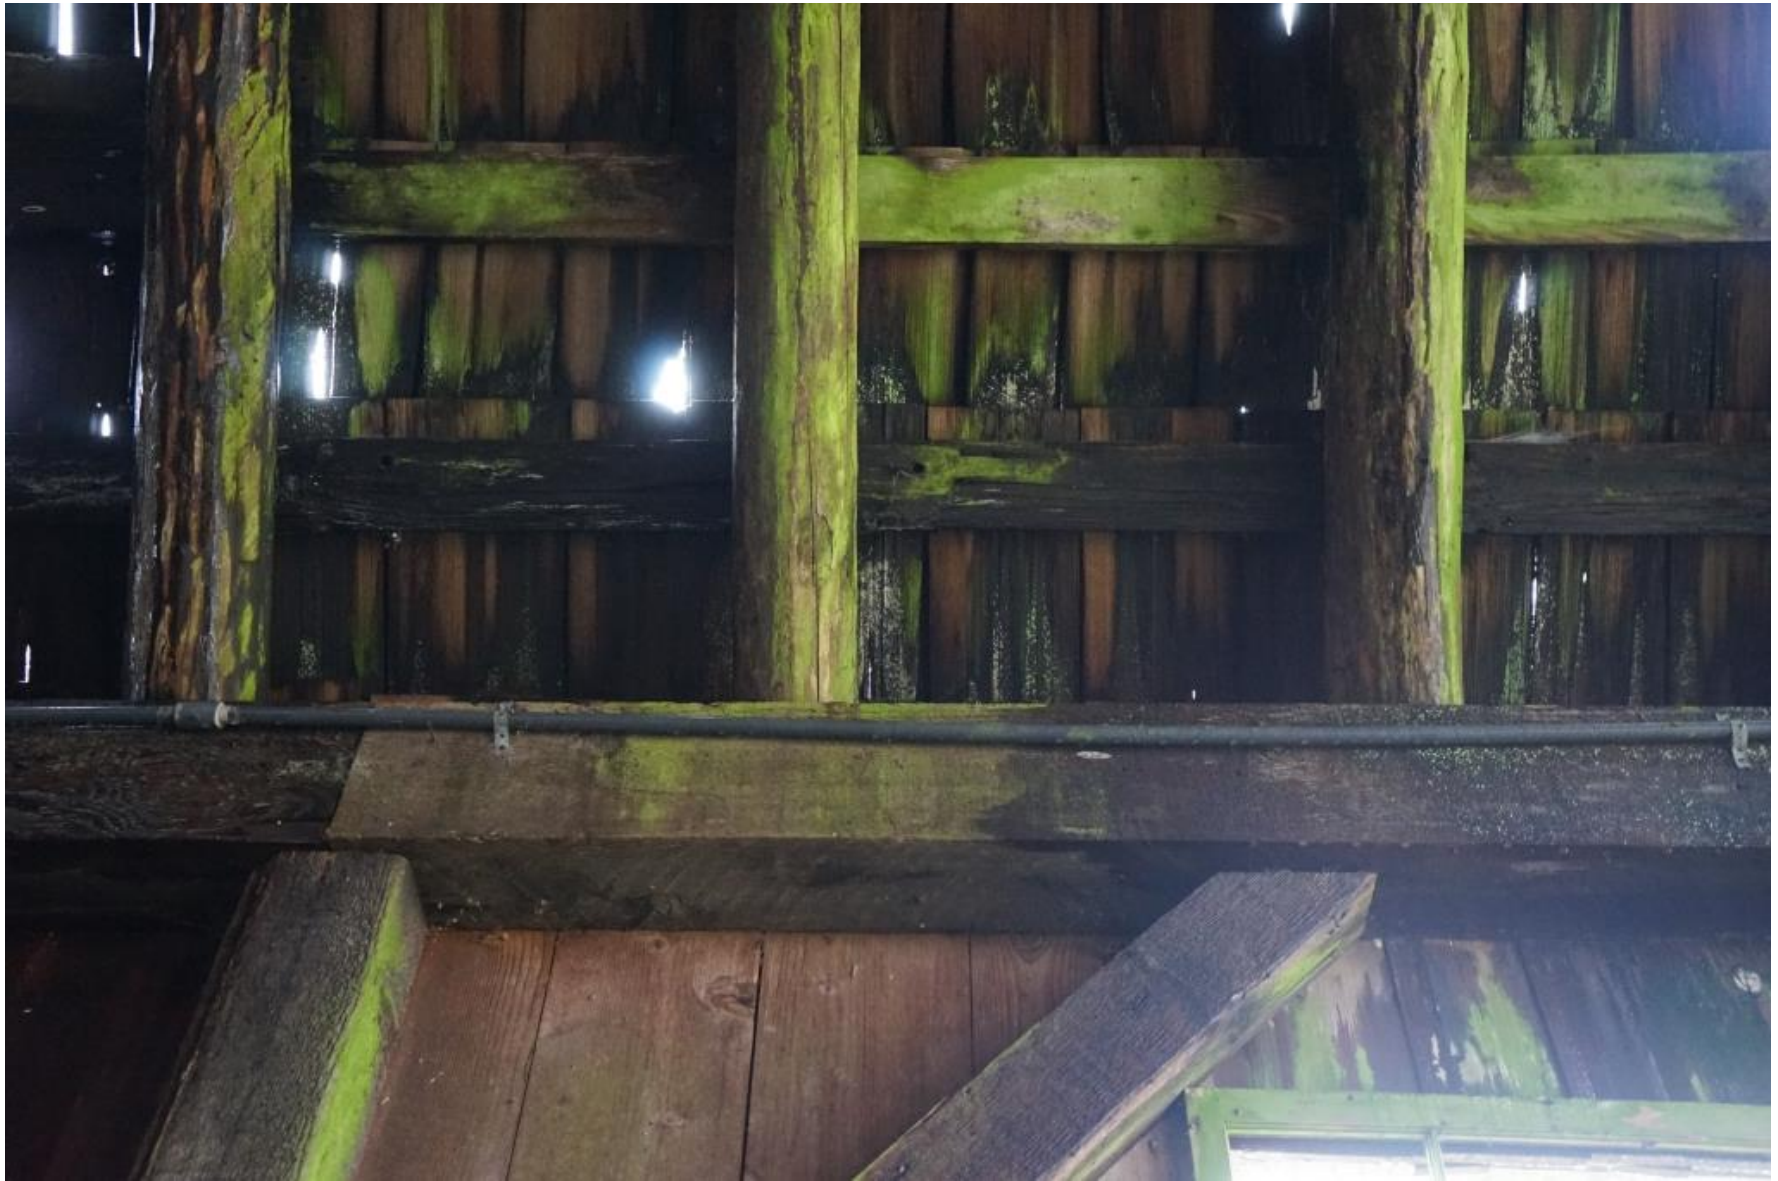
Detail showing connection of purlins to side wall plates, along with side wall posts and diagonal braces. All structural framing to be deconstructed and available for salvage.
