Here are some pictures to show what's required when replacing the A/C compressor, expansion valve and receiver/drier on a 2001 Volvo V70. Even if you don't replace these A/C parts these pictures can help with headlight assembly replacement, bumper cover removal, radiator fan assembly removal, etc.

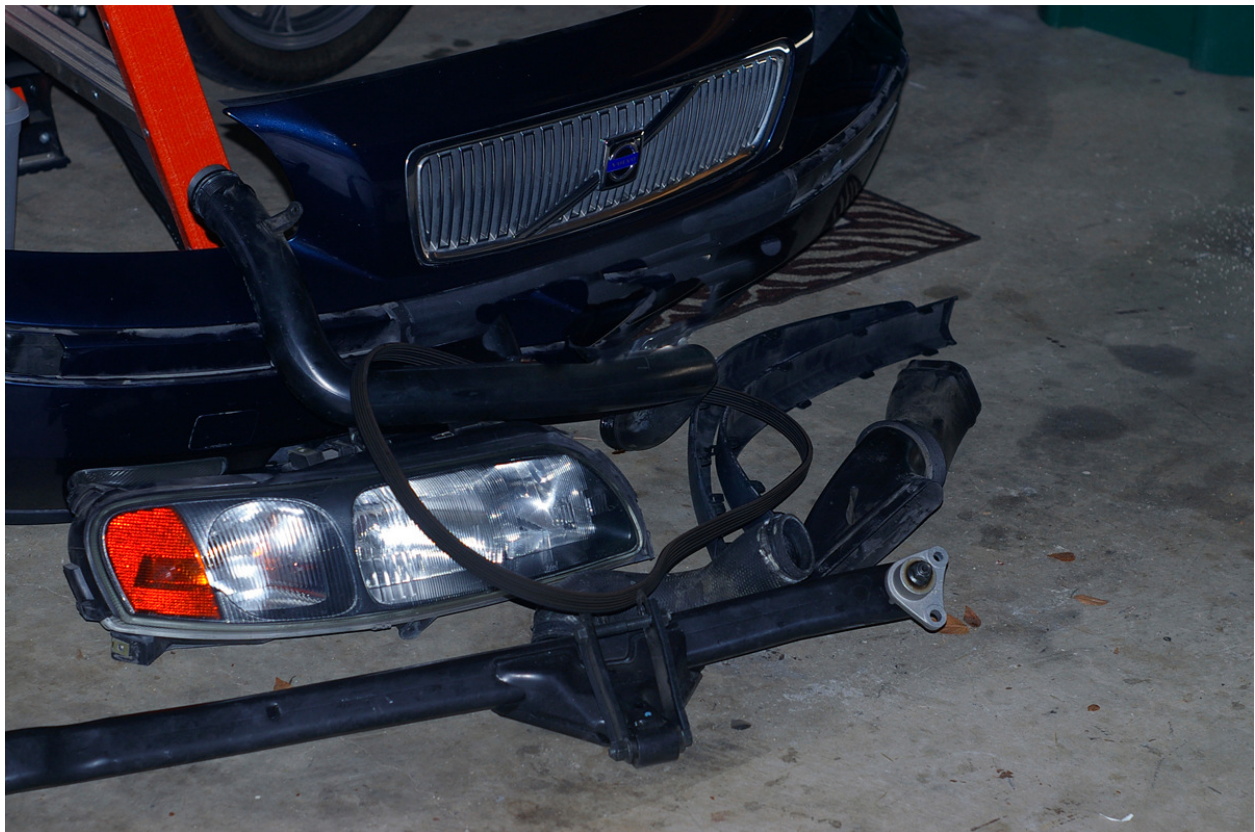
**Figure 1** Here's what needs to be removed for access to the A/C compressor, expansion valve and receiver/drier. Front bumper cover/grill and passenger side headlight to gain access to the receiver/drier, strut brace and turbo to intercooler tube for better access to the expansion valve, serpentine belt and fan/shroud (not shown ) for access and removal of a/c compressor.

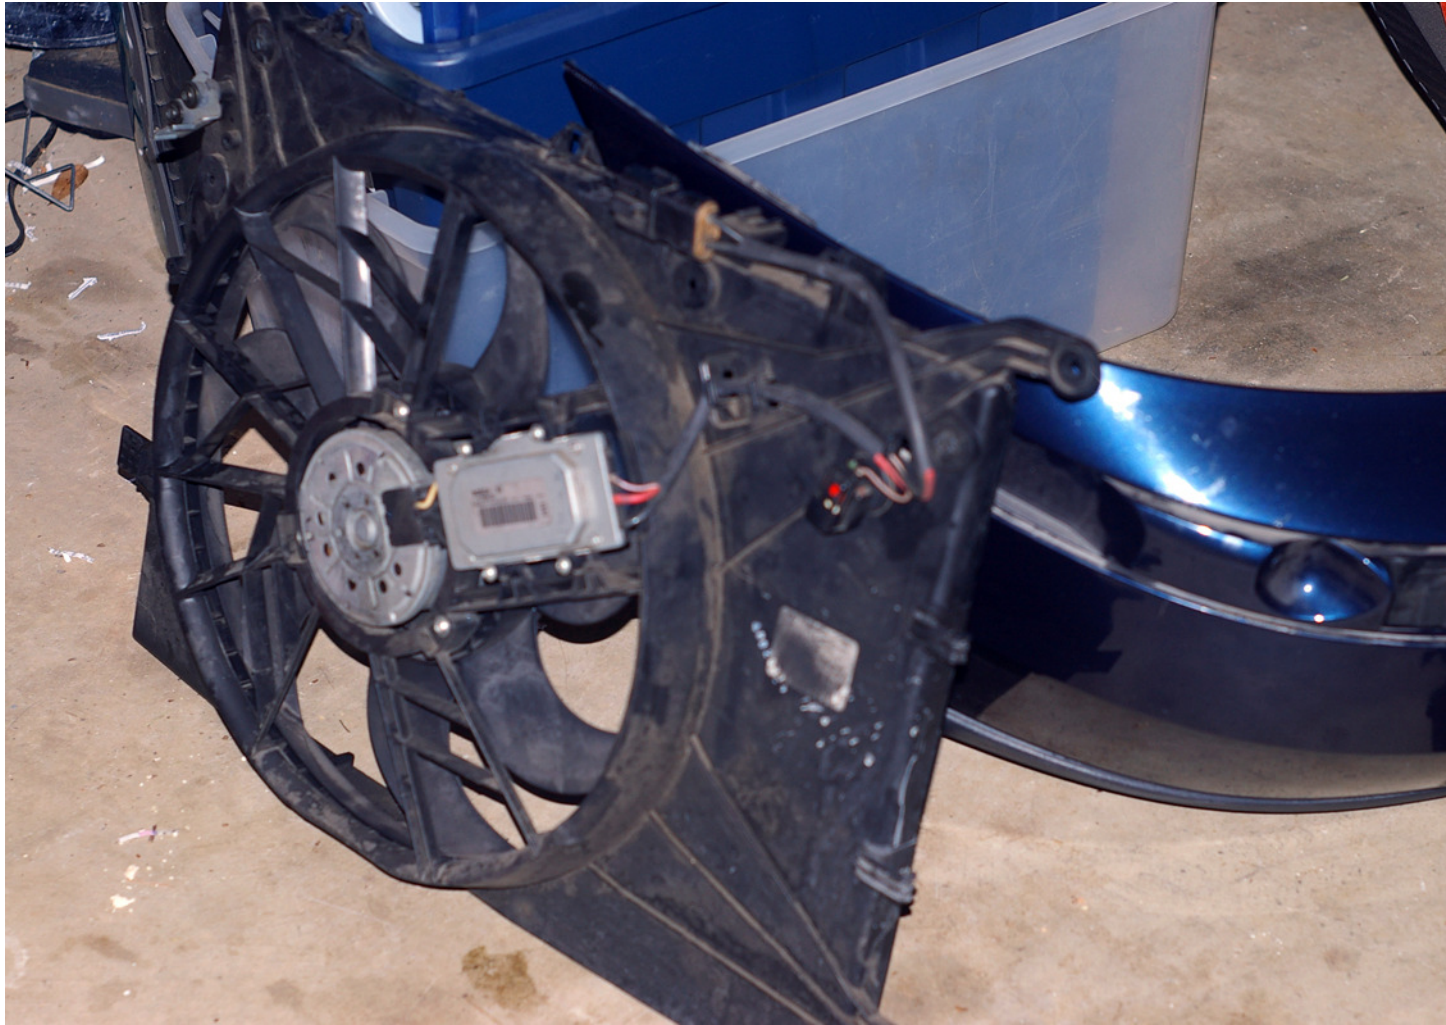
Figure 2 The fan and shroud also needs to be removed for access to the four a/c compressor bolts and removal of the compressor from the top. A/C compressor needs to come out from the top with just enough room between the intake manifold and radiator.

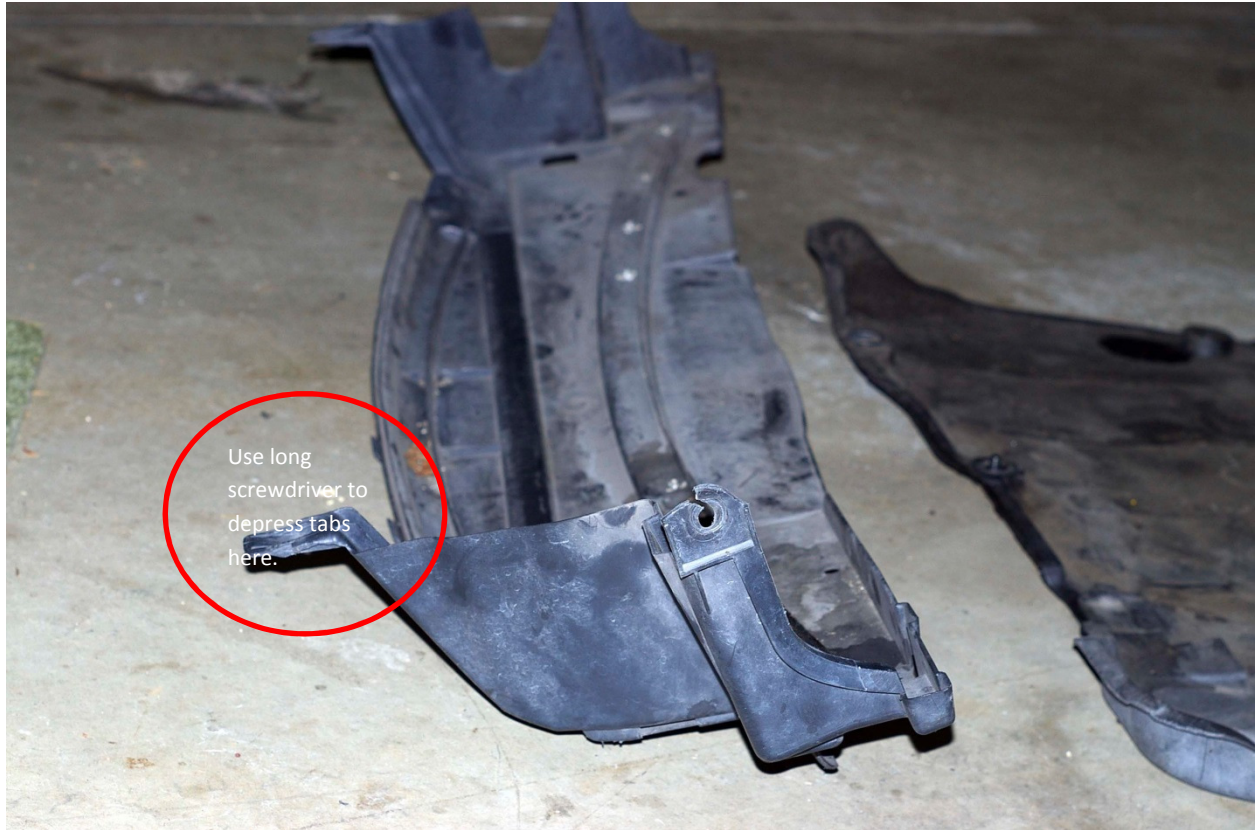
**Figure 3** From under the car, the front air dam and engine belly pan also need to be removed. The front air dam is held on by two bolts, one on each side and two locking tabs up front. A long screwdriver and good lighting is needed to depress the tab fingers up front. While under the car disconnect the fog lights in preparation for the front bumper cover removal.

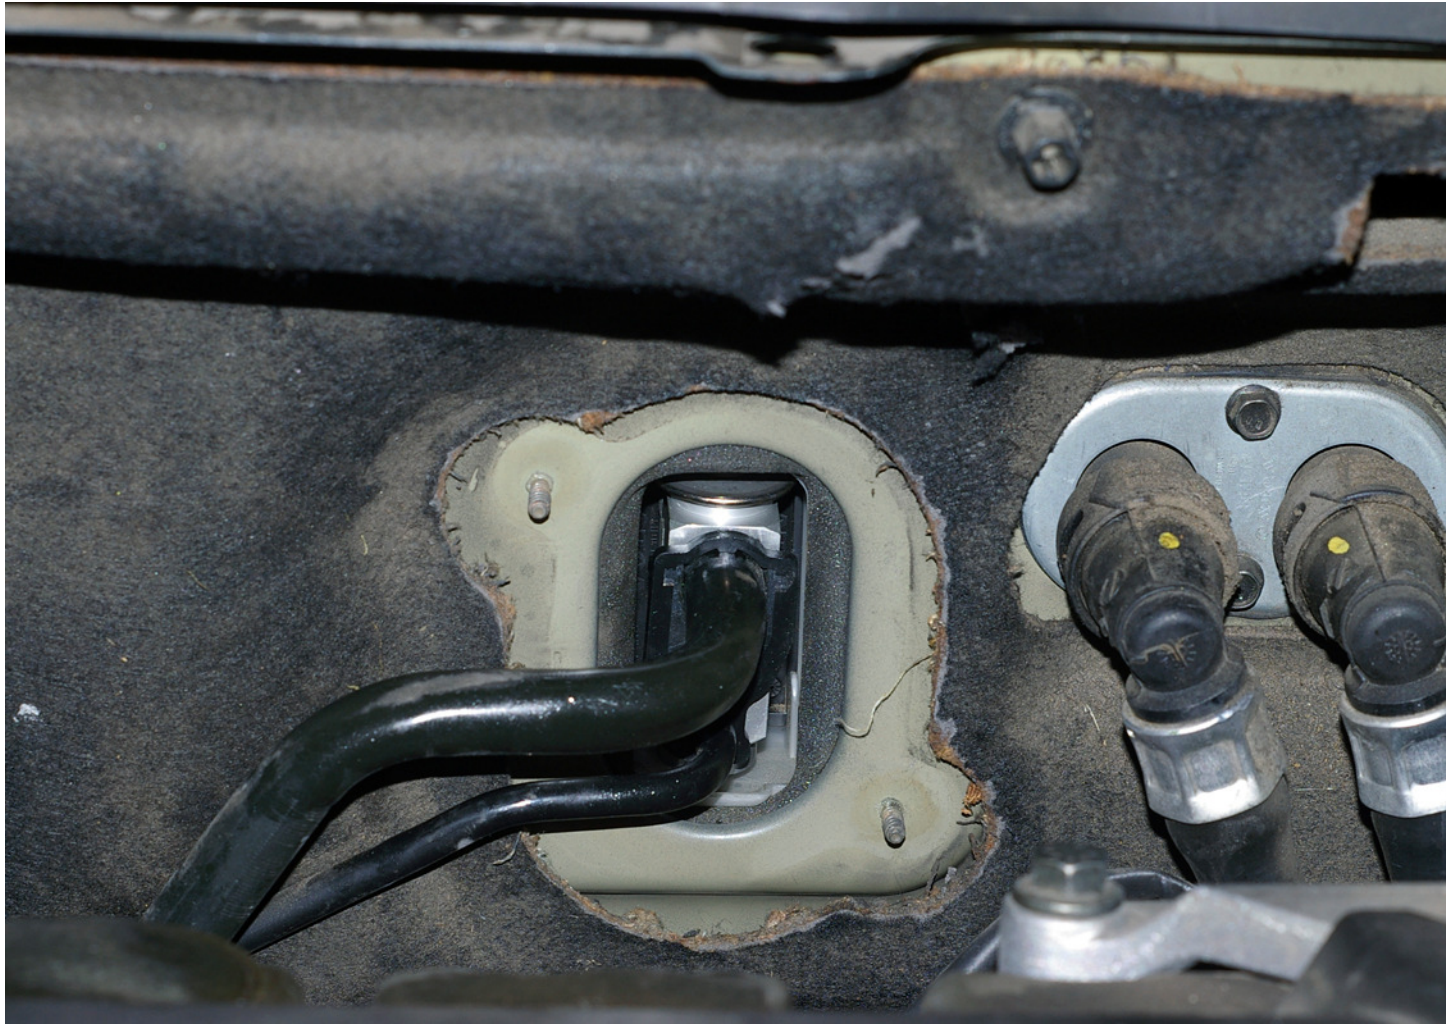
Figure 4 Here's the expansion valve located on the firewall and with the access plate removed. Two stamped metal nuts need to be removed to take off the plate. These nuts are not on tight; just use pliers to grab one of the flat edges and twist.

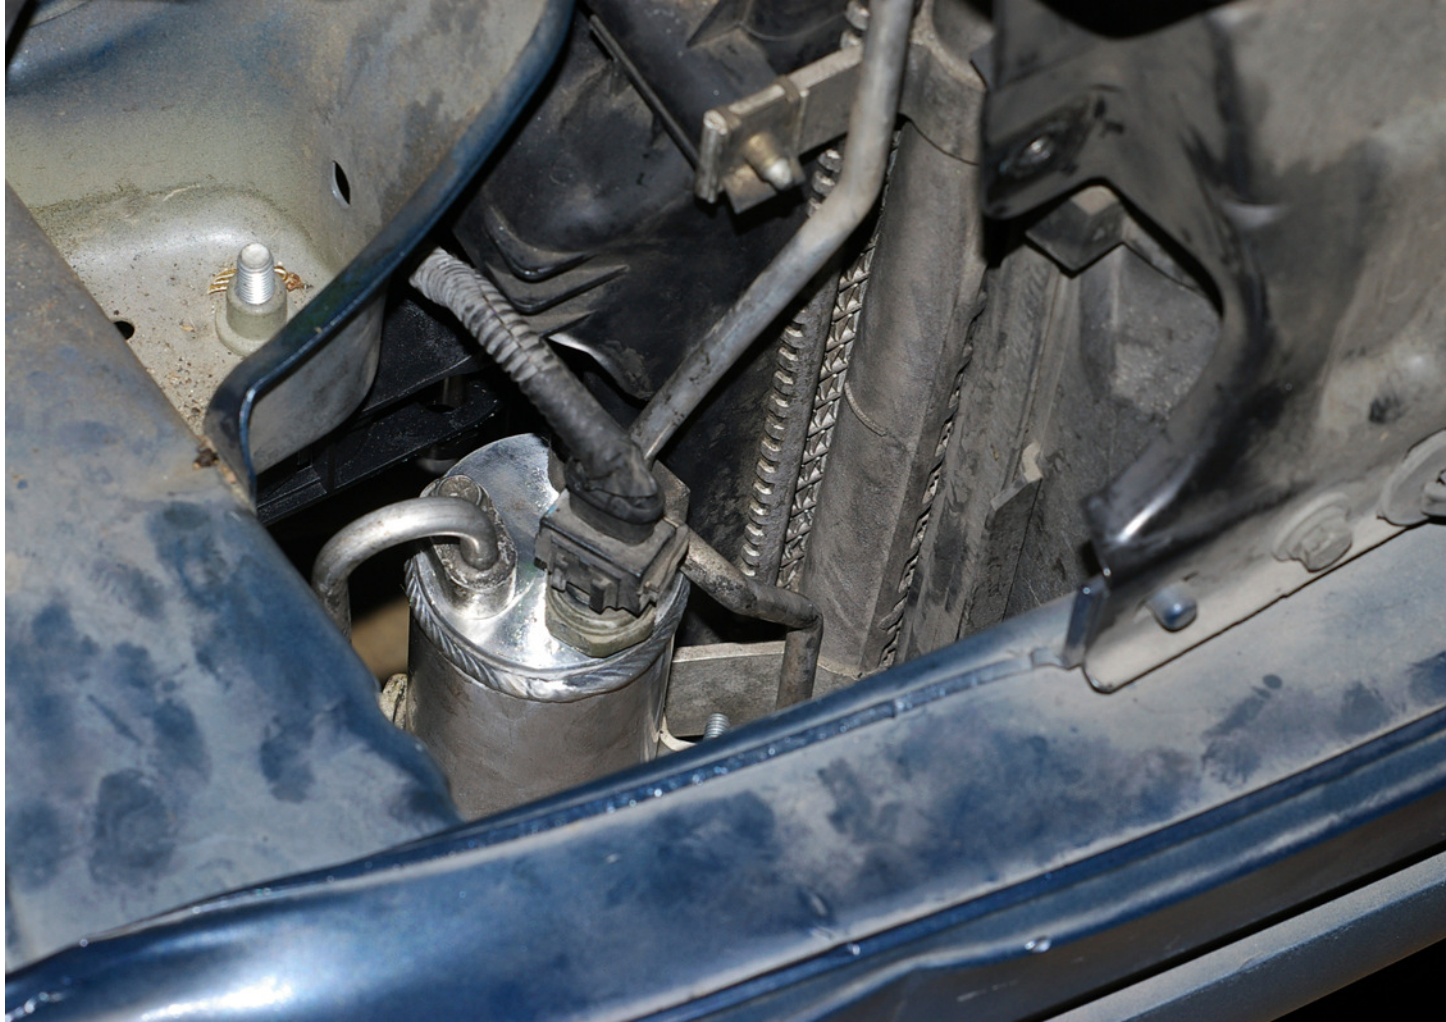
Figure 5 Here's the location of the receiver/drier behind the passenger side headlamp and with the front bumper cover/grill and headlamp removed. The new receiver/drier has been installed in this picture. The receiver/drier removes moisture from the system and provides some filtering.

Any time the A/C compressor is replaced or the system has been open for any length of time it is recommended the receiver/drier be replaced. There is a desiccant bag in the receiver/drier to absorb moisture in the system and once saturated it needs to be replaced. Replace this component last to minimize the time it's exposed to air and moisture. Front bumper fascia and passenger side headlight must be removed for access.

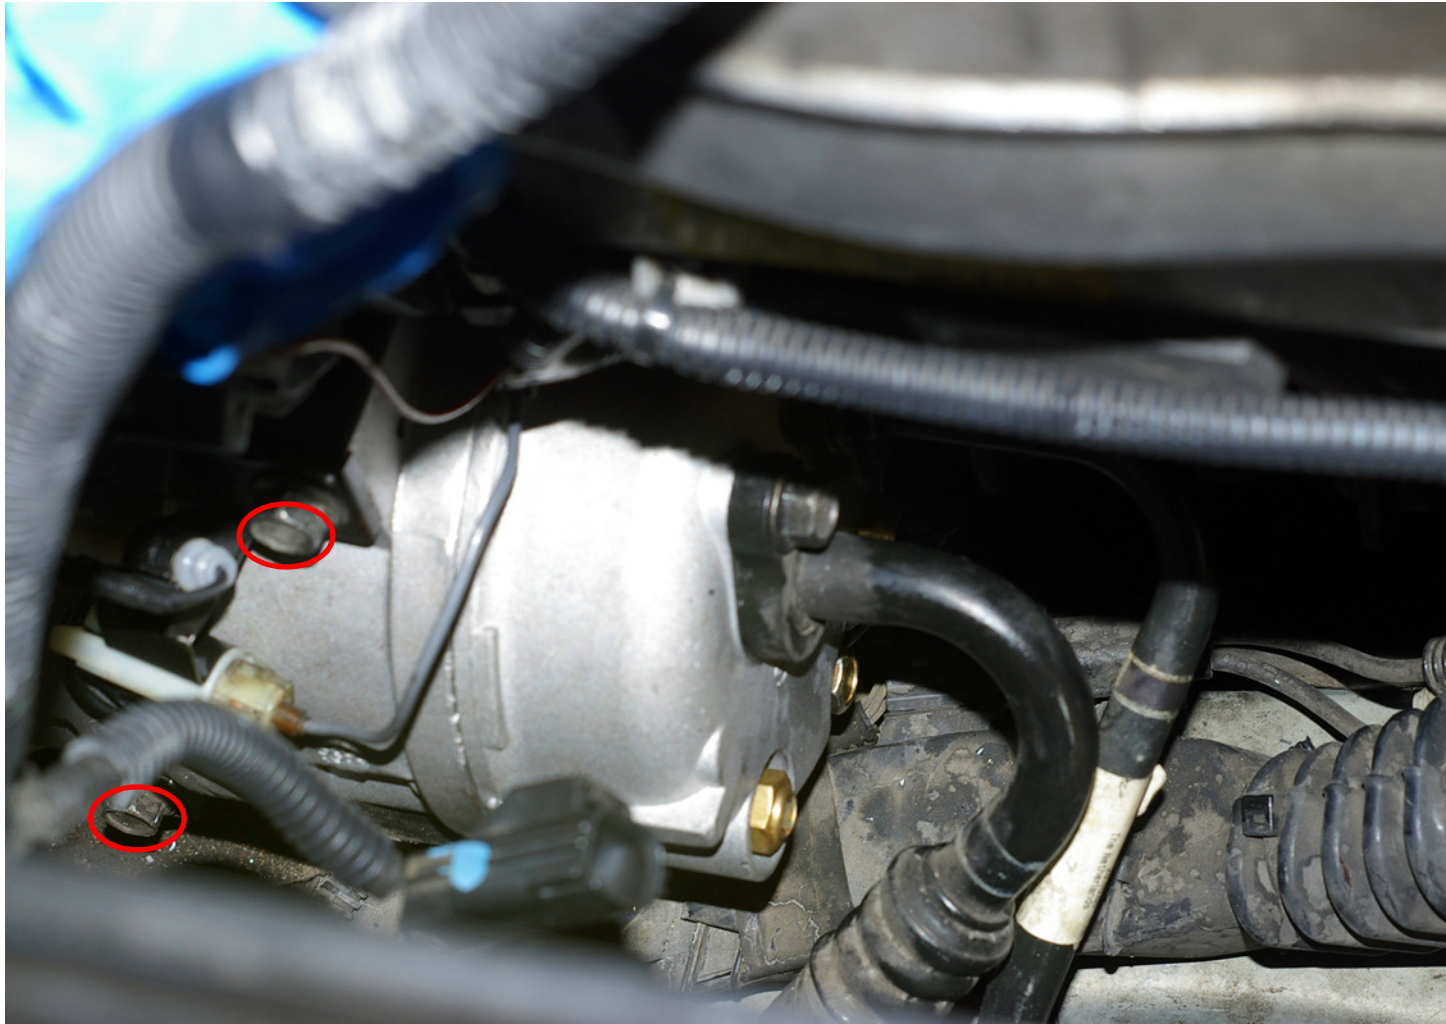
Figure 6 A/C compressor location is below the alternator and attached with four bolts. Once the radiator fan and shroud assembly is removed there's good access to the four bolts and the compressor comes out from the top. Two of the bolts are visible in this picture.

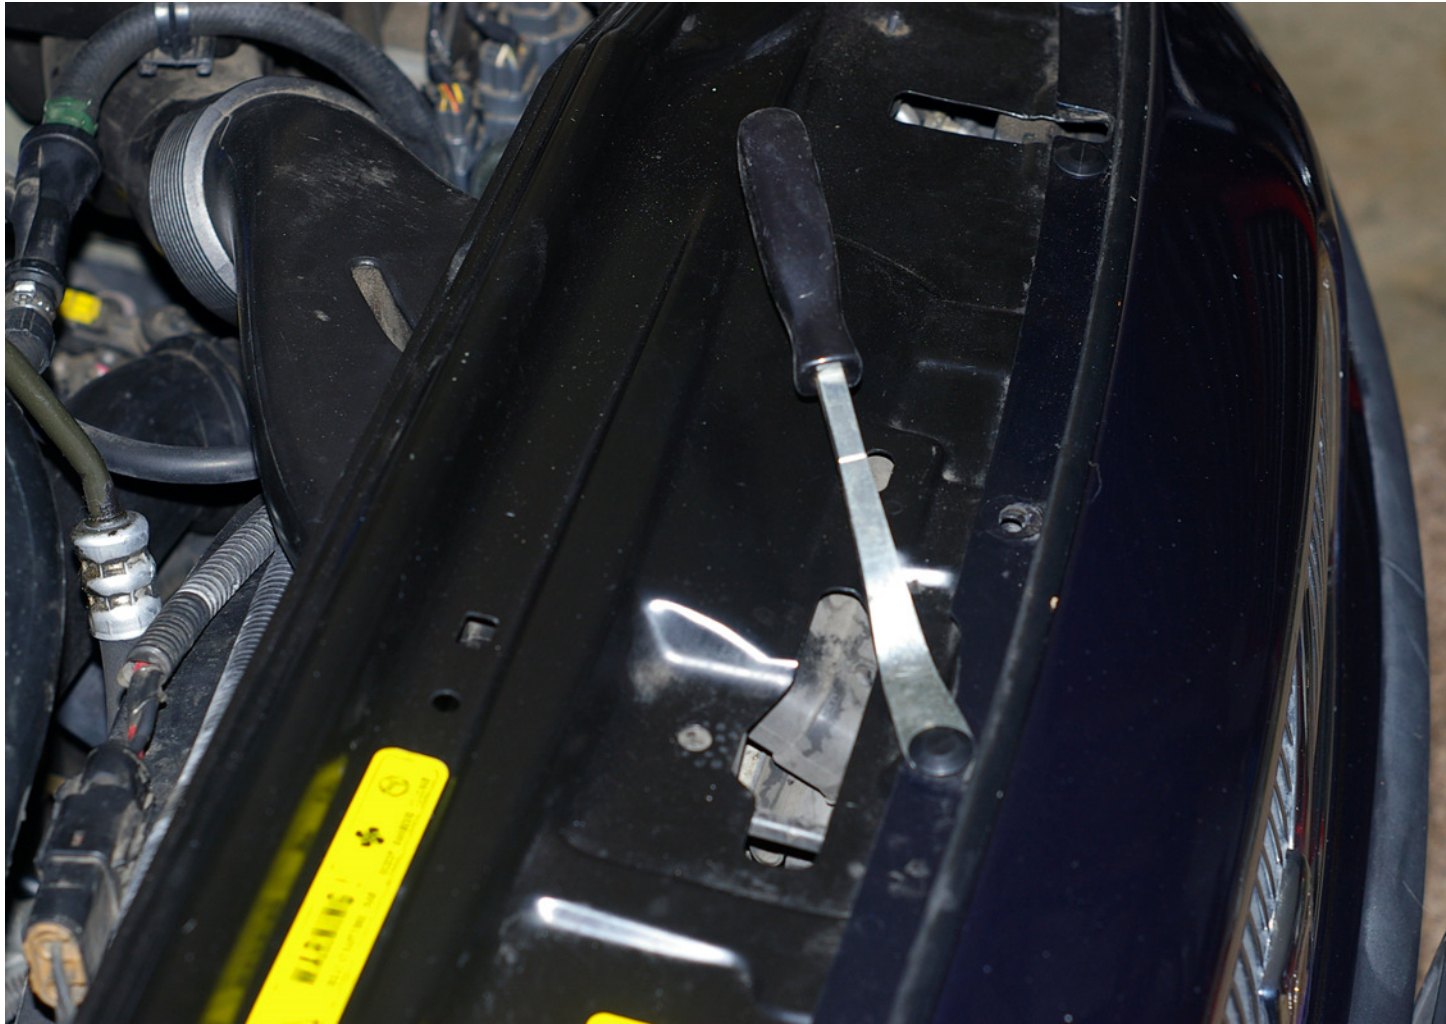
Figure 7 To begin removal of the front bumper cover the plastic push pins on top must come out. The plastic pins on my car all needed to be replaced due to deterioration over the years.

If you ever need to replace a headlight assembly you'll now know how to remove the front bumper/grill for access to the headlight bolts. It doesn't take long to remove. The plastic pins on top need to be removed, two bolts under the bumper trim pieces need to be removed, the fog lights need to be disconnected and two torx screws in the fender wells need to be loosened, then it slides off.

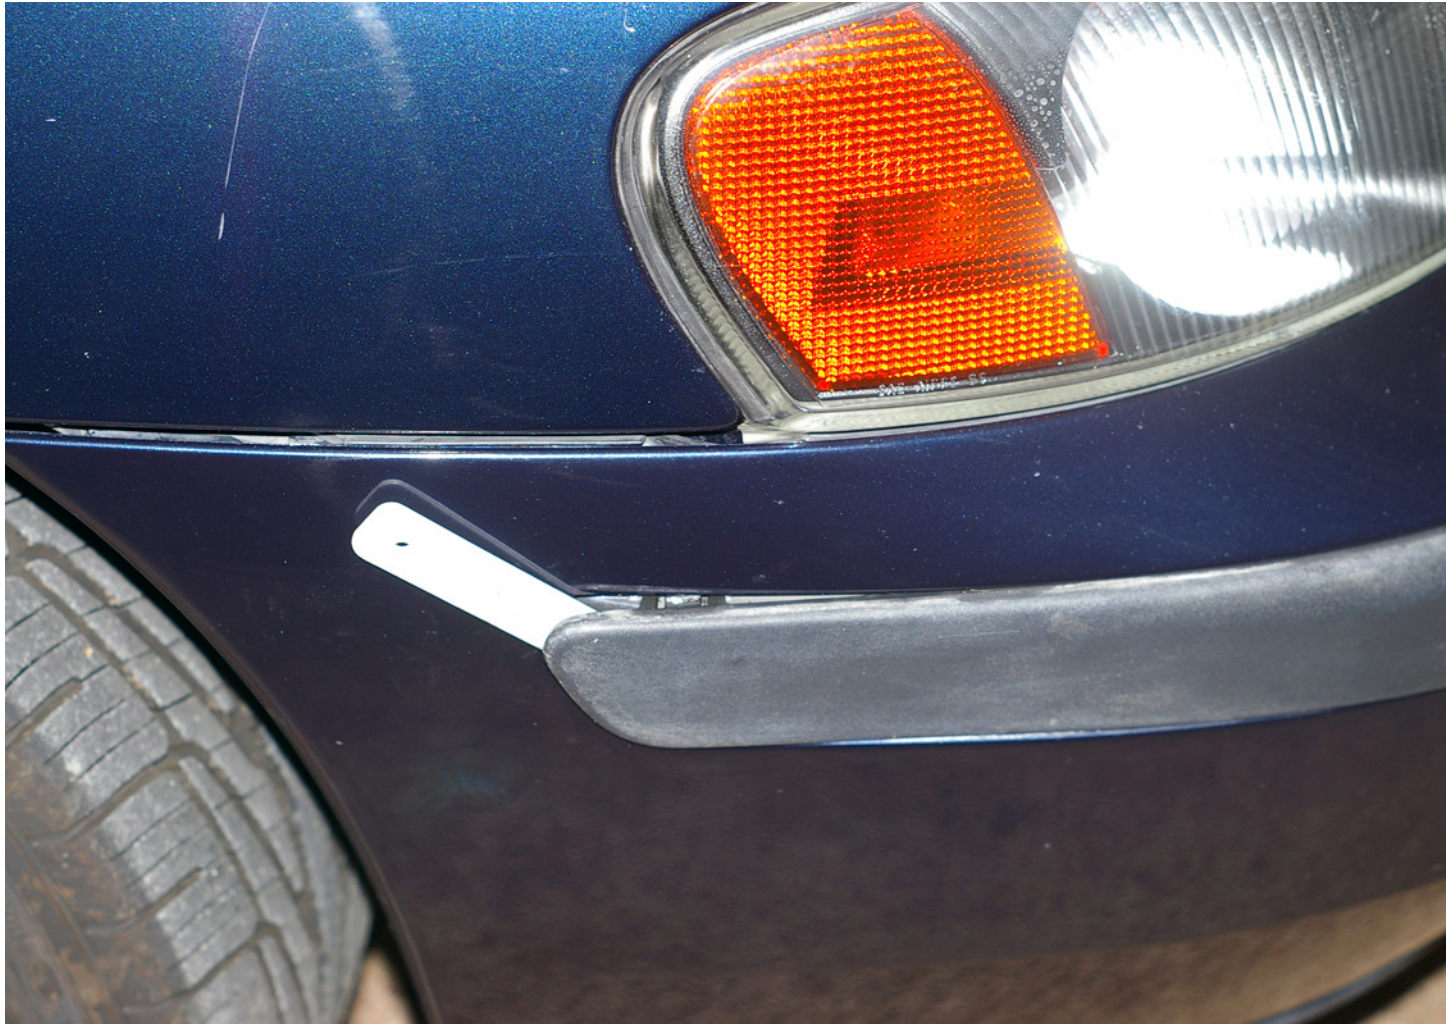
Figure 8 Remove plastic trim pieces on both sides to gain access to two mounting bolts. Don't forget to unplug the fog light connectors prior to sliding the bumper cover off.

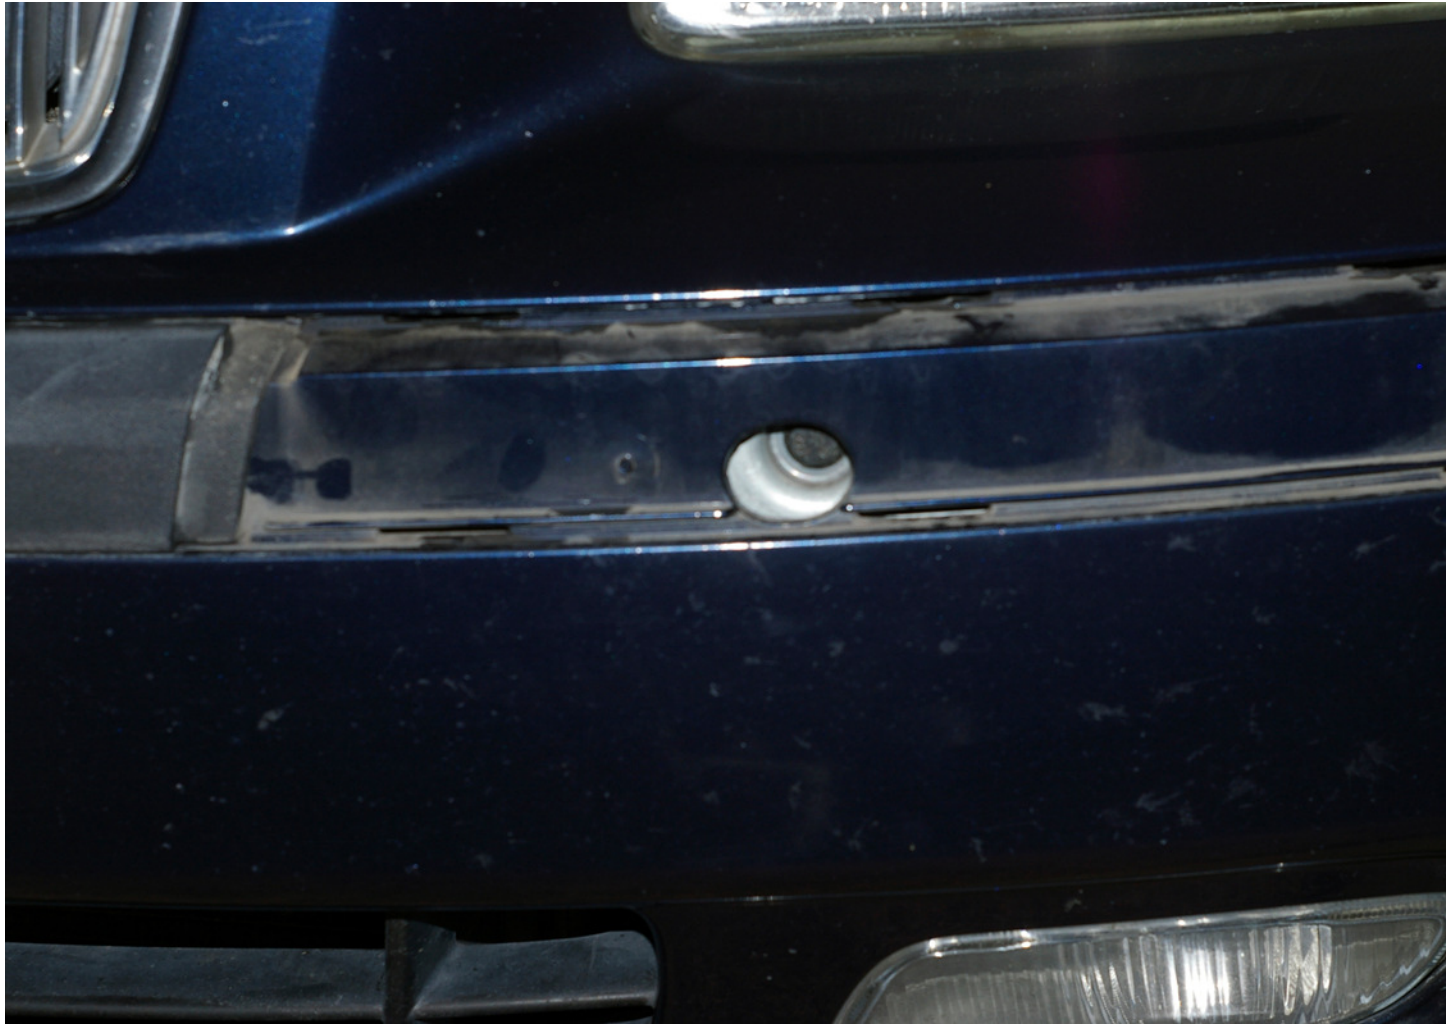
Figure 9 Underneath the bumper trim pieces are two bolts one on each side in the front. Remove these two bolts and take care to prevent the bolt threads from contacting the edge of the metal inserts in the bumper fascia. When I installed one of the bolts the metal insert pieces was not lined up well over the bolt holes in the bumper area and I damaged the threads on the bolts, which damaged the threads in the bumper sheet metal. Just make sure when reinstalling the bolts the holes in the bumper fascia lined up well over the bolt hole threads, push on the bumper if necessary to line things up.

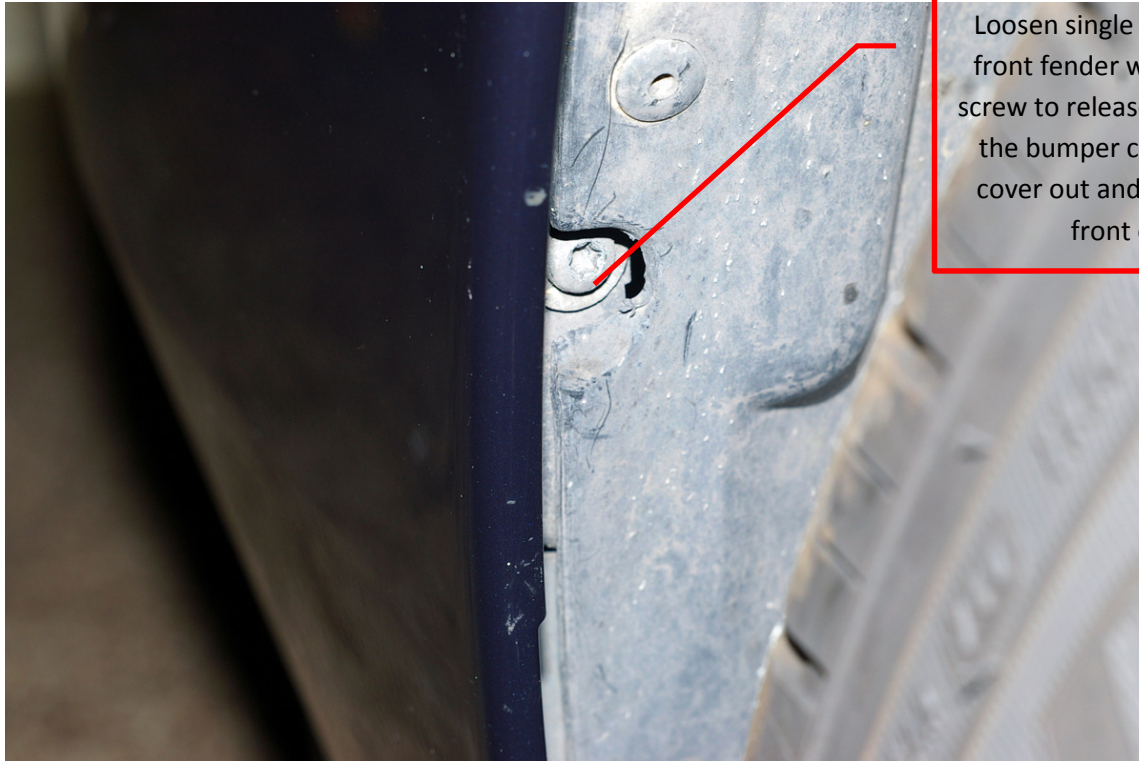
Loosen single torx screw in each front fender well and push in on screw to release the clamp holding the bumper cover. Pull bumper cover out and slide towards the front of the car.

Figure 10 In addition to the plastic push pins on top and the two front bolts these torx screws in the fender wells need to be loosened to remove the front bumper fascia. There are clamps that hold the fascia in place on the sides and these screws (one on each side) loosen the clamps. Once the side torx screws are loosened, push on the torx screws to move the clamp edge back and then the front bumper cover can be pulled out on the side inside the wheel well to clear the clamp. The fascia can then be pulled away from the car.

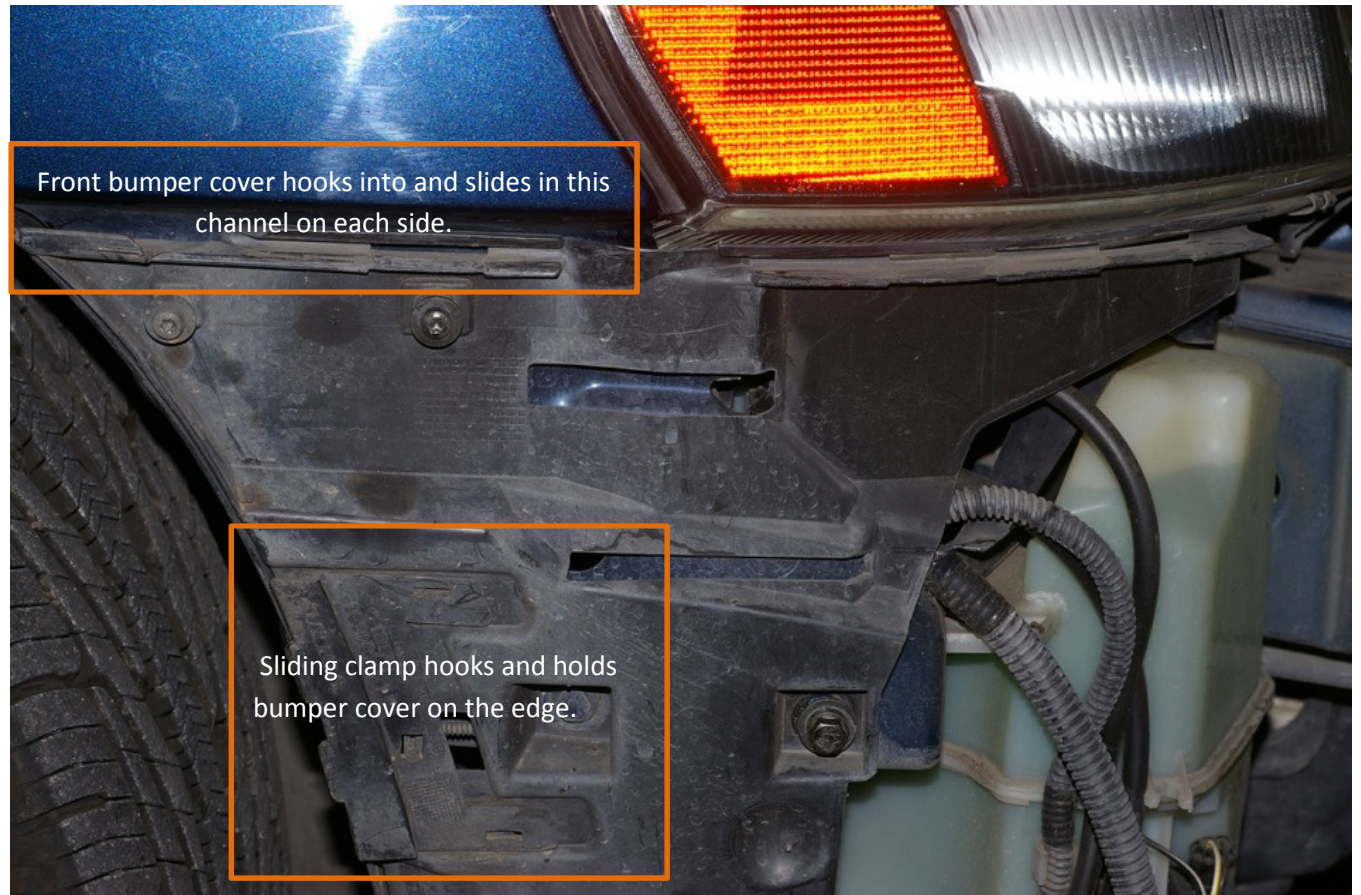
Front bumper cover hooks into and slides in this channel on each side.

Sliding clamp hooks and holds bumper cover on the edge.

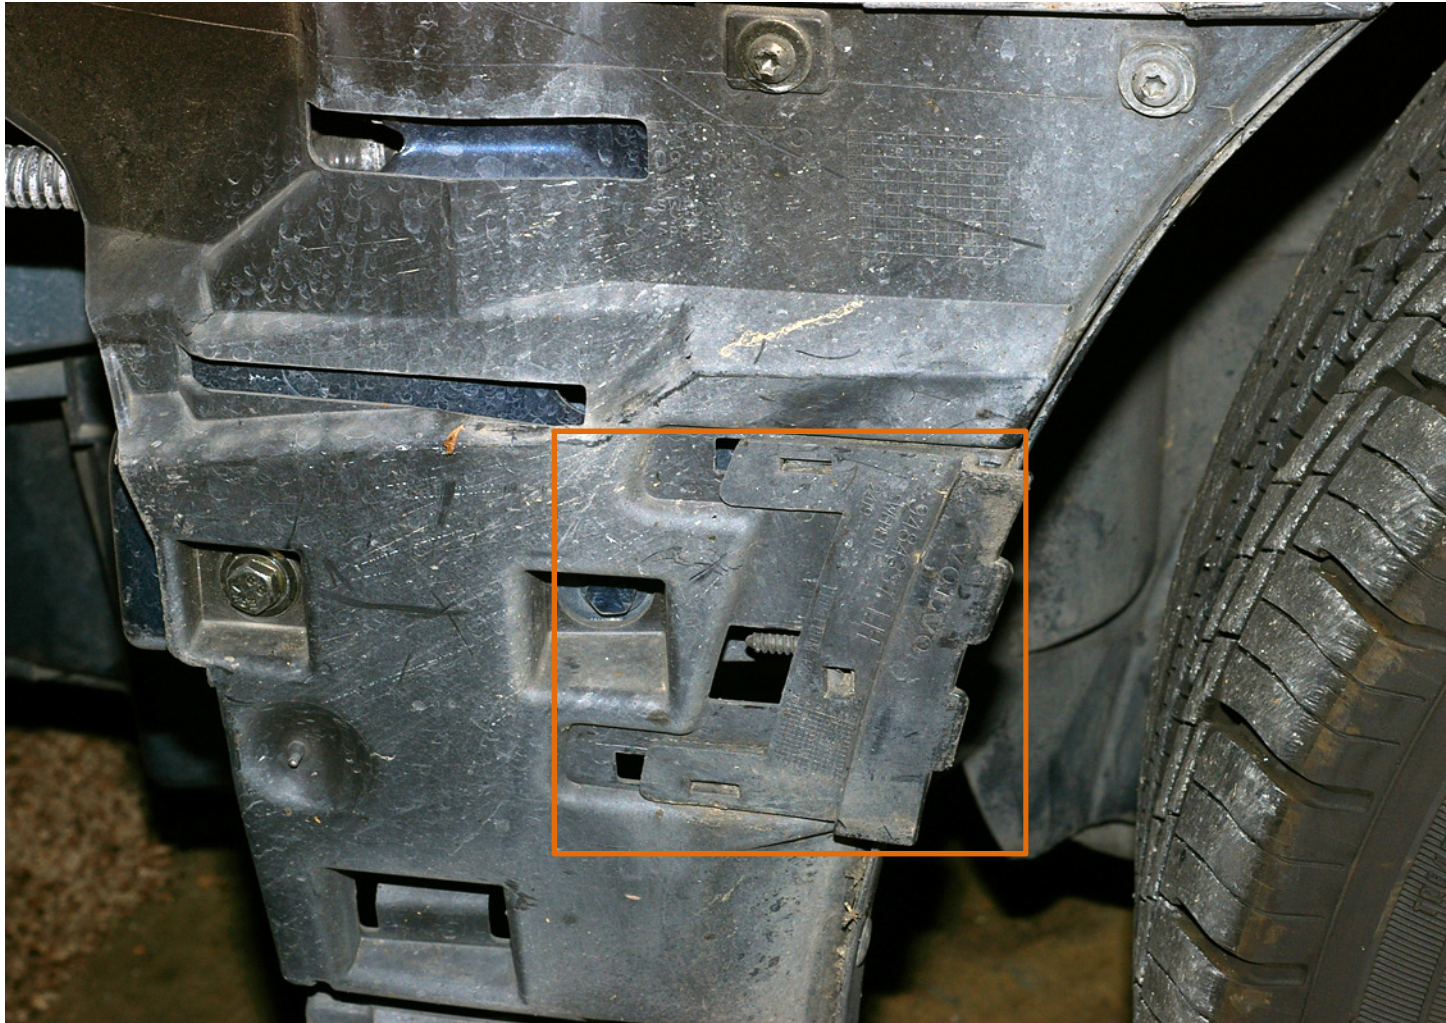
Figure 11 Another view of the sliding clamp that holds the front bumper cover on. When the torx screw is loosened the screw can be pushed in, which moves the clamp and unhooks it from the edge of the front bumper cover.

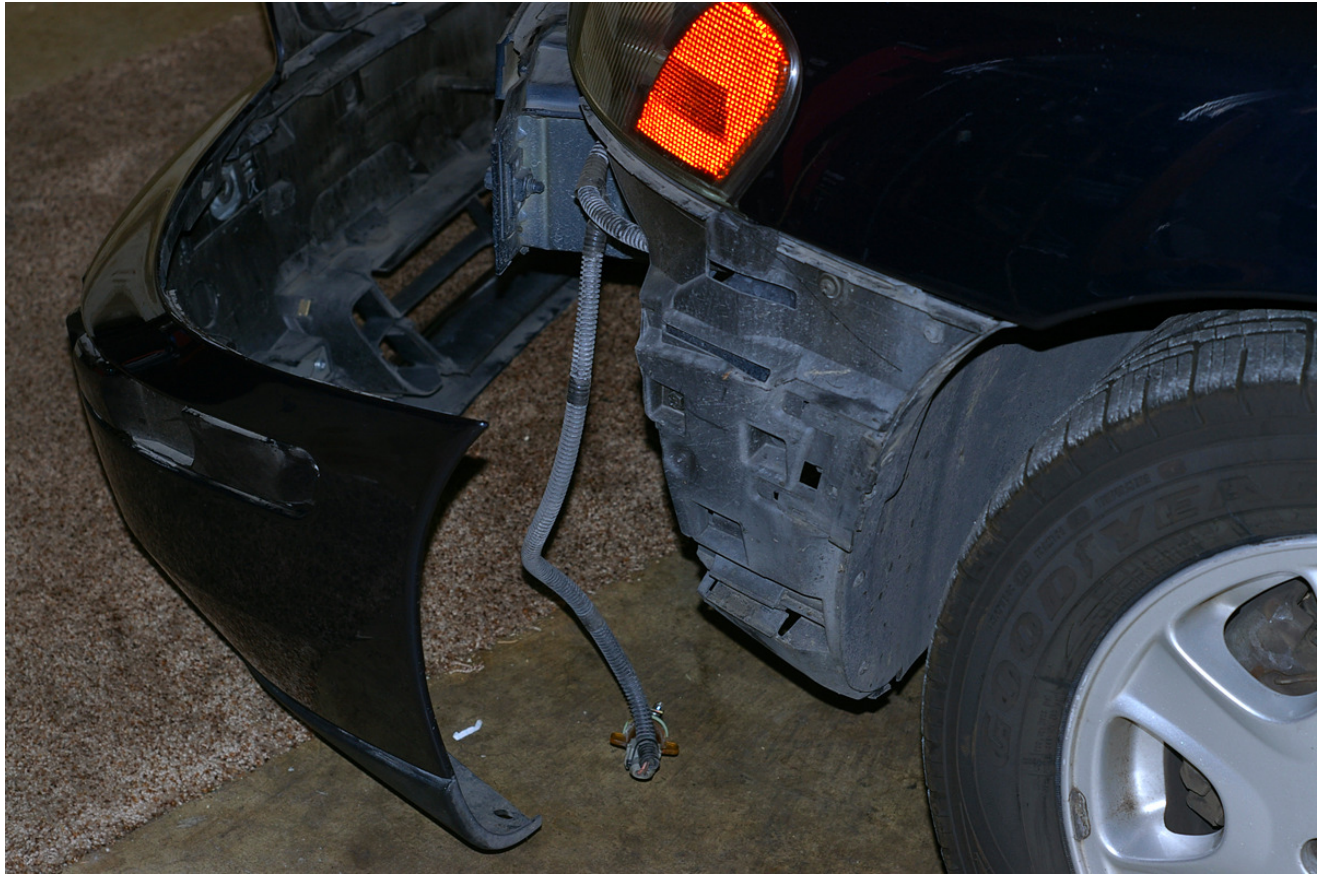
Figure 12 Be sure to unplug fog light connectors prior to sliding front cover off instead of ripping the light sockets apart like I did.

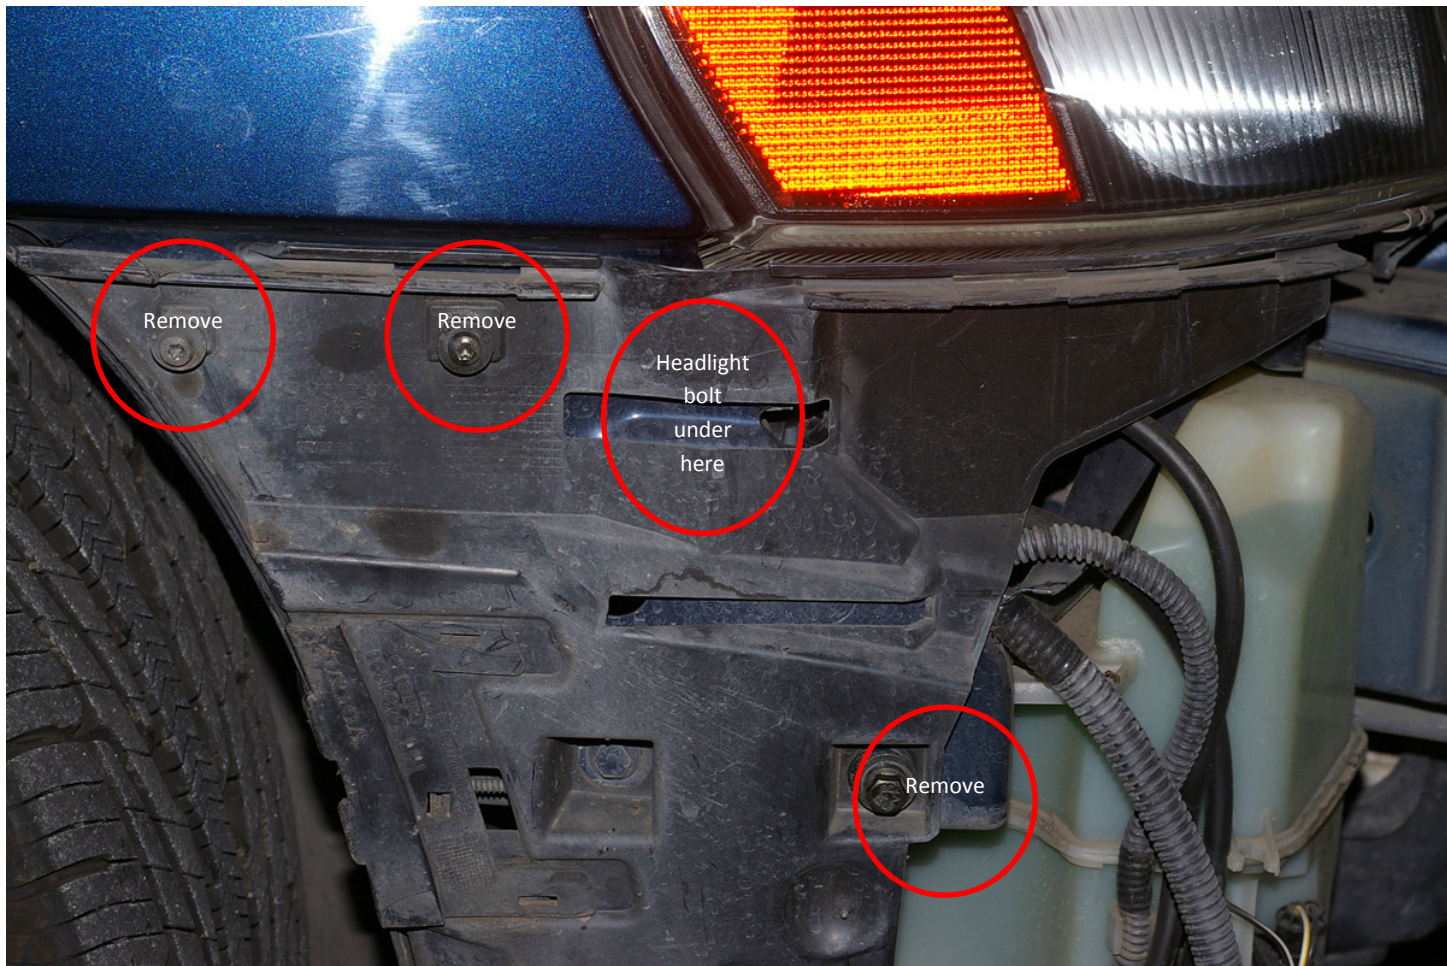
Figure 13 To gain access to one of the headlight bolts these two torx screws and one bolt need to be removed from the side here. Note the sliding clamp that holds the front fascia in place.

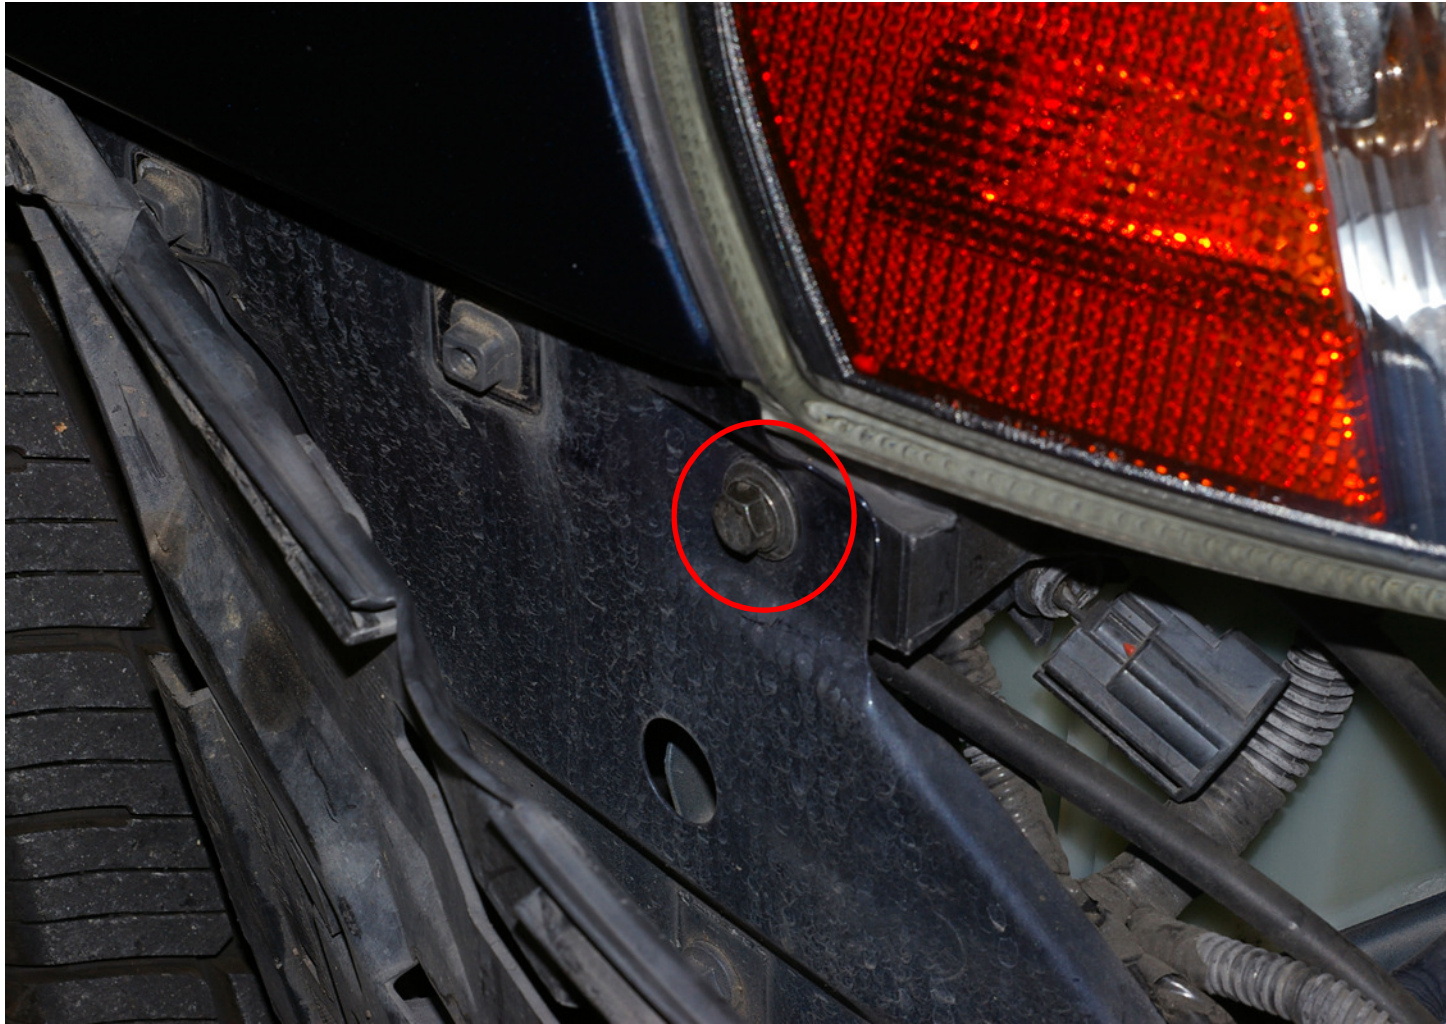
Figure 14 After the two torx screws and one bolt is removed the side plastic piece this piece can be pulled back to remove the headlight assembly bolt. Four bolts attach the headlight assembly, one on the side here two on top and one on the front. The headlight needs to be removed to gain access to the receiver/drier.

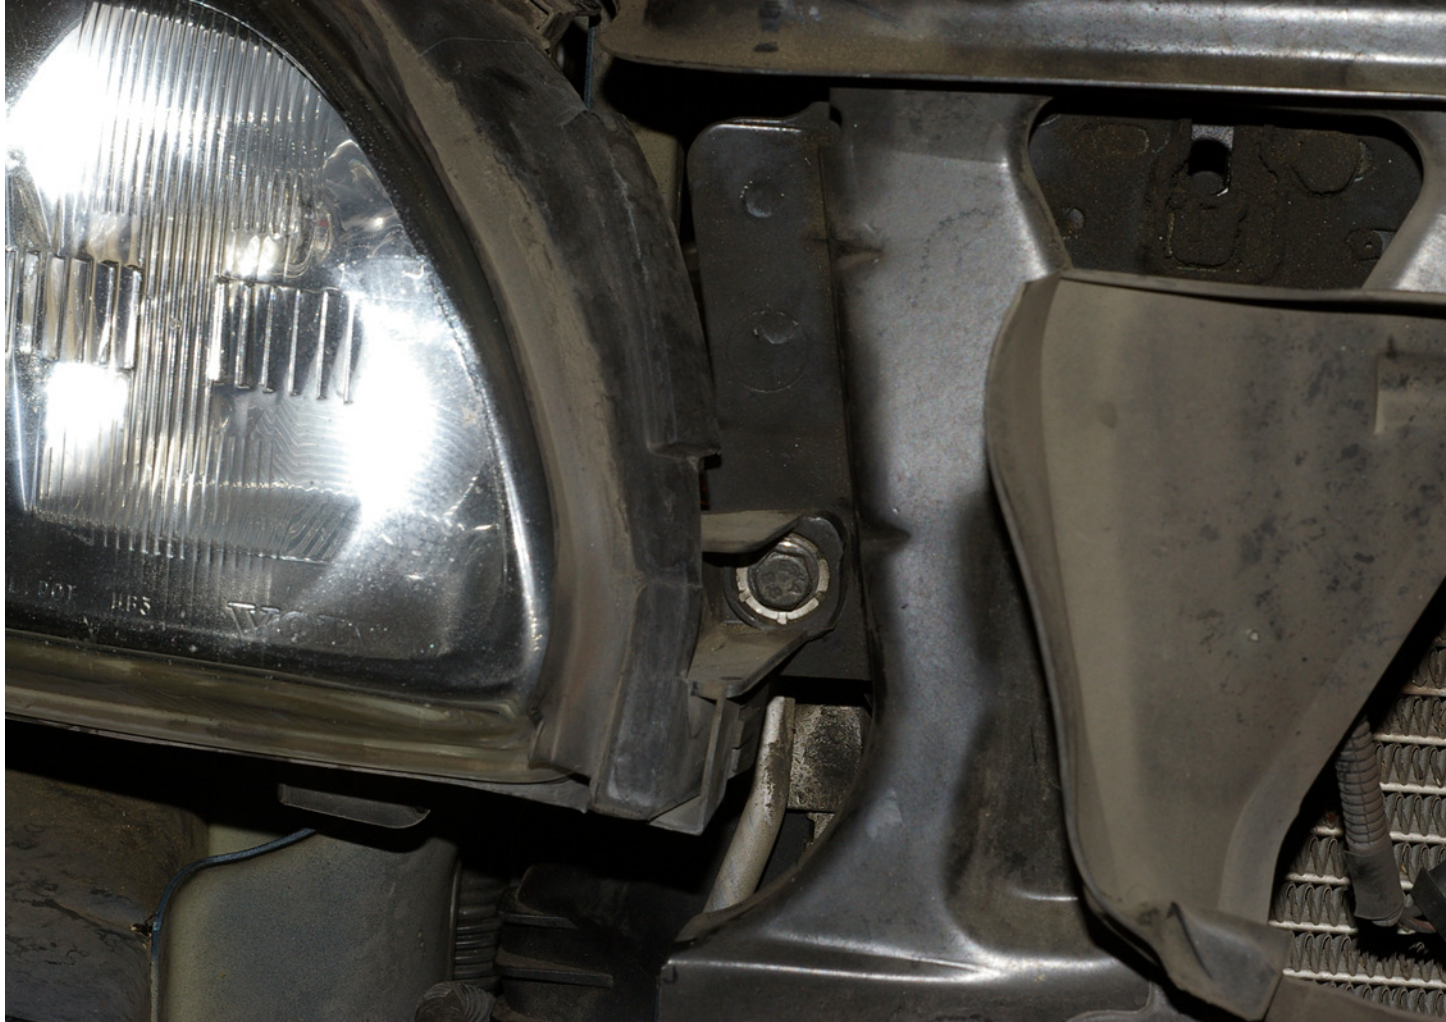
Figure 15 One of the four bolts that needs to come out for headlight removal
