Here are some pictures to show what's required when replacing the A/C compressor, expansion valve and receiver/drier on a 2001 Volvo V70. Even if you don't replace these A/C parts these pictures can help with headlight assembly replacement, bumper cover removal, radiator fan assembly removal, etc.

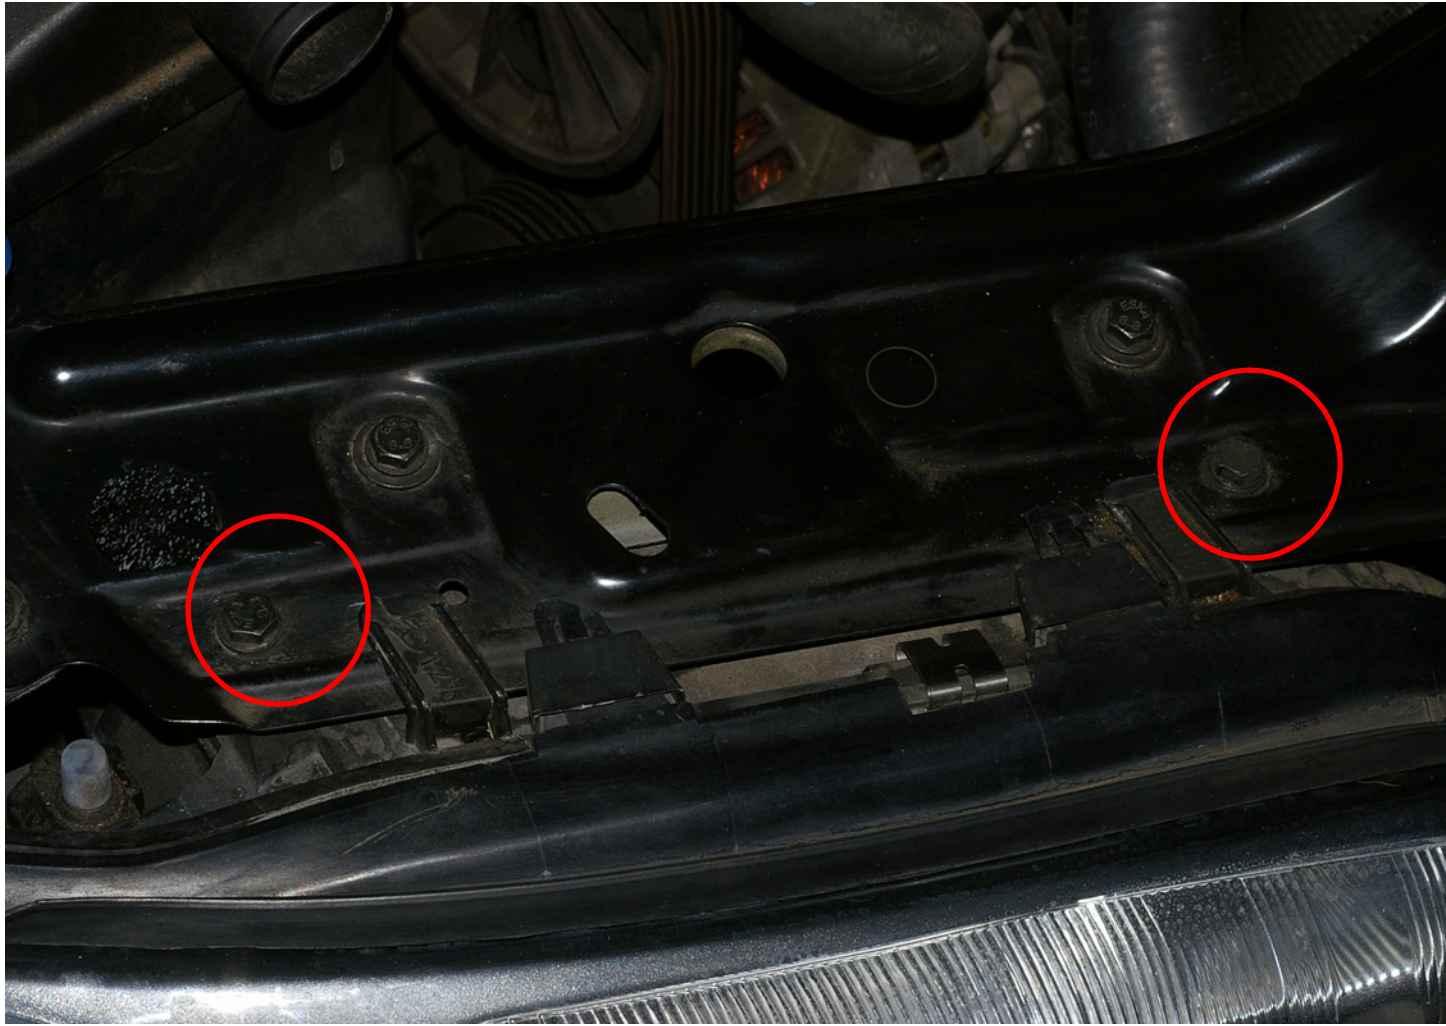
Figure 16 Remove top two bolts of headlight assembly

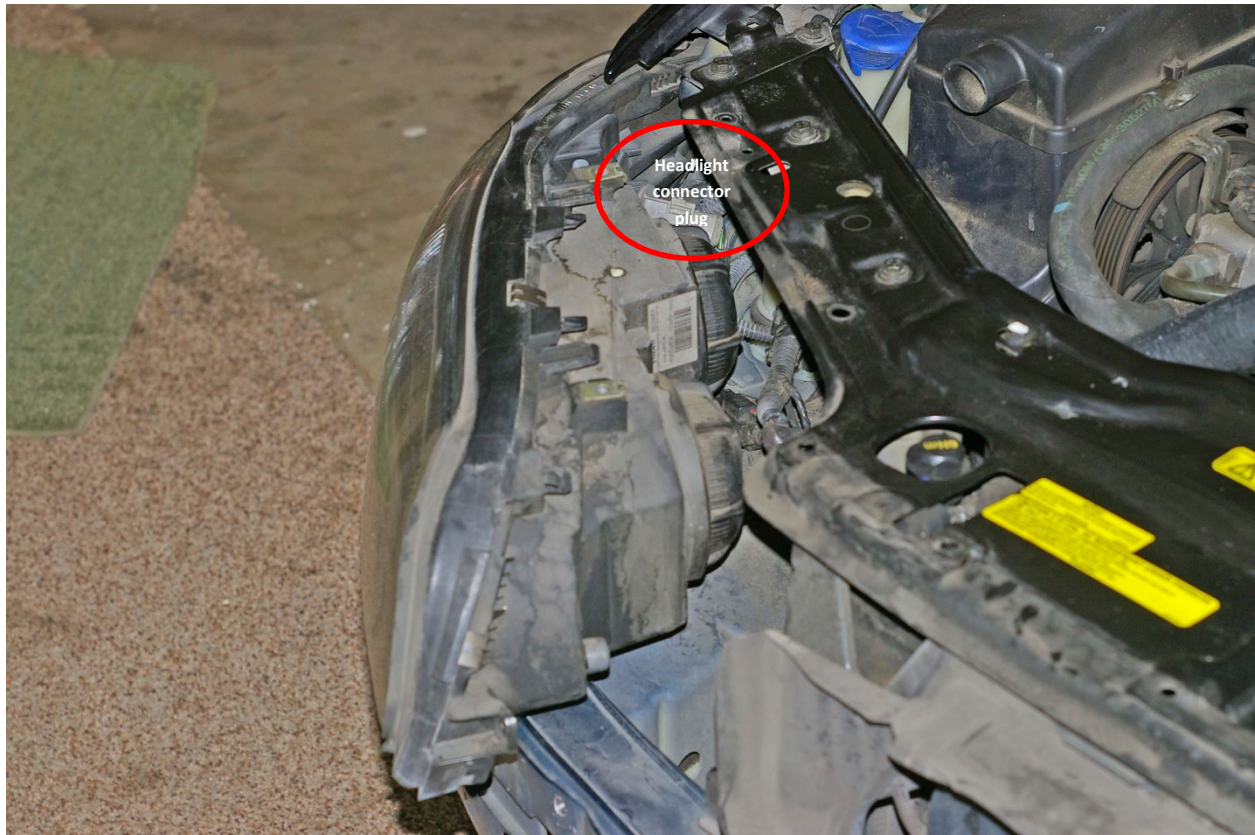
Figure 17 After removal of the four bolts and unplugging the connector the headlight assembly comes out.

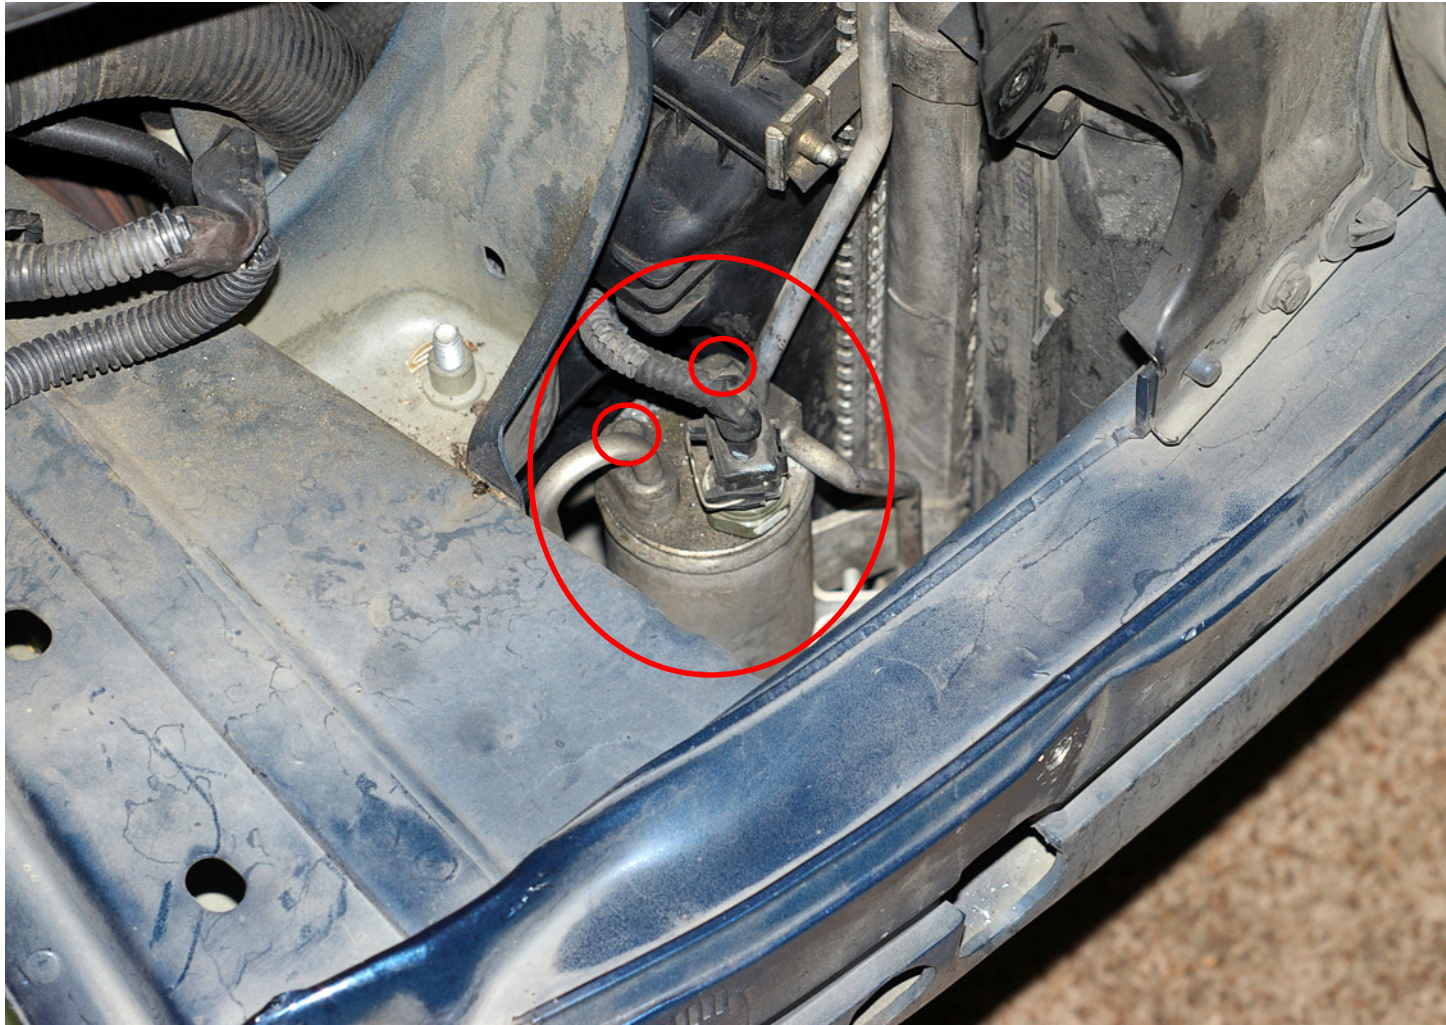
Figure 18 With front bumper cover and headlight removed there's now access to the receiver/drier. There are a couple of 10mm bolts attaching the tubes and a pressure switch to remove.

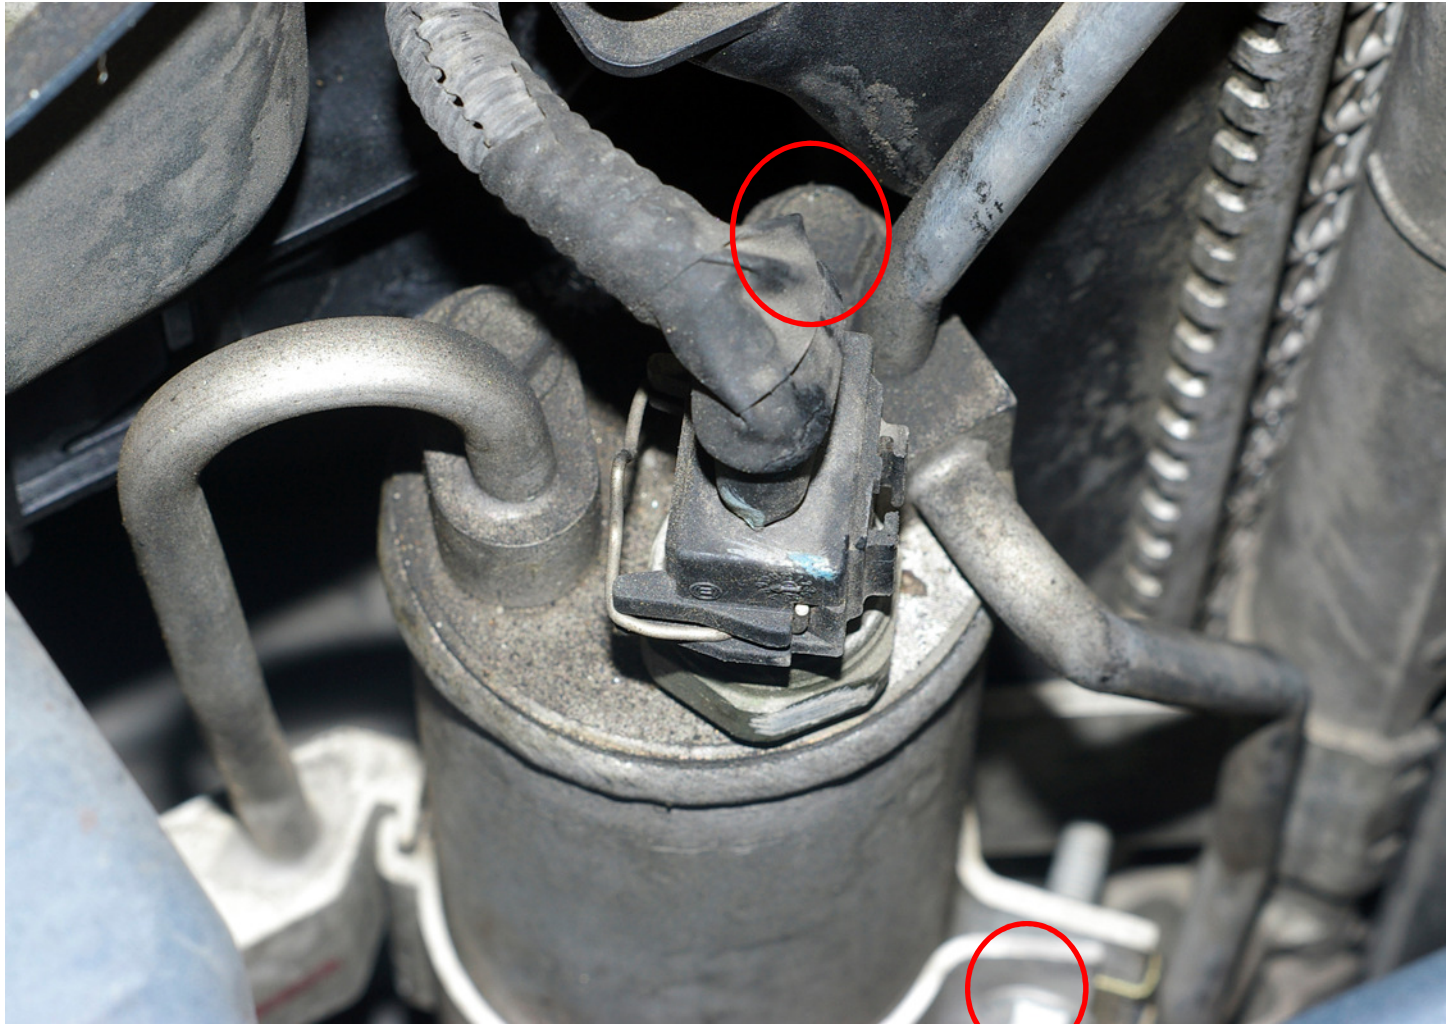
Figure 19 To get a 10mm socket on the bolt to the right I had to carefully pull the receiver/drier out some, which means bending the tubing some. I loosened the receiver/drier clamp bolt (lower right) and the pulled/bent the tubing just enough to get a socket on the top right condenser tube bolt. Disconnect the pressure switch connect for now and remove the switch after the receiver drier is removed. You can get an open end on the pressure switch nut with the receiver/drier installed but the wrench is at a bad angle. After the top two bolts are removed there's still one more below.

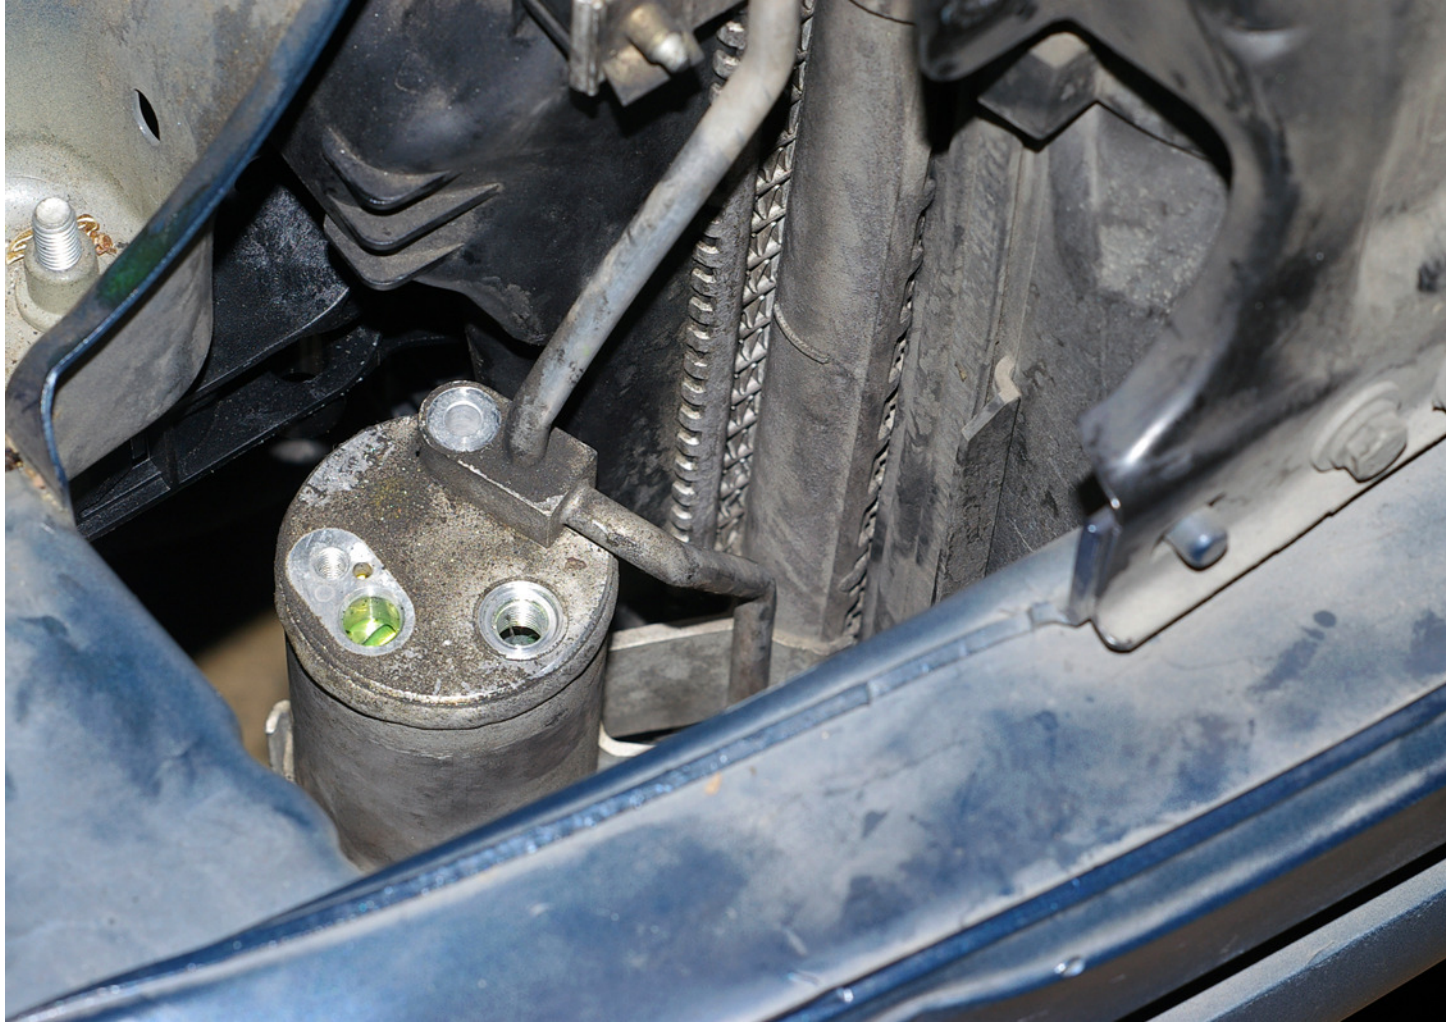
Figure 20 Top bolts and pressure switch removed. For the bolt on the right I had carefully pull out and bend the tubing some to get a socket on this bolt. I removed the pressure switch with the receiver/drier still in the car but it's easier to remove once the receiver/drier it out of the car.

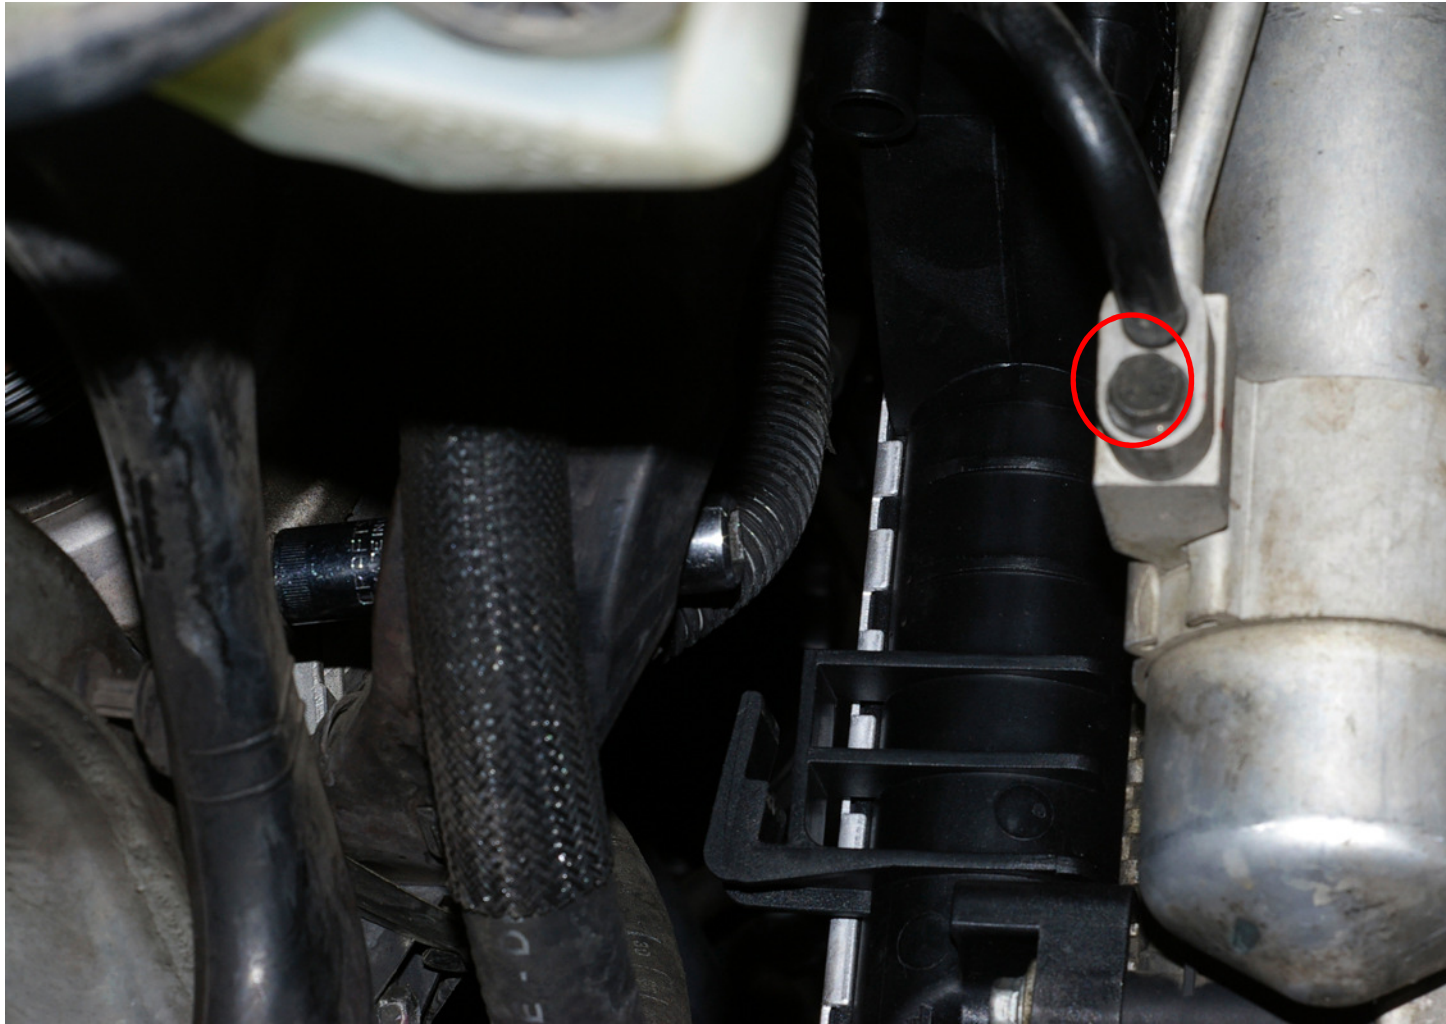
Figure 21 From below, there's one more bolt and to disconnect from the receiver/drier. The receiver/drier clamp bolt (not shown, to the right) also needs to be removed.

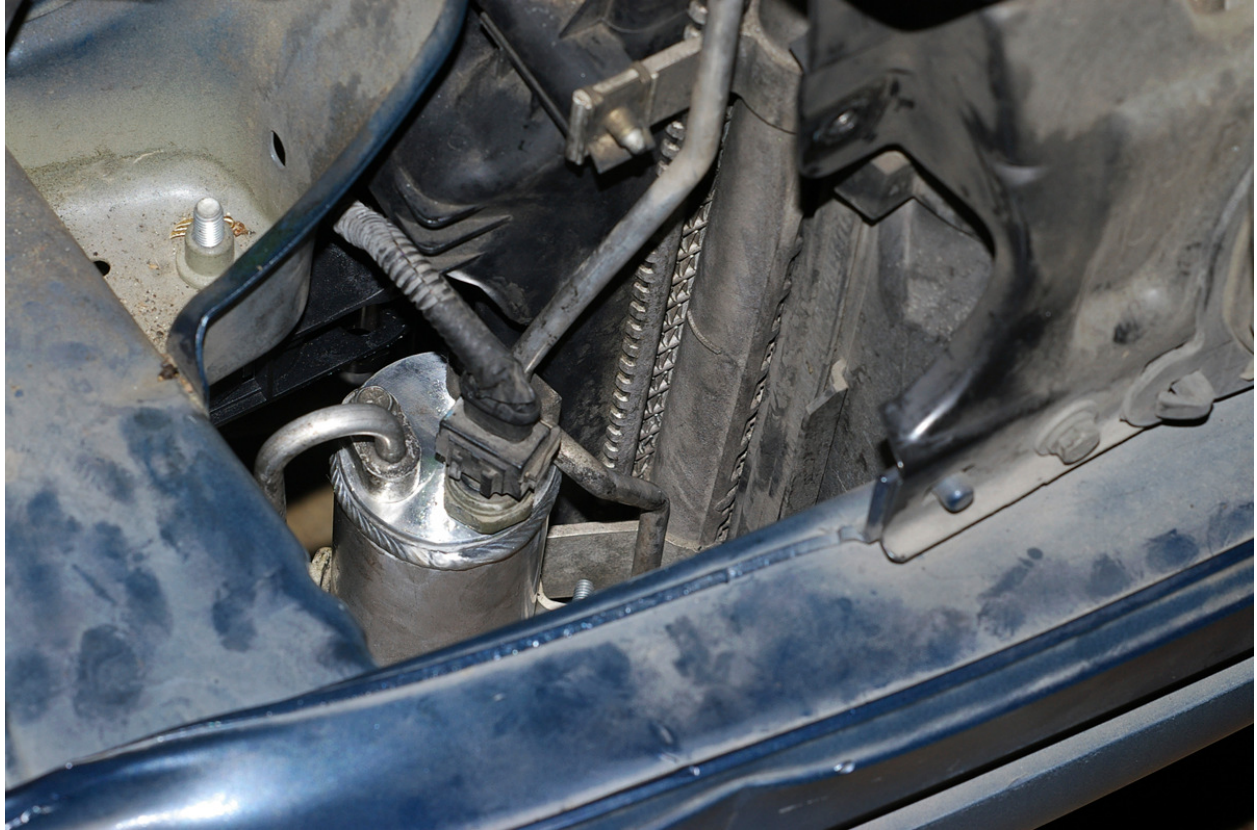
Figure 22 New receiver/drier installed, this should be the last item replaced to minimize the time the receiver drier is exposed to air and moisture.

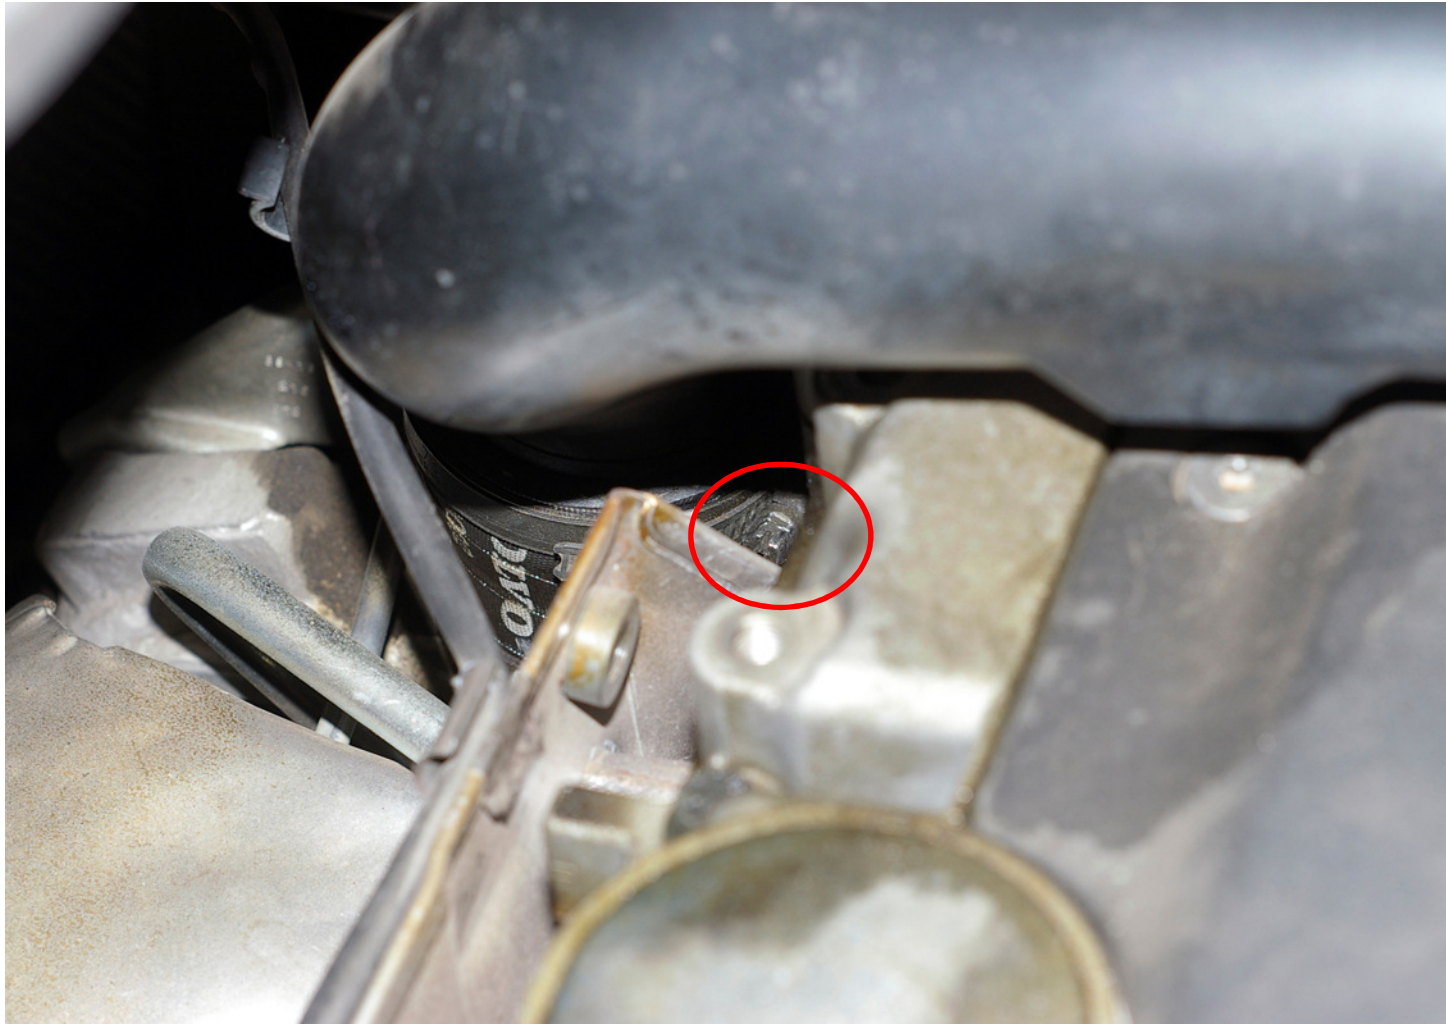
Figure 23 For access to the A/C expansion valve and the A/C compressor the top side turbo to inter cooler pipe needs to be removed. From the back side of the engine the hose clamp right above the turbo needs to be loosened up.

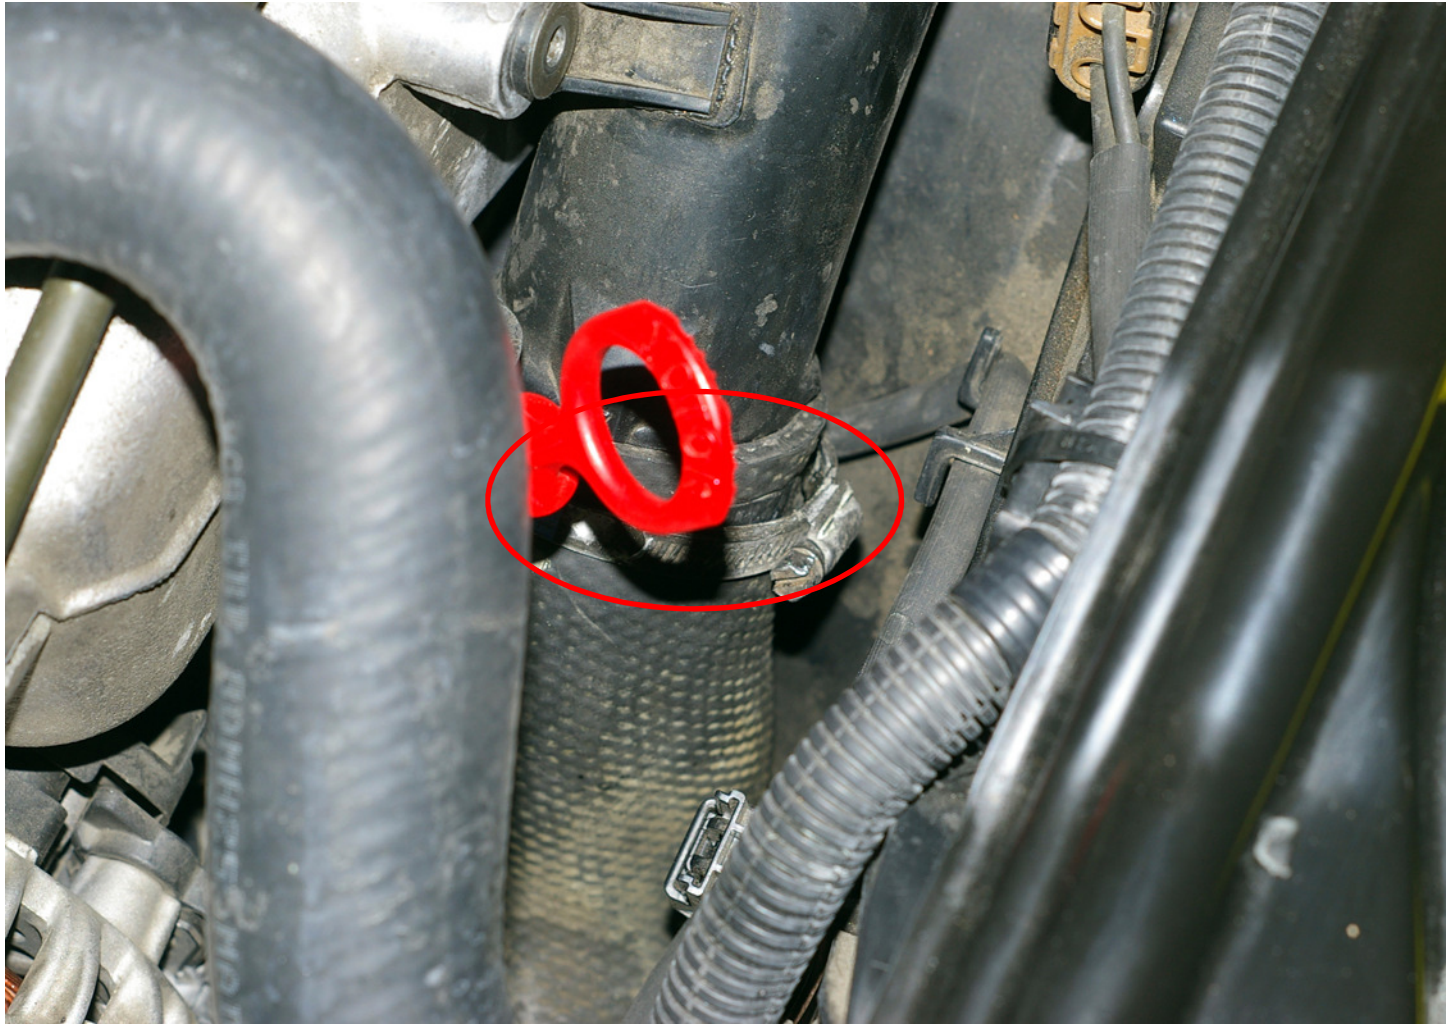
Figure 24 From the front side of the engine; loosen the turbo pipe to intercooler hose clamp. Also a good idea to take out dipstick to prevent breaking the plastic handle off, which I've done. Save \$25 replacement cost.

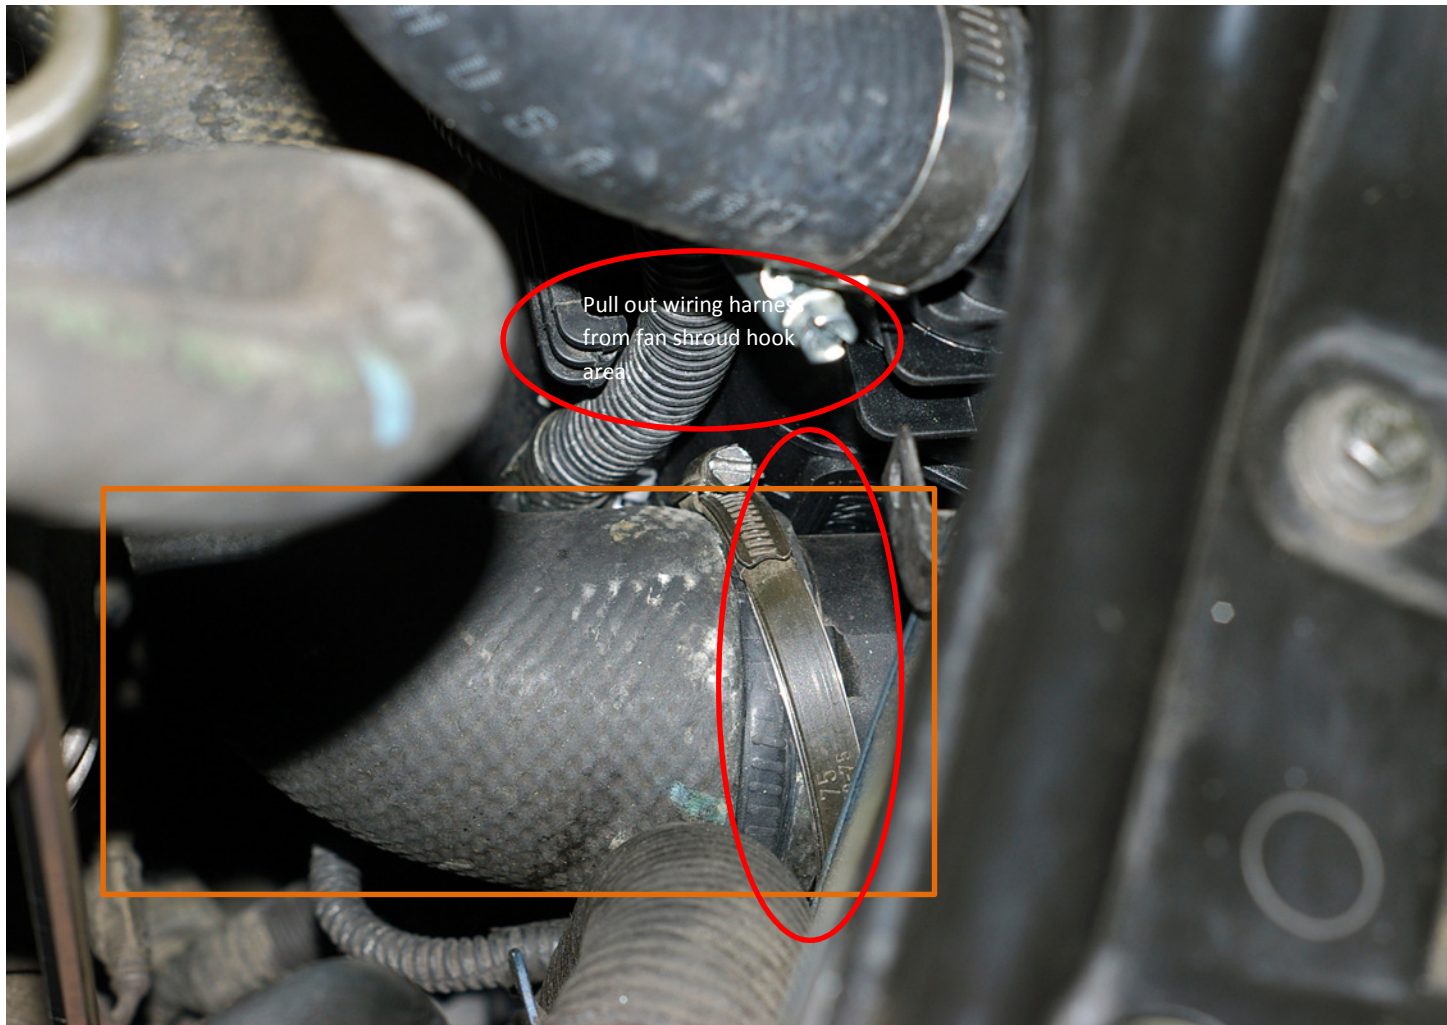
Figure 25 Also, at the intercooler, loosen the hose to inter cooler clamp and remove this short hose piece for better access to the A/C compressor and easier fan shroud removal. Remove dip stick before removing this hose, this is when I broke the dip stick.

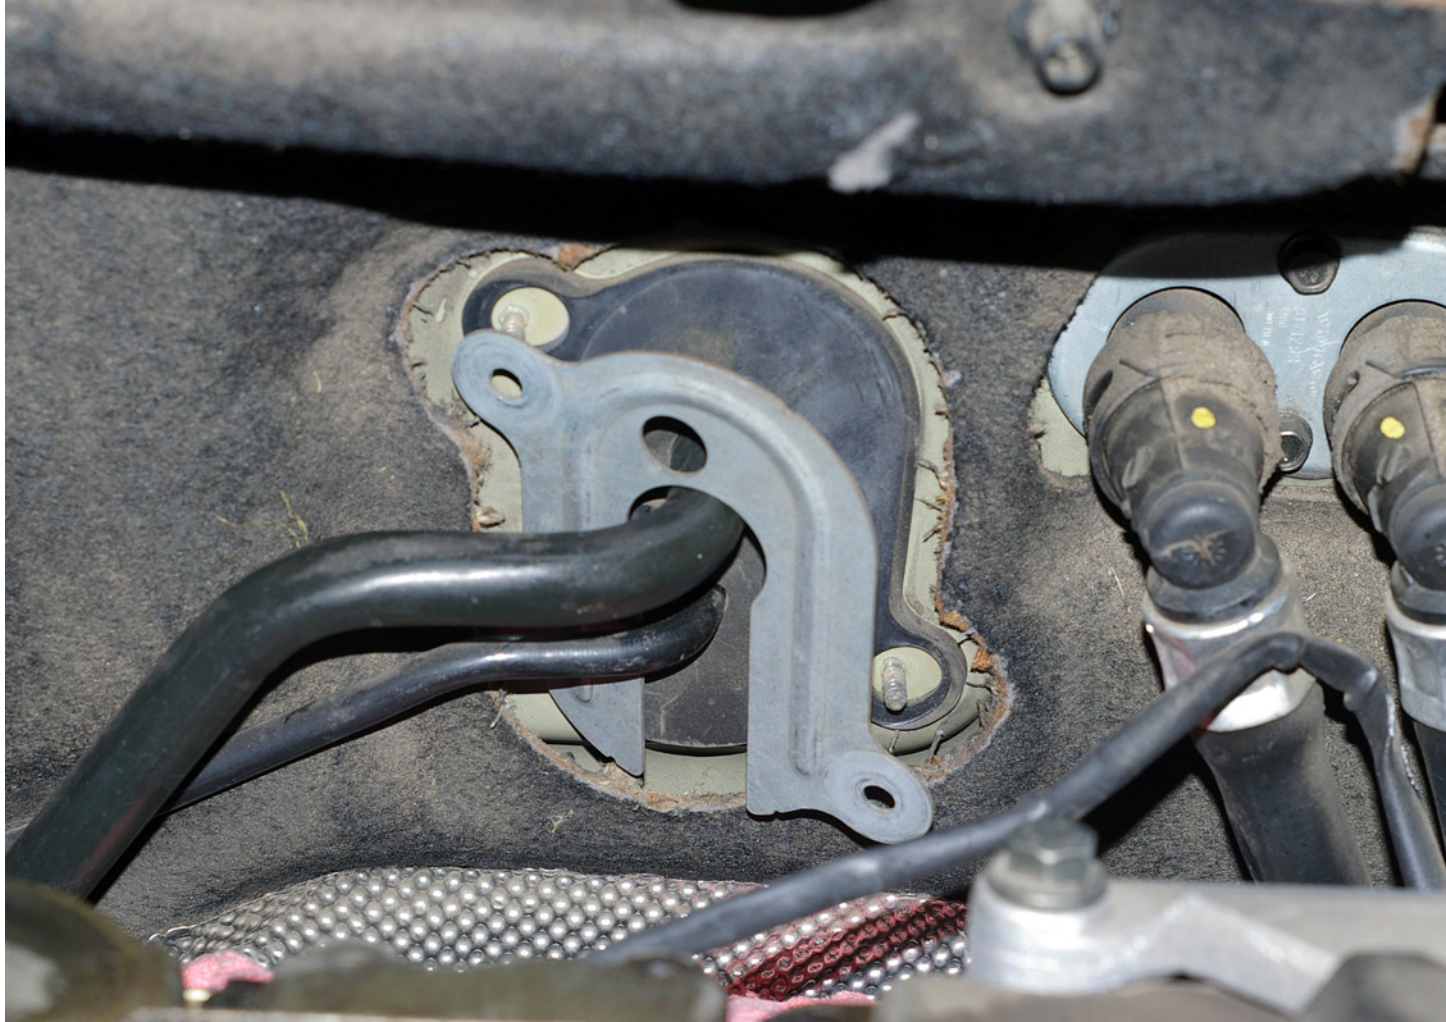
Figure 26 Here's the expansion valve location on the firewall. To get access to the expansion valve there are two stamped metal nuts, the metal plate shown and a rubber insulator behind the plate, remove all. Strut brace and the over the engine turbo charge tube are removed for better access.

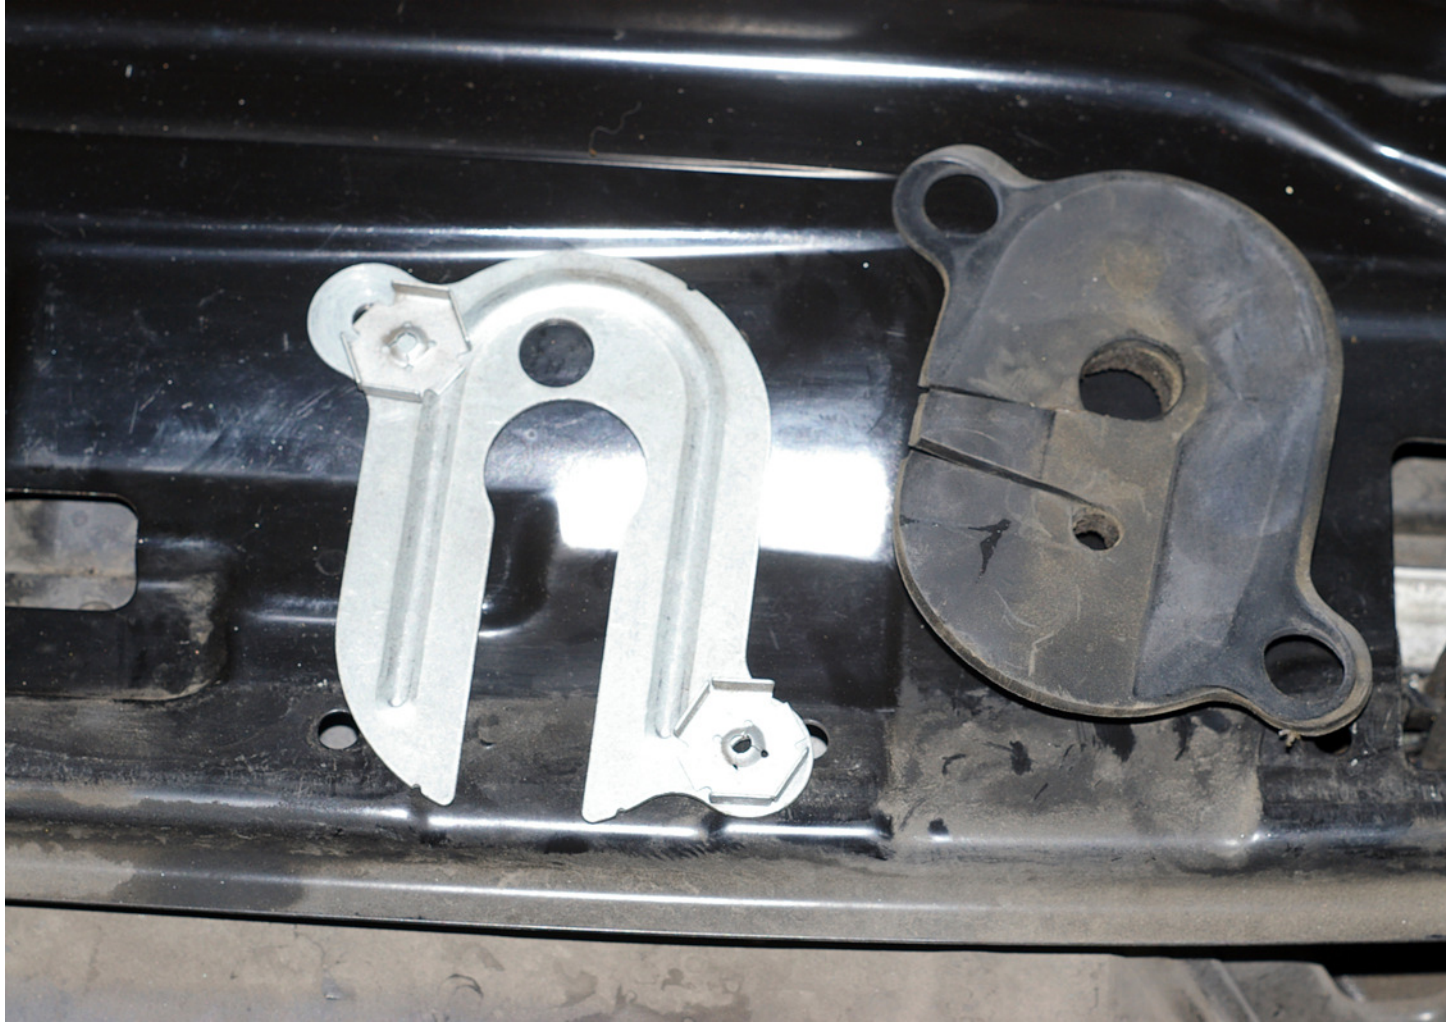
Figure 27 Expansion valve cover plate, rubber insulator and two stamp metal nuts. To remove the nuts I just grabbed the flat bent edge of the nut and twisted, these nuts are not on tight.

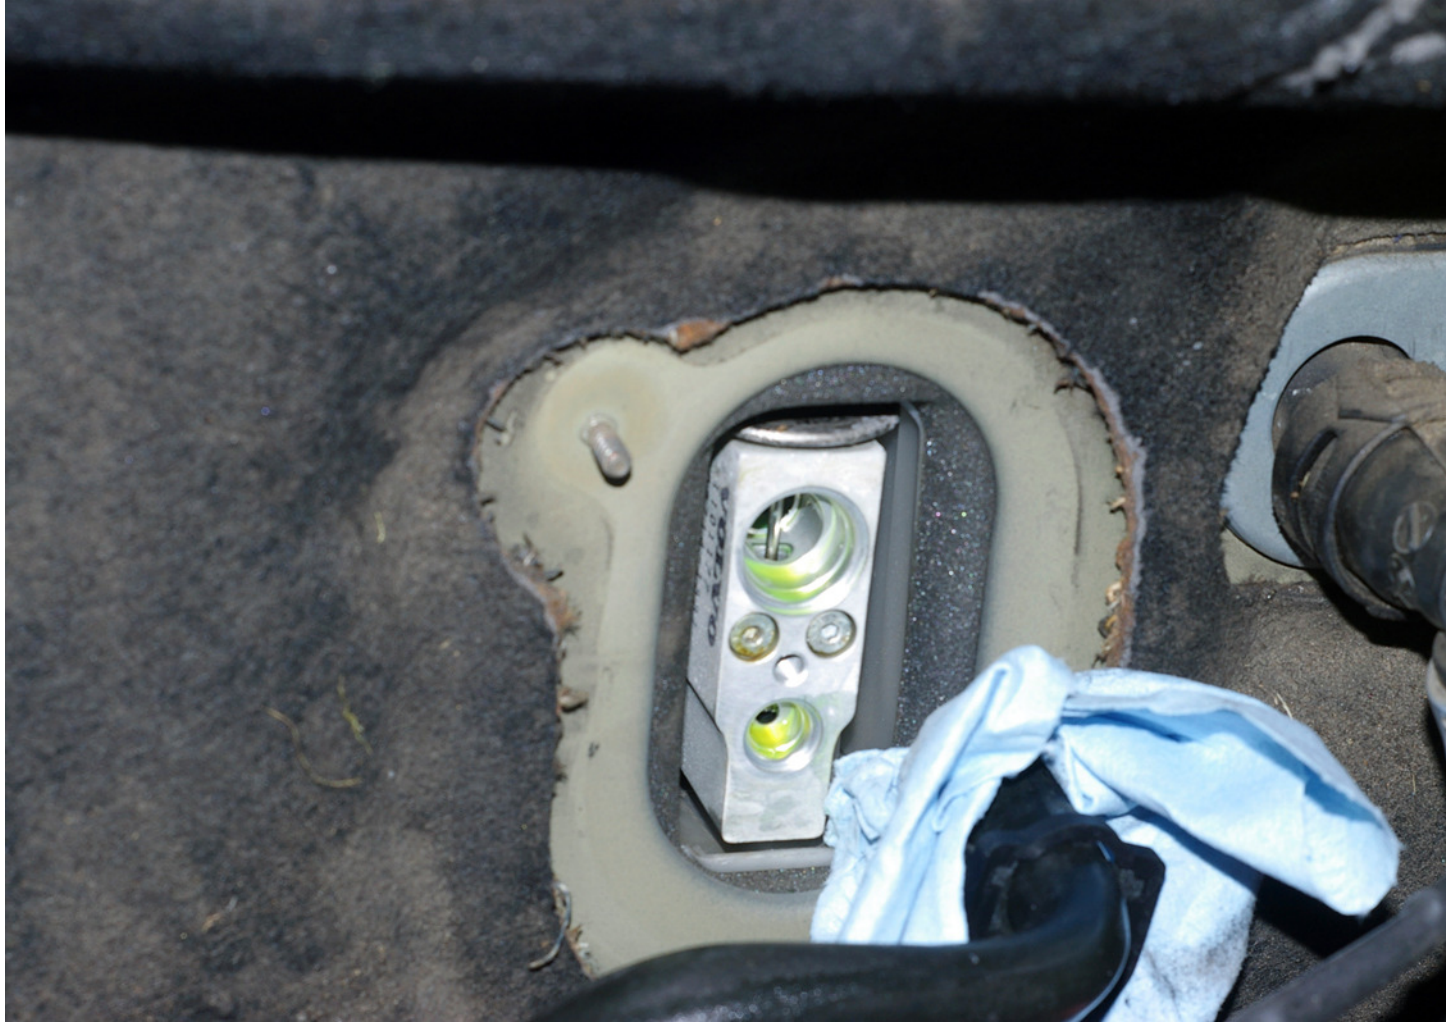
Figure 28 One center bolt (not shown) is removed to take off the high and lower pressure lines to the expansion valve. Two 3mm Allen screws hold the expansion valve to the evaporator. Remove these screws and pull out the expansion valve. Replace all four O-rings behind and in front of the expansion valve. Be careful with the O-ring sizes as the front larger tube is a different size than the larger hole on the other side. I bought a Volvo A/C O-ring kit that had most (but not all) the O-rings needed. I ended up having to re-use a couple of O-rings, one on the receiver/drier pressure switch and one on the compressor hose.

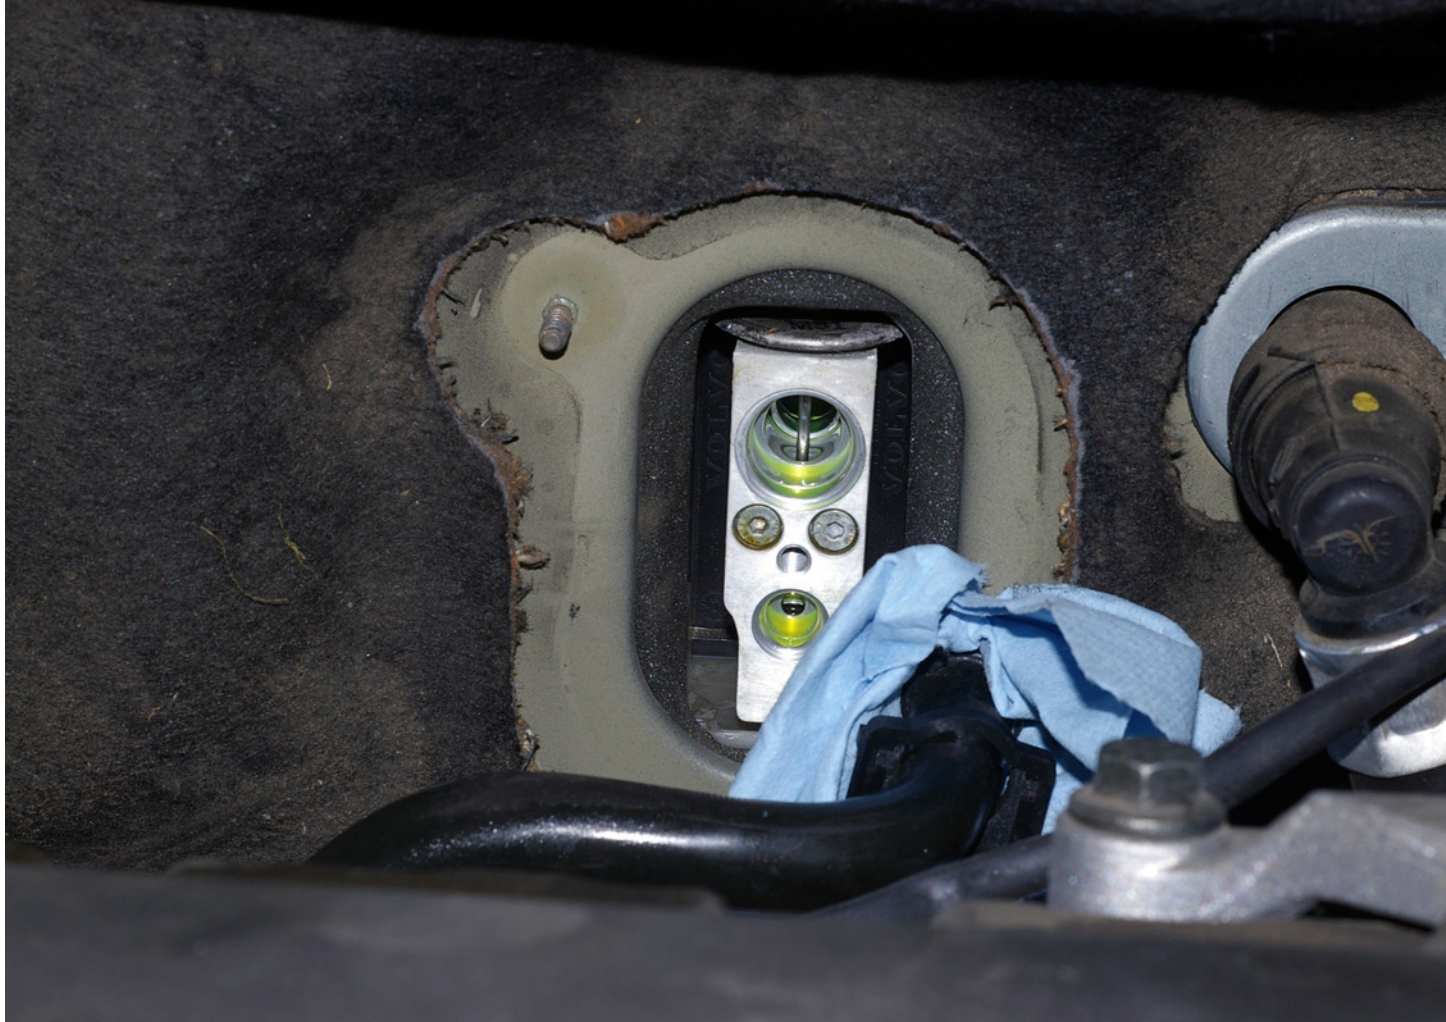
Figure 29 Another view of the expansion valve with high/lower pressure tubes detached.

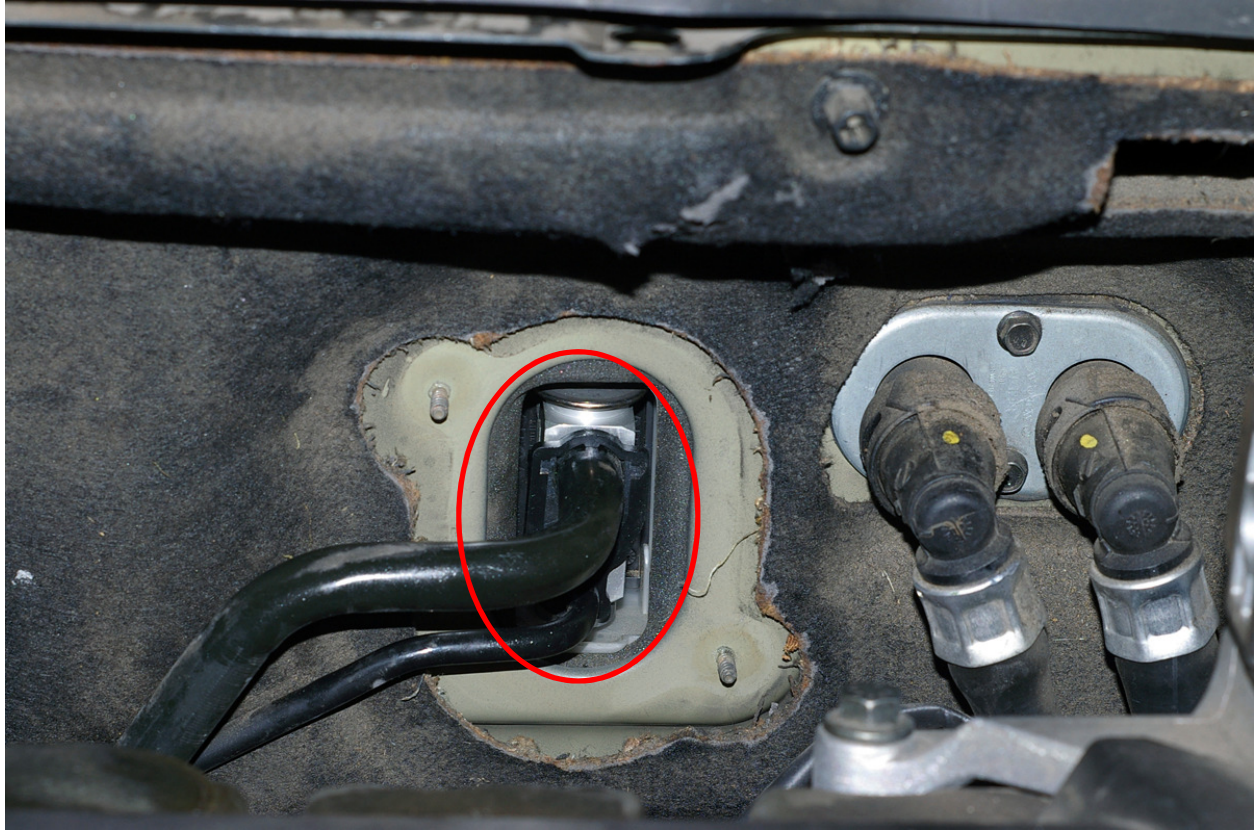
Figure 30 New expansion valve installed, still need to install cover place. I never did a good view of the single center bolt attaching the tubes to the valve.
