Here are some pictures to show what's required when replacing the A/C compressor, expansion valve and receiver/drier on a 2001 Volvo V70. Even if you don't replace these A/C parts these pictures can help with headlight assembly replacement, bumper cover removal, radiator fan assembly removal, etc.

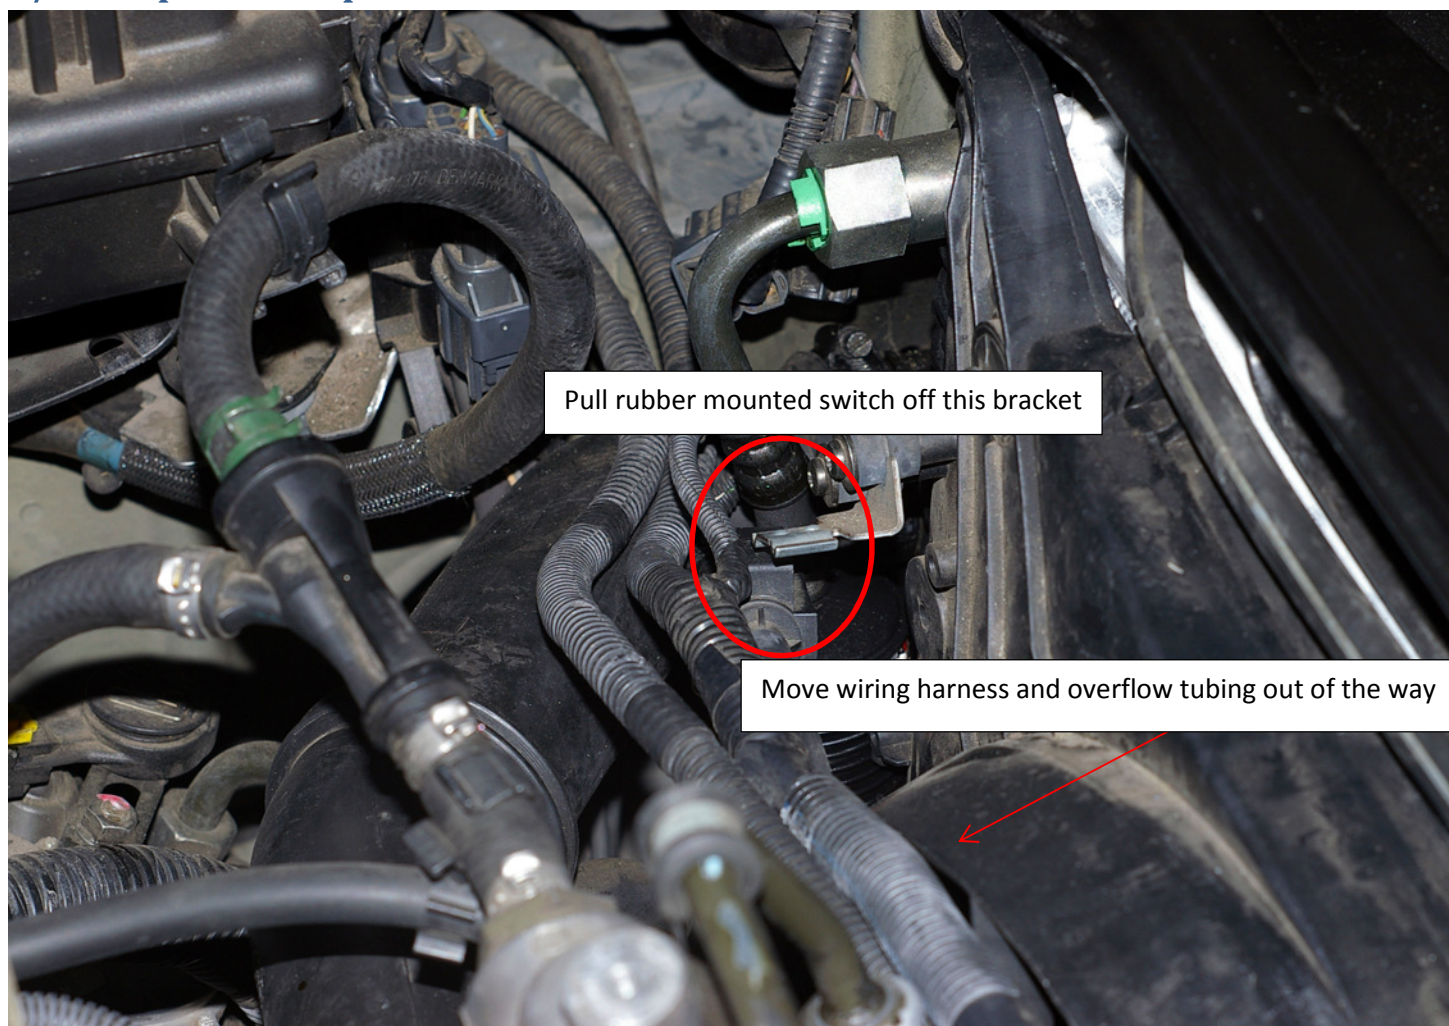
Figure 31 For A/C compressor removal and replacement the radiator fan/shroud must be removed. On top the shroud detach and move the wiring harness and overflow tube back towards the engine. There's also an EVAP switch that needs to be pulled off and shown above, it's rubber mounted and can be just be pulled back off the bracket.

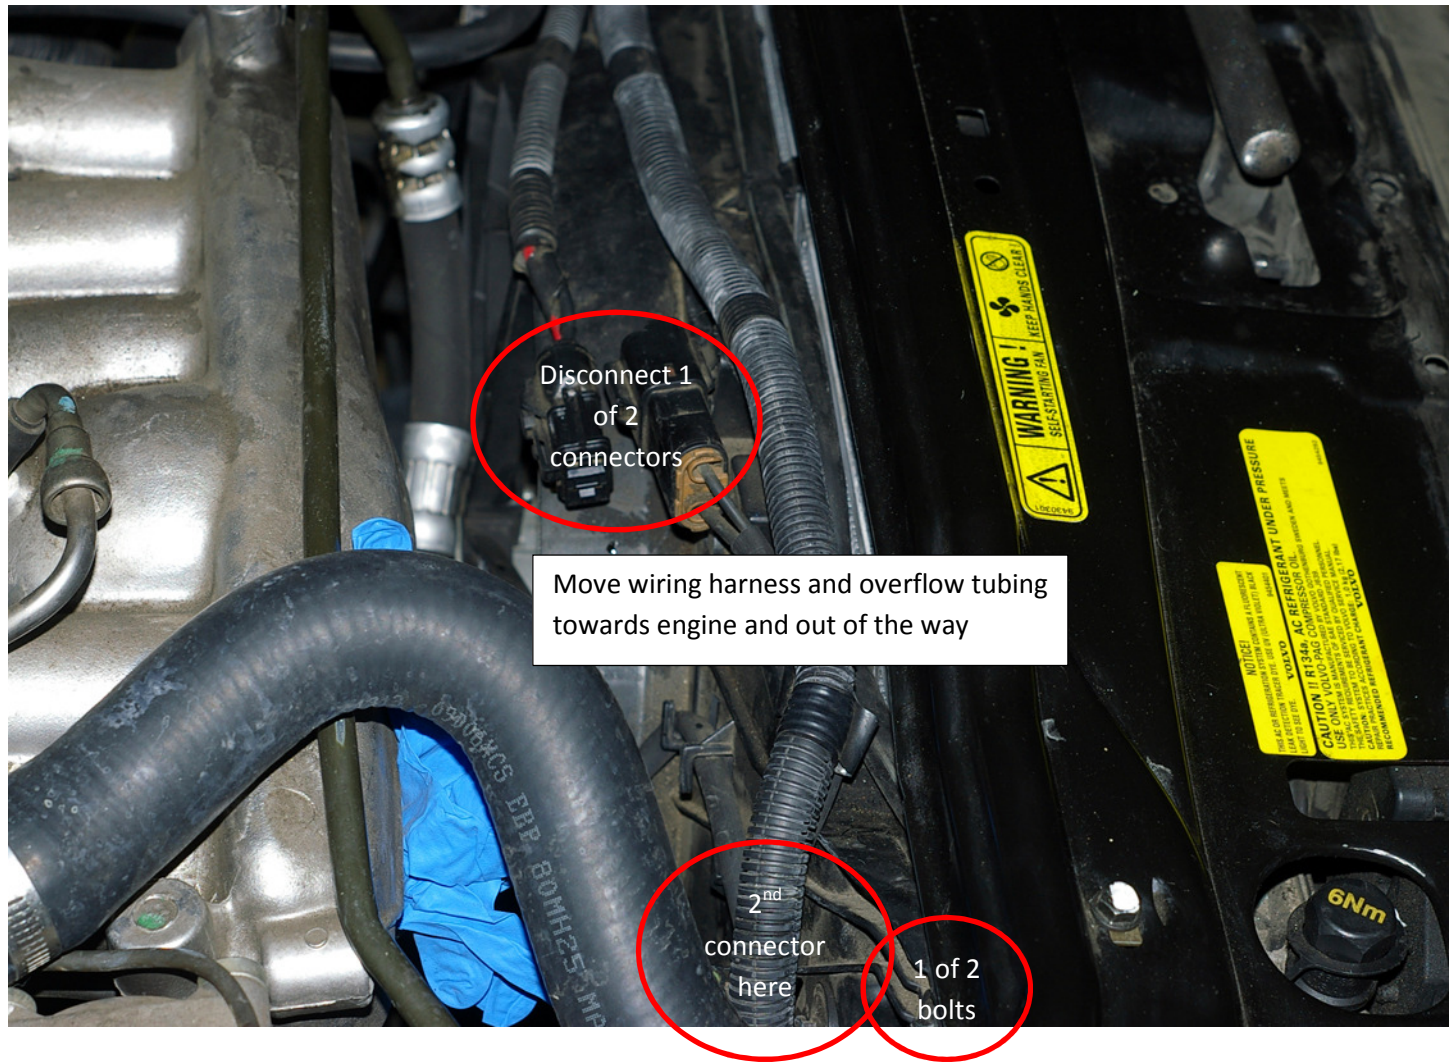
Figure 32 Disconnect two connectors prior to fan shroud removal. One connector not shown in this picture. Remove the two bolts at the top of the fan shroud and pull the fan/shroud assembly up and out. Make sure the wiring harness is not still under the shroud clip area on the passenger side of the shroud. Note, top turbo to intercooler pipe and hose to intercooler are already removed. Pull shroud up slowly, it's a tight fit and the shroud can snag in different places.

Reassembly-- At the bottom of the shroud are two tabs the just slip into slots at the radiator bottom area so make sure these tabs enter the slots when replacing the fan/shroud assembly.

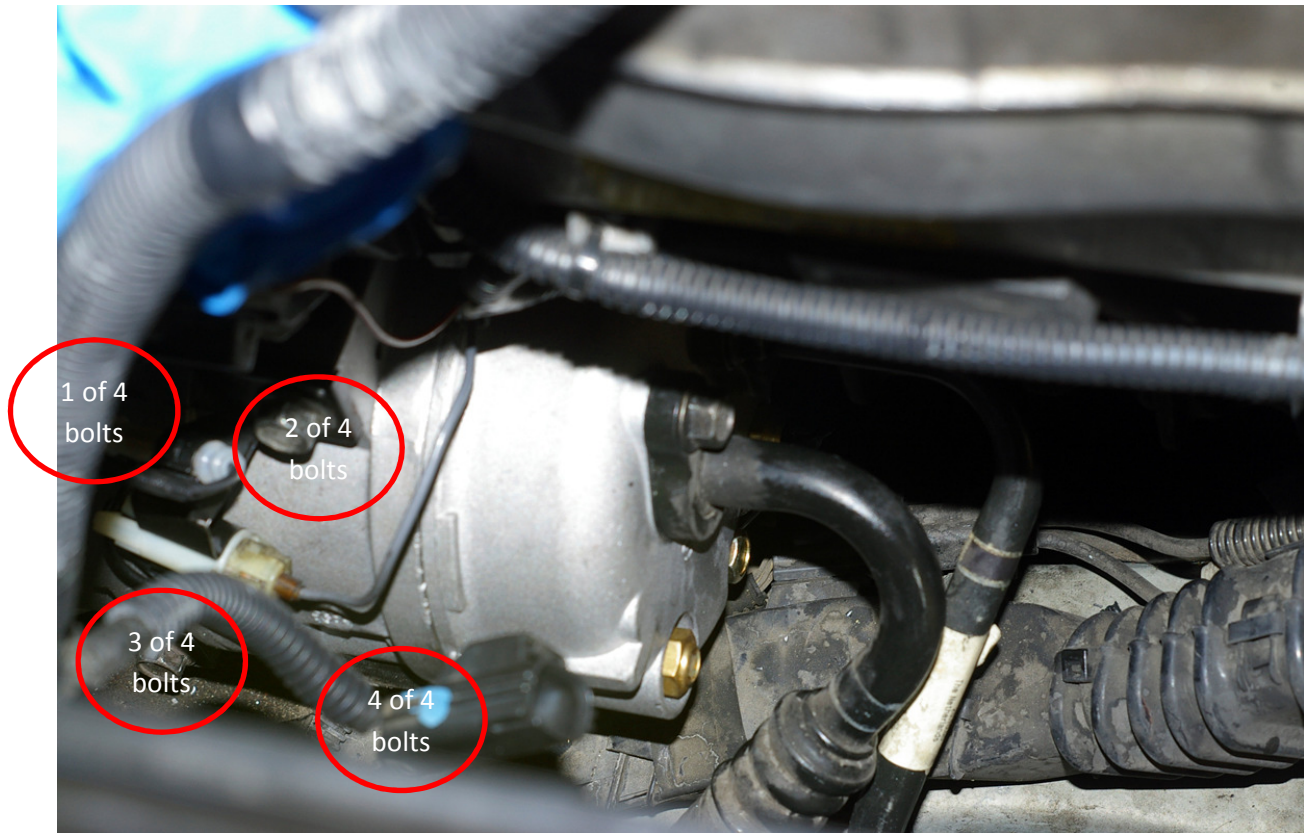
Figure 33 Once the fan and shroud are removed there's pretty good access to the four side mounting bolts on the A/C compressor and the hoses on the rear of the compressor. With the hoses removed, the connector disconnected, the serpentine belt removed and the four side bolts removed the compressor can be pulled out through the top between the intake manifold and radiator.

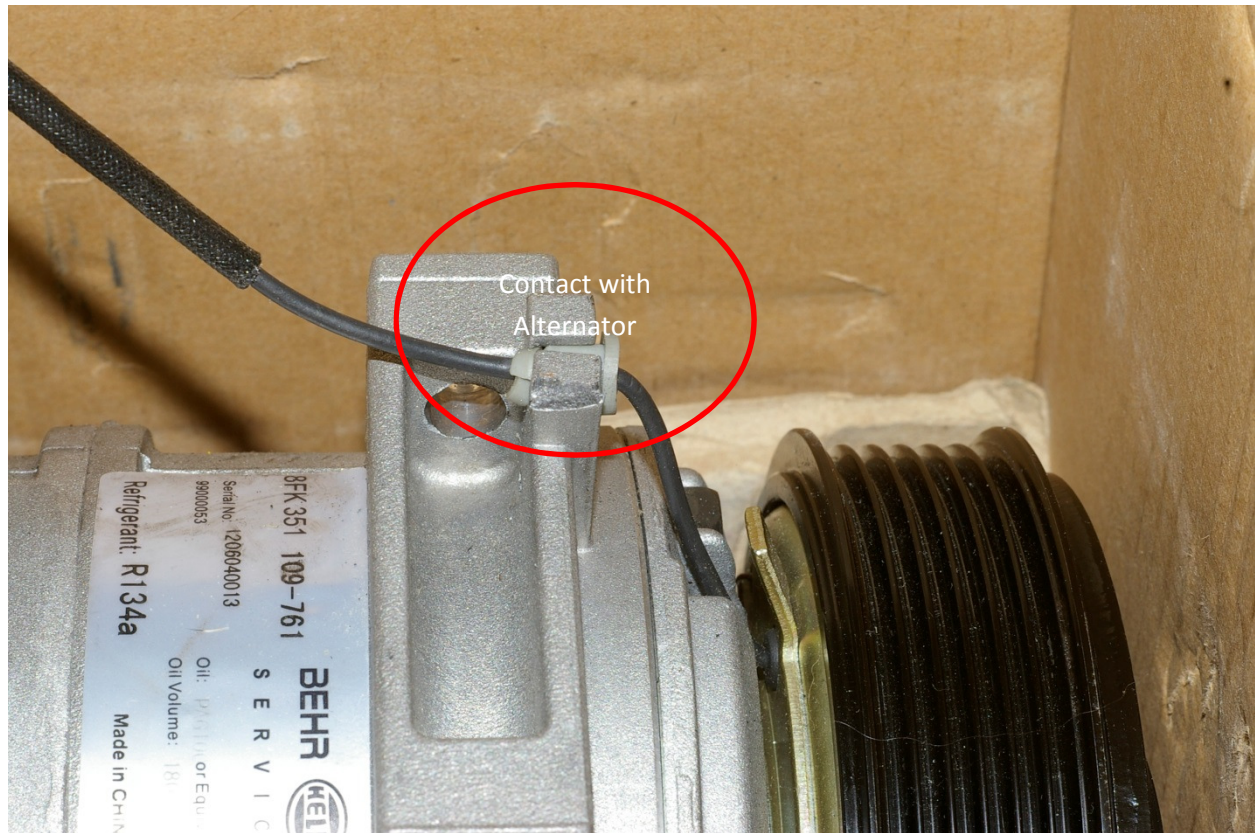
Figure 34 Here is a problem with some of the A/C compressor replacement parts. This Behr A/C compressor has a wire guide tab cast into the upper mounting area and it contacts the bottom of the alternator when tightening down the compressor. I didn't realize this as I was installing the compression since it's so difficult to see and it put a lot of stress on the A/C housing, not to mention what it did to the guide tab. If you have an A/C compressor replacement part like this, I would recommend cutting off this guide tab as the interference with the alternator stresses the A/C compressor housing when tightening the bolts and you just don't want this contact between the alternator and compressor. Or get a replacement compressor without this cast-in tab.
