Geologic and Hydrologic Feasibility for Development Planning,

Two Parcels in Carbon Canyon,
La Vida Hot Springs Area,
City of Brea, California

Prepared by:
Earth Consultants International, Inc.

Project No. 3015
September 28, 2010

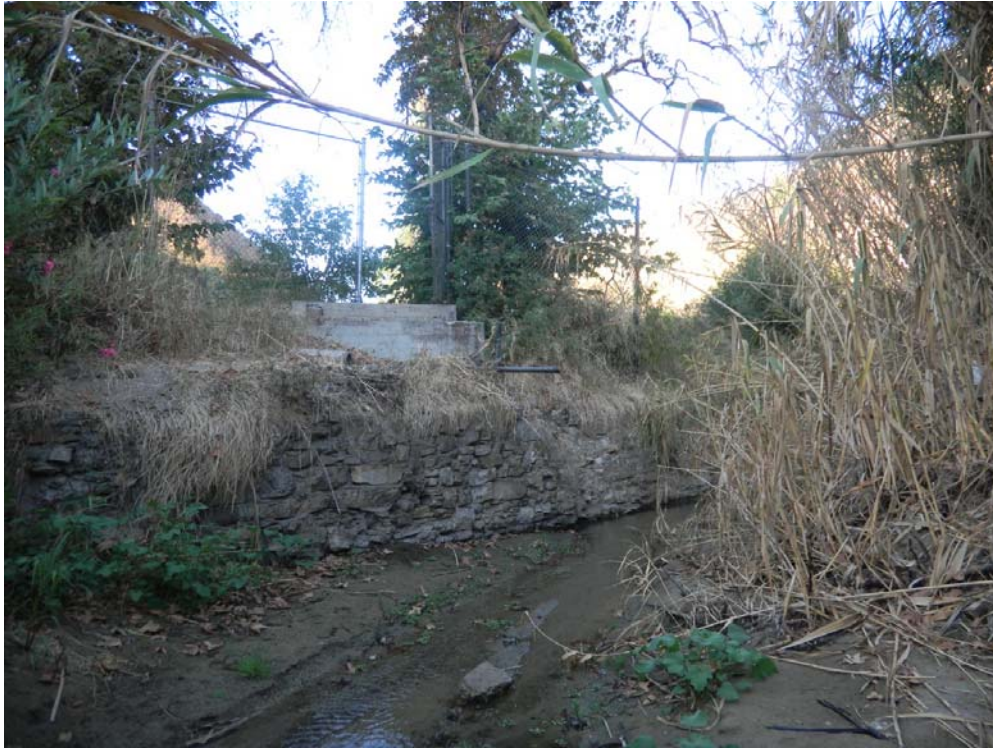
Photo 2: A few remnants of the La Vida resort. This photo shows an old retaining wall constructed to stabilize the creek bank. Concrete footings above the wall are for the footbridge (shown in Photo 1) that led from the bathhouse to the restaurant.

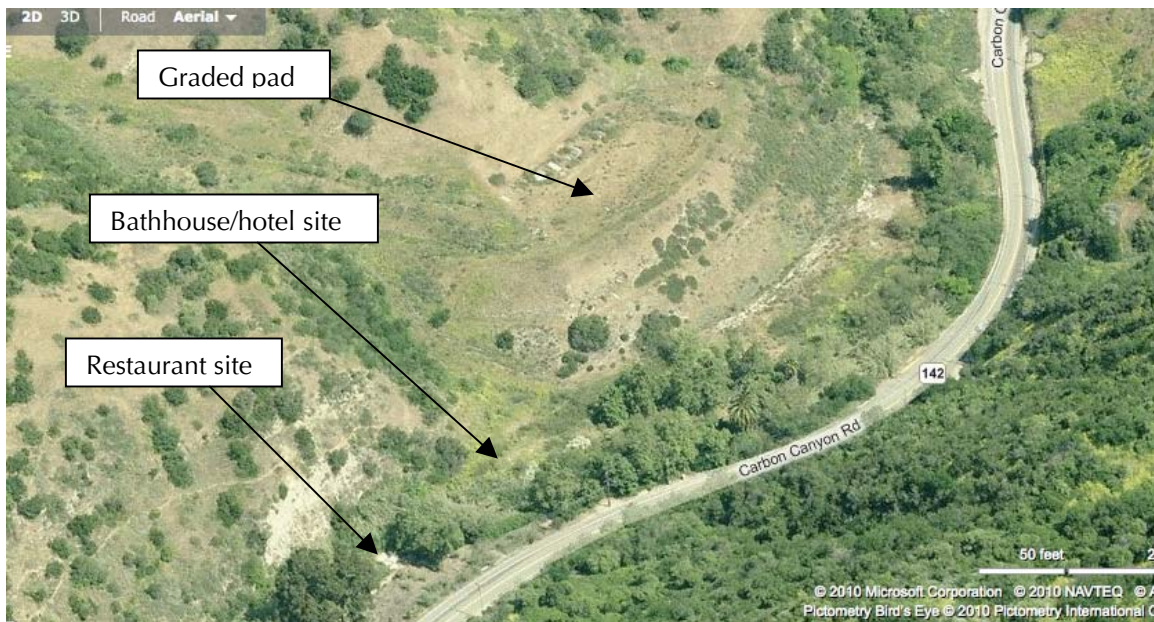
Photo 3: Aerial view of the graded pad and slopes in the northern part of the La Vida parcel. The approximate locations of the former bathhouse and restaurant are shown.

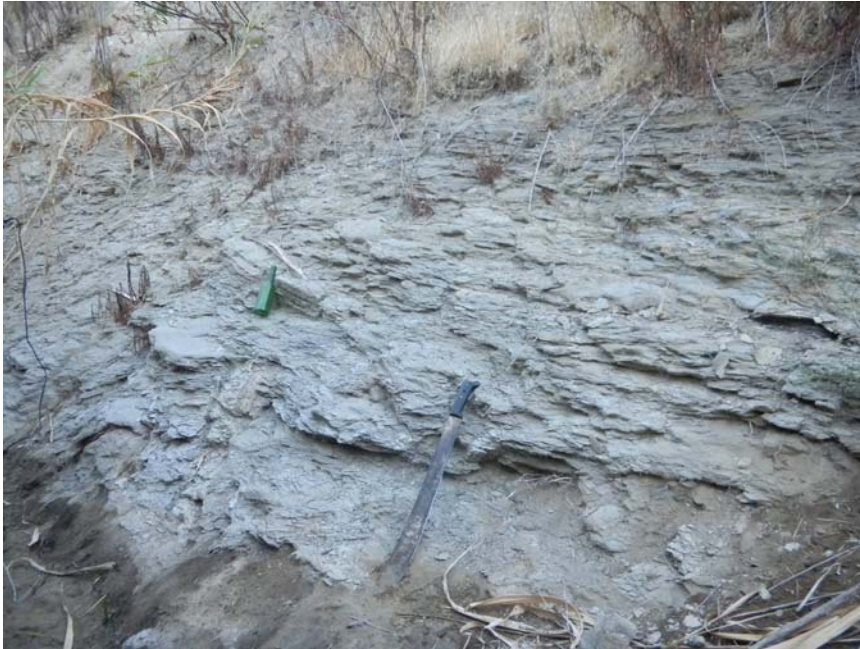
Photo 5: Outcrop of La Vida Member siltstone exposed in the Carbon Creek channel, within the La Vida parcel.

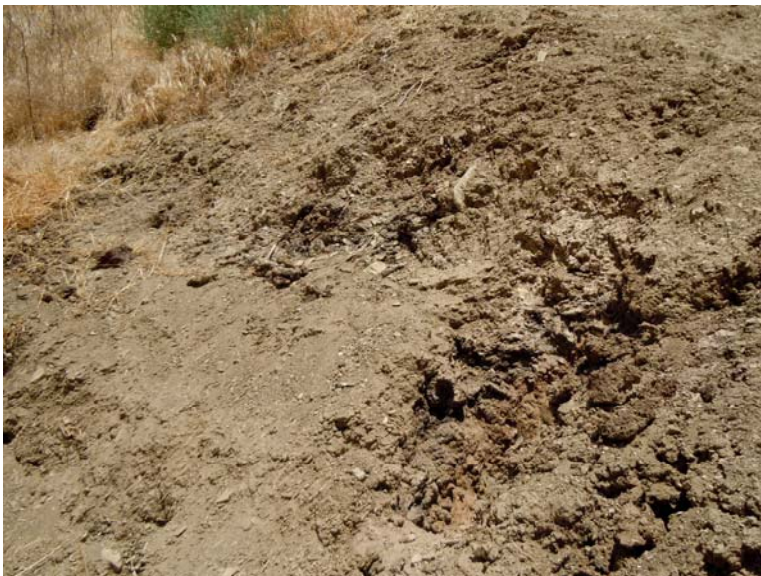
Photo 6: Mineralization and staining of the surface soils, located immediately north of the La Vida spring site.

At the toe of the slope in the canyon wall immediately north of the La Vida Spring pipes, bedrock slide debris has been exposed to reveal a stained and cemented soil matrix impregnating colluvial shale chips. We dug into the exposure and found the ground within to be warmer than the air on cool mornings, and smelling weakly of hydrogen sulfide. The mineralization may be related to the hot spring, and the stained soil may be a feature that led to the siting of the oil exploration well in the late 1800s.

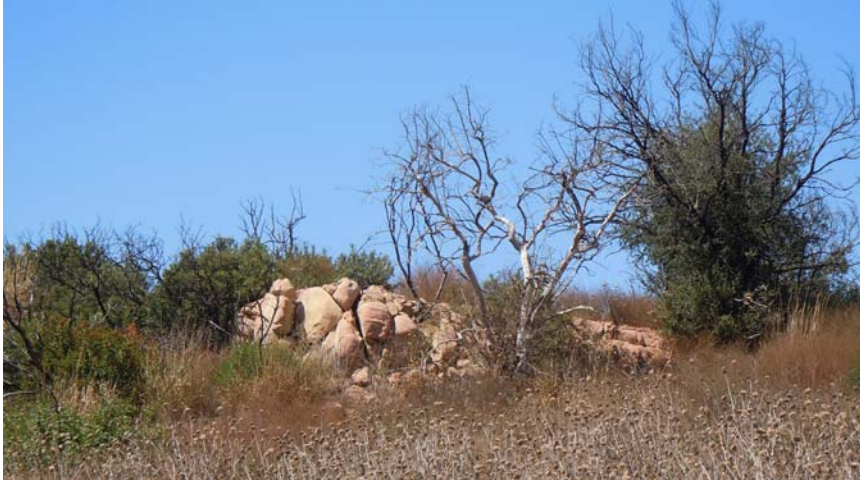
Photo 7: Outcrop of resistant sandstone on the ridgetop in the Ridgeline parcel.

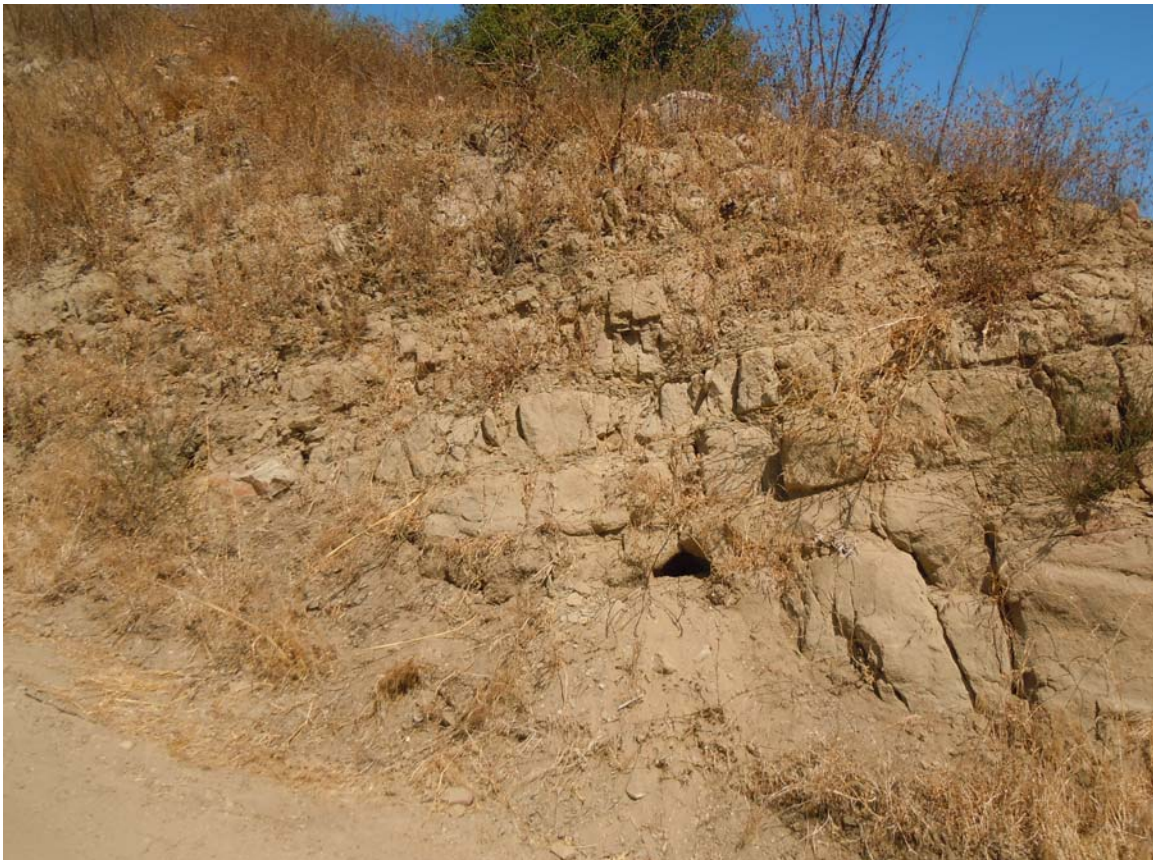
Photo 8: Tilted, interbedded sandstone and siltstone bedrock on the Ridgeline parcel. The thick, cemented sandstones beds (layers) are more resistant to erosion, while the thinly bedded siltstones are weaker, and are the principal layers responsible for landsliding.

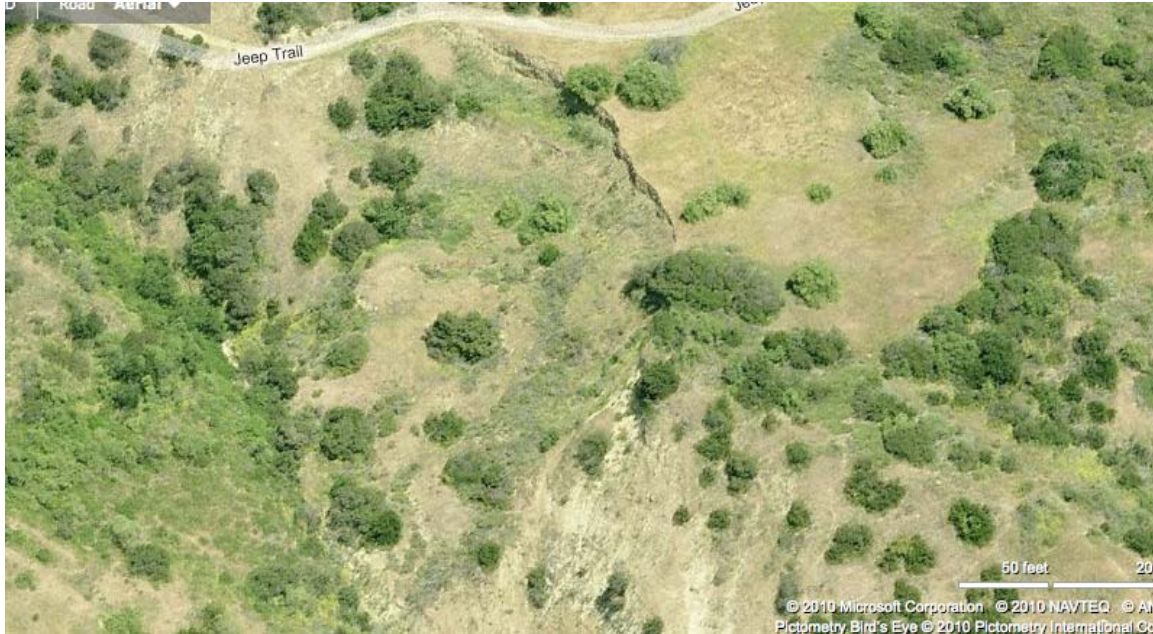
Photo 9: Young, well-defined landslide and scarp, located up-canyon from the site of the La Vida Hot Springs bathhouse. This slide occurred within an older landslide complex.

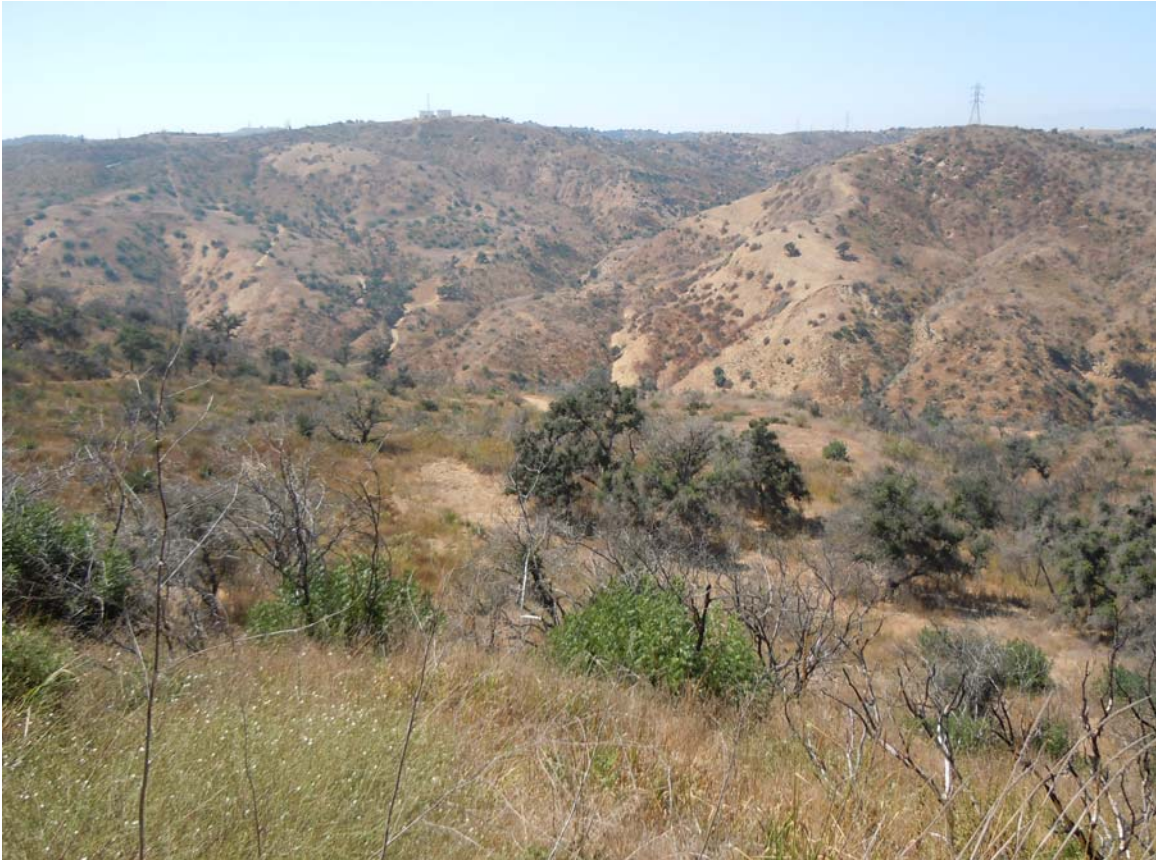
Photo10: The relatively flat area in the foreground is the head of the large landslide on the northwest-facing slope of the Ridgeline parcel. The view is northwest and shows several other landslides on the opposite side of Carbon Canyon.

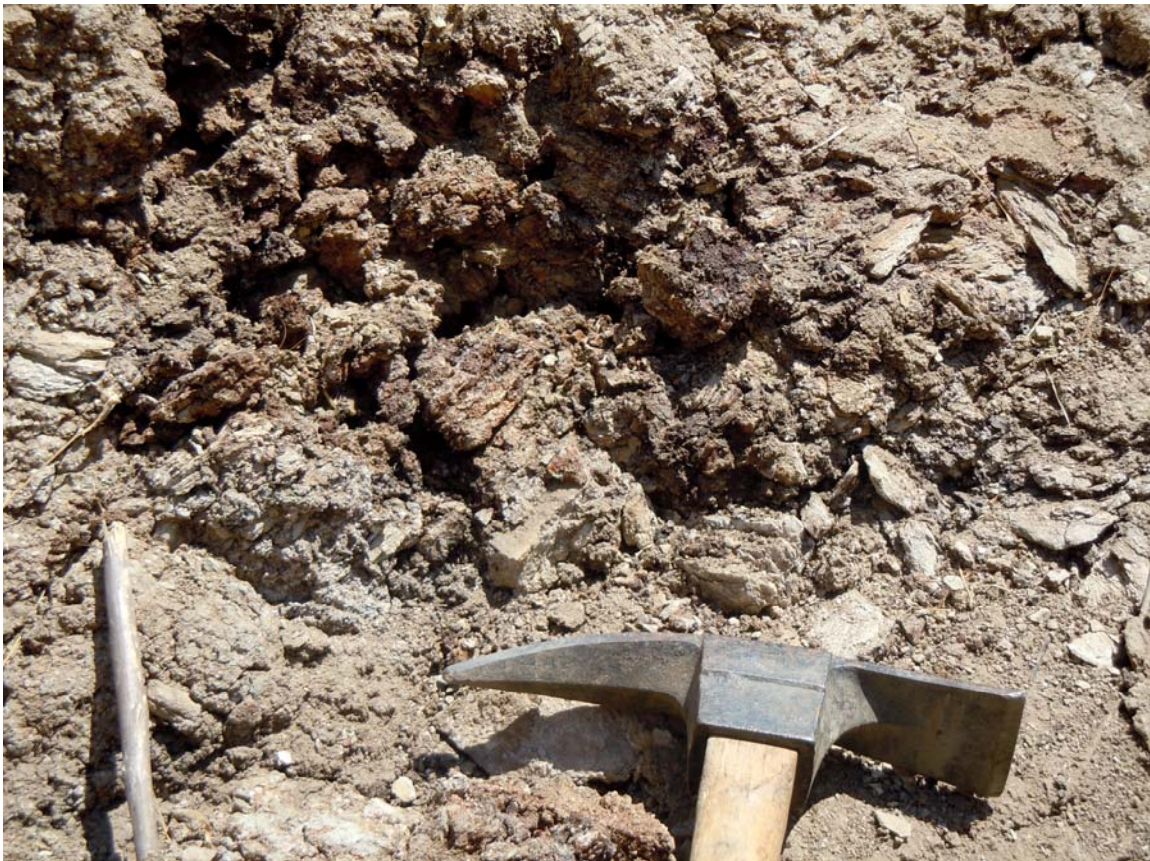
Photo11: Unconsolidated colluvial and rock creep deposits exposed in canyon walls. These materials are highly susceptible to continued downslope movement, hydroconsolidation, and mobilization into mud and debris flows. These deposits are not suitable for support of structures unless removed, moisture conditioned, and recompacted.

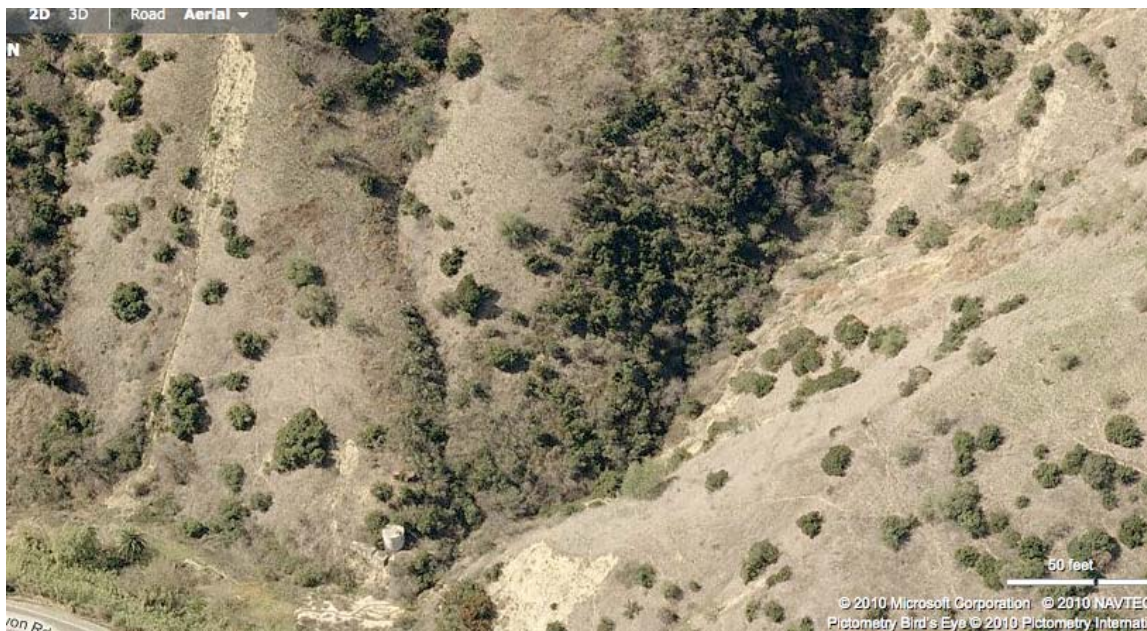
Photo 12: Aerial photo showing recent soil slip scars on steep canyon walls at the La Vida parcel. The old La Vida water tank can be seen at the base of the hills.

Natural slopes in the Carbon Canyon area, including those on the subject properties show signs of shallow failures, most commonly by the accumulation of debris (generally a mix of soil and bedrock fragments) that collects along the toes of slopes and accumulates in drainages.

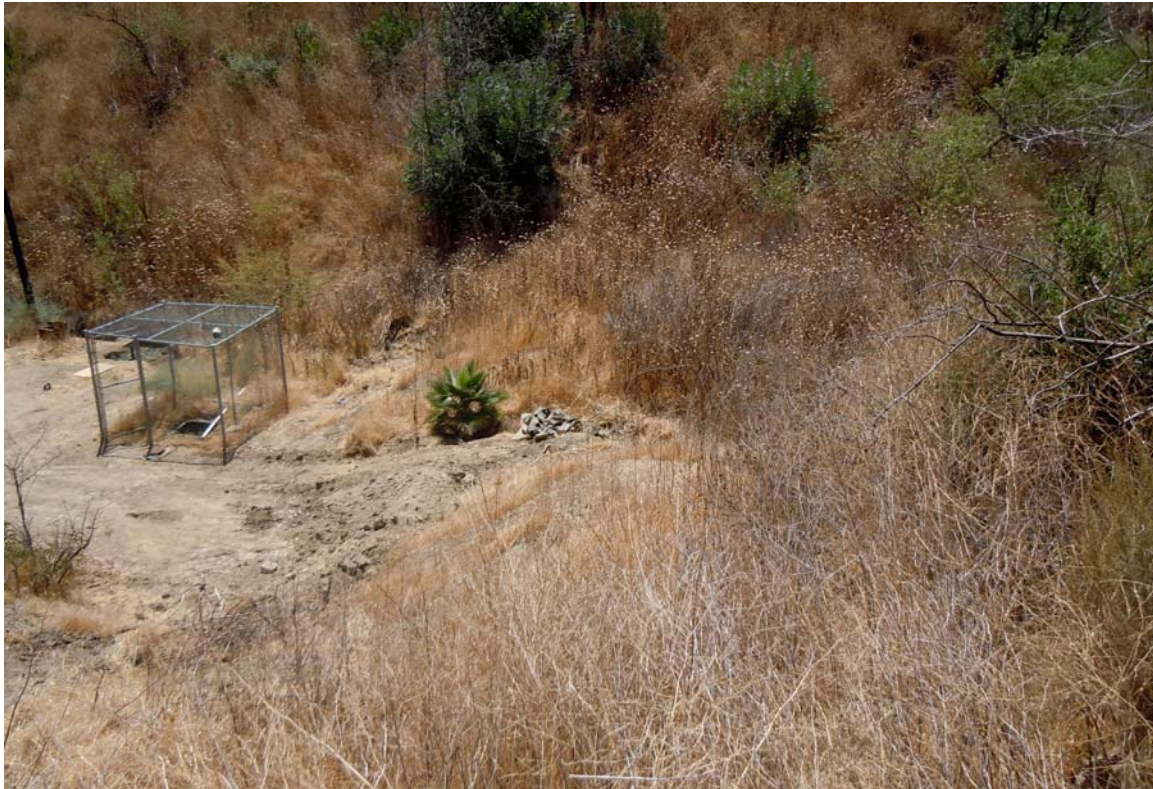
Photo 14: Site of the La Vida spring, which appears to be protected by a small upstream berm.

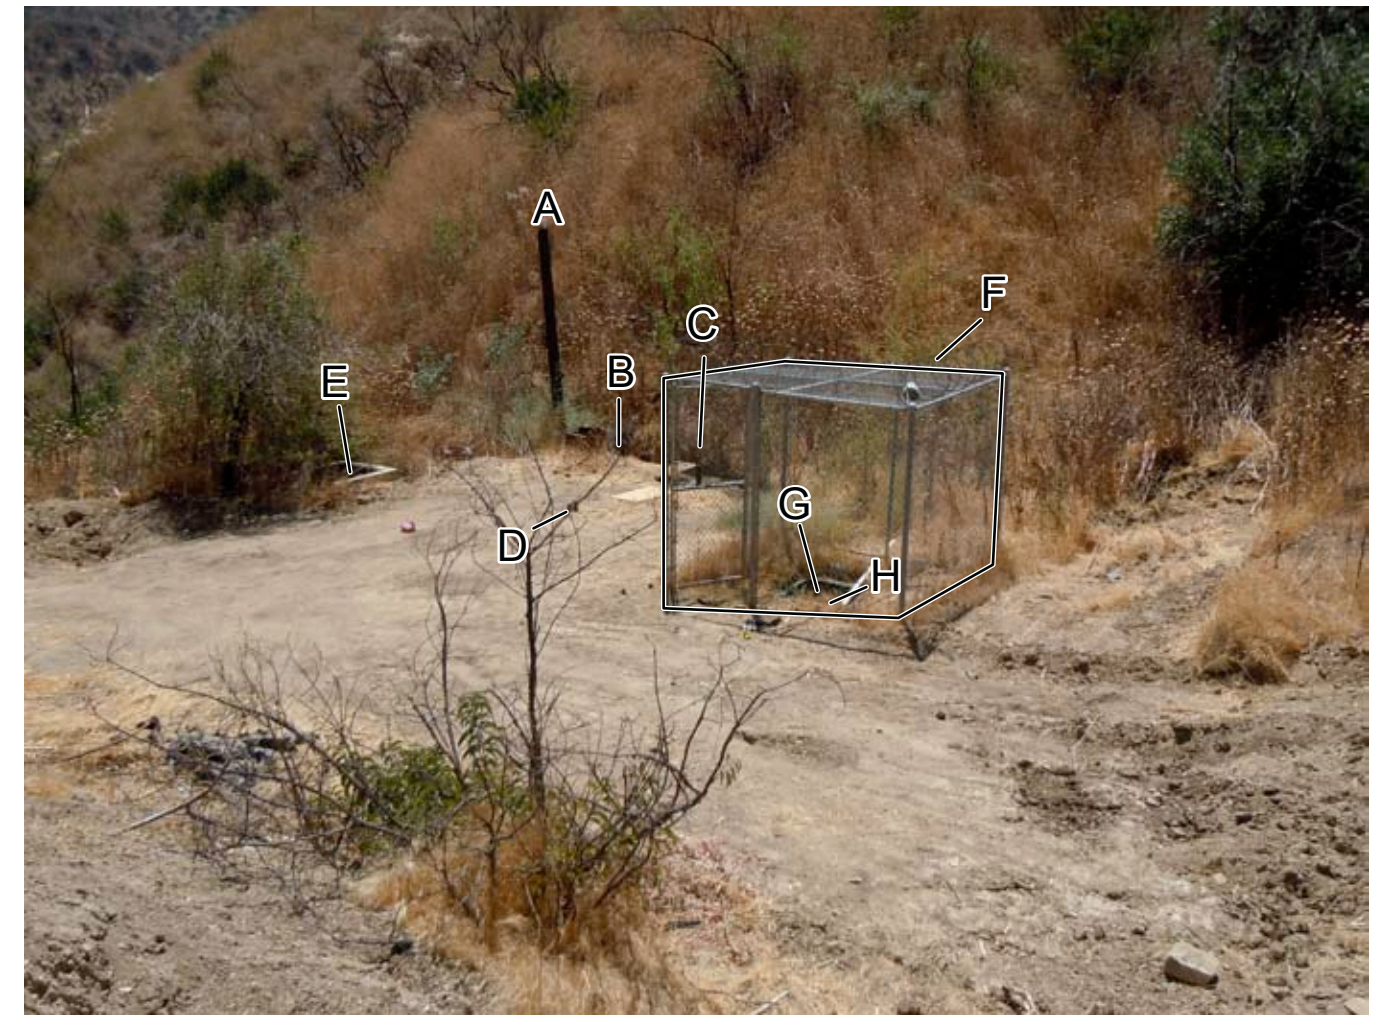
Figure 5

Hot water discharges from pipe (H) into the cement pool (G). Hot water then flows from the pool to the vertical pipe (C) next to the creek.

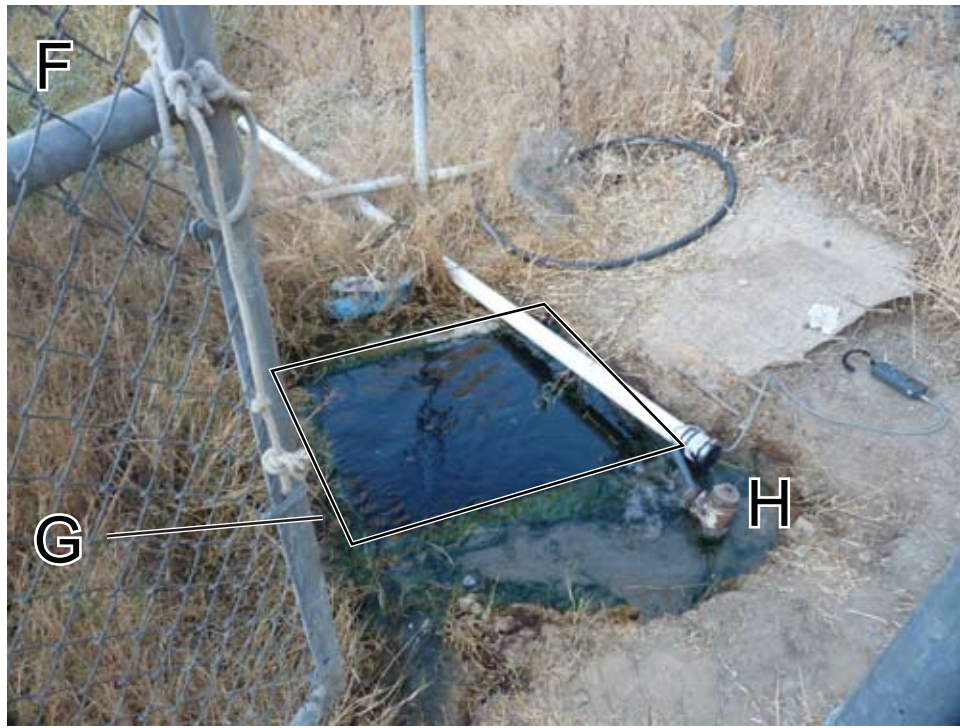
F. Chainlink cage enclosing G (3' x 2.5' pool) and H (source pipe)

H. Steel pipe, 2" in diameter, sticking out 6" above the ground surface and water emptying through a T-fitting, top capped, into G. Empirically tested to be the source of water in C and G; it is unknown whether it is also the source for the other pipes. Pipe is vertical to 2.5' below ground surface, then make s 90 degree bend toward the north.

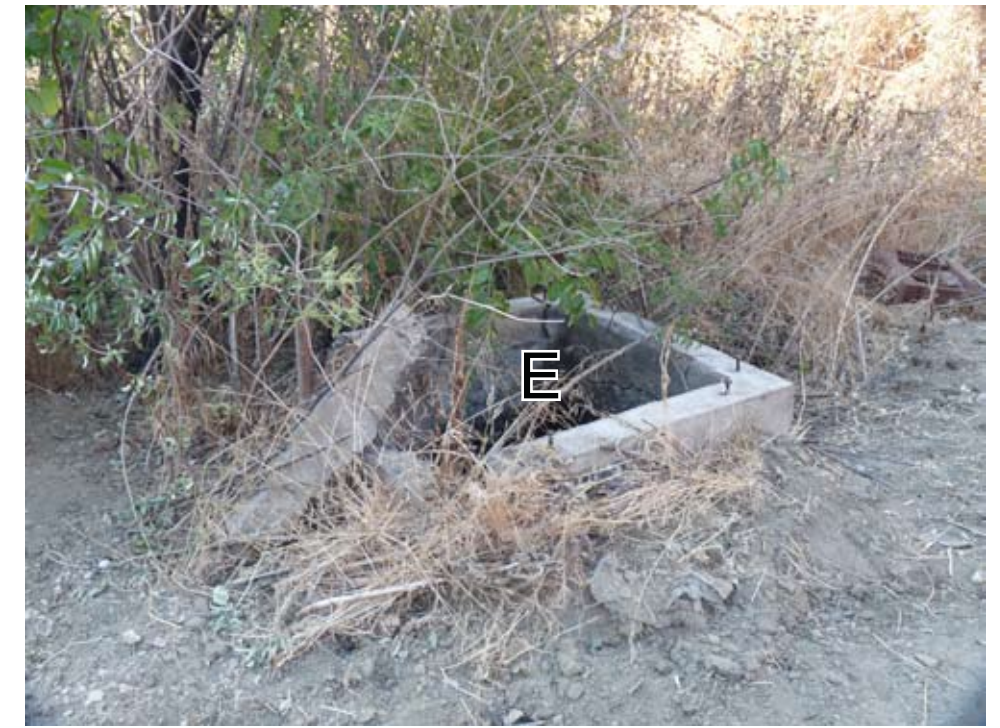
E. Square (4' x 4'), concrete, 4.5'-deep pool with 3' of still water. Water level remains unaffected by G or H.

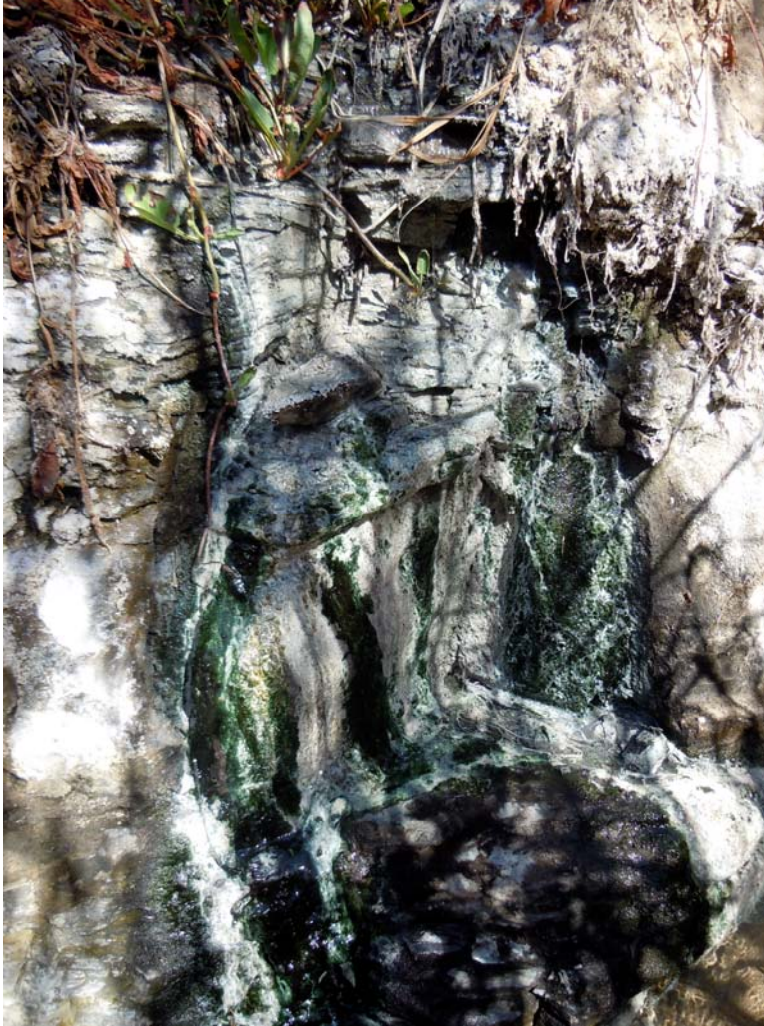
Photo 15: Seep 02 in Carbon Canyon showing the vertical faults intersecting the gently dipping bedrock strata.

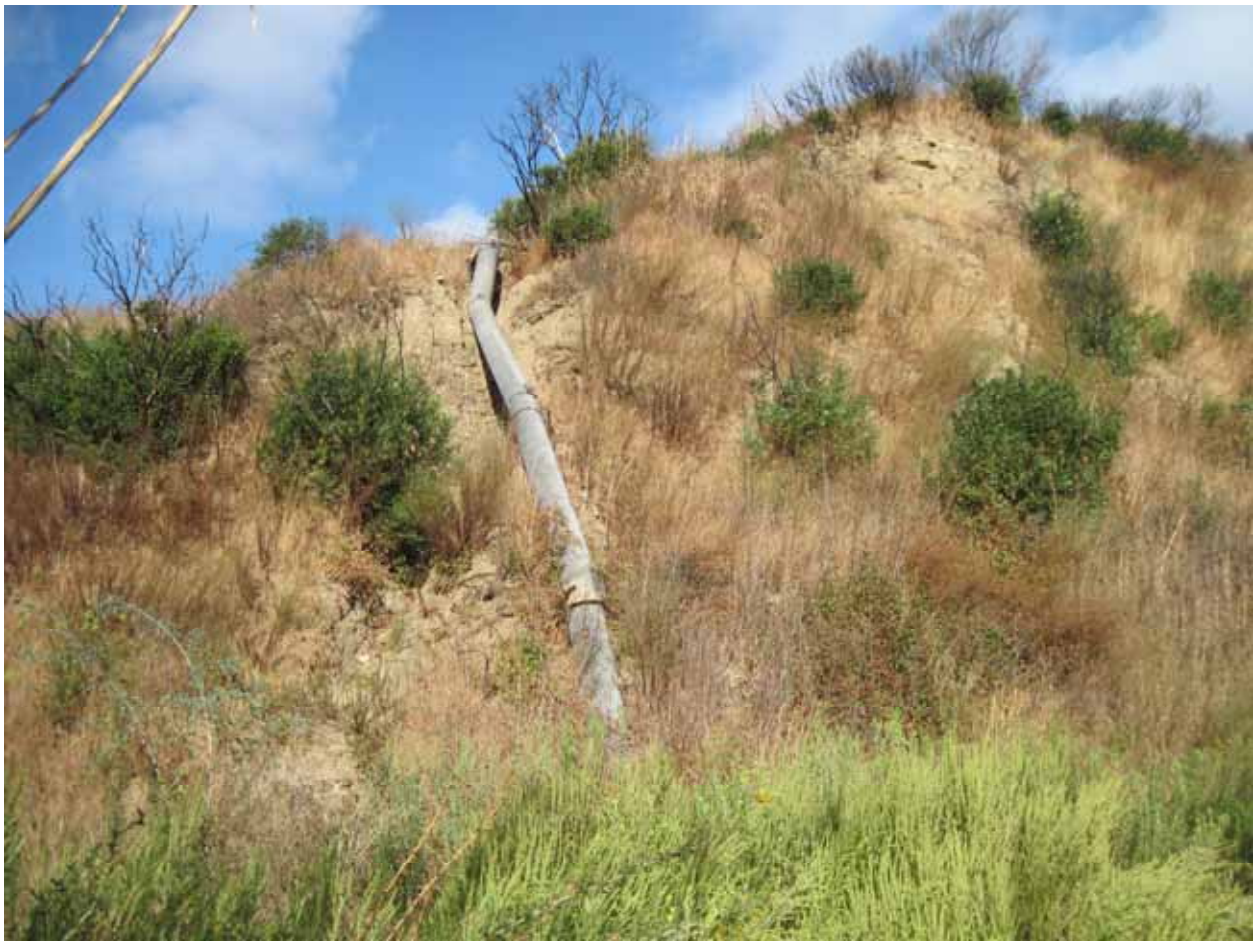
3. Stormwater conveyance pipe along the northern portion of the Subject Property.

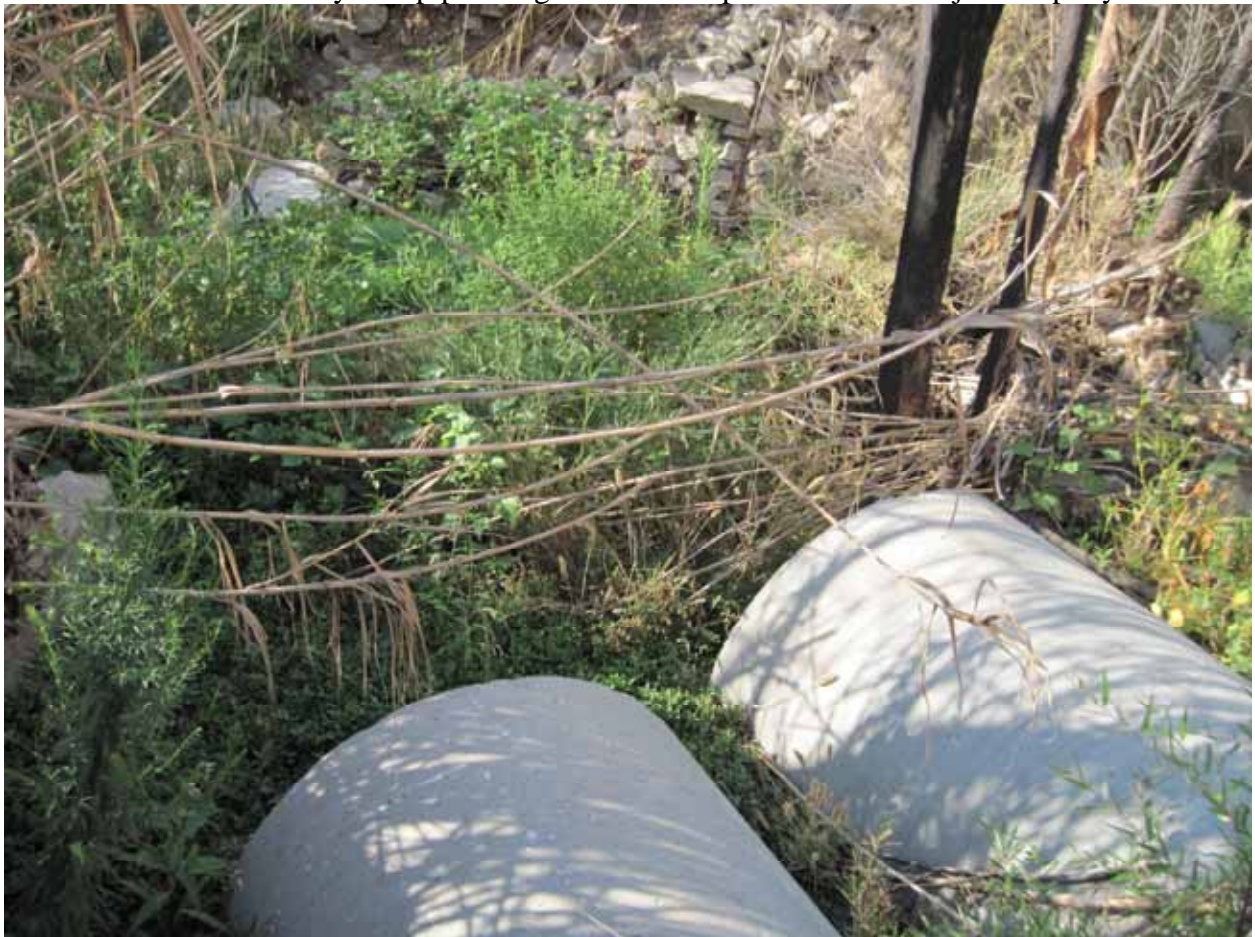
4. Stormwater control pipes within Carbon Creek.

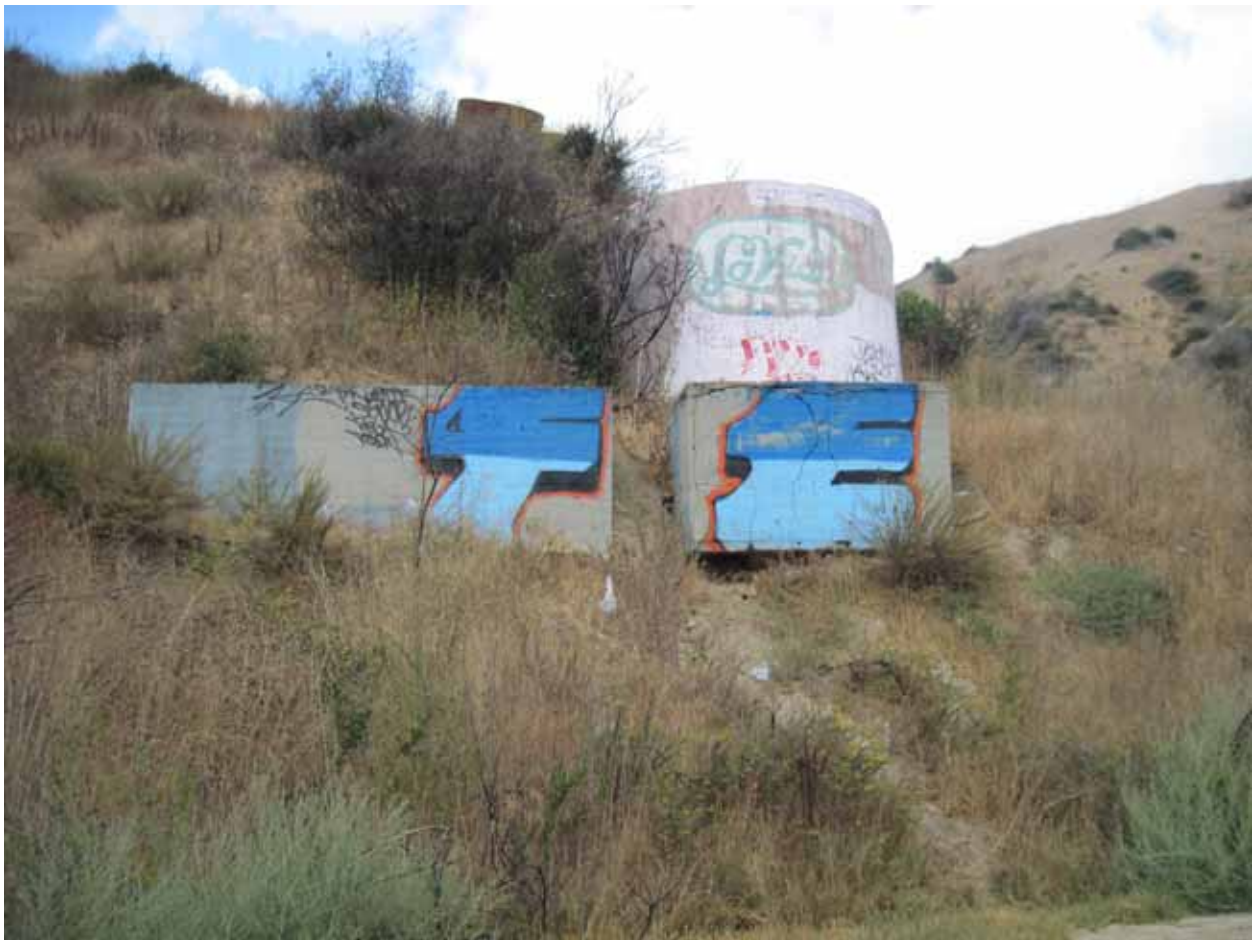
11. Concrete AST located along the southern portion of the Subject Property.

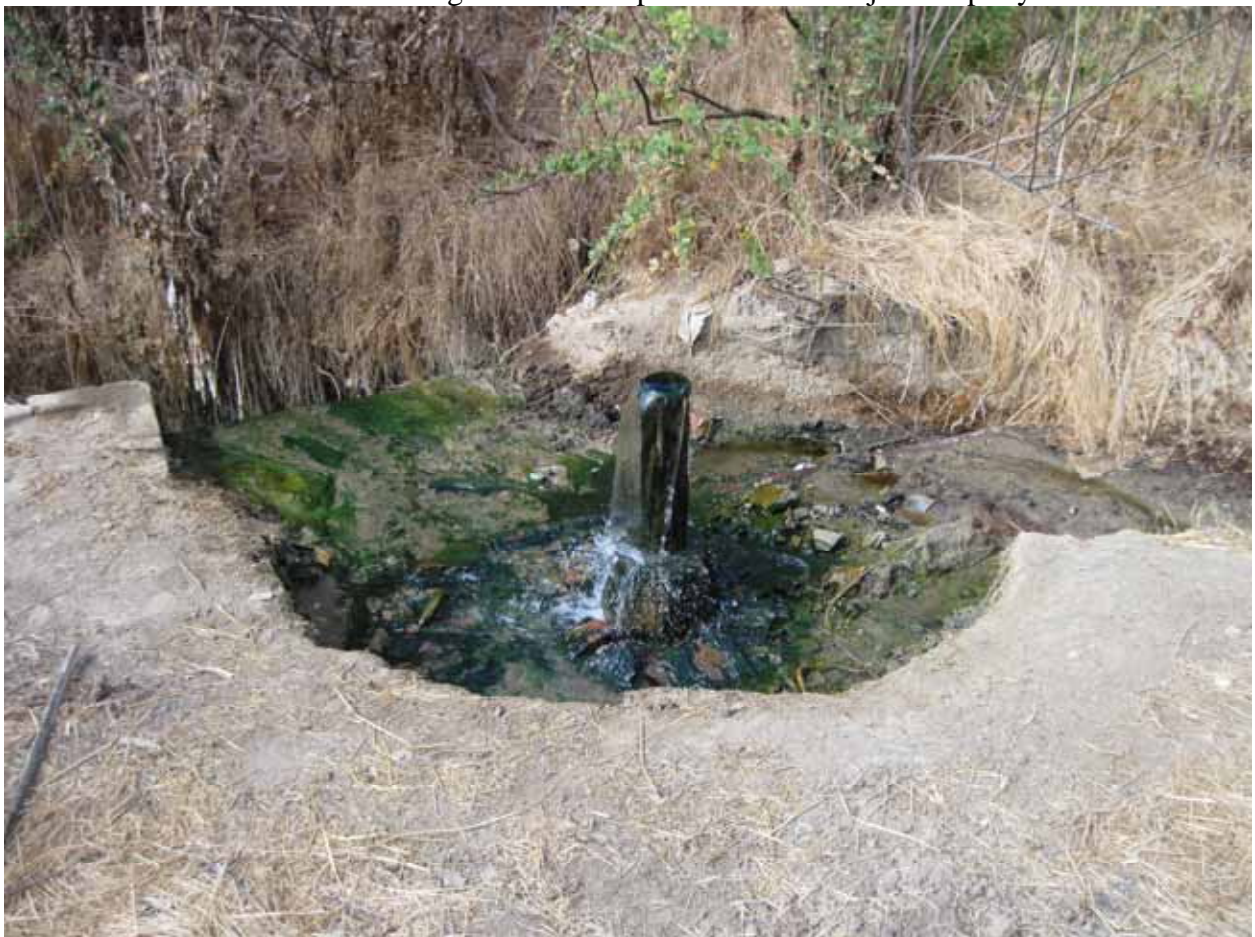
12. Spring water conveyance pipe located along the central portion of the Subject Property.

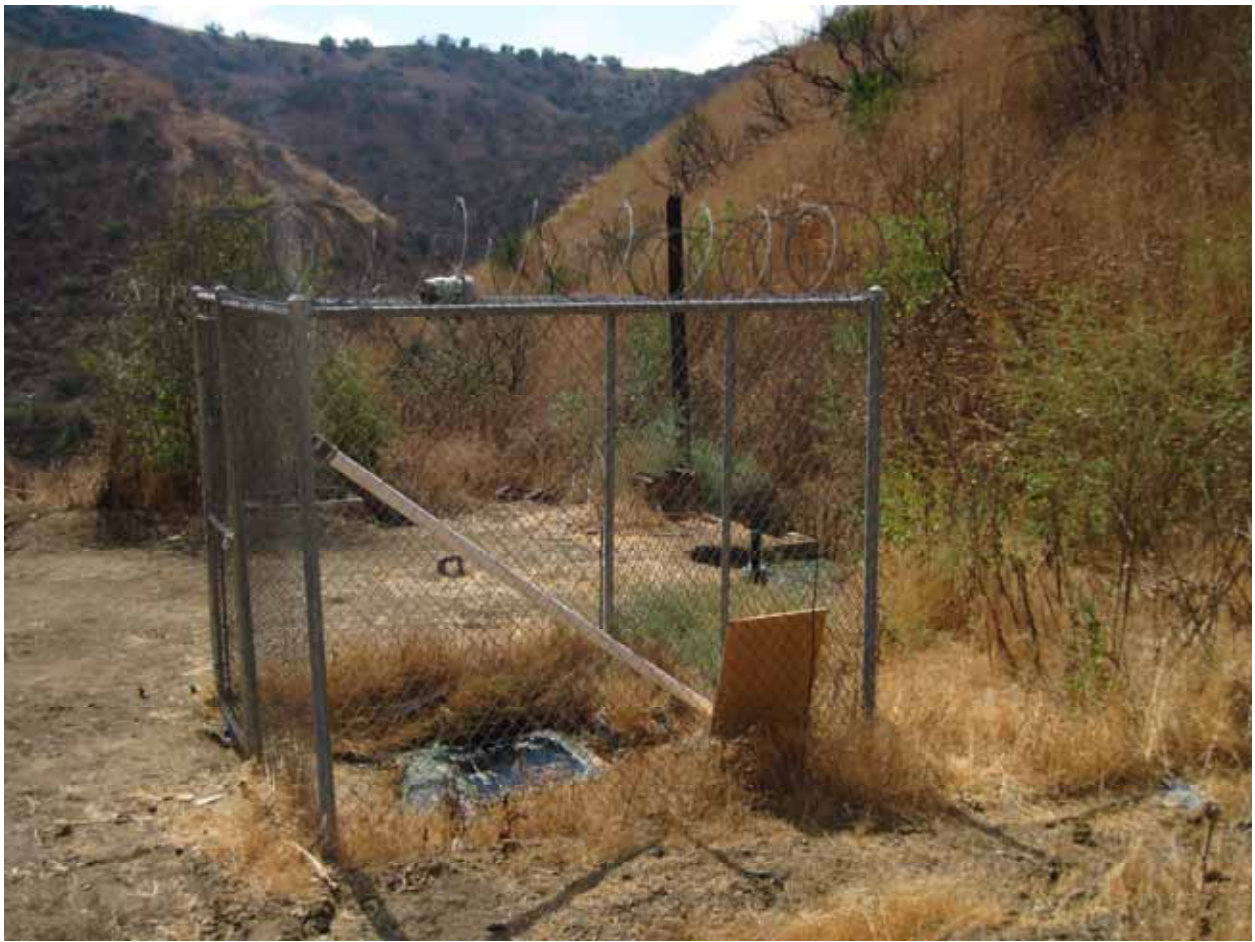
13. Concrete cistern adjacent to spring water conveyance pipe.
