ADVANCED MASTERS IN STRUCTURAL ANALYSIS
OF MONUMENTS AND HISTORICAL CONSTRUCTIONS

Master's Thesis

INVENTORY OF REPAIR AND STRENGTHENING METHODS TIMBER

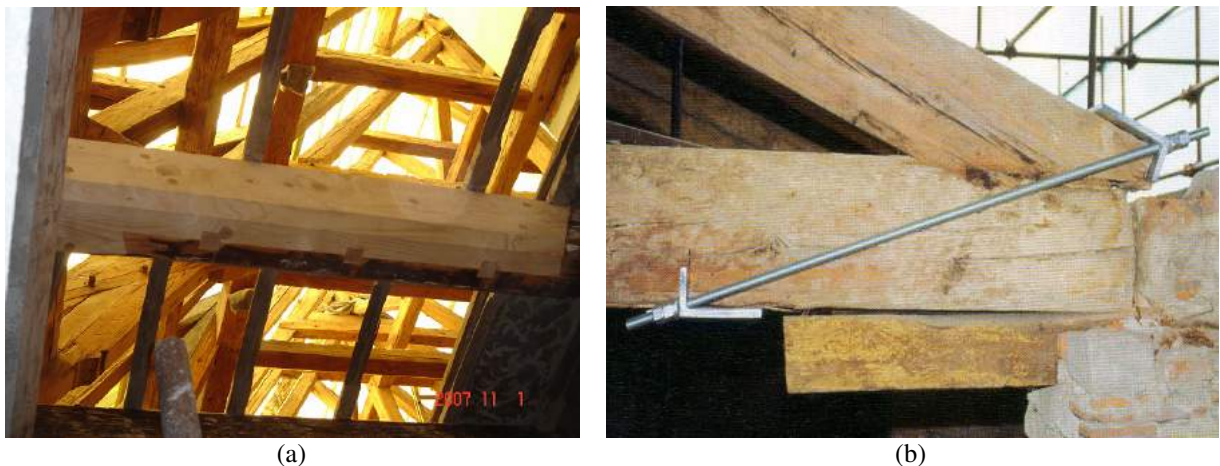
Figure 4 – (a) Prosthesis of a damaged beam extremity by means of timber carpentry, (b) alternative to a prosthesis in the case of a decayed support of a truss.

Both interventions shown on the figure 4 can be considered examples of good practice although different approaches were taken. While in the case of Figure 4 (a) the ideal method for prosthesis was used (all timber intervention by means of carpentry techniques) assuring compatibility of materials, in the case of Figure 4 (b) an alternative to prosthesis, by using a stainless steel tie, allowed the intervention to be extended to an absolute minimum.

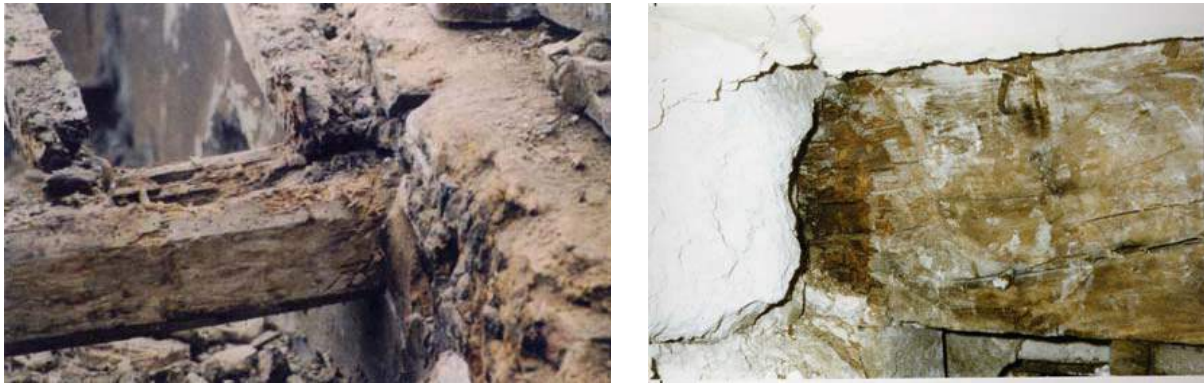
Figure 23 – Wet rot on extremities of beams, in contact with masonry.

Wet rot is a term used to cover the vast majority of fungal species responsible for timber decay. Those that can attack the cellulose but not the lignin are called brown rots. These fungi species leave the wood cross-cracked in cube-like shapes with a characteristic brown colouration. Wet rot that is capable of attacking both cellulose and lignin are called white rots and leave the affected wood fibrous and pale in colour.

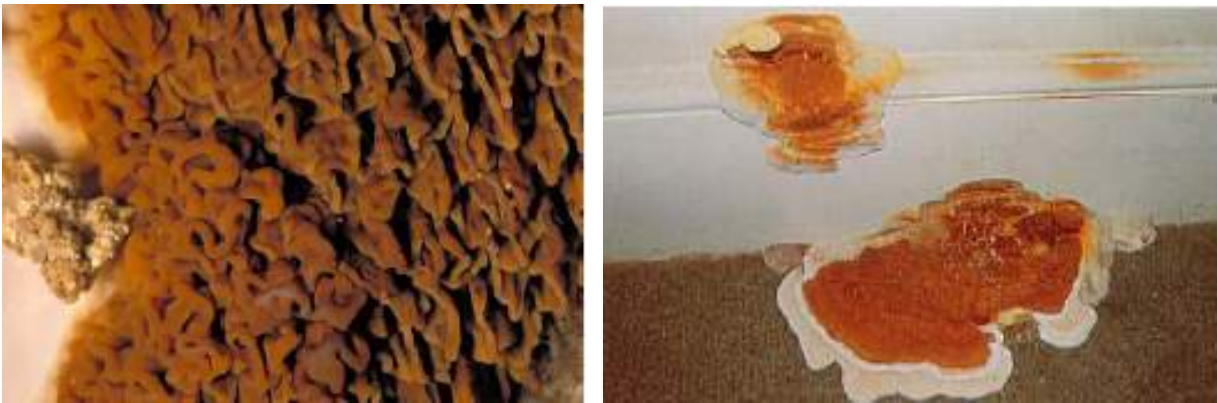
Figure 24 – Dry rot.

A particular species of brown rot, *Serpula Lacrymans*, is the only so-called dry rot fungus. The cube-like shapes on damaged wood are usually larger in size than those of other brown rots, being typically 4 to 7 cm long. A skin-like mycelium is formed, white at first and then turning grey, being easily peeled of the wood. Having a high resistance to alkaline conditions it can also form a strand mycelium that easily penetrates mortar joints in masonry walls. The growth is very fast and may reach 10mm in only one day.

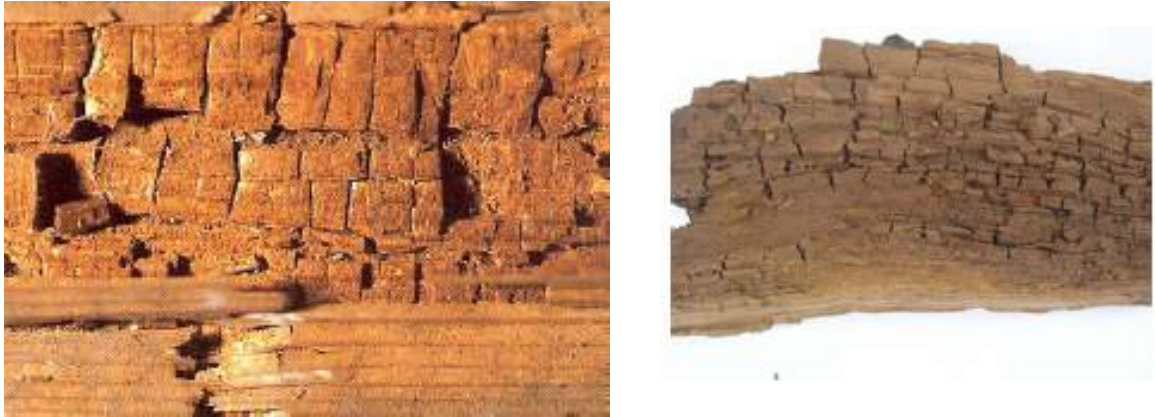
Figure 25 – Typical cube-like shapes of brown rot.

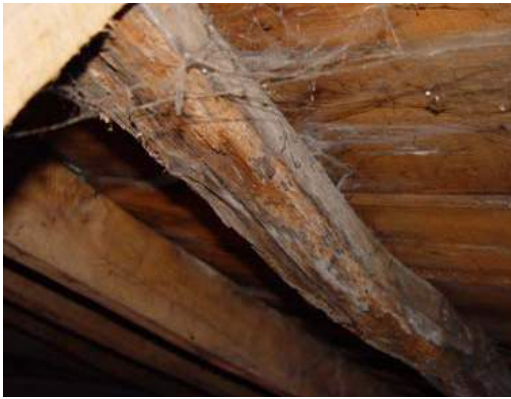
Figure 26 – Reliquary Room of Santa Cruz, Coimbra. Excessive deformation of member.

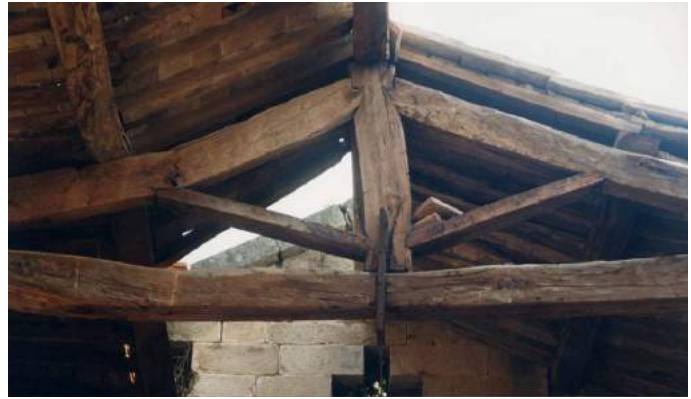
Figure 27 – Church of Mirteto, Italy. Break of the rafter of a truss caused by the instability of the strut.

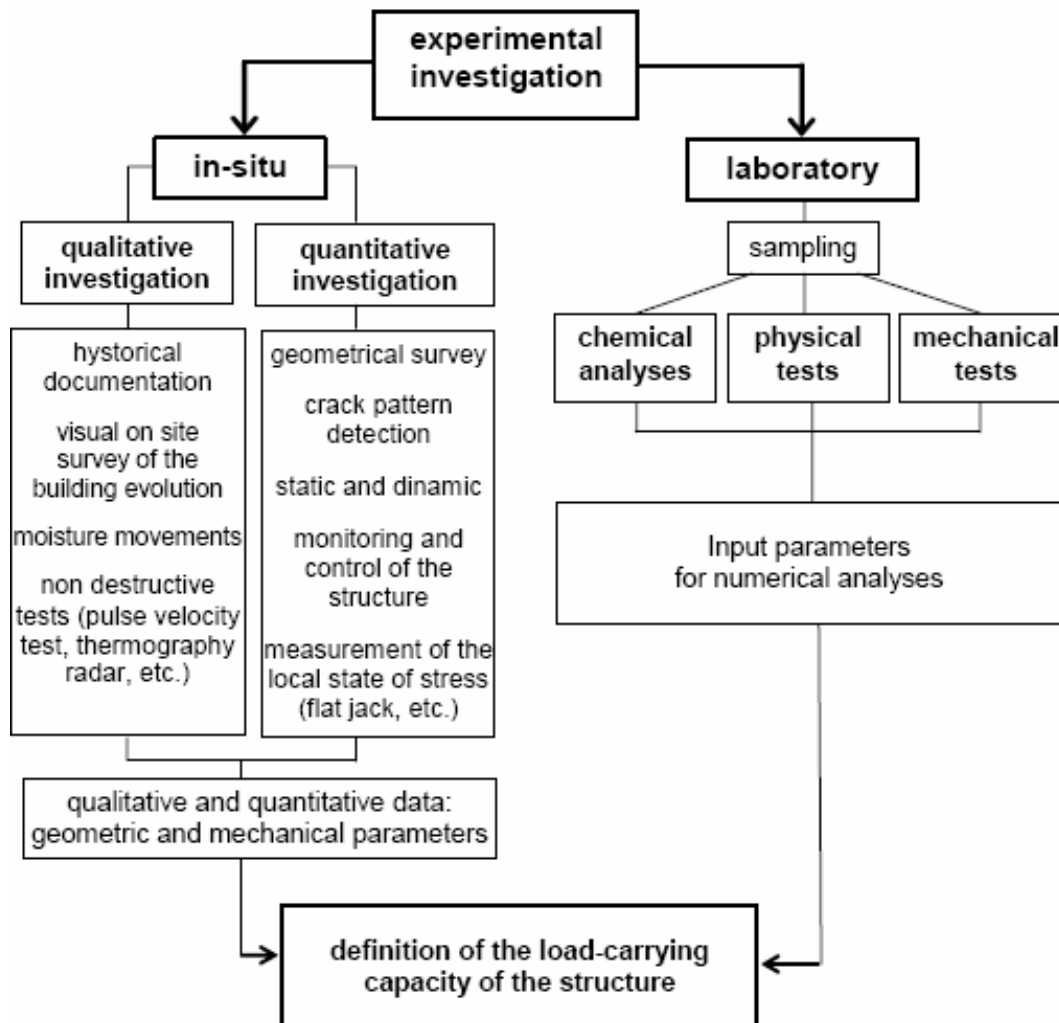
Figure 29 – Experimental survey procedure for structural analysis.

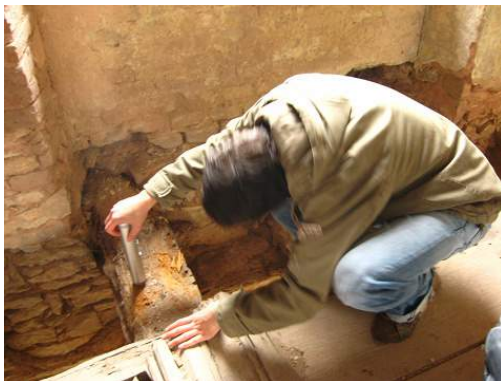
Figure 41 – Pylodin application.

The pylodin is a simple instrument that drives a pin into timber with fixed impact energy. The depth to which the pin penetrates is indicated on the instrument and is inversely proportional to the wood density. It is a simple instrument that easily allows detecting drops of wood density connected to timber decay.

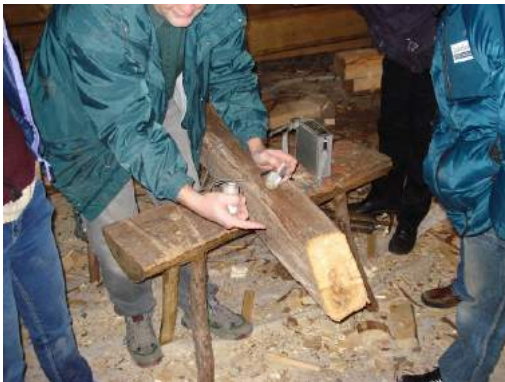
Figure 43 – Sound waves application.

The travel speed of sound or stress waves is higher on materials with higher elasticity modulus and when meeting voids in the material they contour them taking more time to reach the reception point. By applying a sound wave or stress wave in one point and by controlling the time they take to reach a reception point it is possible to detect, by comparison, sound or decayed wood and internal voids originated by biological attack.

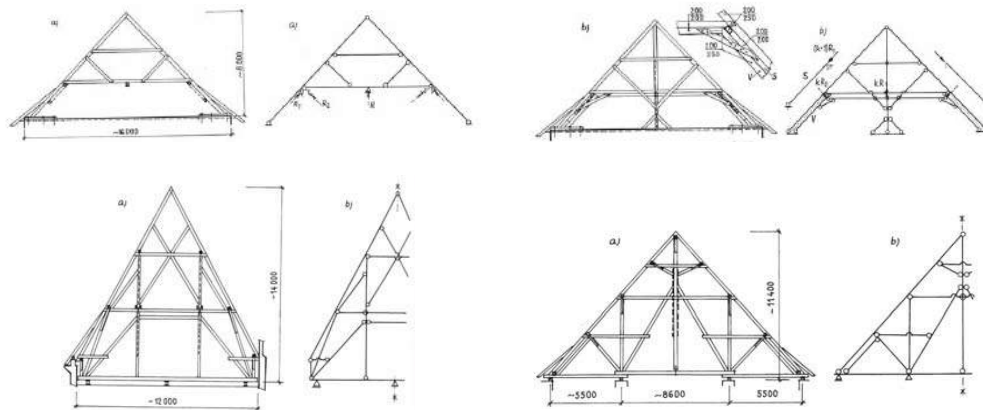
Figure 52 – Some models for timber trusses.

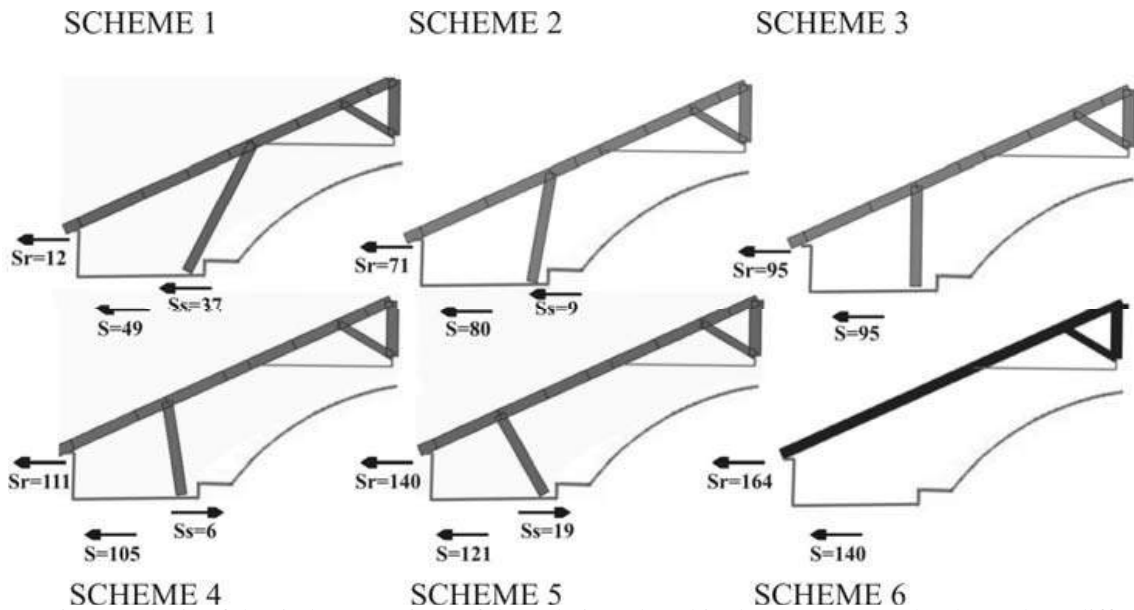
Figure 53 – Analysis of the timber coverings of the Palatine Chapel in the Caserta Royal Palace where different calculated schemes returned very distinct values of the horizontal thrusts.

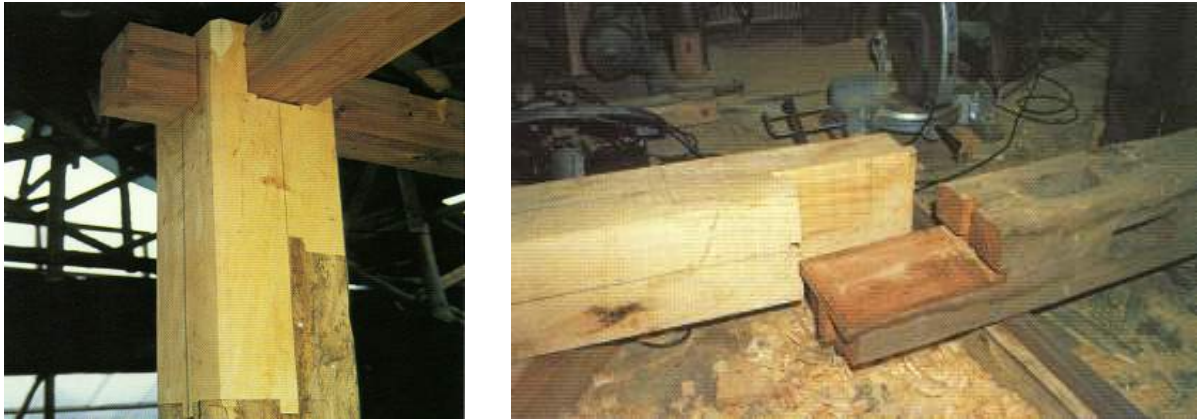
Figure 54 – Examples of timber prosthesis using traditional timber carpentry techniques (Japan).

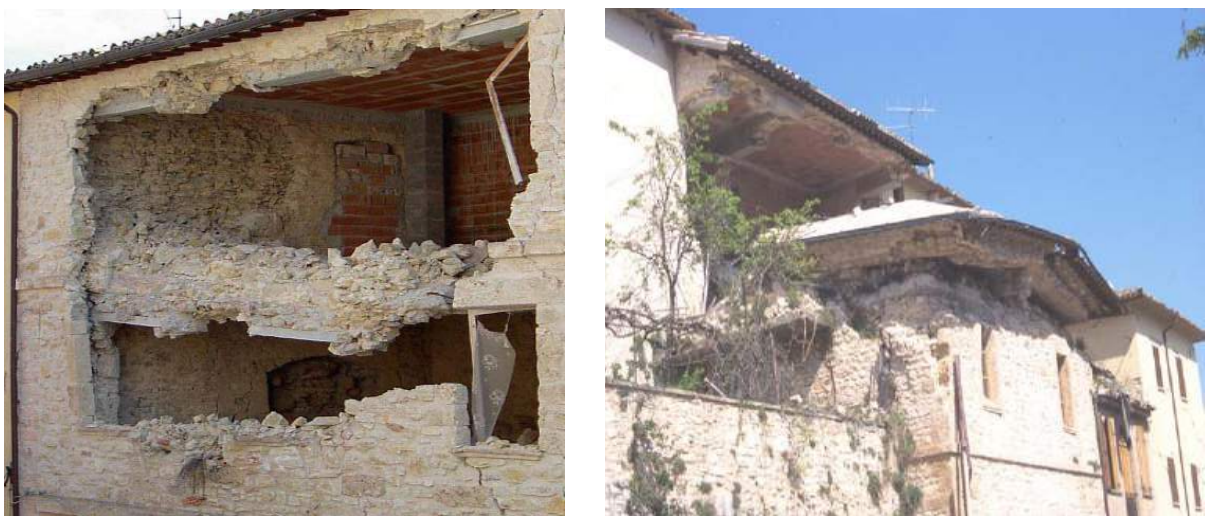
Figure 60 – Out-of-plane collapse of a masonry walls due to “hammering” of concrete floor and roof.

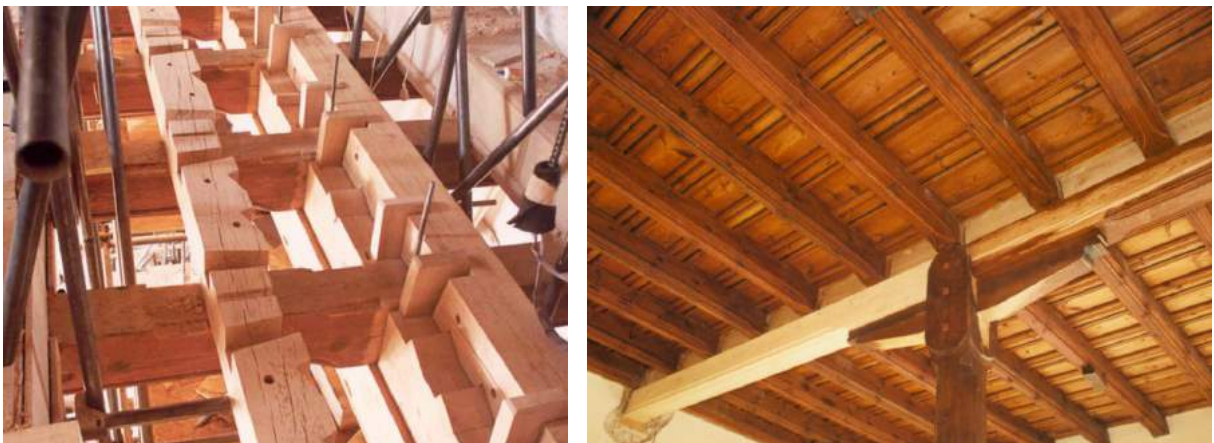
Figure 66 – .Carpentry based restoration of Karlštejn Castle timber floors.

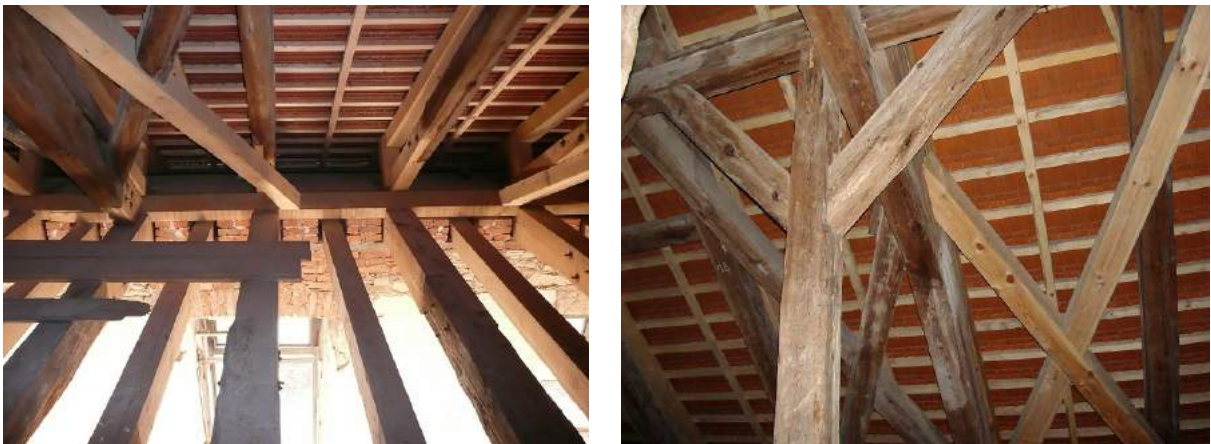
Figure 67 – Substitution of elements on Buštehrad Castle timber roof.

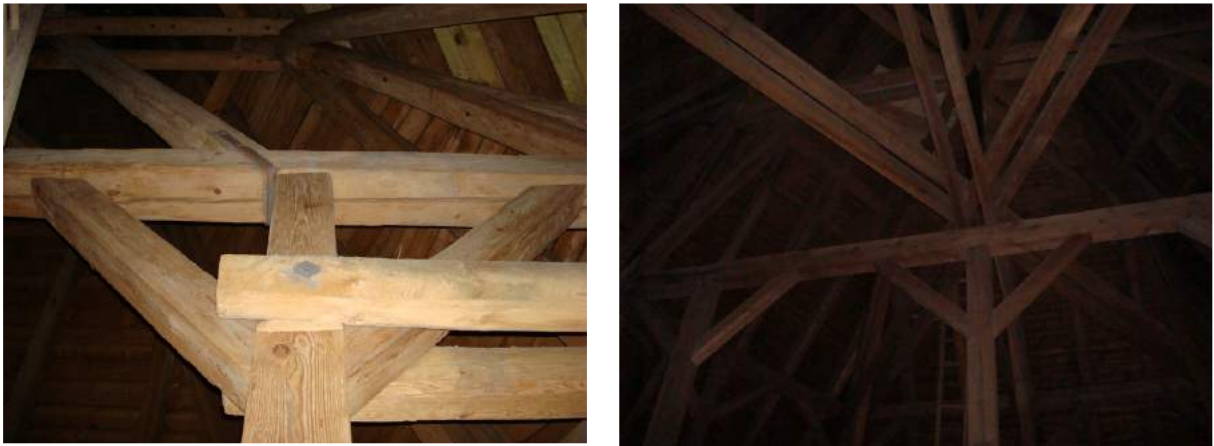
Figure 69 – Addition of timber bracing members (Kutna Hora Cathedral)

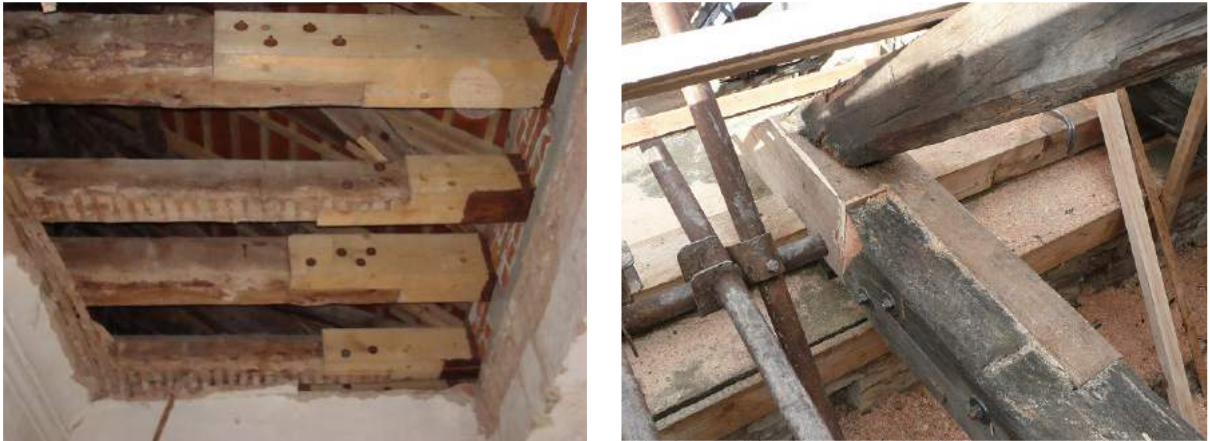
Figure 72 – Example of prosthesis with steel bolts as connectors (Buštehrad Castle).

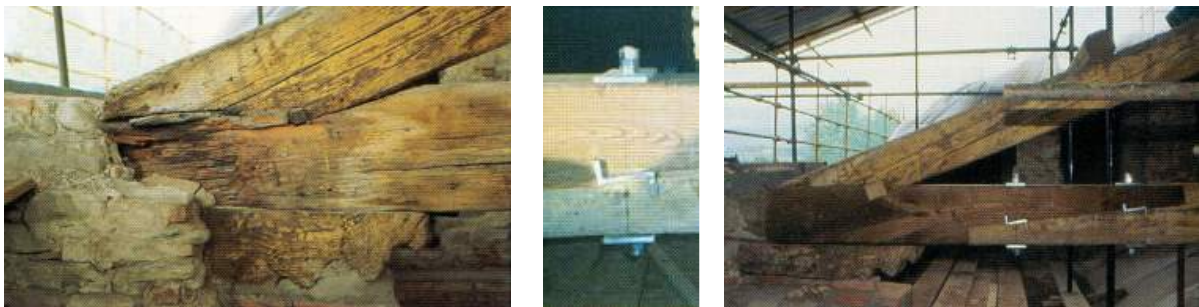
Figure 73 – Examples of prosthesis by similar methods. In both cases the tension in the tie-beam is transmitted by a mechanism of shear parallel to the timber grain but in one case the mechanism is achieved by steel plates (a) and in the other is obtained by carpentry detail (b).

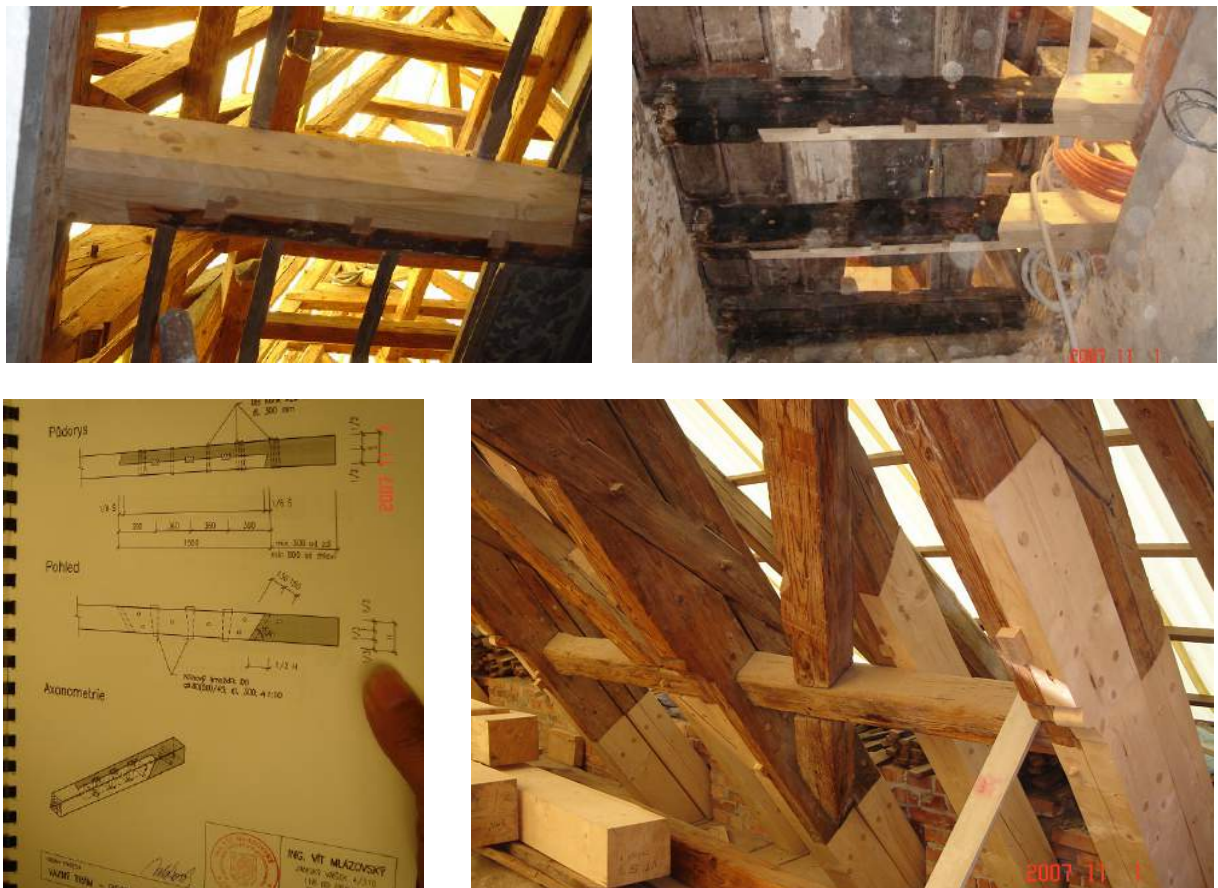
Figure 74 – Prostheticisation with all timber connections and modern carpentry techniques. “Butterfly” dowels joining old floor joists with new strengthening flange beams (Building in Prague).

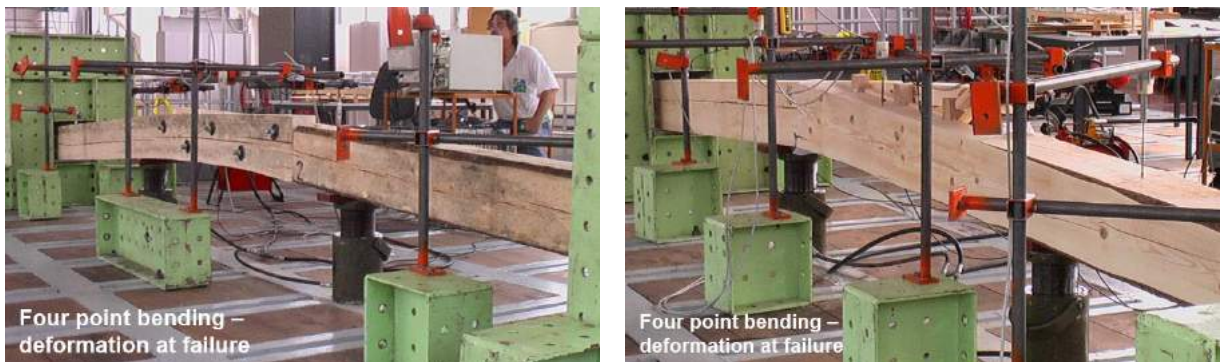
Figure 75 – Four point bending tests to compare the performance of steel and timber connections (ITAM, Prague).

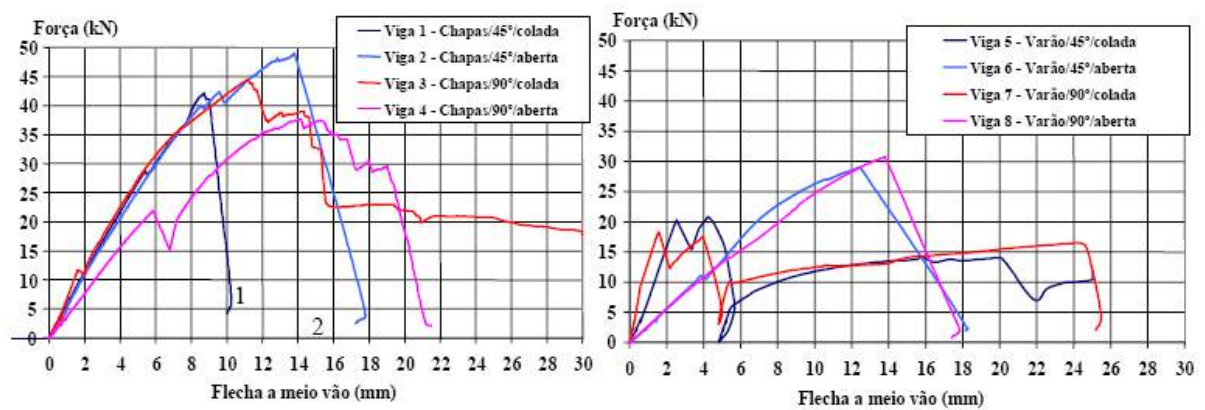
Figure 79 – Performance of the tested connections using FRP bars and lamellas (LNEC, Lisbon)

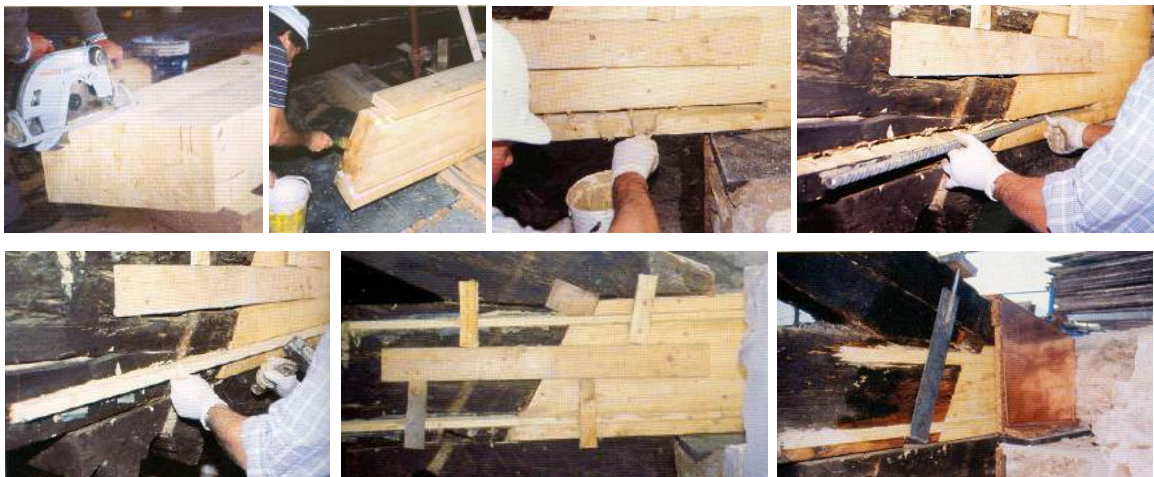
Figure 80 – Sequence of execution of a prosthesisation using steel bonded bars to achieve structural continuity.

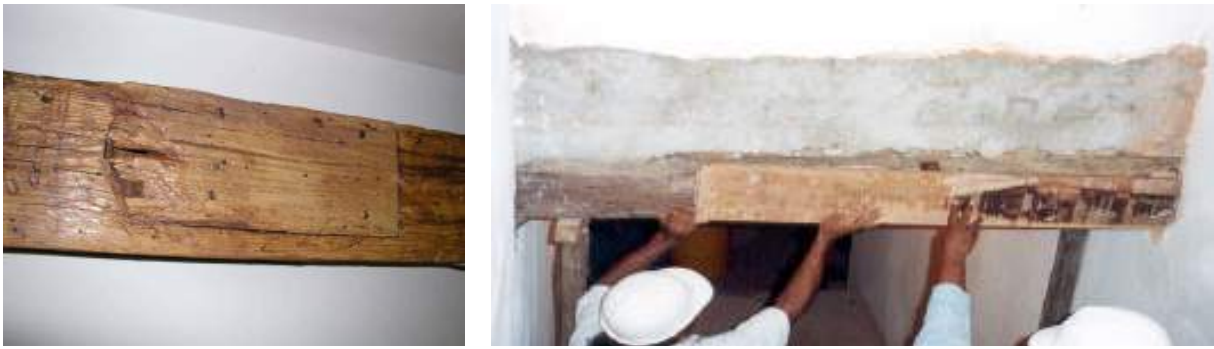
Figure 81 – Sealing.

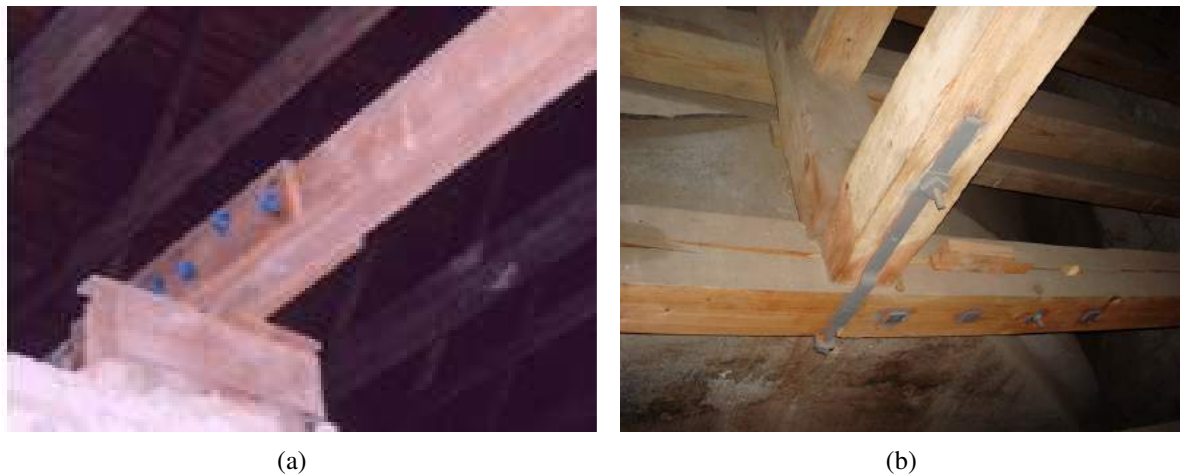
Figure 83 – Example of application of traditional techniques on the repair of cracks. (a) *Empalme*, (b) Sticking of crack with steel bolts.

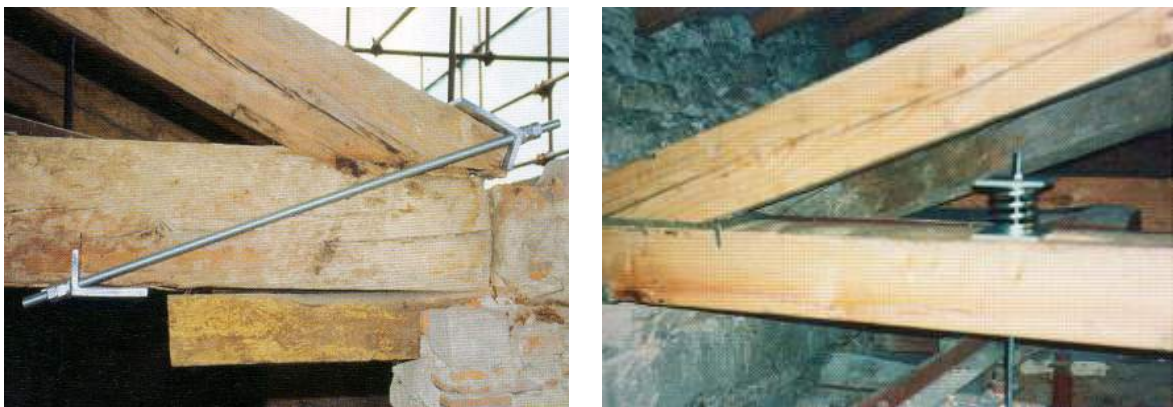
Figure 87 – Repair of connections by moving the location where the tie-beam receives the rafter horizontal thrust.

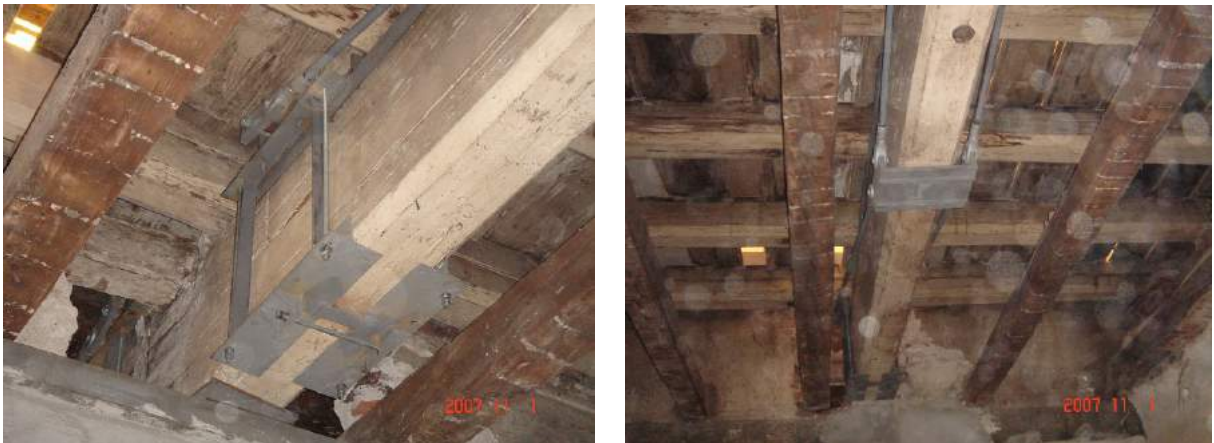
Figure 101 – Post-stressing of a beam.

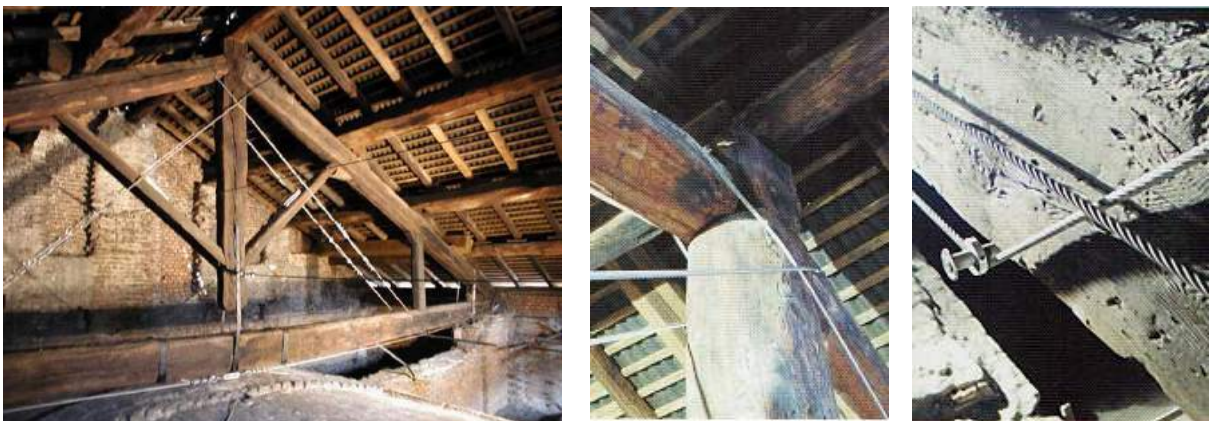
Figure 102 – Scheme and details of an intervention using post-tensioned steel cables and the addition of a timber member, giving the rafters an extra support and loosening the bending on the tie-beam at the same time.
