A History of Restoration, a Restoration of History

BETHLEHEM • PALESTINE

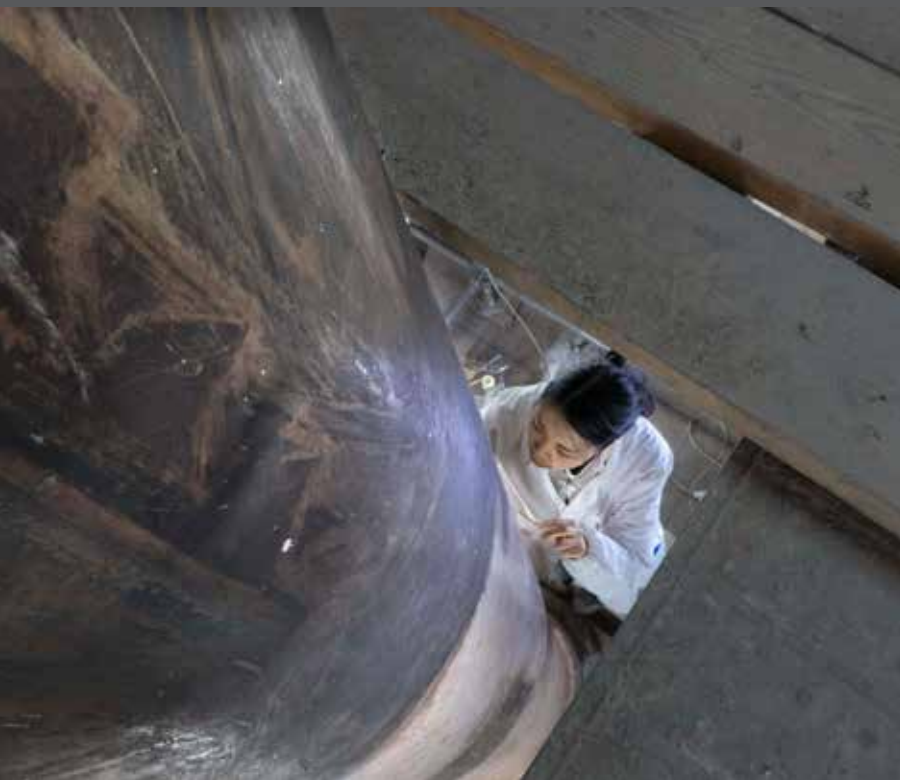
Restorer working on the decorative paintings of the columns.

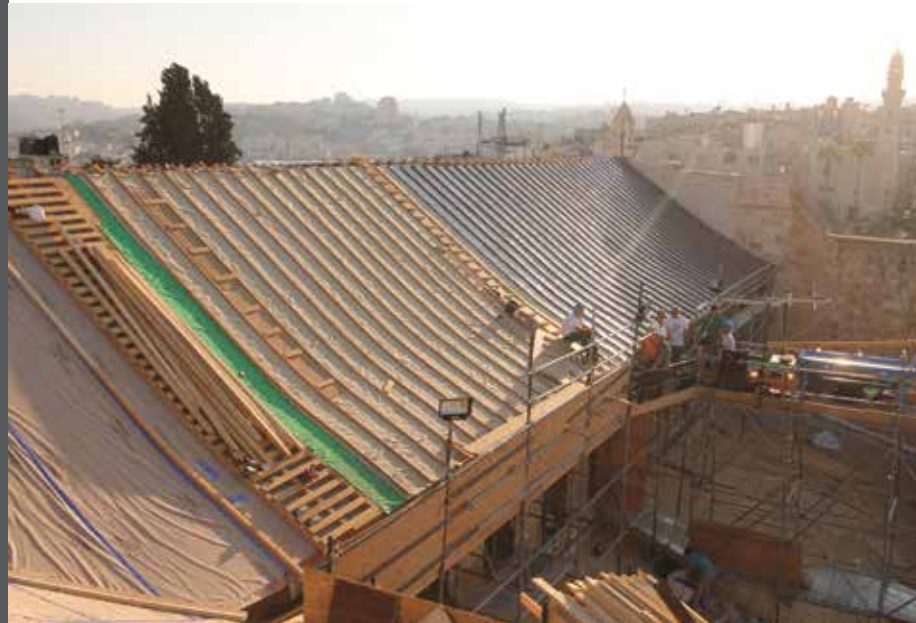
The roof of the basilica during the restorative works.

The year-long restoration of the roof was undertaken by replacing the damaged wood, or filling it, with the same ancient larch wood from Italy. Anatolian oak wood was also utilized as it was already used in limited restorations during Ottoman times. In total, 8 percent of the wood used

was Anatolian. New lead sheets from Germany were put in place over the wood. Italian wool was inserted between the lead sheets and the wood beams, and it was inserted using small pieces of wood that create an aeration system able to dry any drop of water and to thermally insulate the basilica.
