# ***Blue Palmetto Home Inspection***

## **Property Inspection Report**

Home Sweet Home

111 Dream street, Dream City, SC 29485

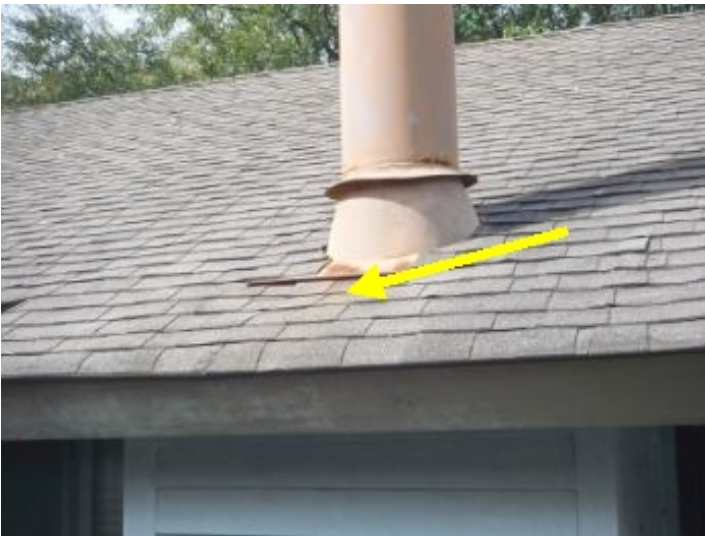
Area of concern- Area of concern pictured. - Probable leak under chimney area noted.

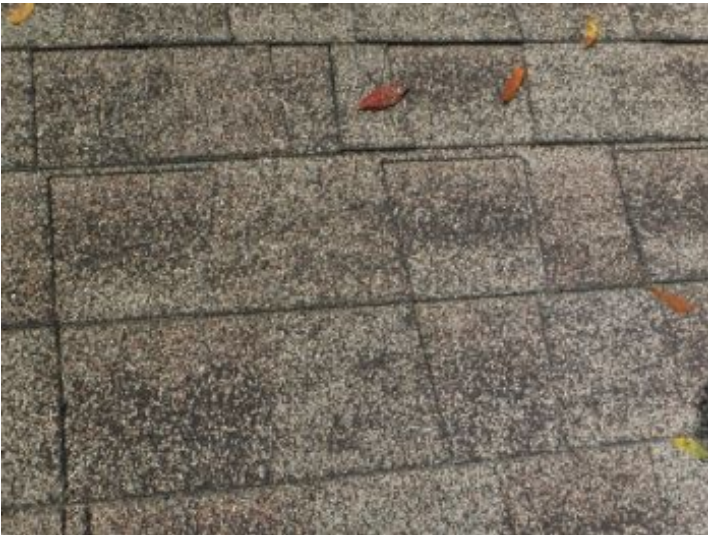
Granule Loss- Significant granule loss noted. Typically this is a sign that the roof covering is nearing the end of its useful life.

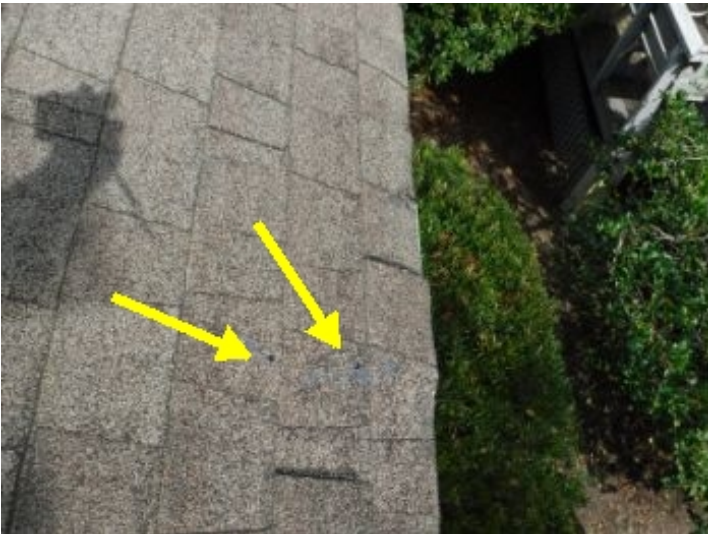
Nail pop pictured. Repair as needed to prevent moisture intrusion.

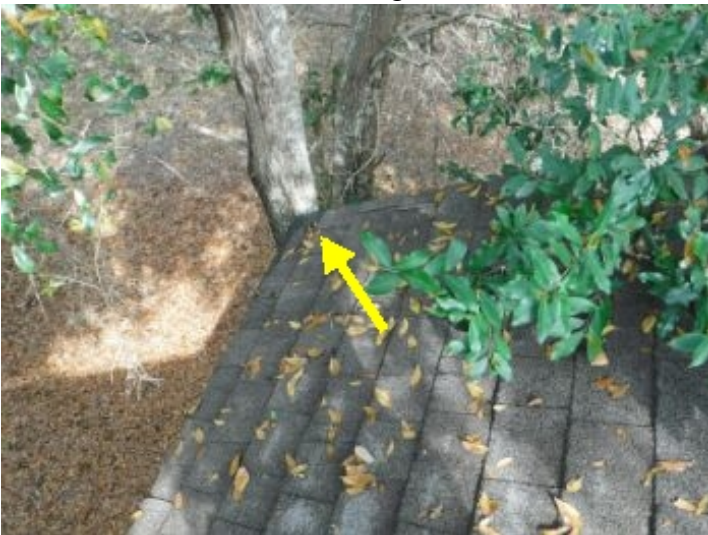
Broken or damaged shingles at overhang location/s shown. Repair as needed.

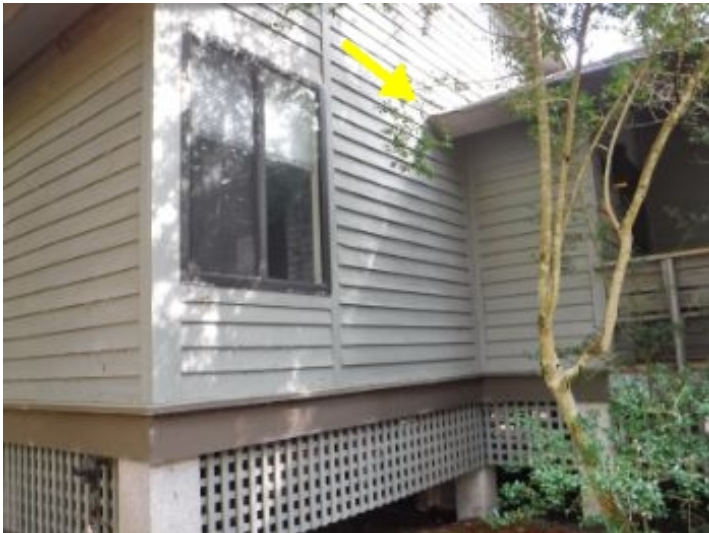
Kickout flashing is missing at the location pictured or other places . Kickout flashing is a piece of metal bent so as to divert water away from the house. It is used where a roof surface meets a wall. Lack of kickout flashing can allow moisture to enter behind the siding at that location and may cause damage. An example of kickout flashing can be found at <http://www.summerville-home-inspector.com/content/what-kickout-flashing> . There is frequently moisture penetration where kickout flashing is missing. Recommendation is to add the kickout flashing where needed. Note that it appears that there is flashing here but it isn't bent to deflect water away from home. Recommend improve.

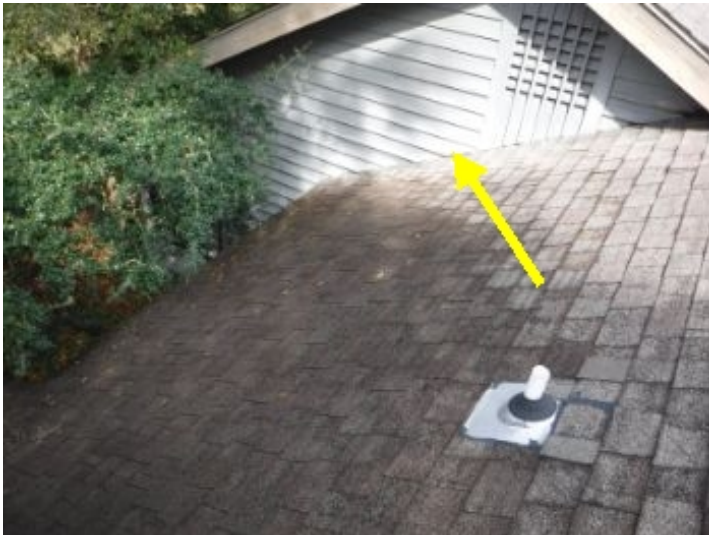
Gable Wall Flashing (workmanship)- Non professional workmanship noted on the gable wall flashing. Step flashing should be under each single and bent upwards twice as far as over (6"-4" for 10" flashing). Recommend repair as needed for reliability.

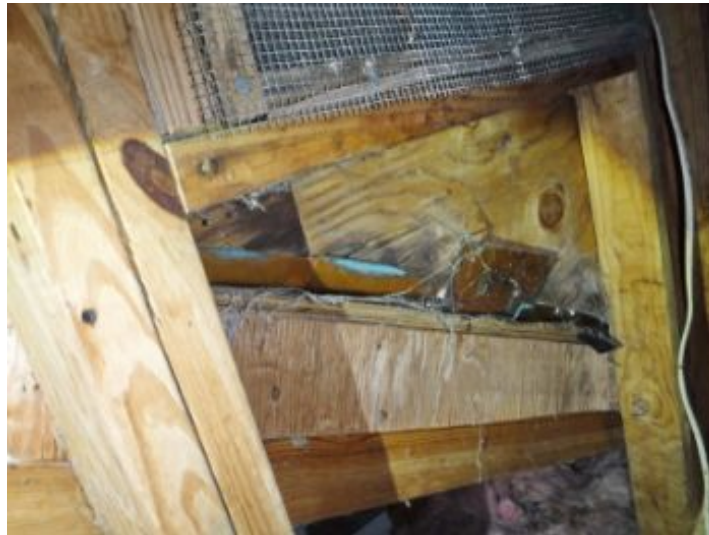
shows attic view of questionable flashing on half gable wall

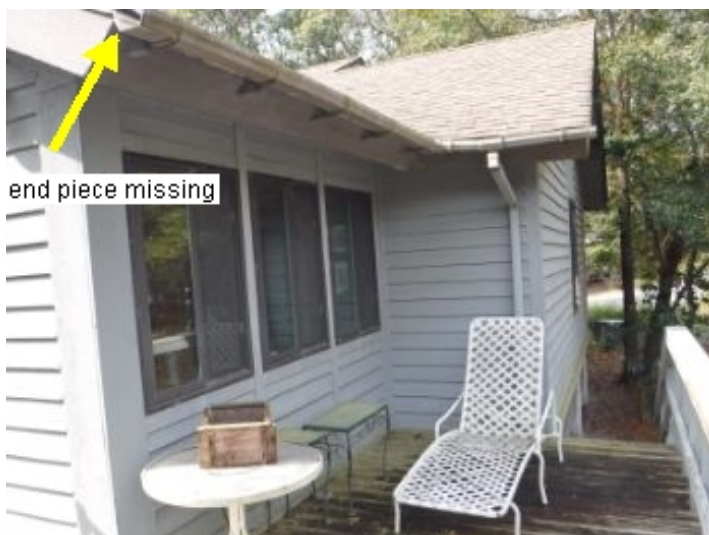
Clean gutters: Significant amounts of debris and blockage evident.

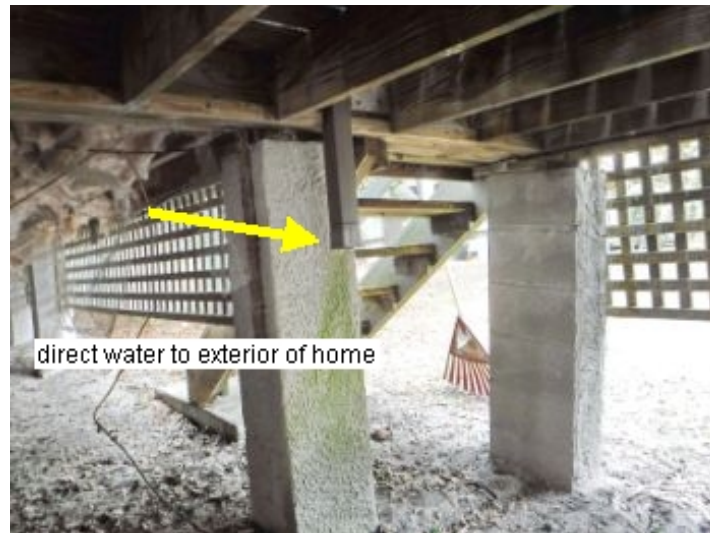
| Page 14 Item: 5 | gutters and downspouts observations | <ul style="list-style-type: none"> <li>• Gutters are in disrepair along back porch area with clogged, missing sections. Also drainage exit under home is improper. Water should flow to the exterior away from the house. Recommend improve.</li> </ul> |

Gutters are in disrepair along back porch area with clogged, missing sections. Also drainage exit under home is improper. Water should flow to the exterior away from the house. Recommend improve.

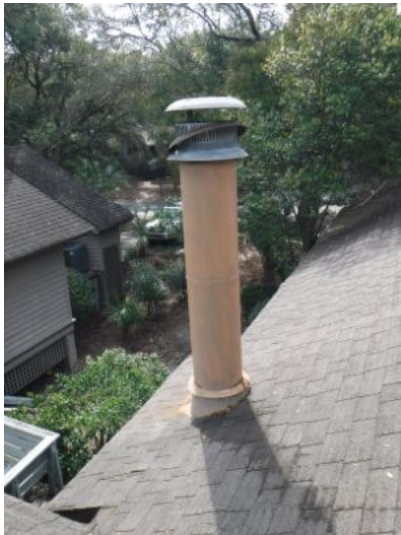
| Page 15 Item: 7 | Chimney Observations | <ul style="list-style-type: none"> <li>• Bracing- Chimney pipe is a little tall so a brace is recommend. Typically a brace is recommended if pipe is over 5' above roof line. Have a professional brace it properly.</li> </ul> |

Bracing- Chimney pipe is a little tall so a brace is recommend. Typically a brace is recommended if pipe is over 5' above roof line. Have a professional brace it properly.

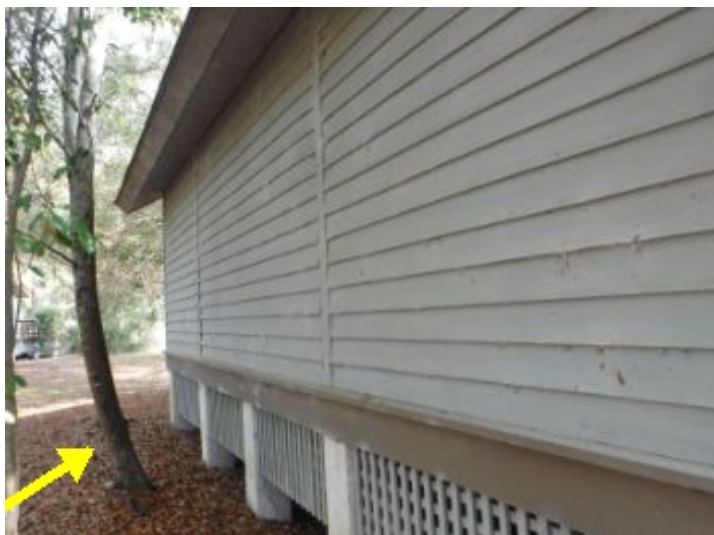
Be aware that the roots of trees within 10 feet of foundations, concrete patios and sidewalks can damage the building components. Generally trees closer than 10' should be removed to eliminate the possibility of foundation damage by root growth. Remember that damage from tree root growth is not always gradual. Suggest monitor at the very least or take corrective action if warranted.

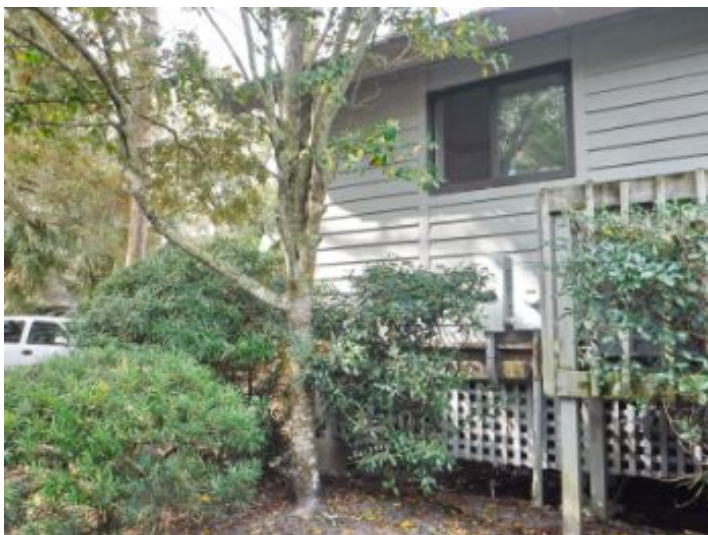
Maintenance Tip- Shrubbbery in contact with the home should to be trimmed back to protect the home or roofing components .

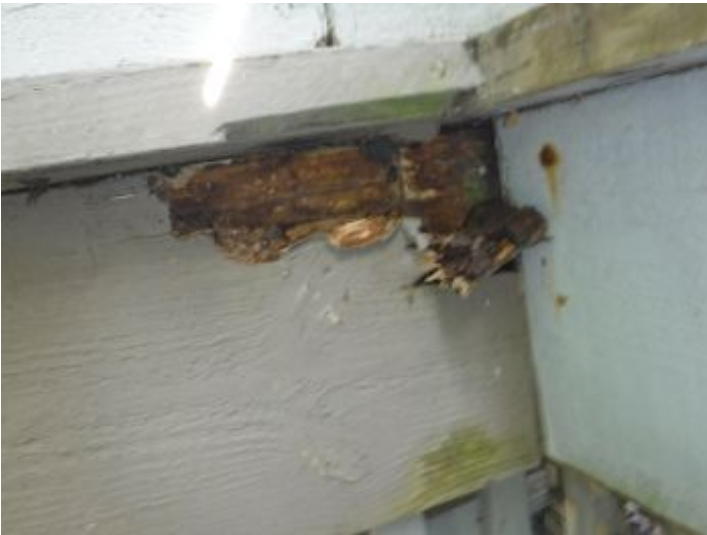
| Page 18 Item: 1 | Trim Condition | <ul style="list-style-type: none"> <li>• Decay (pictured)- Decay at pictured location. Repair as needed.</li> </ul> |

Decay (pictured)- Decay at pictured location.  
Repair as needed. In corner of deck.

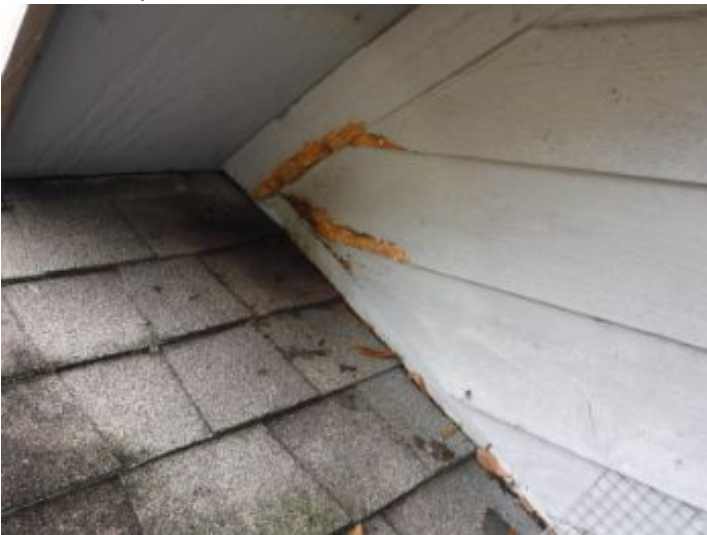
rodent chewed trim shown- improve flashing here  
at next re- roof

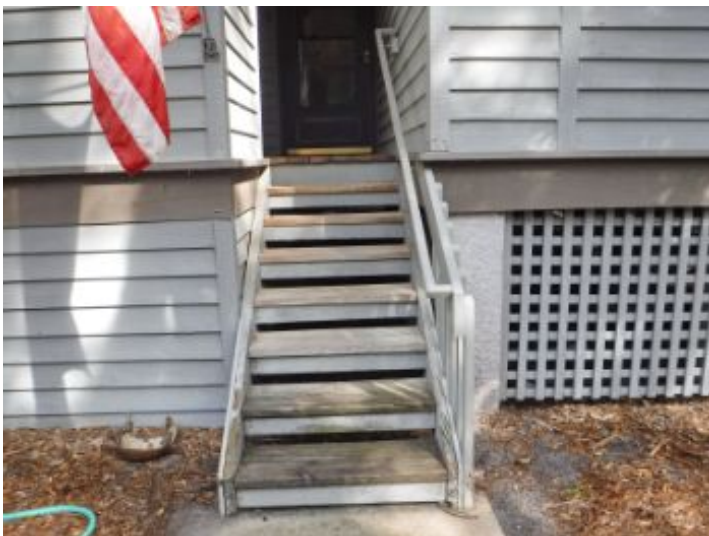
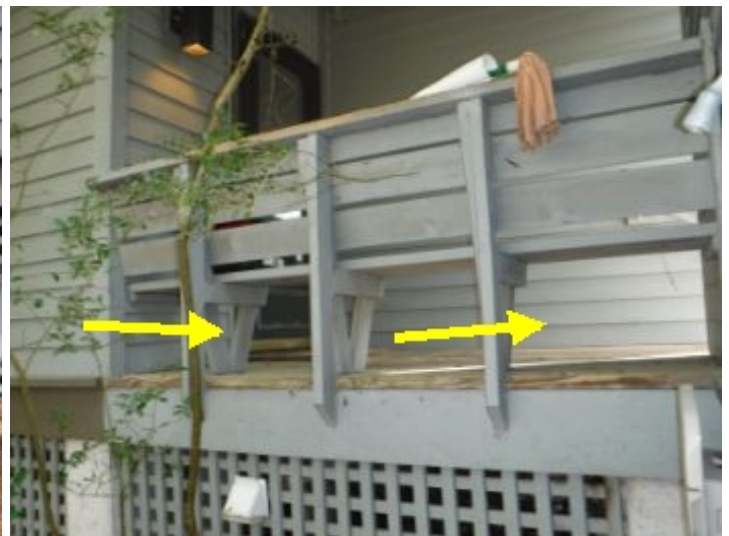
Modern safety rules require raised floor surfaces over 30" in height to have guards 36" in height. These guards must not permit passage of a 4" sphere and be strong enough to resist a 200 lb load. Recommend consider improvement for safety.

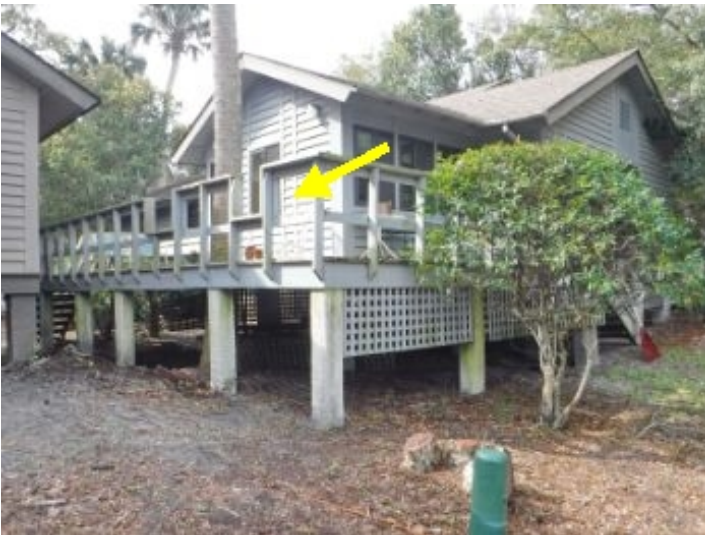
Noted there were missing or insufficient guards in the screened porch area. Modern safety rules require that raised floor surfaces over 30" in height above ground have guards 36" in height. These guards must not permit passage of a 4" sphere and be strong enough to resist a 200 lb load. Also existing guards are in poor shape with flimsy loose connections. Recommend consider improvement for safety.

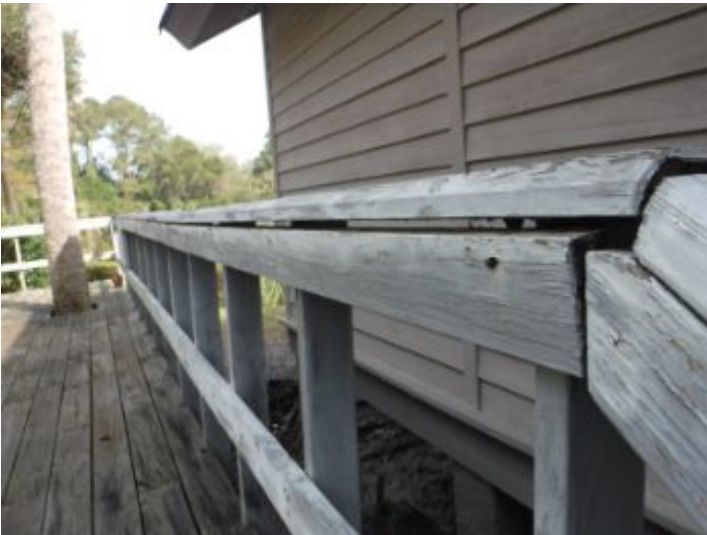
Noted there were missing or insufficient guards in the porch area. Modern safety rules require that raised floor surfaces over 30" in height above ground have guards 36" in height. These guards must not permit passage of a 4" sphere and be strong enough to resist a 200 lb load. Also existing guards are in poor shape with flimsy loose connections. Recommend consider improvement for safety.

The walking surface deck boards are nearing their useful life. Consider replacement soon. Note\* Replacing the deck surface is an inexpensive way to breath new life into an existing deck as the surface boards tend to age faster than the floor support structure.

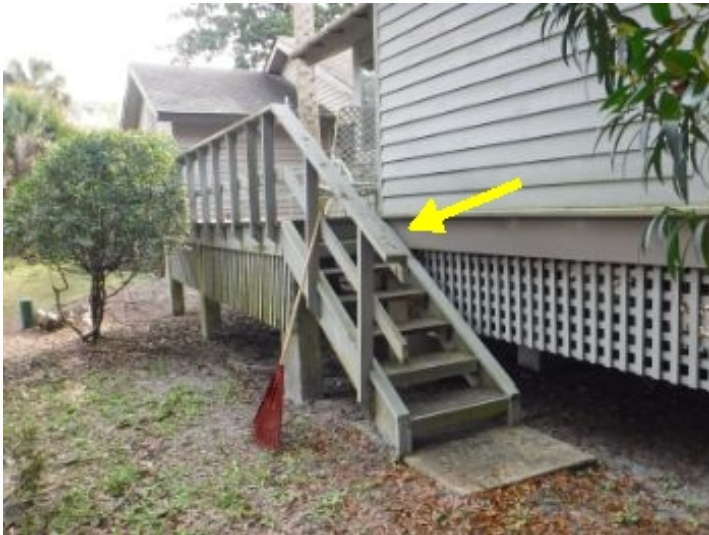
| Page 22 Item: 10 | deck/stairs condition | <ul style="list-style-type: none"> <li>• Modern safety rules require a graspable handrail for safety on all stairs of 4 or more risers or over 30" in height. A graspable handrail is about 2" in diameter. In addition raised floor surfaces over 30" in height require guards 36" in height. These guards must not permit passage of a 4" sphere (4 3/8" for stair guards) and be strong enough to resist a 200 lb load. Recommend consider improvement for safety.</li> </ul> |

Modern safety rules require a graspable handrail for safety on all stairs of 4 or more risers or over 30" in height. A graspable handrail is about 2" in diameter. In addition raised floor surfaces over 30" in height require guards 36" in height. These guards must not permit passage of a 4" sphere (4 3/8" for stair guards) and be strong enough to resist a 200 lb load. Recommend consider improvement for safety.

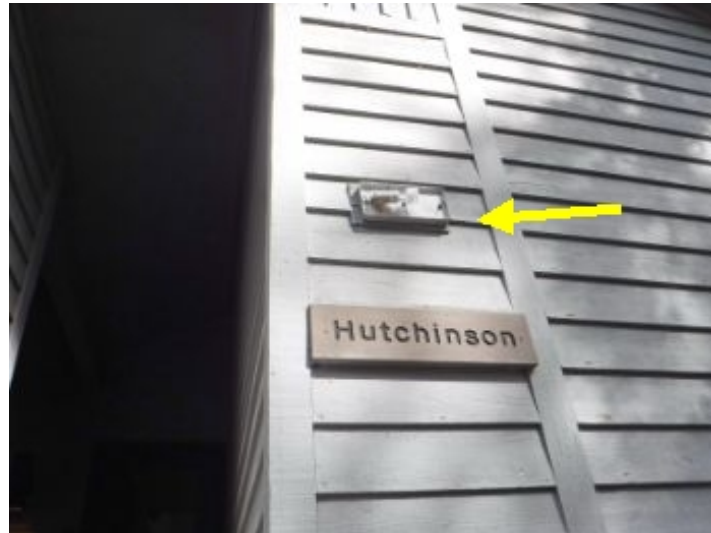
Lamp Disrepair (pictured)- Lamp as pictured is in disrepair and not sealed from the elements. Recommend replace as needed.

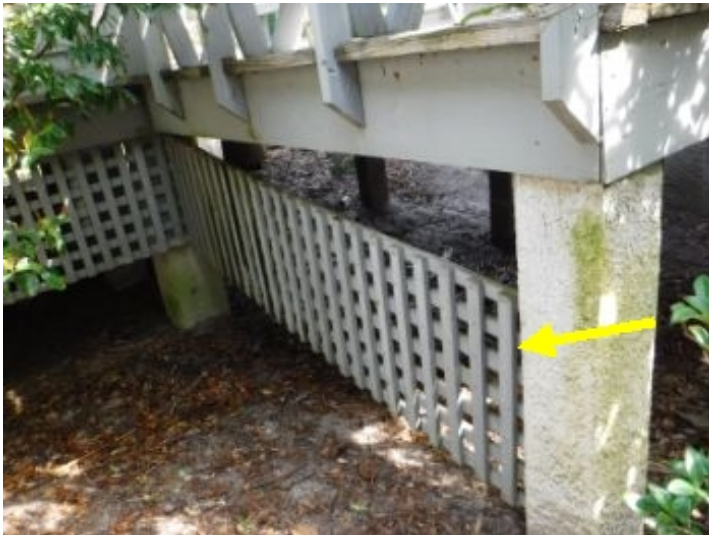
The under floor lattice was in disrepair in a few places (some are pictured) and we suggest review and repair all. Actually we recommend extending the lattice to the ground to discourage entry by vermin. Recommend repair all as needed.

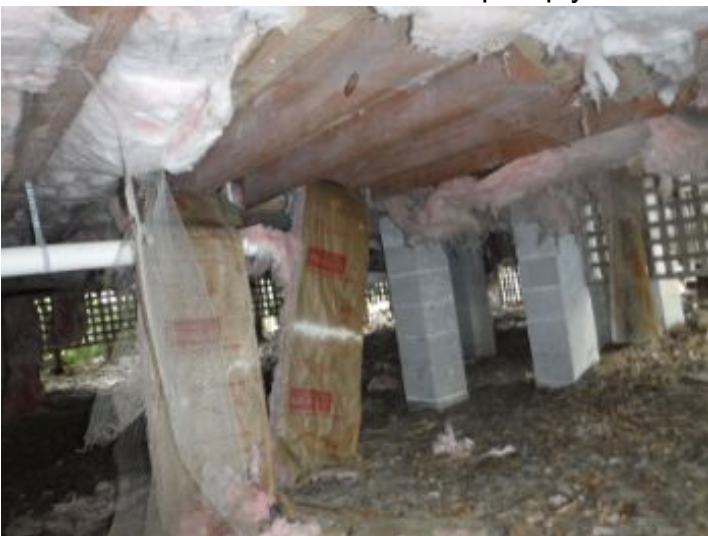
missing insulation shown

Insulation (support)-There is some insulation falling down in various areas. This can be due to improper attachment. Install more insulation supports rods where needed or netting to retain the insulation in place. Note that open netting is marginal at keeping out rodents. Consider alternatives such as house wrap or plywood.

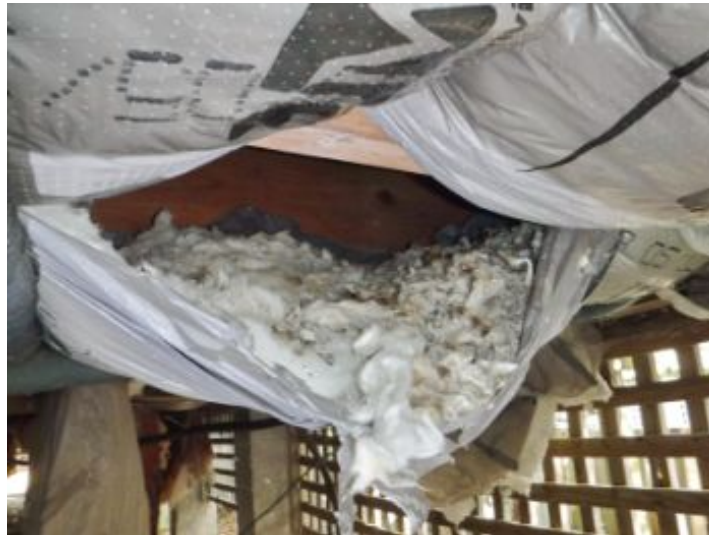
Insulation (support)-There is some insulation falling down in various areas. This can be due to improper attachment. Install more insulation supports rods where needed or netting to retain the insulation in place. Note that open netting is marginal at keeping out rodents. Consider alternatives such as house wrap or plywood.

recommend replace insulation with rodent droppings and take steps to prevent re-entry.

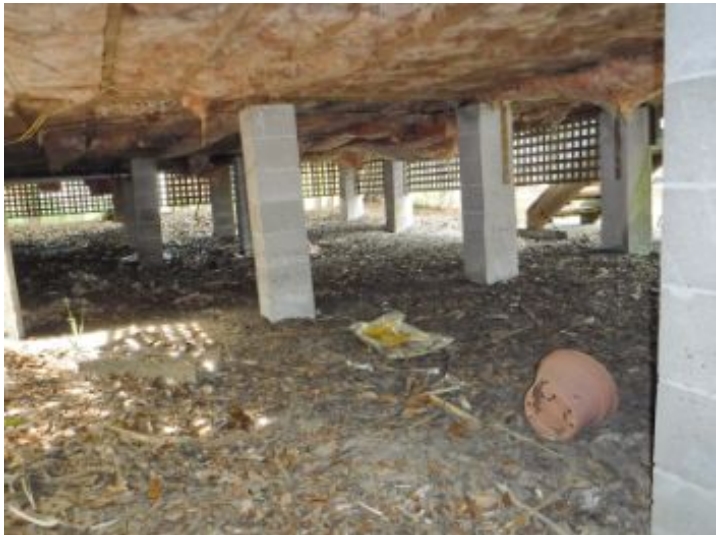
Pier by back deck stairs is leaning, is not filled with concrete and is open at top. Open cells are not allowed. Have it repaired.

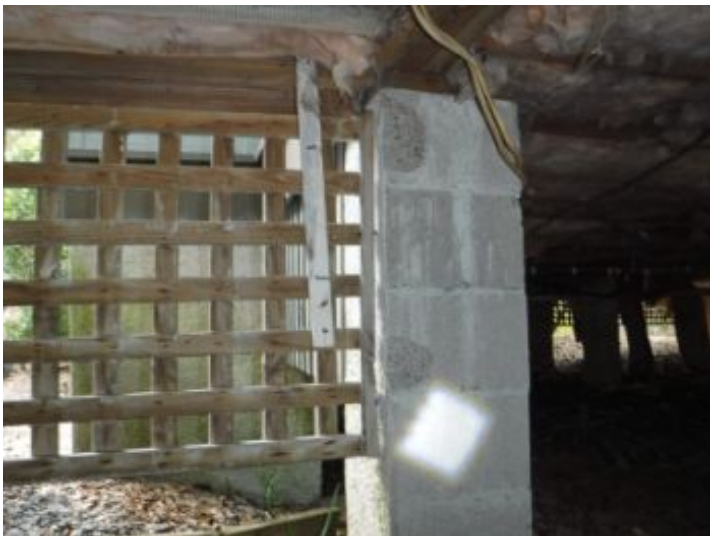
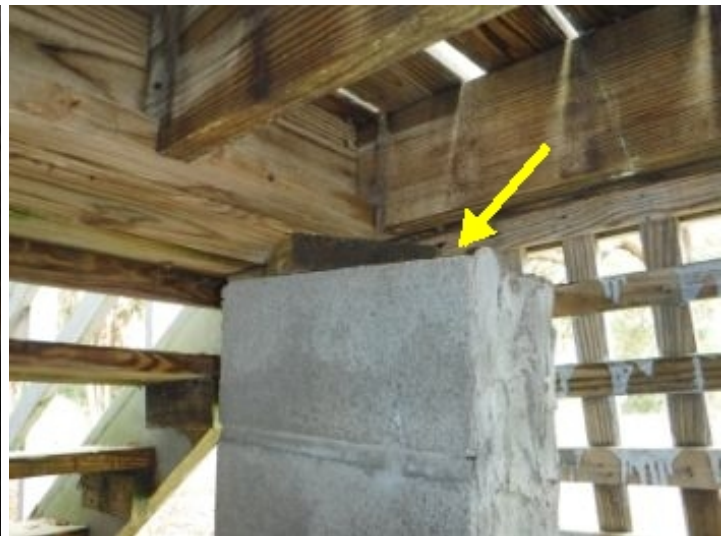
close up view of crack at bottom of pier reveals no reinforcing concrete or steel

Pier by back deck stairs is leaning, is not filled with concrete and is open at top. Open cells are not allowed. Have it repaired.

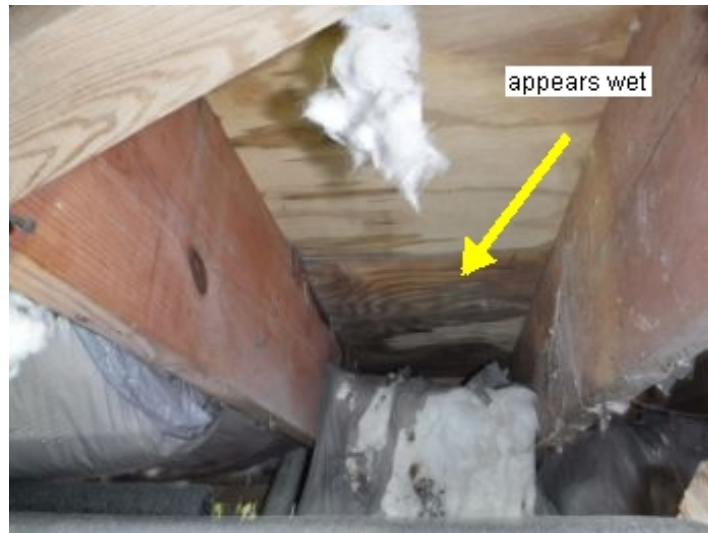
- Moisture Damage- Pictured area shows moisture damage from past/present leaks. Under kitchen area. Repair as needed.

Moisture Damage- Pictured area shows moisture damage from past/present leaks. Under kitchen area. Repair as needed.

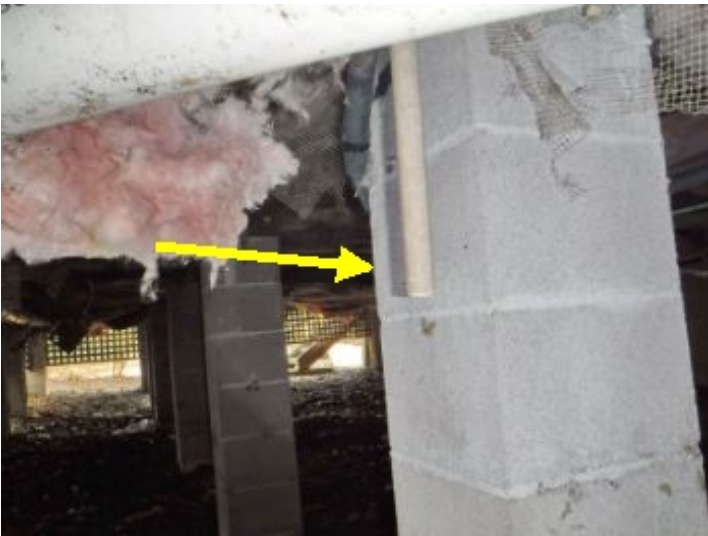
piping needs a little support here

HVAC Overflow (exit)- The air handler condensate line was noted exiting in the crawlspace area. These should exit to the exterior of home. This is to prevent moisture in the crawlspace which is undesirable. Repair as needed.

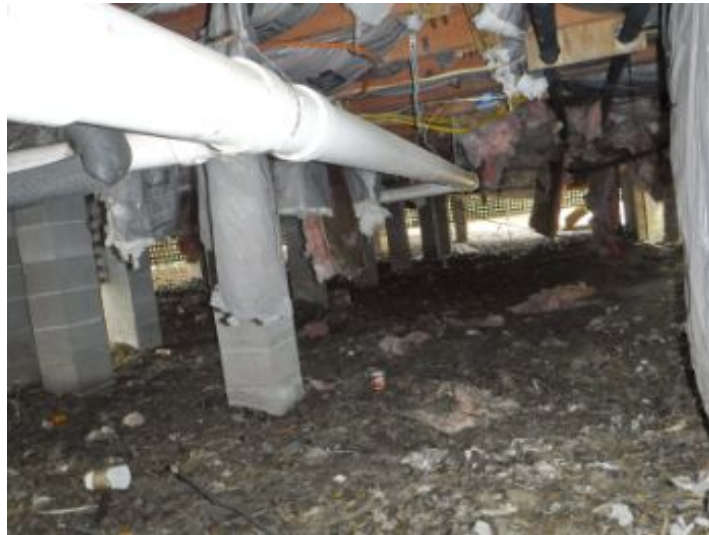
The refrigerant line (from the air conditioner) has gaps in the insulation in places in the crawlspace. Insulation is required. A line which is not insulated will suffer a performance loss and condensation will form on piping causing moisture issues in the crawlspace which is undesirable. Recommend improve.

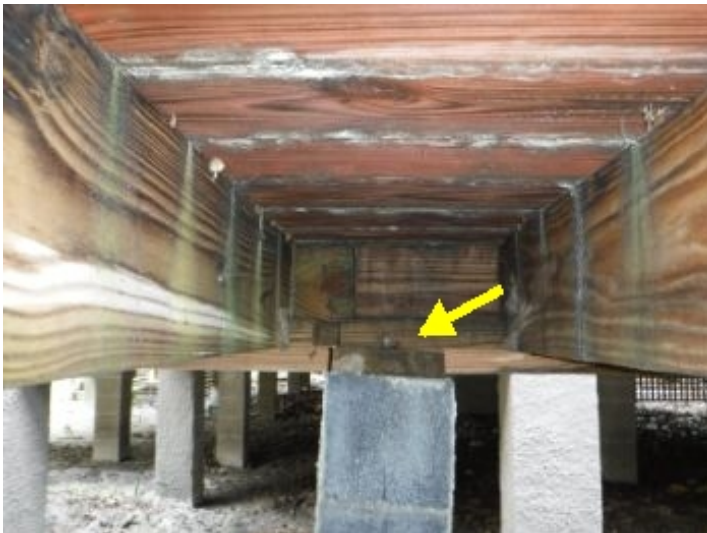
• **General Comments and Analysis-** Although it appeared that metal strapping was inside the piers in the ones I checked it was not the case. It appears in the few I checked that a short piece was bent into an L shape and only bolted to the band. Effectively useless as far as wind uplift resistance is concerned. Recommend have an engineer or a contractor who specializes in foundation repair review and advise.

shows missing anchor bolts

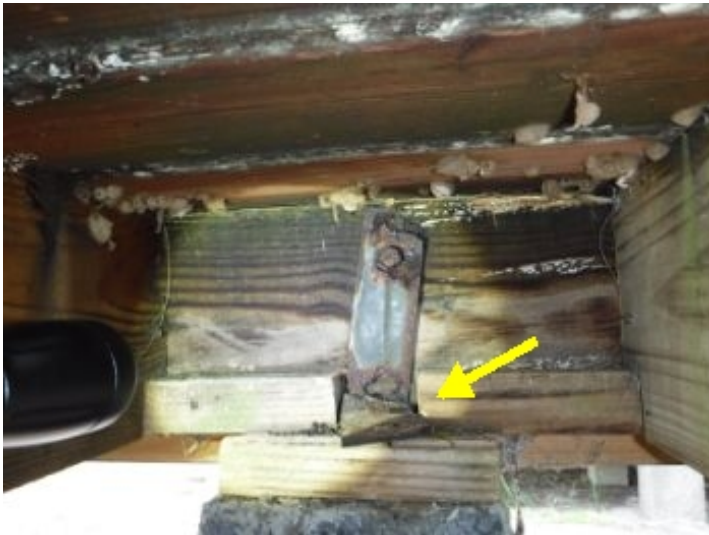
severely rusting anchor

General Comments and Analysis- Although it appeared that metal strapping was inside the piers in the ones I checked it was not the case. It appears in the few I checked that a short piece was bent into an L shape and only bolted to the band. Effectively useless as far as wind uplift resistance is concerned. Recommend have an engineer or a contractor who specializes in foundation repair review and advise.

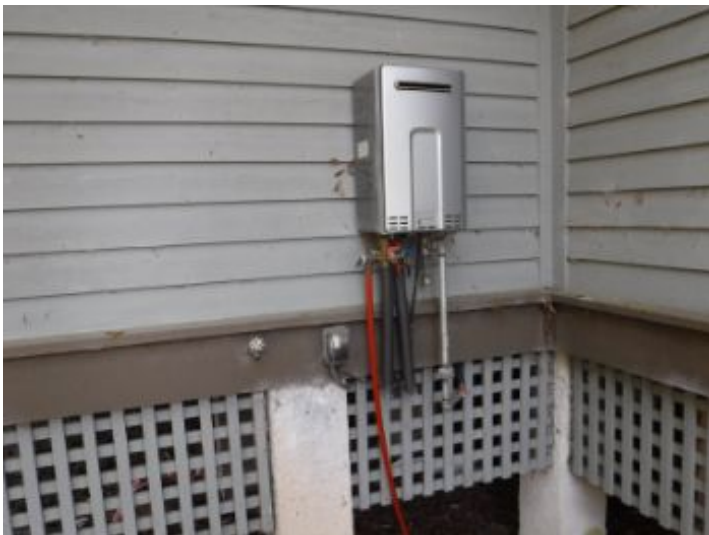
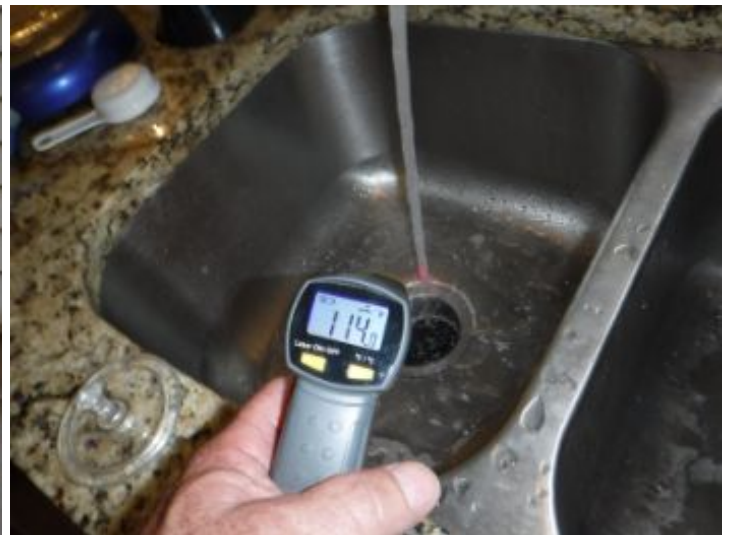
- Water Temp (reading)- The water temperature at faucet is reading 110-115 degrees which is considered hot.

Water Temp (reading)- The water temperature at faucet is reading 110-115 degrees which is considered hot.

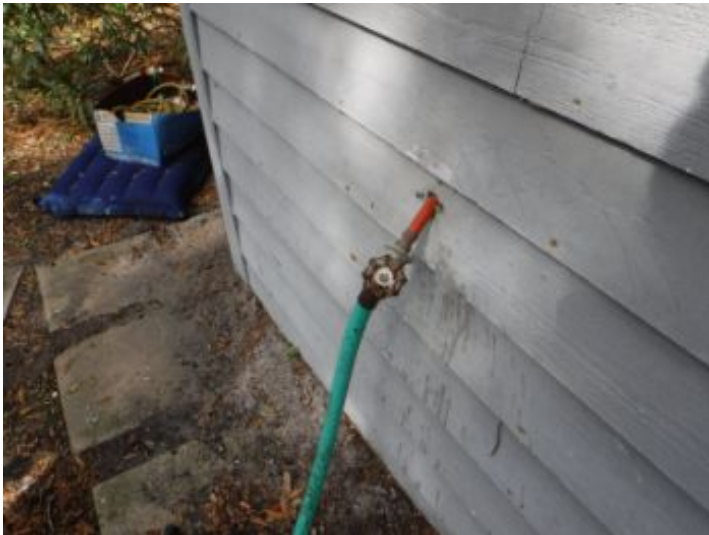
Hose bib (attachment)- Hose bib is not firmly attached. Repair as needed.

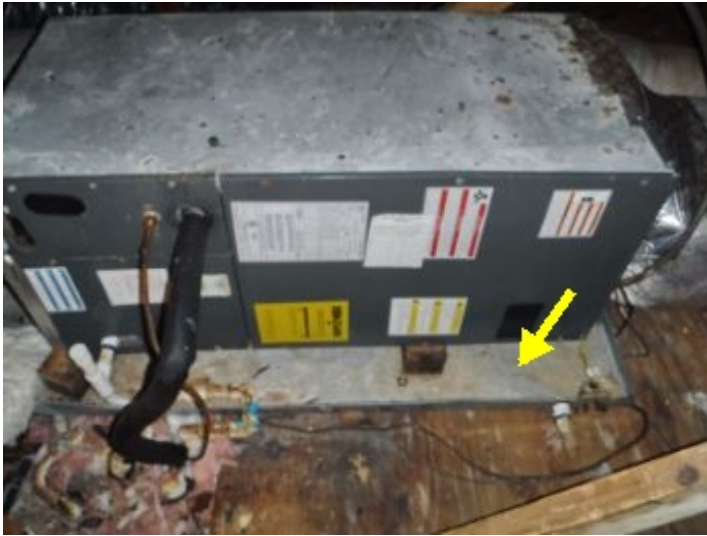
There was rust or efflorescence in the overflow drain pan. Normally the overflow pan should be empty and the presence of rust and efflorescence indicates that the primary pan was blocked at some point in time and overflowing into the secondary pan. Efflorescence is a type of white powdery salt left behind when water evaporates repeatedly. Recommend evaluation/improvements by a qualified HVAC contractor to make sure this does not happen again.

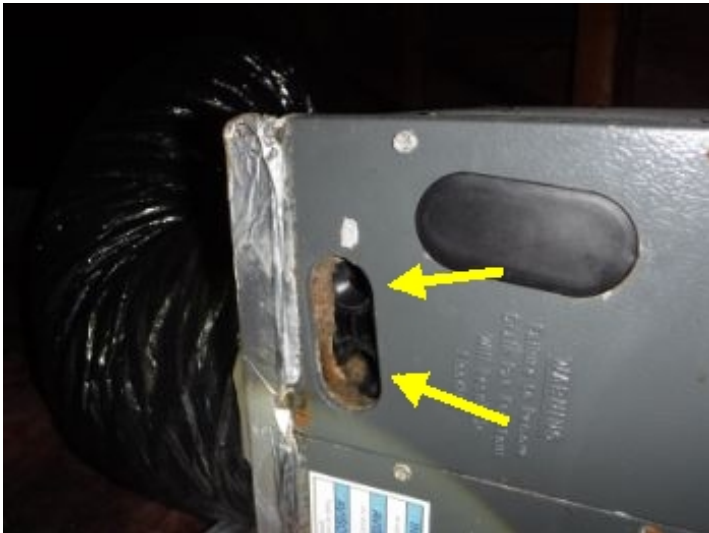
Pan Drain Line (absent) Pan drain line is absent or capped. This is allowed if an automatic (float switch) disconnect device is present. However should the primary drain line fail the overflow pan will be full of water which will be difficult to remove even if a capped fitting is present. Recommend that the pan drain be extended to the exterior of the home for optimum performance.

open ports allows air to escape; suggest adding plug

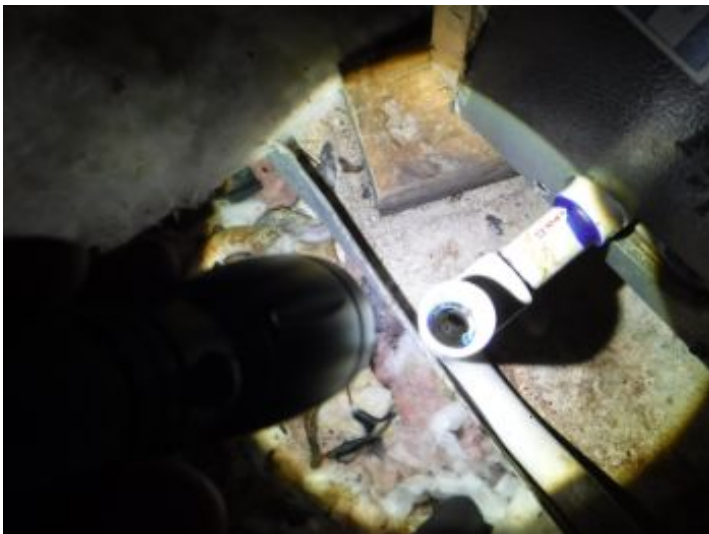
\*Gunk or other buildup noted in the condensate trap. When traps clog a backup will happen. Recommend cleaning.

trap with cap removed showing gunk in trap- clean

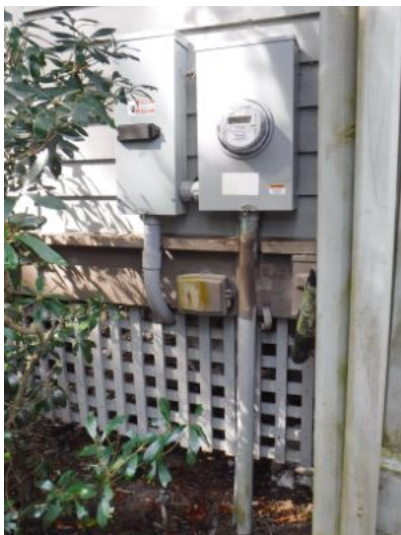
• Grounding clamp at the ground rod is loose. Repair as needed for safety. Grounding clamps must be torqued to specifications (good and tight).

Grounding clamp at the ground rod is loose. Repair as needed for safety. Grounding clamps must be torqued to specifications (good and tight) and driven flush to grade.

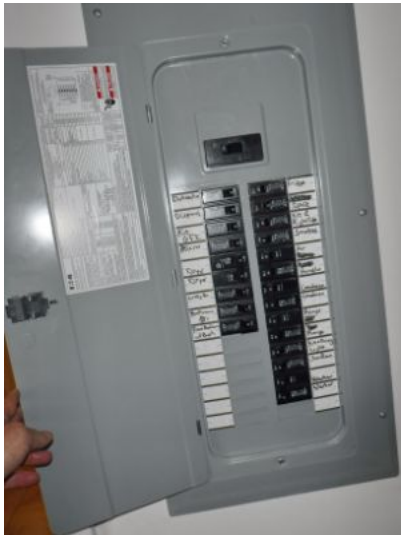
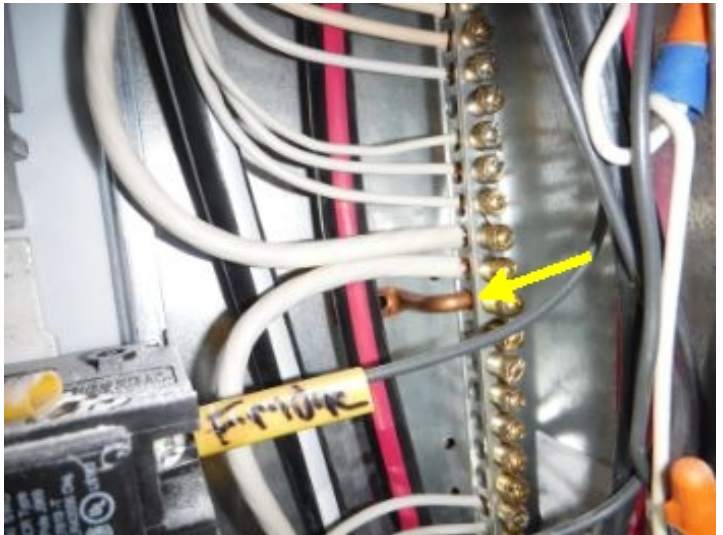
- More Information- For more information about bonding and grounding go to <http://www.summerville-home-inspector.com/content/what-difference-between-grounding-and-bonding>.
- It appears that the neutral terminal is connected (bonded) to the grounding terminal in the subpanel by a neutral wire/grounding bar. This is incorrect. The bonding takes place in the first, and only the first, means of disconnecting. This is where the GEC (ground rod) is tied in to. The ground and neutral are separate systems from that point on. Have a qualified electrician correct.

It appears that the neutral terminal is connected (bonded) to the grounding terminal in the subpanel by a neutral wire/grounding bar. This is incorrect. The bonding takes place in the first, and only the first, means of disconnecting. This is where the GEC (ground rod) is tied in to. The ground and neutral are separate systems from that point on. Have a qualified electrician correct.

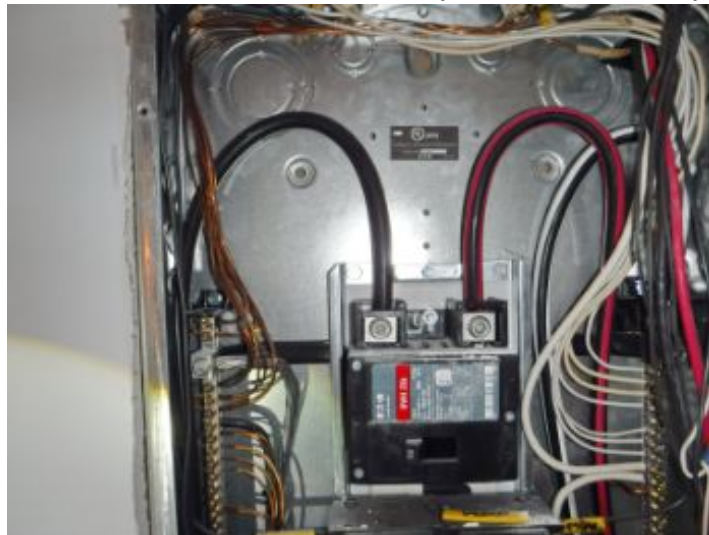
It appears that the neutral terminal is connected (bonded) to the grounding terminal in the subpanel by a neutral wire/grounding bar. This is incorrect. The bonding takes place in the first, and only the first, means of disconnecting. This is where the GEC (ground rod) is tied in to. The ground and neutral are separate systems from that point on. Have a qualified electrician correct.

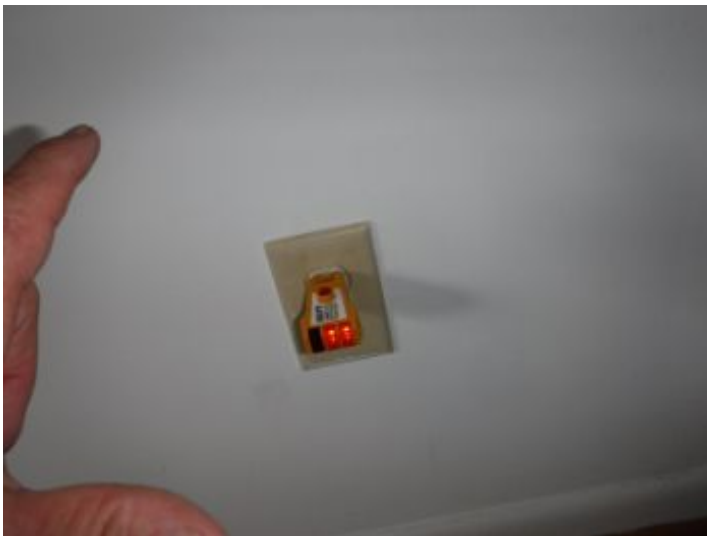
\*Outlets- An electrical outlet/s as pictured showed an - loosely mounted in box - condition. Repair as needed. More than several noted.

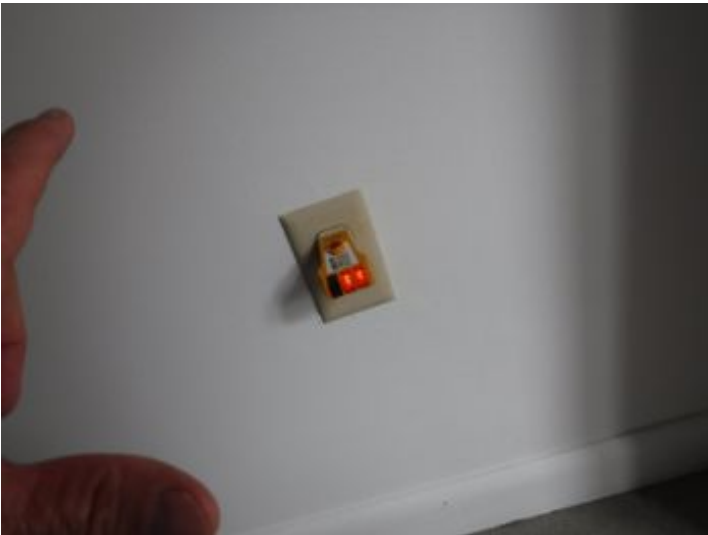
\*Outlets- An electrical outlet/s as pictured showed an - hot, neutral reversed (reversed polarity) - condition. Repair as needed.

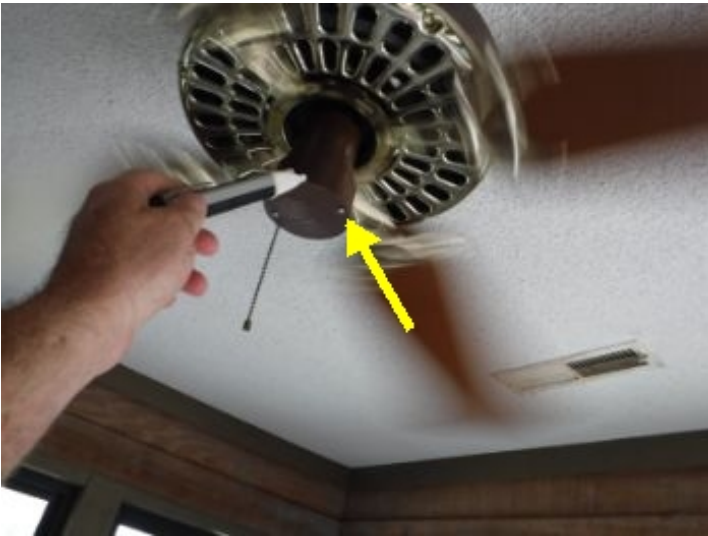
\*Outlets- An electrical outlet/s as pictured showed an - loose connection - condition. Repair as needed.

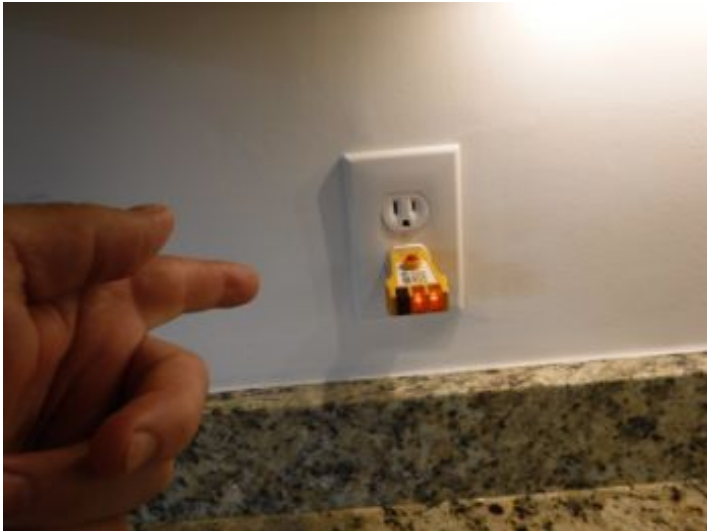
Not Protected kitchen- Some kitchen receptacles did not test positive for GFI protection. Modern rules specify all receptacles serving kitchen counters be GFI protected. Recommend improve for safety.

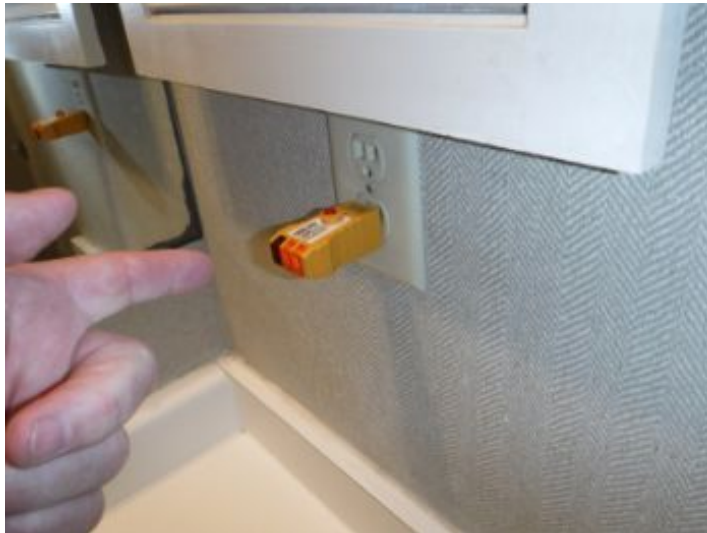
Not Protected- The bathroom receptacles did not test positive for GFI protection. Recommend improve for safety.

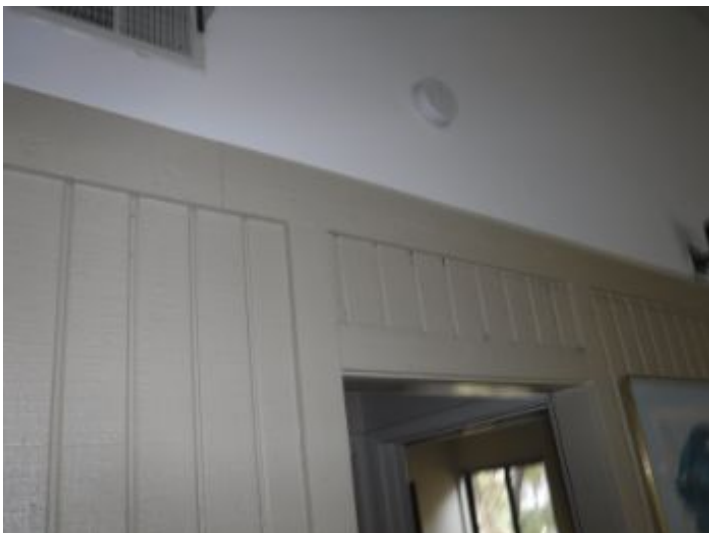
Testing (device failed)- Note at least one smoke/CO detector failed. (pictured) Probable battery issue. Repair as needed.

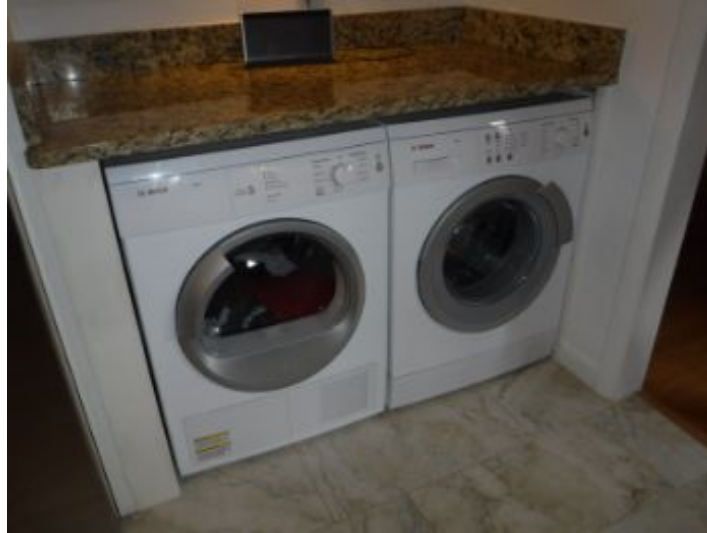
- Not Tested- The washer and dryer was not evaluated for function.

connection box and standpipes were not observable

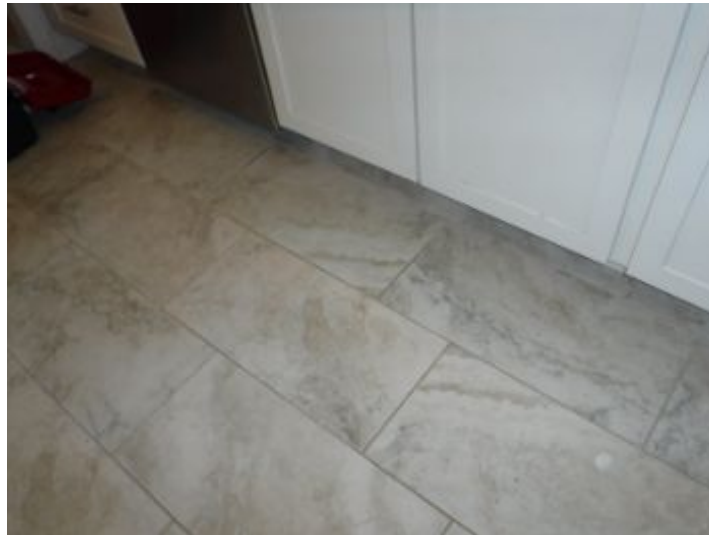
- Spongy at pictured location- possible loose adhesion due to past or present leak. Suggest further investigation.

Spongy at pictured location- possible loose adhesion due to past or present leak. Suggest further investigation.

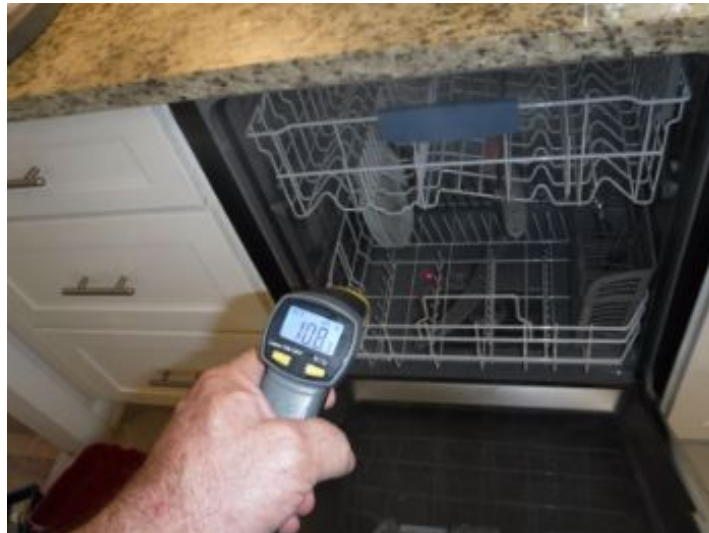
Tested (passed)- Tested and seemed to work satisfactorily.

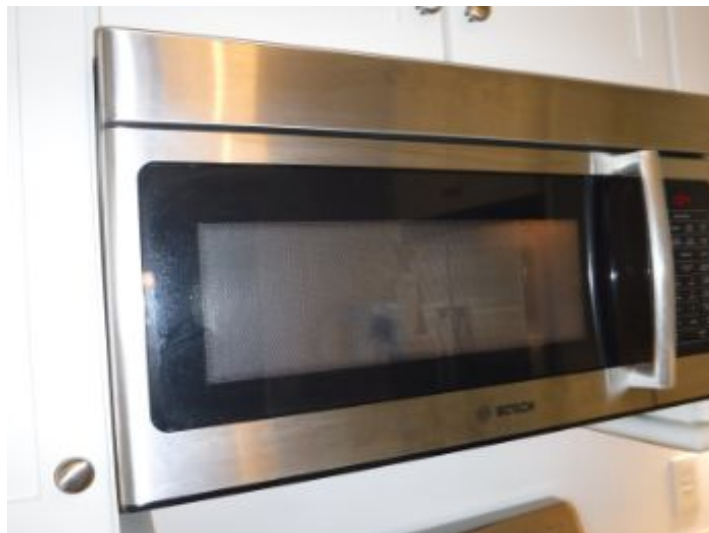
OK- Heating function- Microwave properly heated a cup of water when activated.

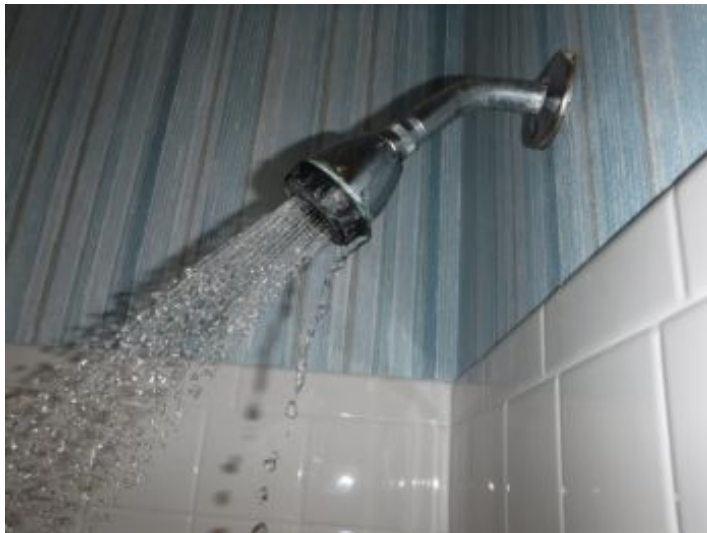
Shower Head (leaks)- Shower head leaks. Needs to be tightened.
