# ***Blue Palmetto Home Inspection***

## **Property Inspection Report**

Home Sweet Home

111 Dream street, Dream City, SC 29485

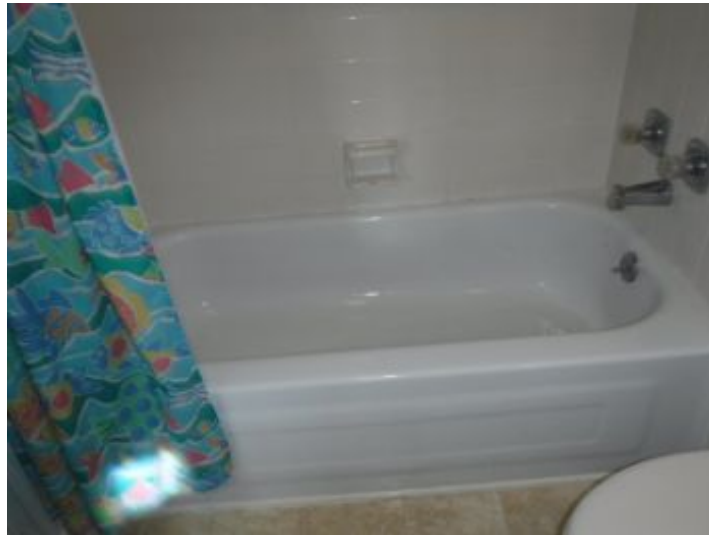
Faucet (leaks)- Faucet handle leaks while operating. Recommend contacting a licensed plumber to repair.

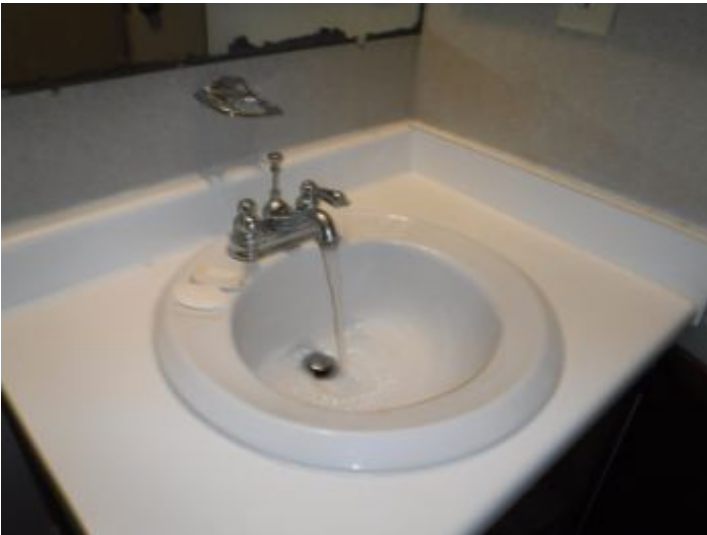
Stopper (adjustment)- Stopper needs slight adjustment.

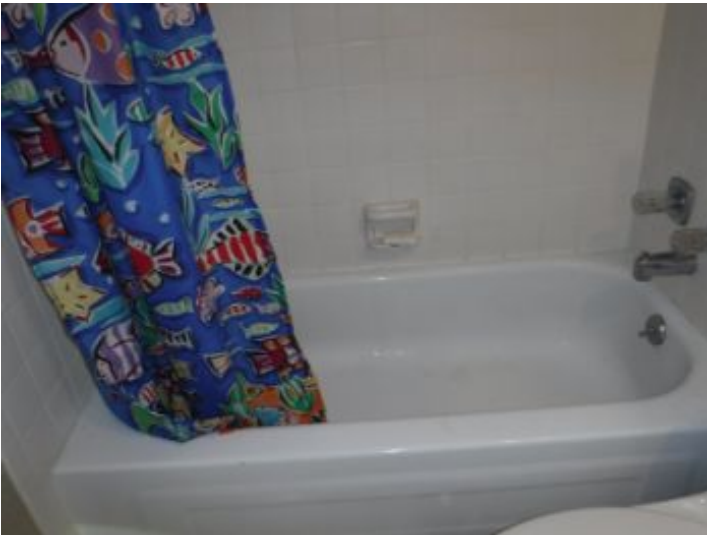
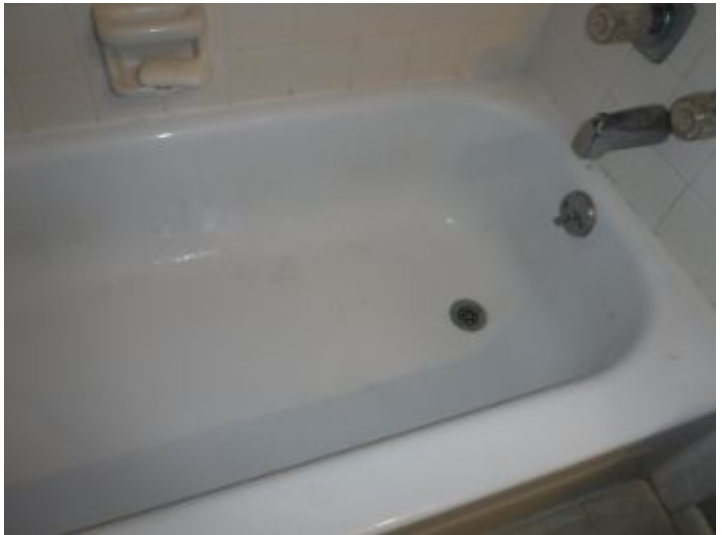
- Ceramic coated metal tub noted.
- Minor chips noted in finish. Chips and scratches can be refinished by a professional. (Recommended)

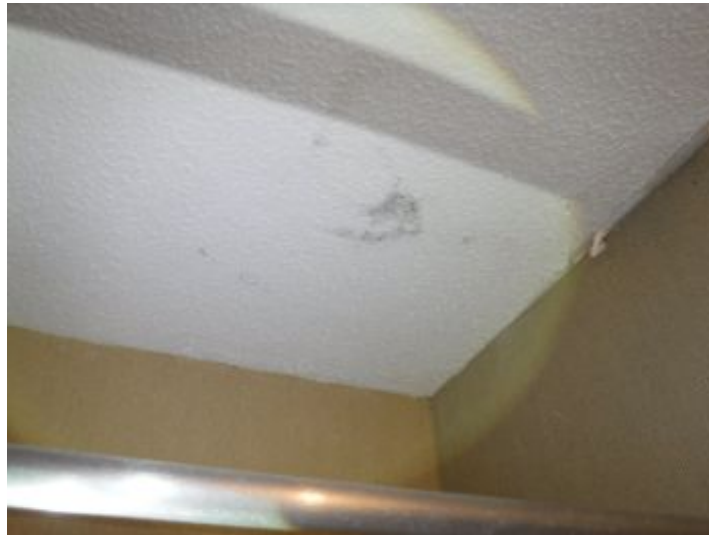
Stain on ceiling at pictured location. Further investigation required. Possible past vent stack leak or high humidity over tub.

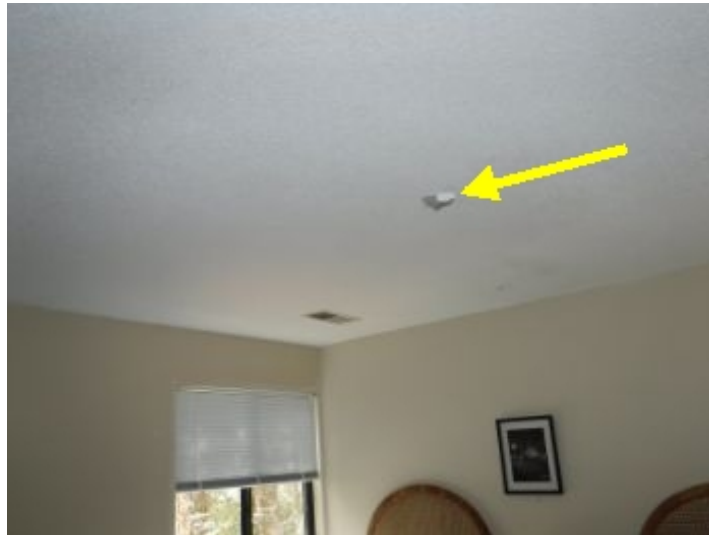
Textured Ceiling- Textured ceiling is coming down in places. Often this is due to excessive moisture or high humidity on either side of the sheetrock. Usually it is very difficult to repair this by blowing more texture because it will not stick well. Suggest removal of the loose texture and painting the ceiling or priming and then blowing more texture at the affected spots.

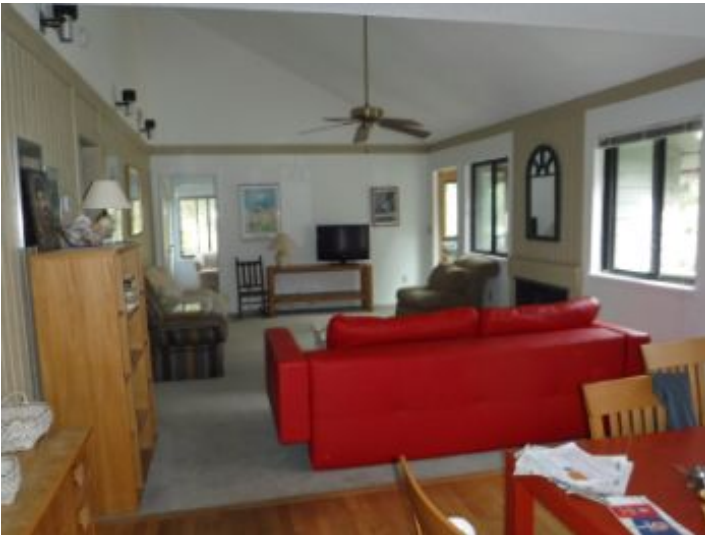
Floor felt spongy here- probably improper subfloor attachment

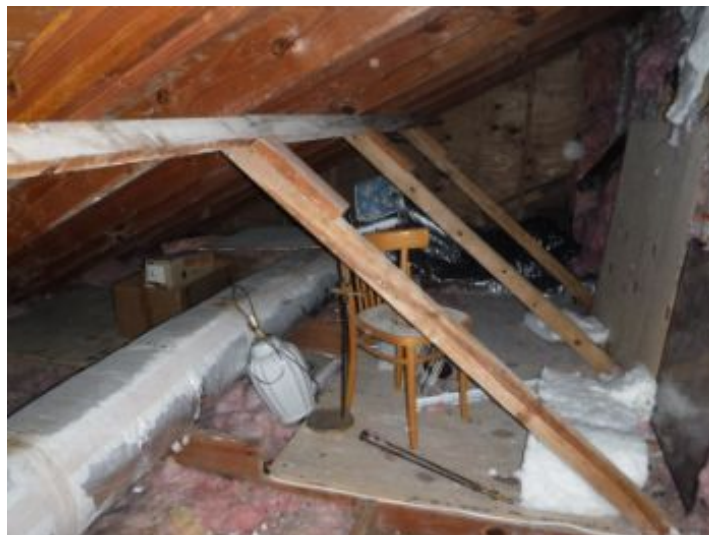
- Inspection Restriction (insulation)- Limited view and access of components due to deep insulation.
- Inspection Restriction (areas)- Some attic areas were not accessible.
- Recommend Improve (access)- Recommend adding access to all attic areas. An access is required whenever there is 30" of clear headroom in that area.

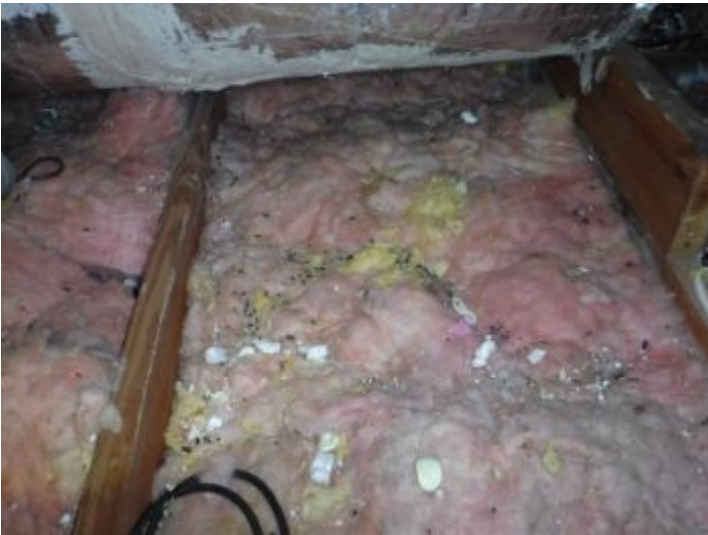
Rodents- Evidence of rodent entry into attic observed. Some insulation was noted with rodent feces on it. These should be replaced and attic should be reviewed for possible entry points.

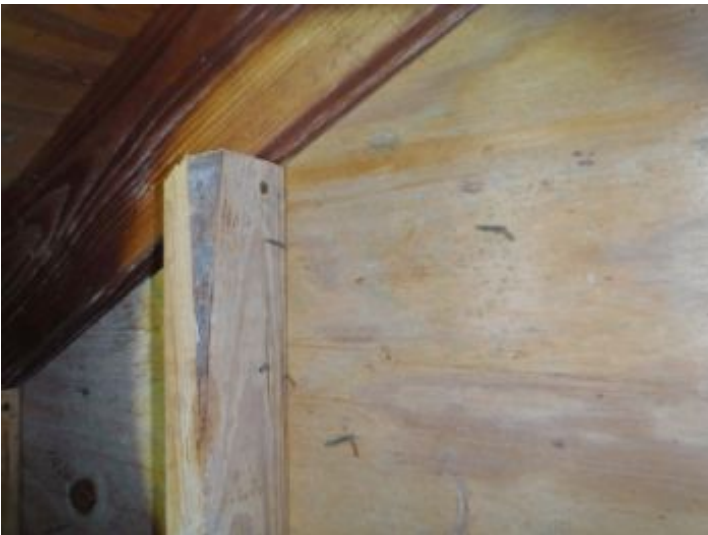
Microbial Growth- Some microbial growth observed on some framing components in the attic. Some areas are pictured. Although generally it was a modest amount it was not insignificant. Recommend improve attic ventilation. Some remediation is suggested (removal and treatment) especially if sensitive individuals.

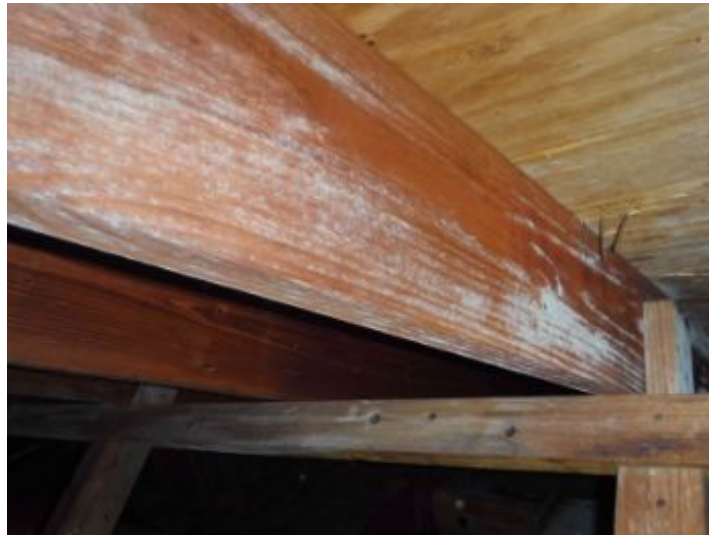
Microbial Growth- Some microbial growth observed on some framing components in the attic. Some areas are pictured. Although generally it was a modest amount it was not insignificant. Recommend improve attic ventilation. Some remediation is suggested (removal and treatment) especially if sensitive individuals.

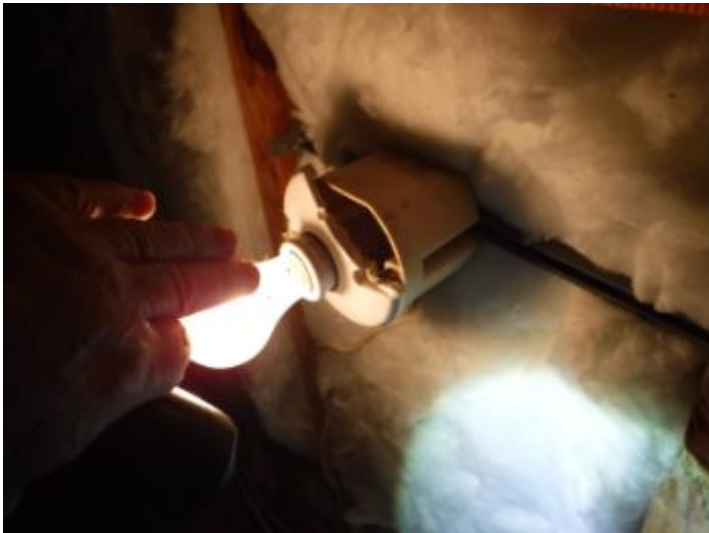
broken fixture needs replacement

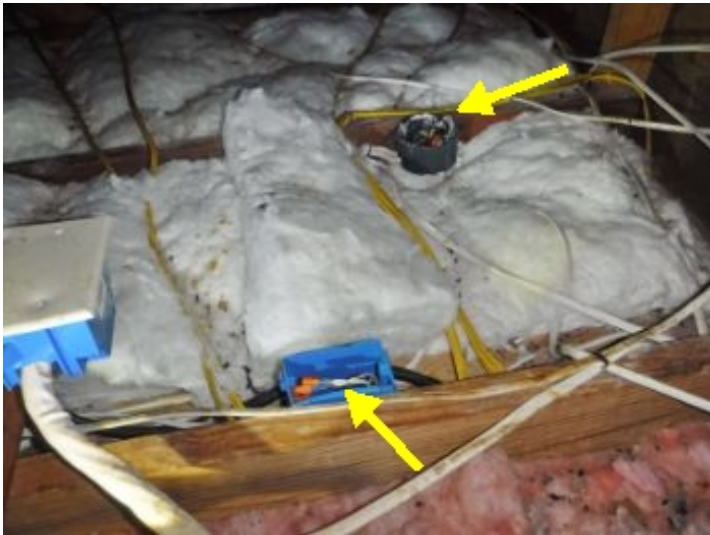
J Box Covers- Noted more than several junction boxes without a suitable cover, which is a safety concern. Some are pictured. Recommend installing proper covers, as needed, for safety. In addition boxes need to be properly attached to framing as required. Recommend repair all as needed.

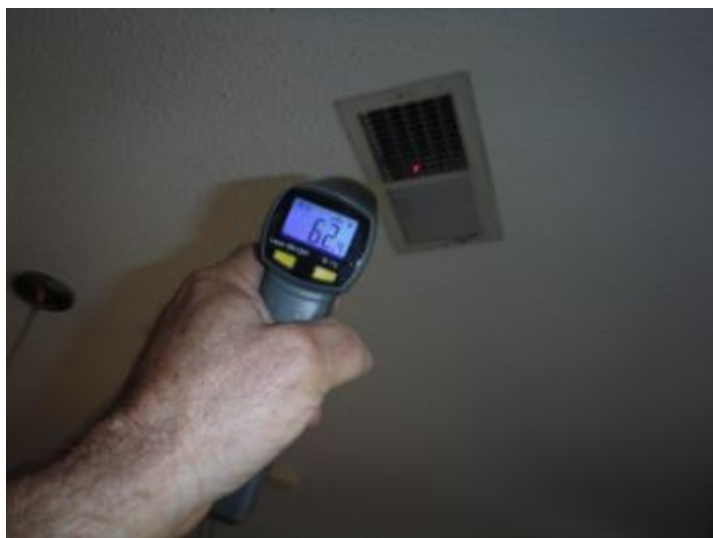
ok- AC on 62°

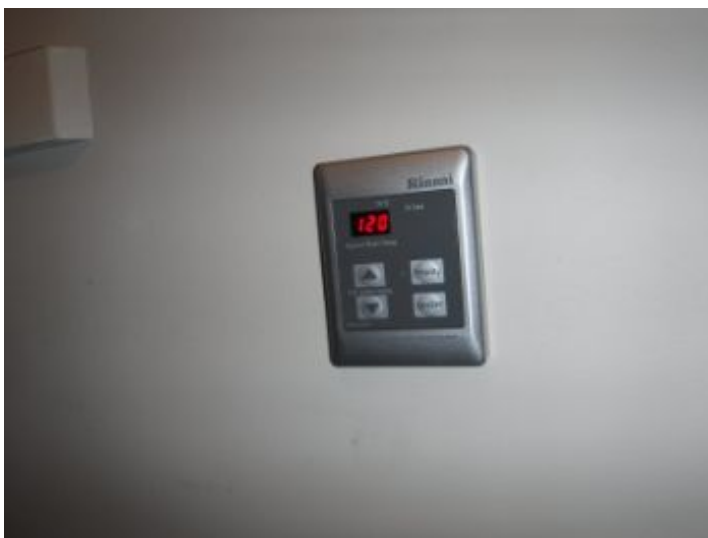
water heater adjustment

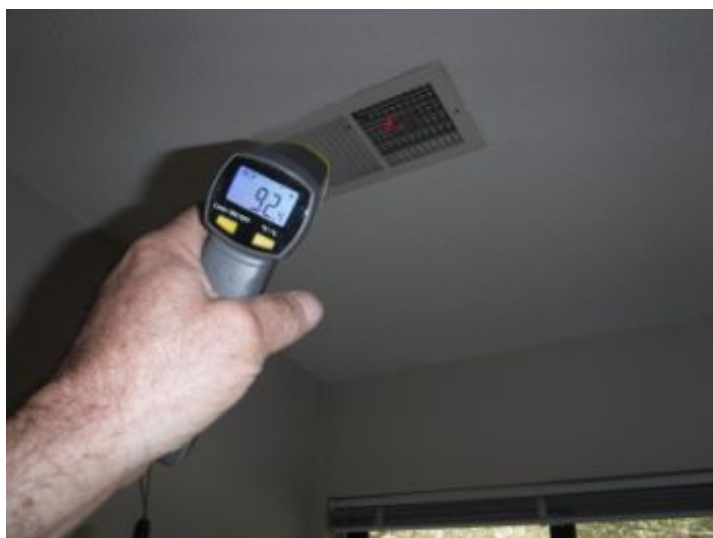
ok- heat on 92°

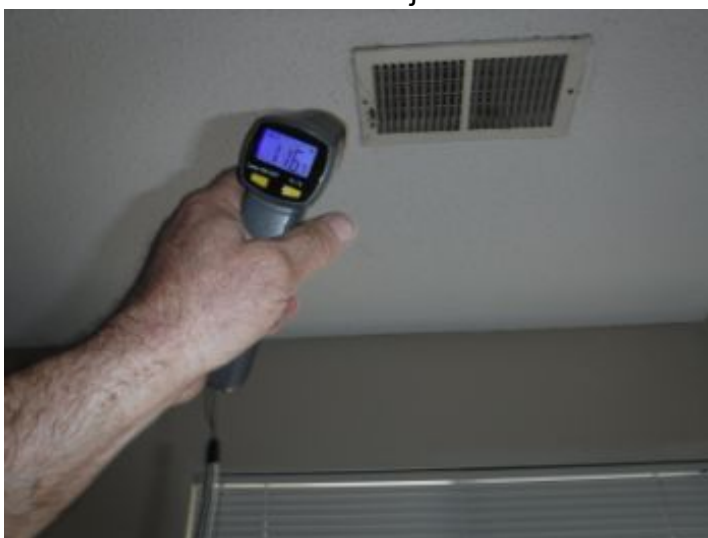
ok- heat on 116°
