## HMAS Sydney II Commission of Inquiry

### Report on Technical Aspects of the Sinking of HMAS *Sydney* and HSK *Kormoran*

DSTO-GD-0559

This report describes the technical findings of the battle and sinking of HMAS Sydney and HSK Kormoran based on historical and archeological evidence. The battle occurred on the 19<sup>th</sup> of November, 1941 off the West Australian coast. The wrecks of the two ships were discovered in March 2008 and their subsequent underwater exploration has shed light on the events that took place during and after the battle.

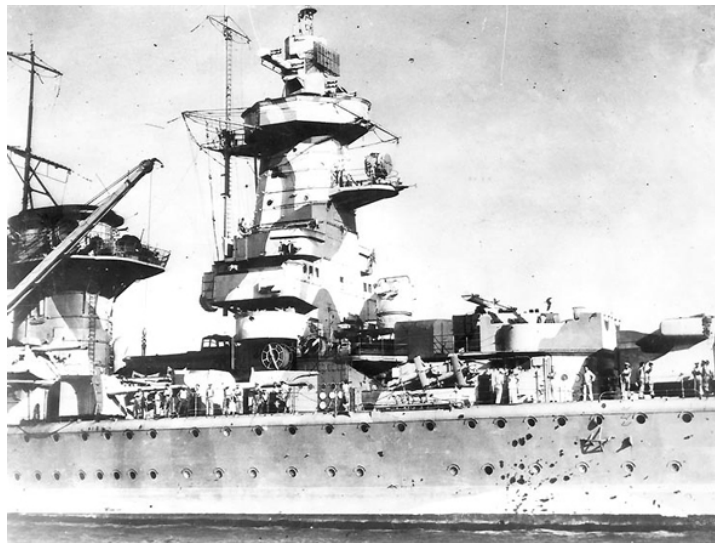
The German pocket battleship *Admiral Graf Spee* (Figure 11 to Figure 13) was involved in the Battle of the River Plate in December 1939. The damaged ship withdrew to Montevideo. Three days later, the ship was taken out of harbour and scuttled in shallow water. The scuttling charges caused a large fire on the ship [28].

Figure 11: Bridge structure of Admiral Graf Spee following the Battle of the River Plate [29]

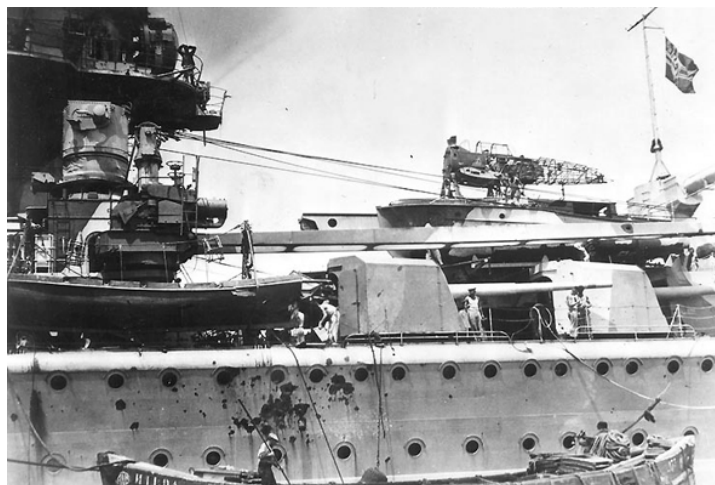
Figure 12: Burnt aircraft on Admiral Graf Spee, after the Battle of the River Plate [29]

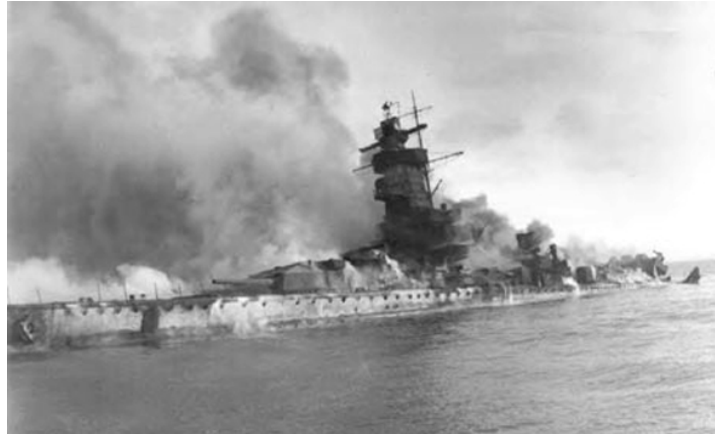
*Figure 13: The Admiral Graf Spee burning after scuttling charges had been detonated [30]*

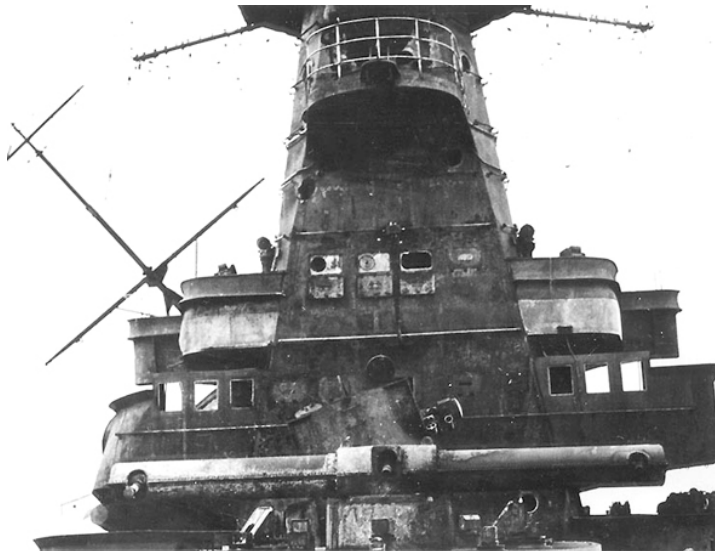
*Figure 14: Bridge structure of Admiral Graf Spee following the fire [29]*

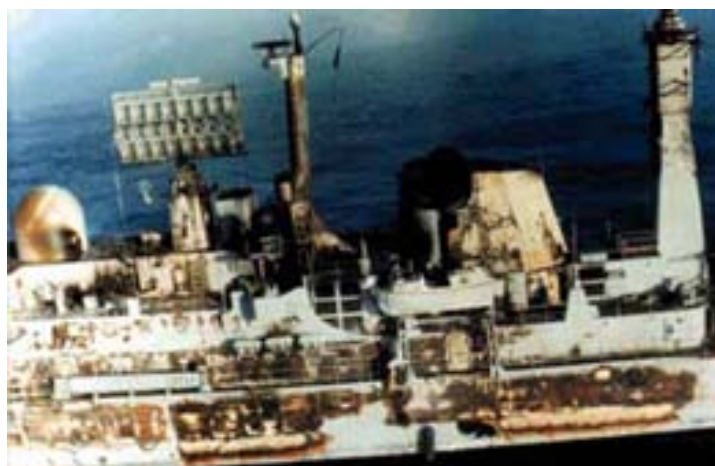
HMS *Sheffield* (Figure 15 and Figure 16), a destroyer, was hit by a missile on 4 May 1982 during the Falklands War. A large fire was started and could not be brought under control, forcing the crew to abandon ship [31].

Figure 16: Fire damage to *Sheffield* [33]

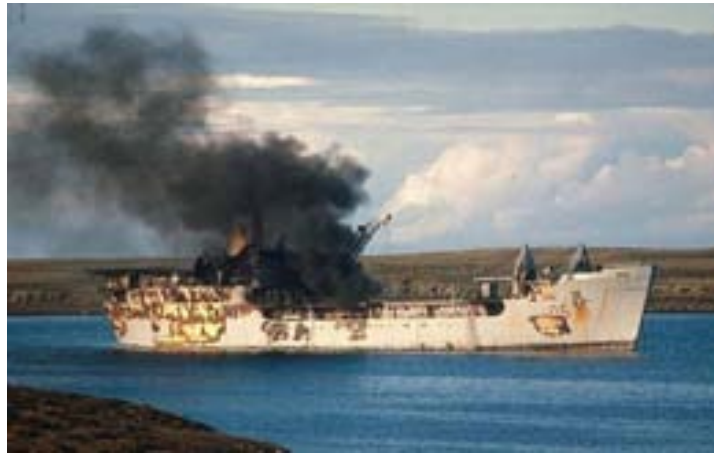
R.F.A. *Sir Galahad* was hit by bombs dropped from aircraft on 8 June 1982, during the Falklands War. This started a large fire, and the crew abandoned the ship [34]. The exterior damage to the ship can be seen in Figure 17.

Figure 17: Fire damage to Sir Galahad [35]

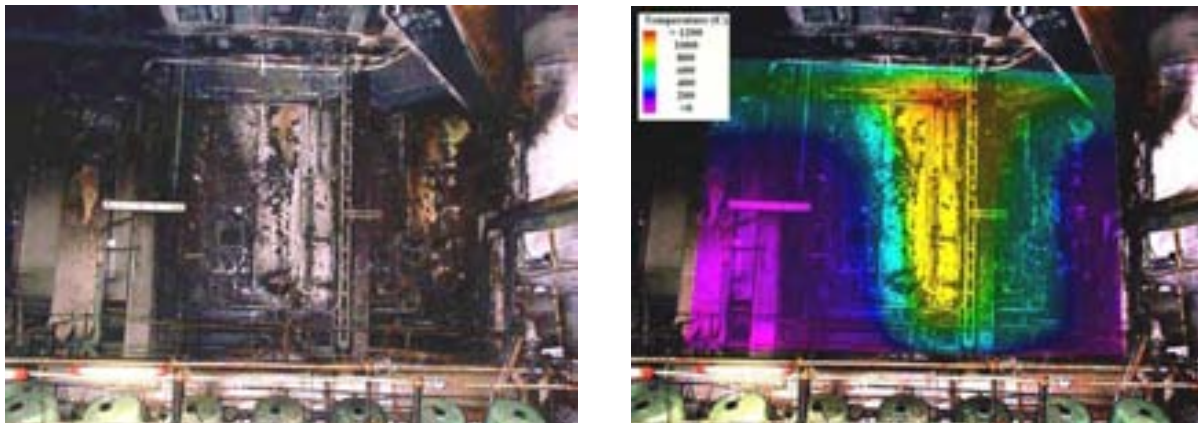
A fire in the engine room of HMAS *Westralia* caused by diesel leaking from a fuel line on an engine occurred on 5 May 1998. The spray fire impinged against a bulkhead adjacent to the engine, causing damage to paint and materials attached to it. A computer-based fire simulation was carried out, and the results matched the damage observed [36], this is illustrated in Figure 18.

Figure 18: Damage to a bulkhead adjacent fire and fire simulation results overlaid on the damage

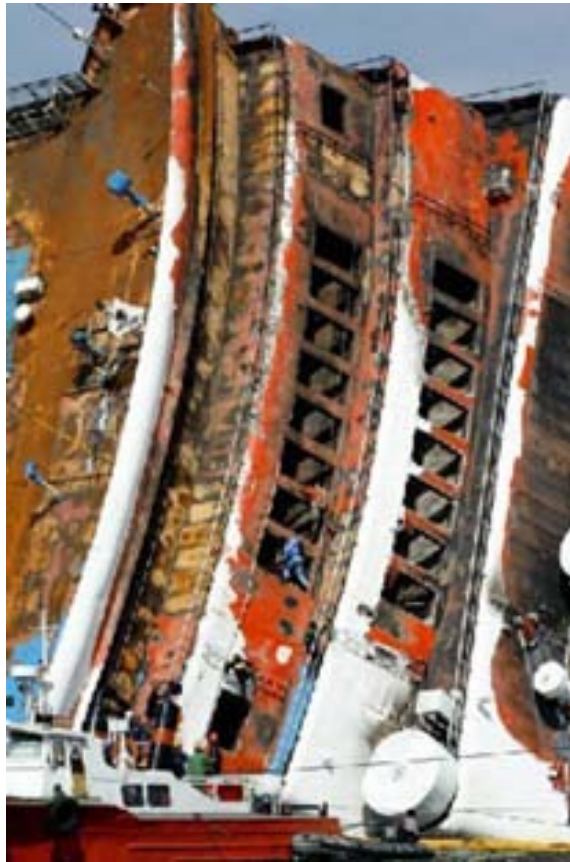
A terrorist bomb exploded on *Superferry 14* in February 2004, igniting a fire [37]. Photographs after the fire, as displayed in Figure 19, show the damage to the ship [38]. Paint can be seen burnt through to the undercoat and the steel structure in places.

Figure 19: Fire damage to Superferry 14 [38]

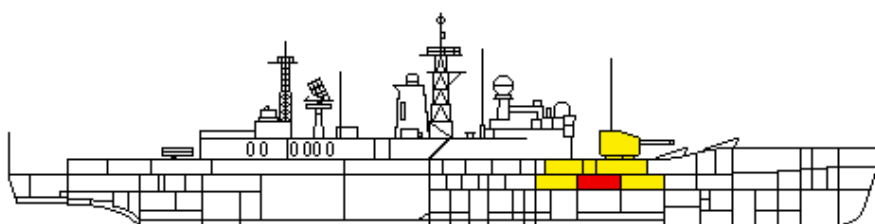
A series of experiments were undertaken on the Ex HMAS *Derwent* in 1994 [41], including fire and smoke experiments, Figure 20. A fire designed to simulate a fire after a missile hit was set in a large sleeping space, Figure 21, and spread to neighbouring compartments. The ship was tied at the bow, and able to pivot with the wind, which was therefore along the line of the ship. The smoke from the fire moved through openings in the ship to the upper decks, and along the ship with the wind. The obscuration of the ship's structure shown in Figure 22 is an indication of the thickness of the smoke.

Figure 21: Fire originated in red compartment, and spread to yellow compartments

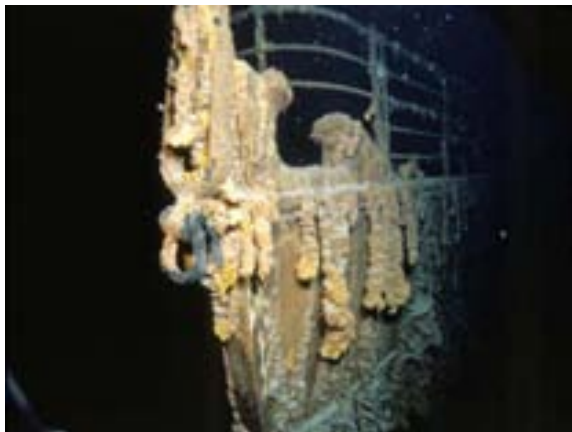
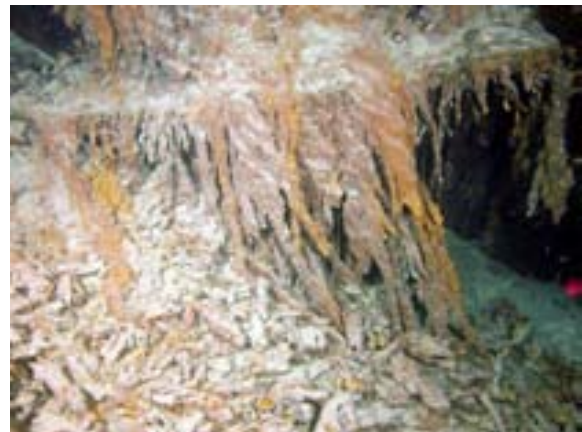
'Rusticles' removed from RMS *Titanic* contain bacteria which consume components of the steel structure (the ship is deteriorating through physical and biological effects) [54]. Table 5 provides a comparison of the presence of rusticles in other ships lost in about the same time period as *Sydney* together with the condition of the *Titanic* which was lost 30 years earlier. Images of rusticles on *Titanic* are shown in Figure 27.

Figure 27: Rusticle formations on Titanic [57]

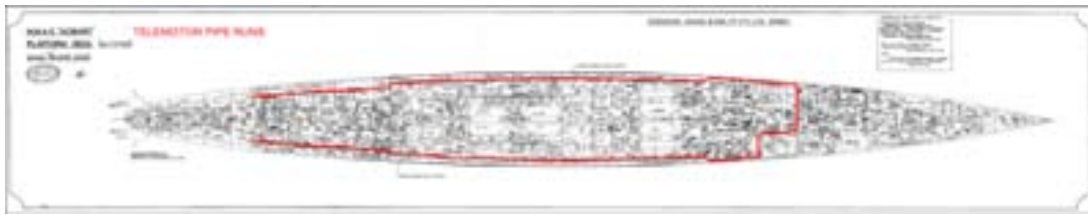
Figure 50: HMAS Hobart's run of telemotor pipes

The actual run of the telemotor pipes in *Sydney* is not known, although the information is available for her sister-ship, *HMAS Hobart*. The ships were built by different shipbuilders, so whilst the arrangement in each was likely to be similar, it might not have been identical. In *HMAS Hobart* (see Figure 50) the port pair of pipes was led out to the port side, probably supported by pipe hangers directly under the Lower Deck (the deck above the Lower Steering Position). There the pipes ran aft close to the ship's side until about frame 86, the forward bulkhead of the forward Boiler Room, where they were led inboard of the cable passage at the ship's side. The starboard pair of pipes was similarly run, although for a shorter length directly at the ship's side [89].

If the pipes in *Sydney* were run in the same manner, the telemotor pipes would have been extremely vulnerable to shell fire between the Lower Steering Position and the forward Boiler Room bulkhead, being unprotected by armour and close to the ship's side. From the forward bulkhead of the forward Boiler Room to the after bulkhead of the aft Engine Room the pipes were protected by the side armour, and further aft the location of the pipes a short distance inboard from the side of the ship would have given some protection.

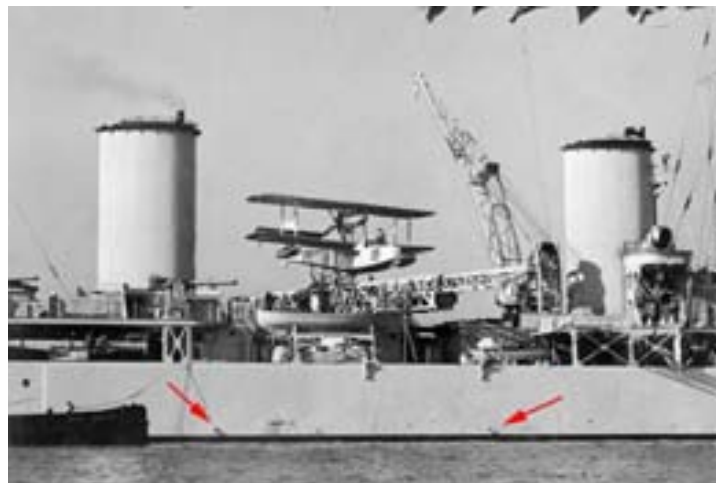
Compartments above the waterline were fitted with drains which discharged over the ship's side. upper deck scuppers were also fitted to help clear the upper decks of water. All these drains terminated above the waterline and, along with soil and waste pipes from galleys, heads and washplaces, were fitted with storm valves (screw-down non-return valves) to prevent back-flow of sea water. Even the ship's side armour was penetrated by these discharges, as shown in Figure 52.

Figure 52: The arrows indicate upper-Deck scupper discharges on Sydney which have been fitted through the ship's side armour [97].

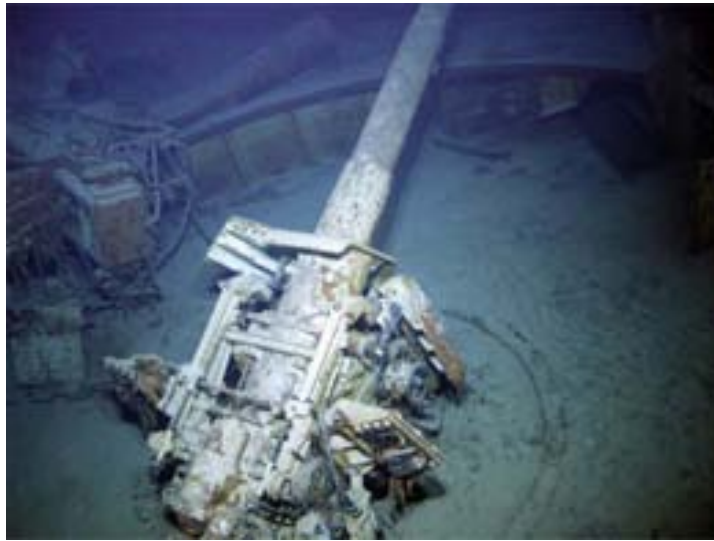
Figure 98: *Kormoran's* No. 3 15 cm gun in hold [158]

The following describes the guns and camouflaging that can be seen in the footage of *Kormoran*. Figure 98 shows *Kormoran*'s No.3 gun.

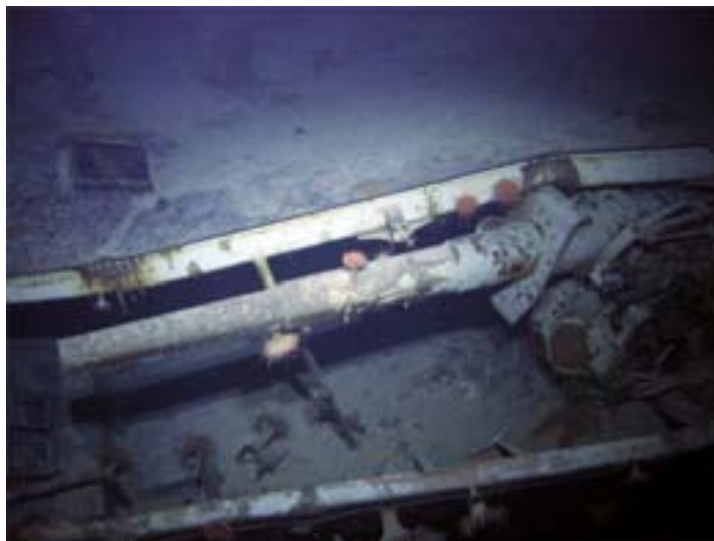
Figure 99: *Kormoran's* No.2 15 cm gun forward port side [160]

Figure 99 shows that the Forecastle deck has collapsed onto *Kormoran's* No.2 gun, most likely due to damage from the collapse of the masts and/or the sinking process, but there are no signs of weapon damage from *Sydney* shells.

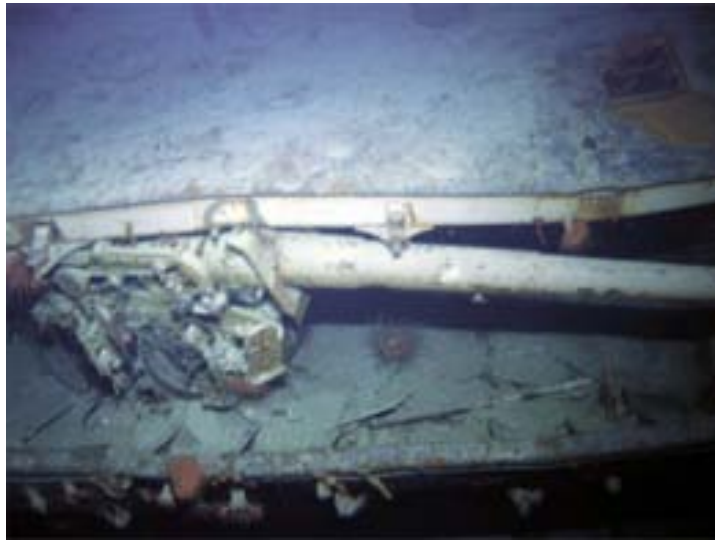
Figure 100: *Kormoran's* No.1 15 cm gun forward starboard side [161]

Figure 100 shows that the Forecastle deck has collapsed onto *Kormoran's* No.1 gun, most likely due to damage from the collapse of the masts and/or the sinking process, but there are no signs of weapon damage from *Sydney* shells. The hinges for the camouflaging plates can be identified on the Forecastle deck.

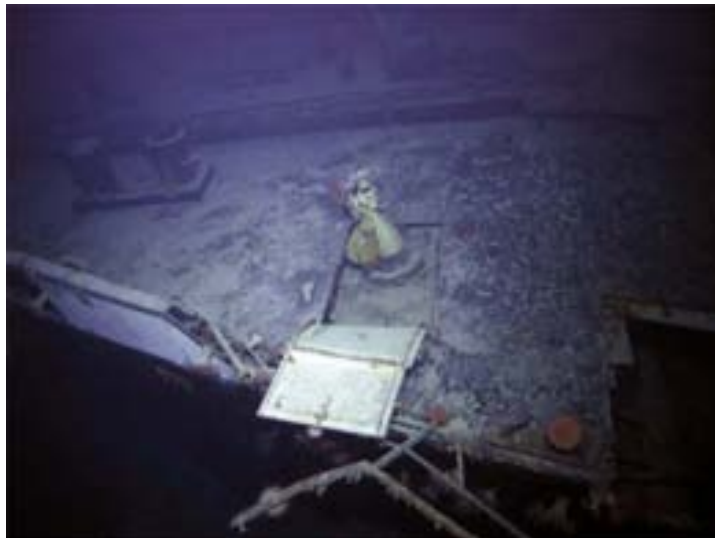
Figure 101: *Kormoran's* 2 cm gun forward port side [162]

Figure 101 shows the forward port side 2 cm gun, with the camouflaging cover open next to it.

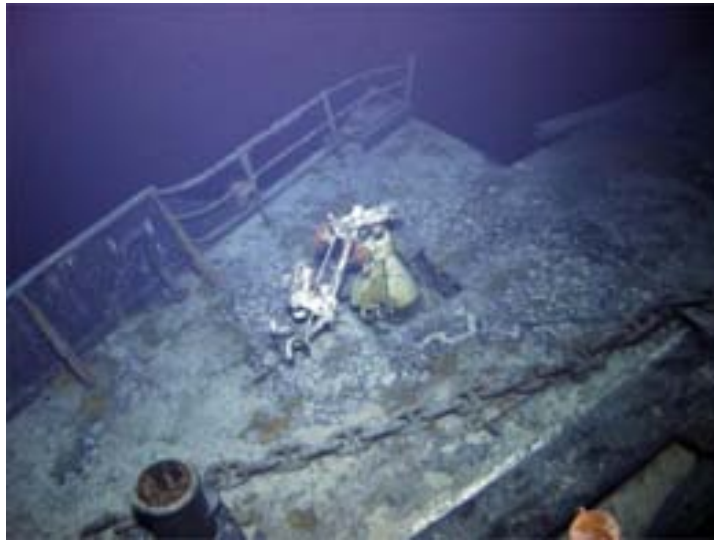
*Figure 102: Kormoran's 2 cm forward starboard gun [163]*

Figure 102 shows the forward starboard 2 cm gun. The figure shows the gun platform is separate from the deck allowing for the gun to be raised from below the deck.

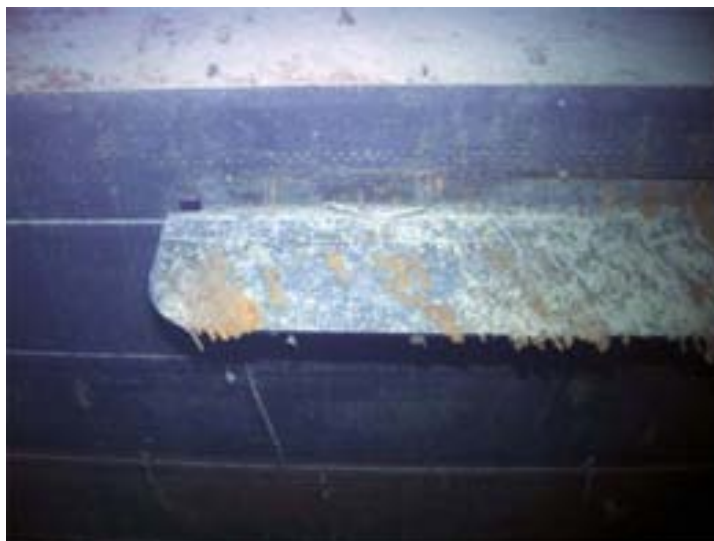
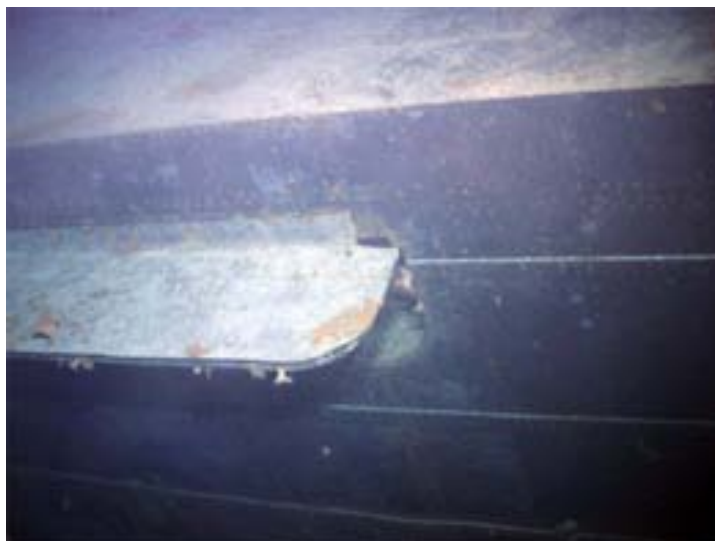
*Figure 103: Above water torpedo flap starboard side [164]*

*Figure 104: Above water torpedo flap port side [165]*

Figure 103 and Figure 104 show the flaps used to camouflage the starboard and port side above water torpedo tubes. Unfortunately the ROV was unable to view into the space below the flap to observe the torpedo tubes.

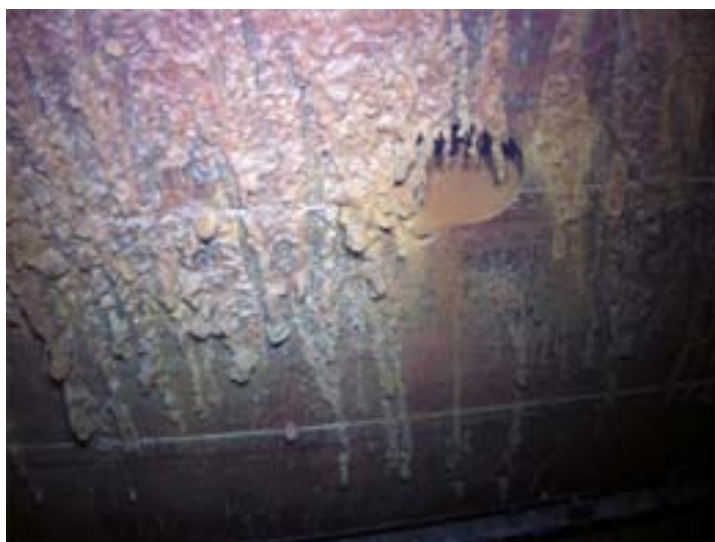
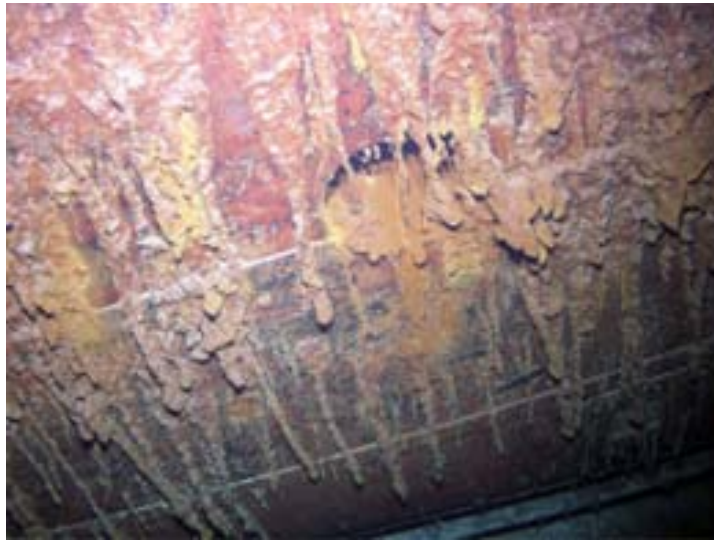
*Figure 105: Below water torpedo tube starboard side [166]*

Figure 106: Below water torpedo tube port side [167]

Figure 105 and Figure 106 have been identified as the underwater torpedo firing tubes.

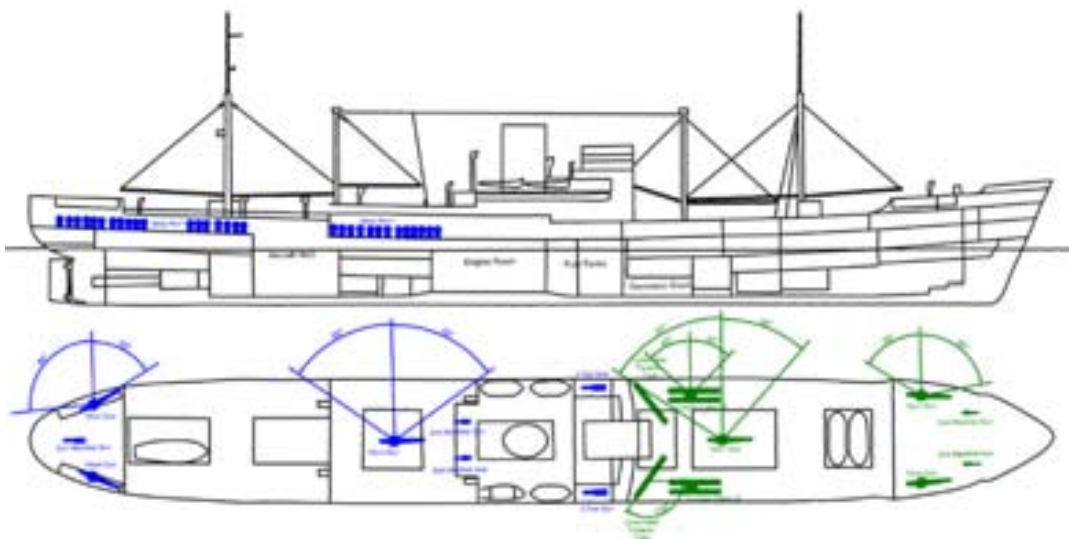
The weapon mountings and locations that are identifiable on the bow section of *Kormoran*, match those provided by the drawing of *Kormoran* [159] and highlighted in green in Figure 107. The other weapons cannot be identified due to the wreckage of the aft section of *Kormoran*.

Figure 107: Weapons identified within the wreckage are marked as green and match those presented in reference material [148].

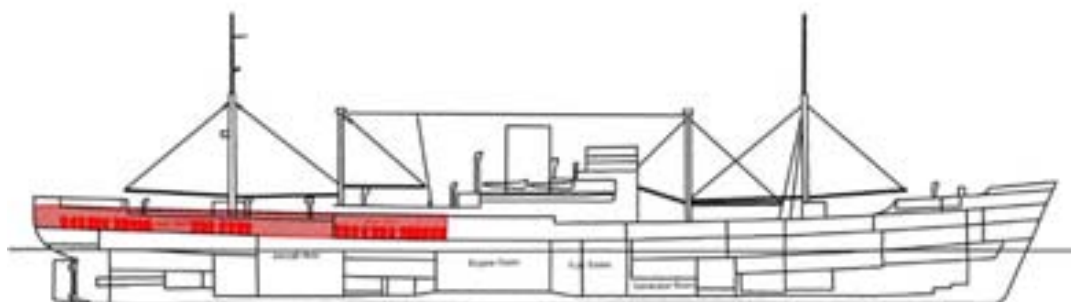
*Kormoran's* greatest vulnerability to an HE shell was the large stowage of mines which the ship could carry. *Kormoran* could stow 360 EMC mines each having an explosive weight of 290 kg (as shown in Figure 108), and these were stored above the waterline in a large compartment space extending along most of the aft structure (as shown in Figure 109). The location of these mines above the waterline made *Kormoran* vulnerable.

Figure 109: The stowage of mines extended for a large section of the aft end of *Kormoran*. The stowage area is exposed to any HE shells due to the section being above the waterline.

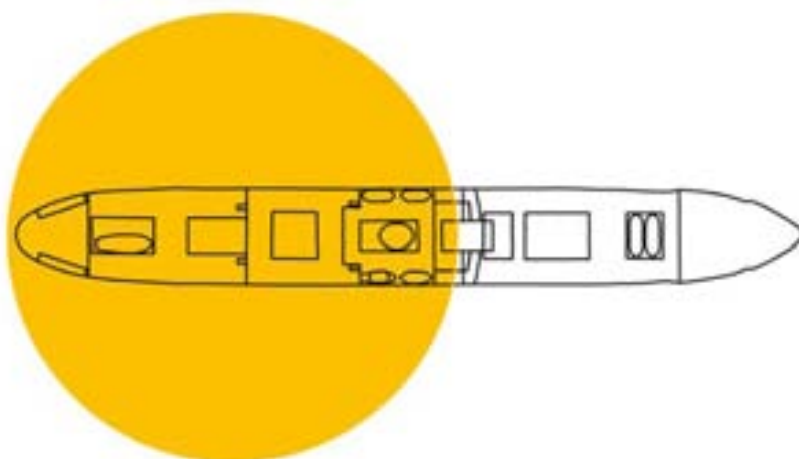
Detonation of one of these mines would result in a mass detonation of over 100 tonnes of explosive in this area and totally destroy the rear of the ship. Figure 110 illustrates the extent of the damage as predicted using XVAM.

*Figure 110: Extent of damage resulting from mass detonation of mines*

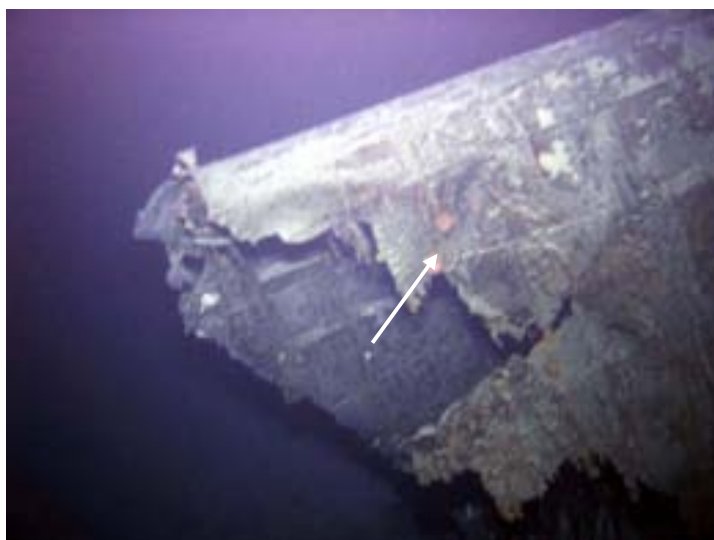
Damage close to the port side of the bow's keel shows the typical concave indentation of an explosion on this surface consistent with torpedo damage (see Figure 114). This damage indicates that *Sydney* was hit by a torpedo on the port side. As the hole edge is at frame 19, the detonation occurred aft of this frame, at a frame between frame 19 and frame 30. The probable detonation location from the evidence would be in the vicinity of Frame 25, around the Type 125 Sonar Dome (as shown in Figure 115 and Figure 116).

Figure 114: Break in bow on Port side showing indentation due to torpedo detonation [172]

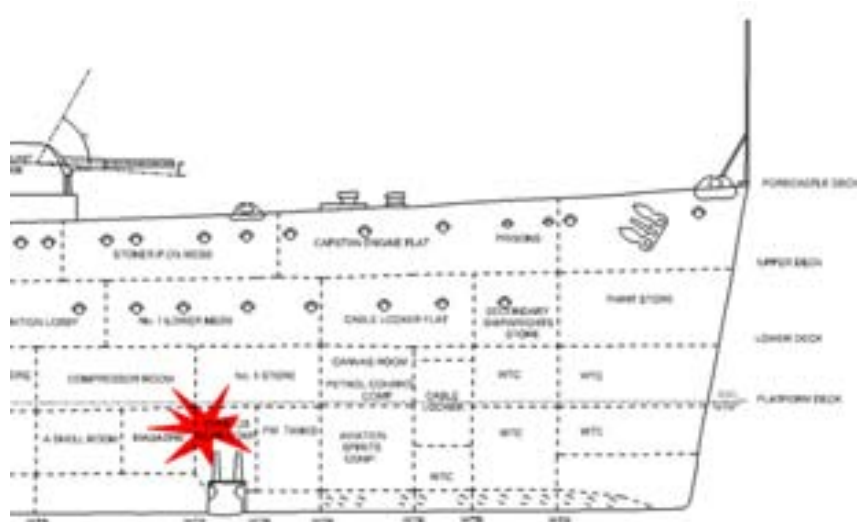
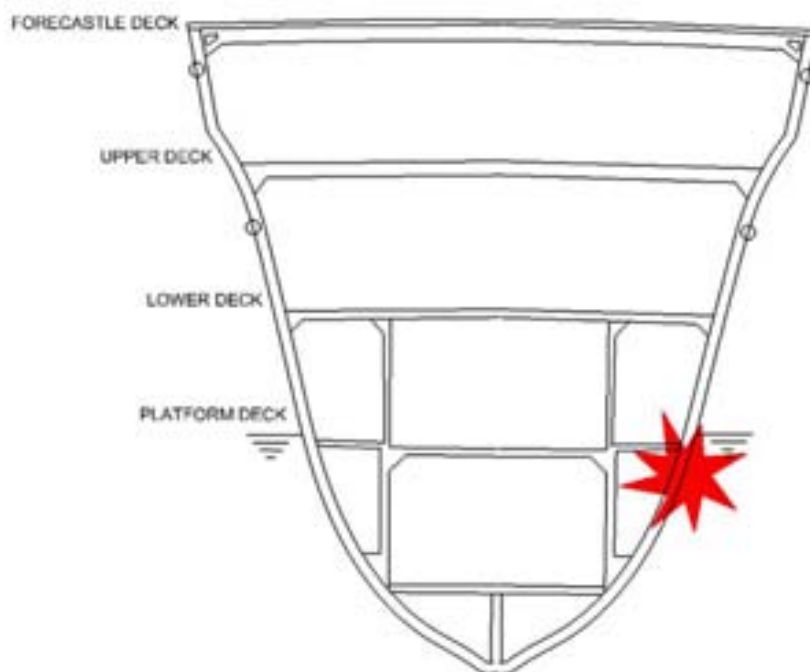
Figure 115: Probable Torpedo detonation location on the port side based on evidence from the wreckage. (Profile shown is of the starboard side)

Figure 116: Probable Torpedo detonation location on the port side based on evidence from the wreckage site.

Observations made from the ROV footage show extensive physical damage to the bow of Sydney. This damage is detailed in Chapter 6, which shows the location and extent of the damage to the hull Figure 115, Figure 116 and Figure 124, indicating a single contact-detonated torpedo hit.

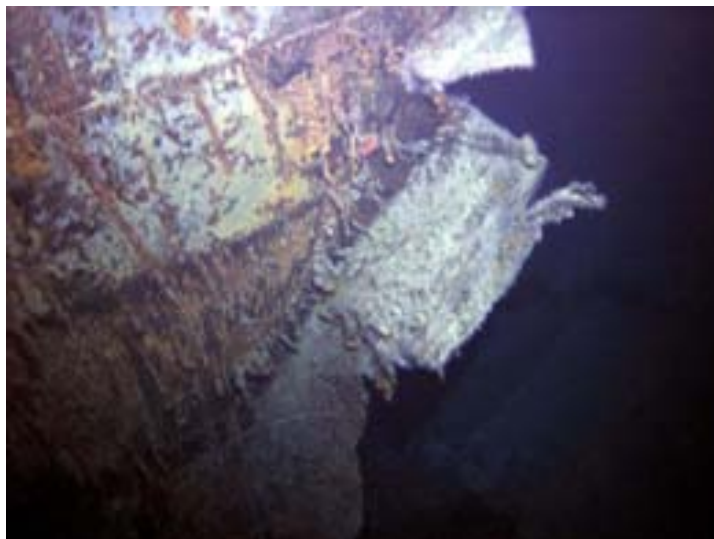
The flaring on the starboard side panels shown in Figure 117 indicates that the damage from the torpedo detonation on the port side has progressed and, either caused a hole or bulging on the starboard side of the hull. The fresh water tanks in the vicinity of the detonation would have been one mechanism that would have transferred the explosive energy from the port to starboard side resulting in this flaring. It is not uncommon for torpedo damage to penetrate both sides of the ship, as is demonstrated by damage to USS St. Louis in Figure 118.

Figure 117: Flaring on the starboard side panels indicating that the torpedo either caused a hole or bulge on the starboard side [173]

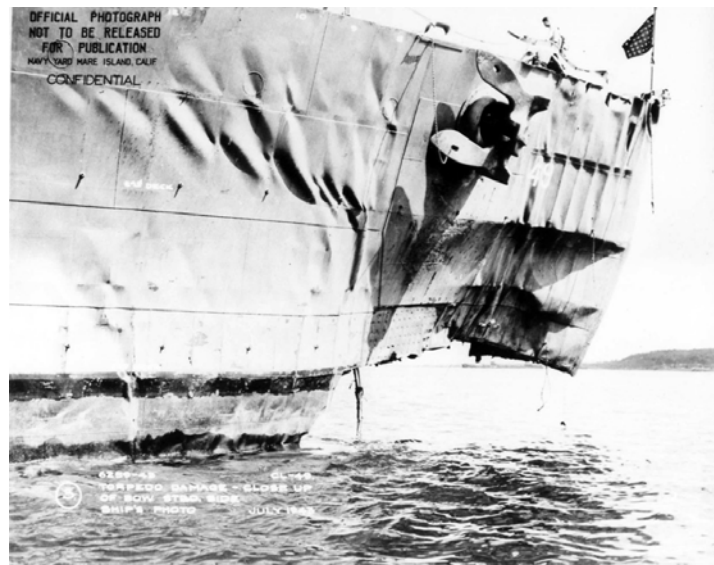
Figure 118: Torpedo damage to USS St. Louis in July 1943. This damage has penetrated through the hull [174].

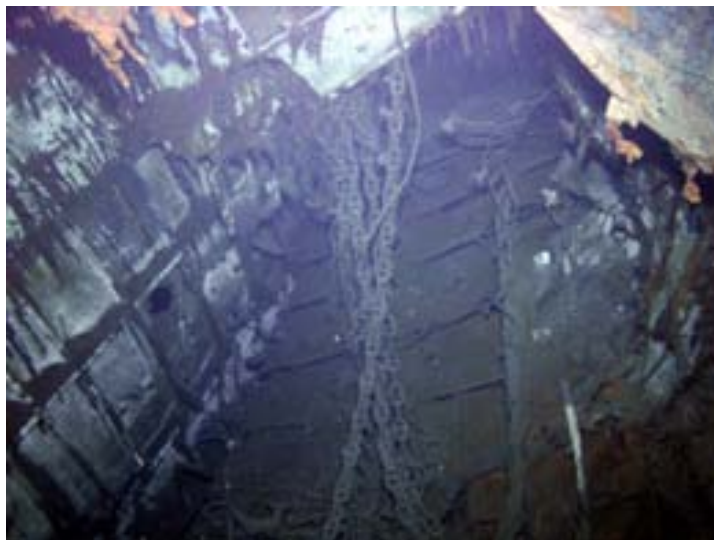
Figure 119 shows significant damage to the internal structure inside the bow, with the decks and bulkheads lying at the top of the inverted bow section. The heavy anchor cable is still attached and can be seen trailing out of the break in the hull. It is likely that the collapse of the deck has occurred as a result of the sinking process and would not have been a direct result of the torpedo detonation.

Figure 119: Internals of the bow show collapsed decks and connected anchor chains [175]

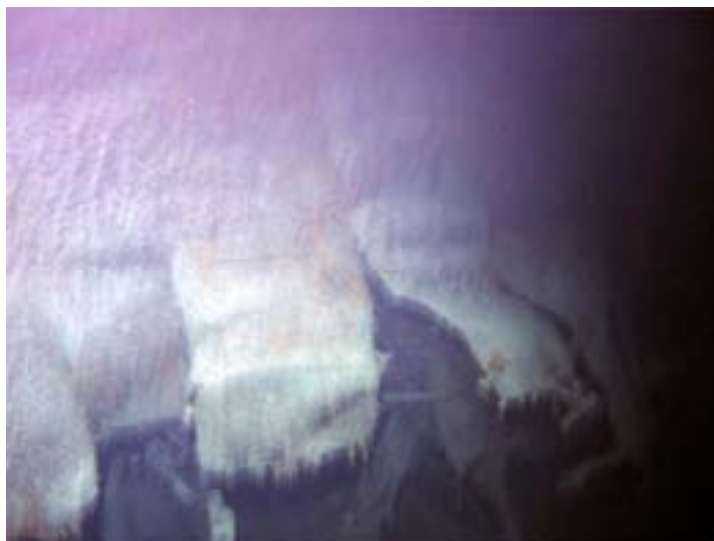
The Forecastle deck plating on the starboard and part of the port side is bent downwards, as shown in Figure 120. The Forecastle deck plates can be identified as matching frame 19, and have separated at the end of the wooden decking. Figure 121 shows that on the port side a large section of deck plate has been wrapped around the barrels of A Turret.

*Figure 120: Tear in Forecastle deck on main hull [176]*

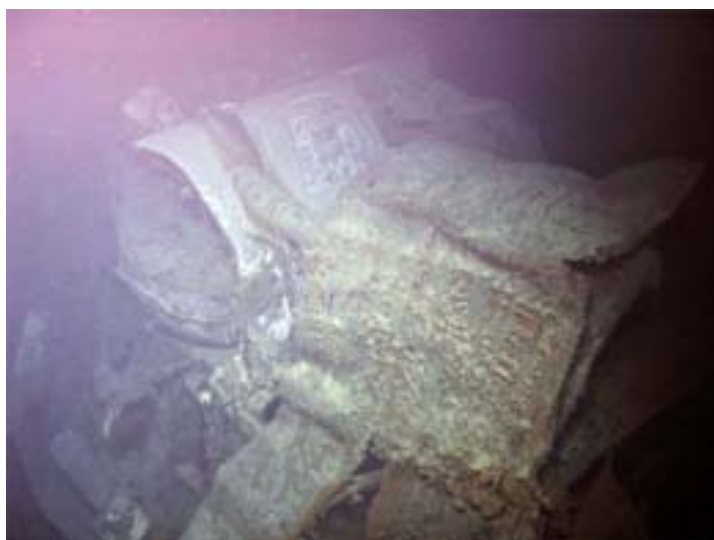
*Figure 121: Forecastle deck wrapped around A Turret [177]*

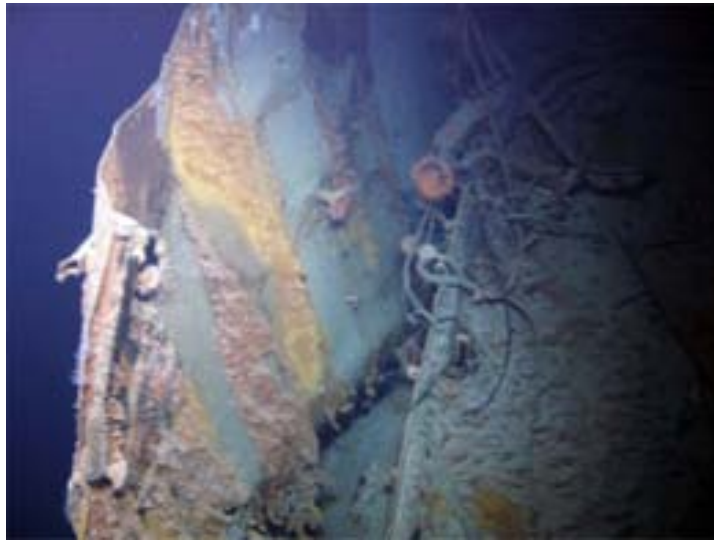
Examination of the main hull section on the starboard side shows a large section of hull plate that has been torn and bent right past the A turret to frame 35. Figure 122 shows that a large section of the hull plate has been bent upwards on the starboard side. This damage may have been attributed to a detonation in the forward magazine, but this theory has been discounted by considering video footage of the ship which shows that the bulkheads surrounding the major magazine in this region to be intact. Due to the angle of the ship, a large amount of debris and limited footage of this region, it is difficult to differentiate between damage due to the torpedo, subsequent damage to the hull and damage due to the sinking process.

Figure 122: Starboard side of main hull bent upwards [178]

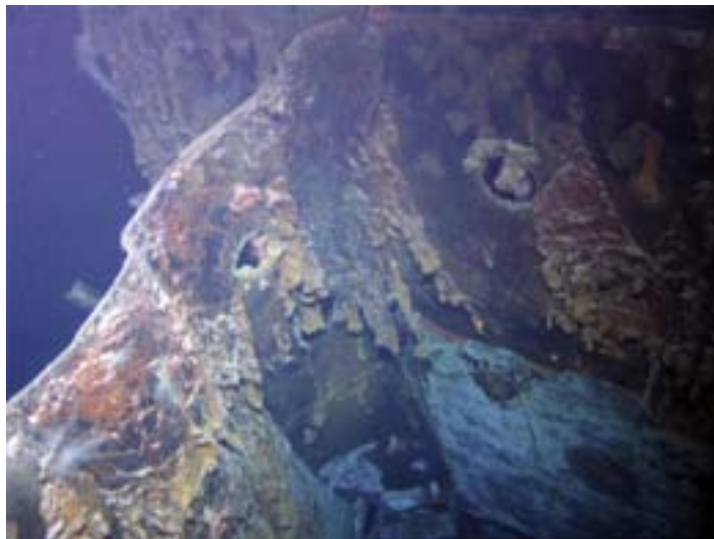
On the port side, the hull plate has been torn back at 90° to the rest of the hull (see Figure 123). It is highly likely that this bend is due to a combination of the torpedo damage weakening the hull structure and the loading on the hull during the sinking. Once again it is difficult to differentiate between torpedo and sinking related damage.

Figure 123: Port side of hull bent 90° to the rest of the hull [179]

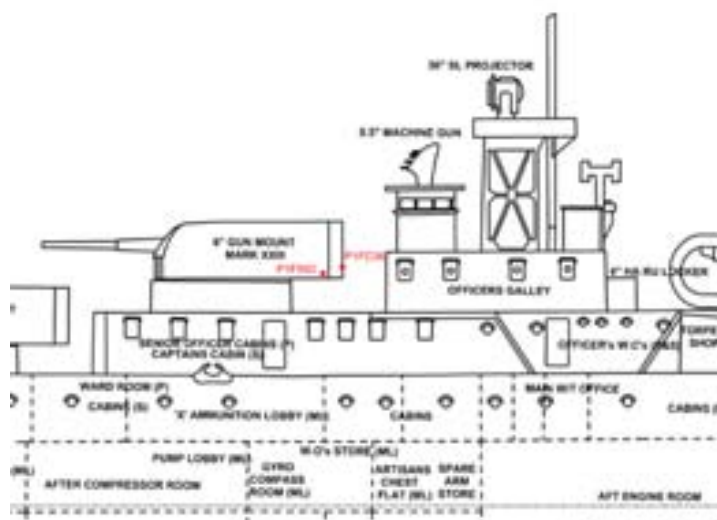
Figure 128: Location of weapon damage to port side of X Turret\*

\*Note: This damage is on the port side of the turret, but was probably due to a shell aimed at Sydney's starboard side.

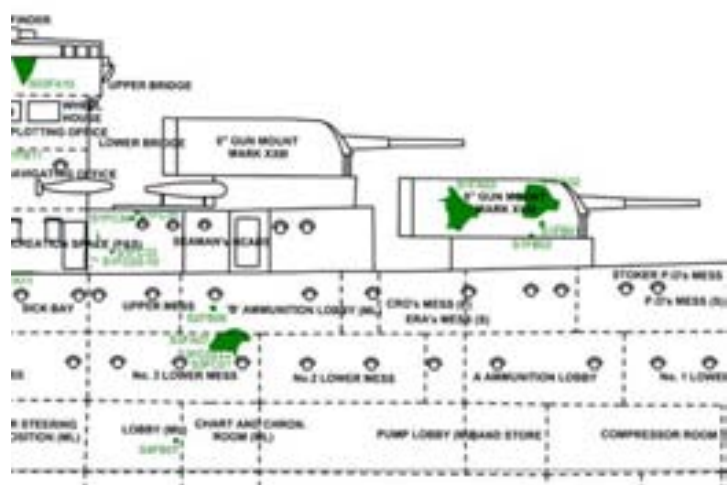
Figure 129: Location of weapon damage to starboard side around A Turret

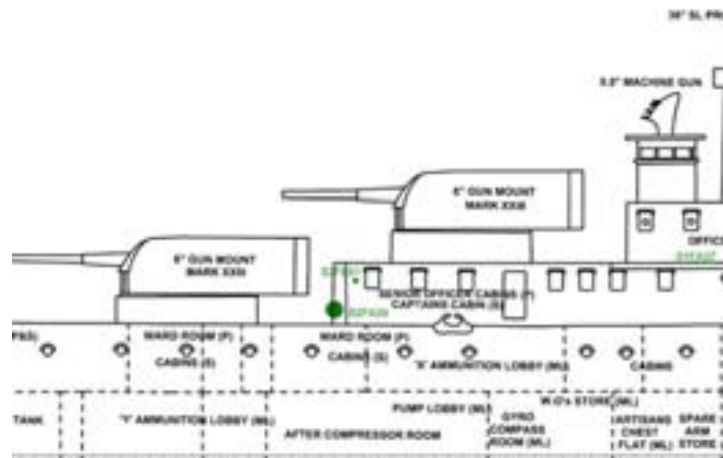
Figure 133: Location of weapon damage to starboard side around Y Turret

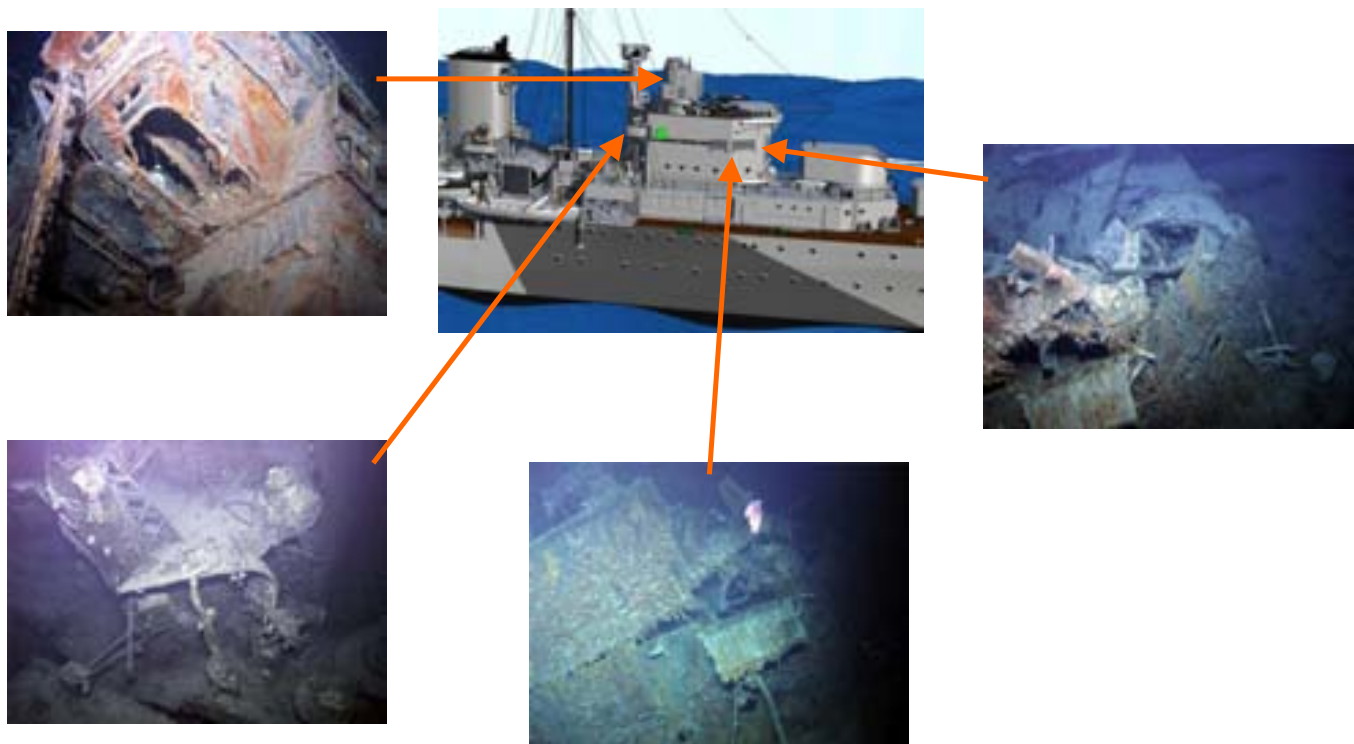
Figure 134: Composite image of forward superstructure – starboard [180-183]

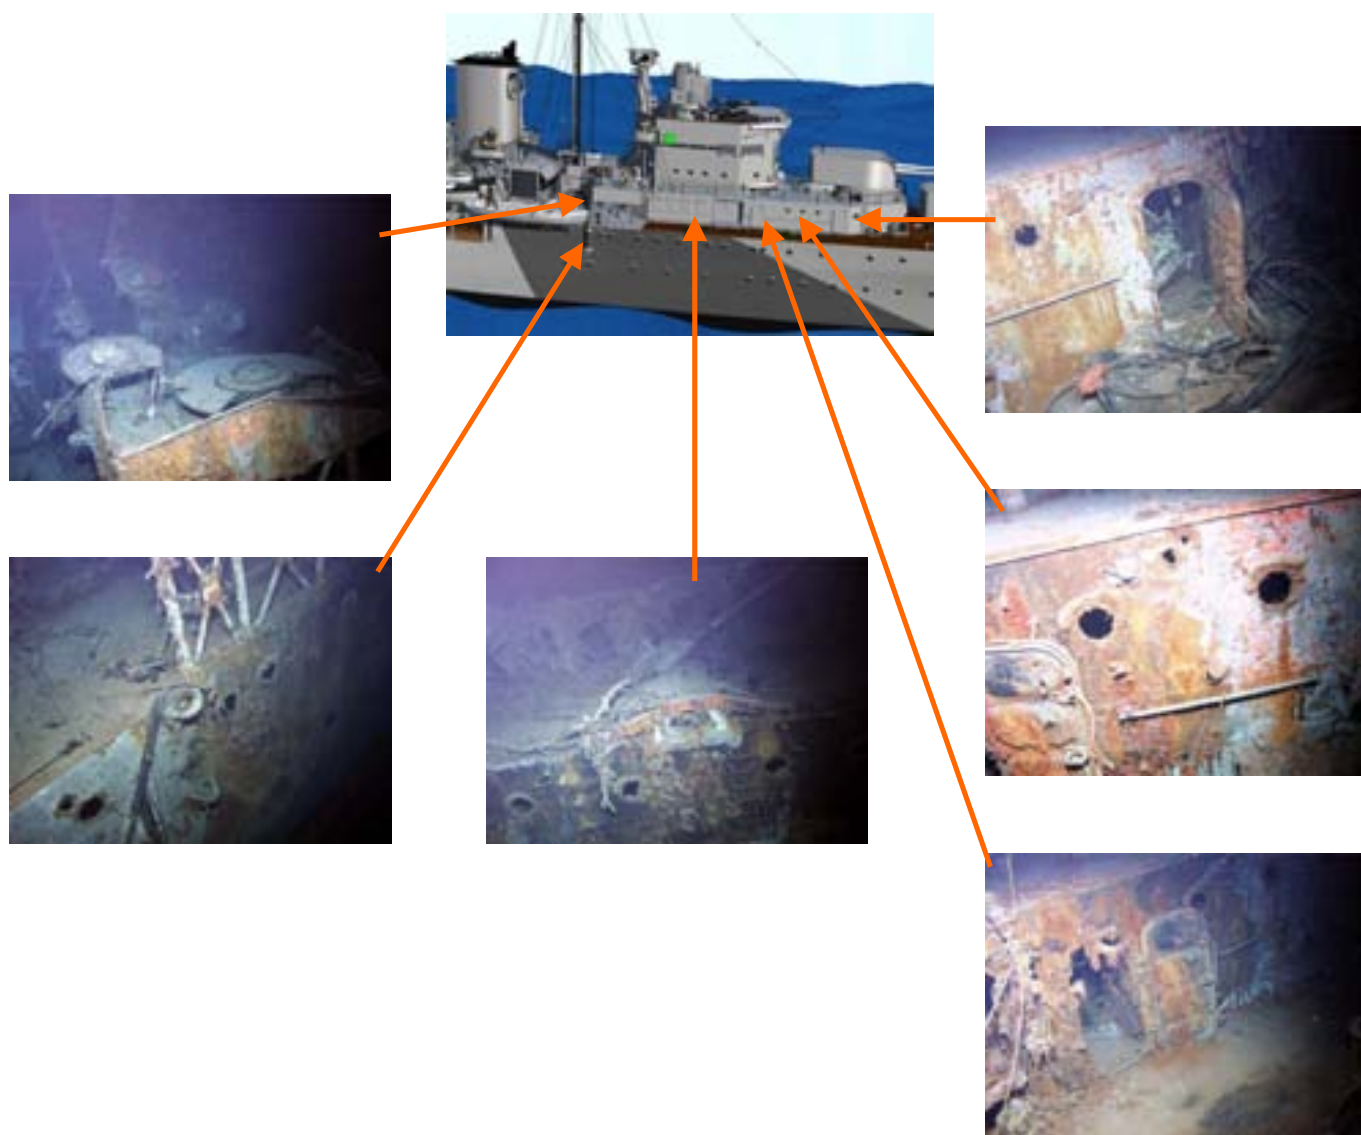
Figure 135: Composite image of forward Forecastle deck – starboard [184-189]

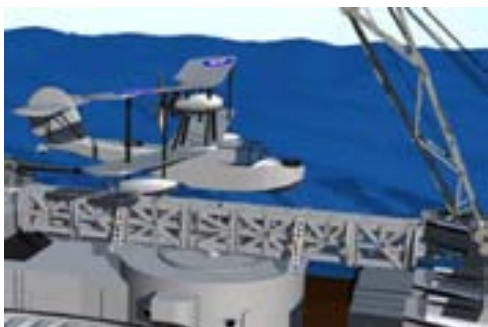
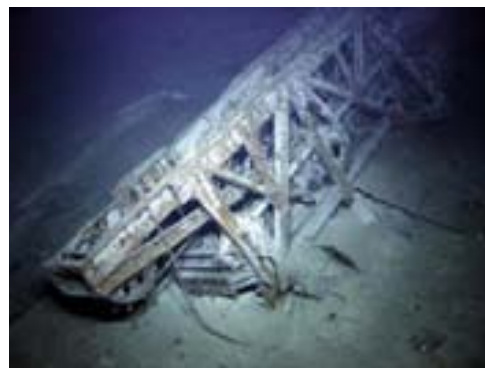
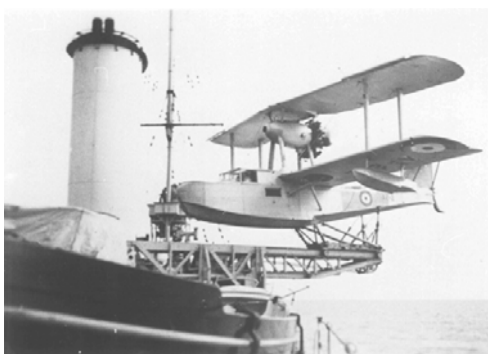
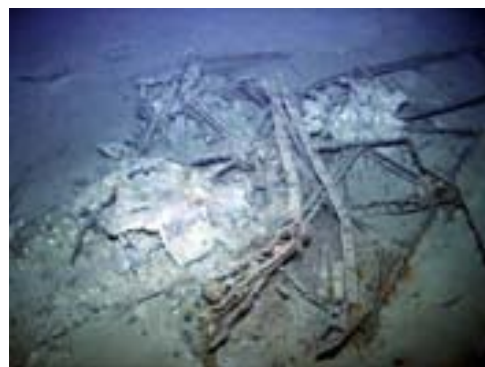
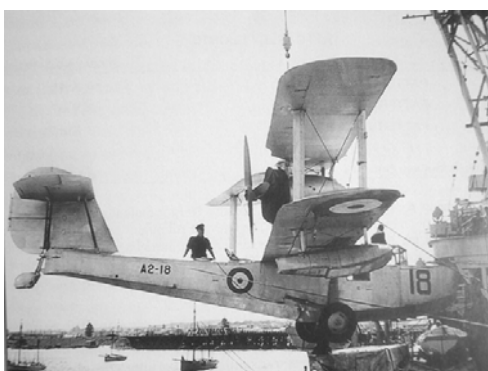
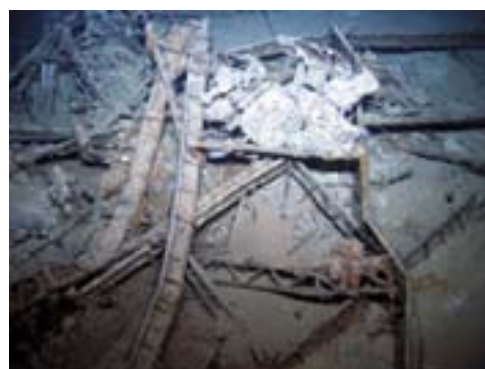
Figure 142: Midships – aircraft [211-213]

Aircraft catapult

Possibly aircraft wreckage

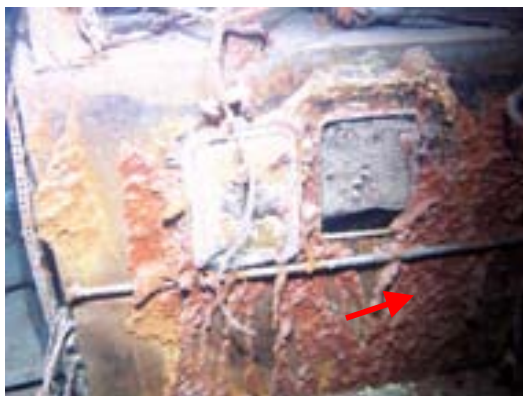
Officer's galley, Forecastle deck (aft - port). Note the rusticles (see arrow).

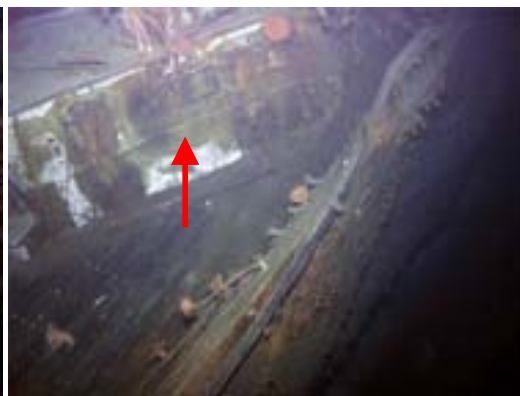
Captain's sleeping space, upper deck (aft - starboard). Note the discoloured patches due to heat transfer from a fire (see arrow).

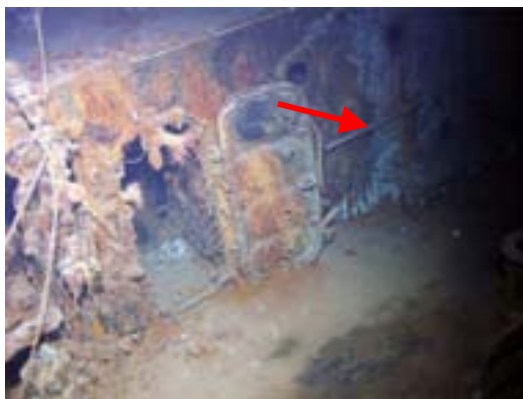
Recreation space/heads, Forecastle deck (forward - starboard). This photograph shows the boundary between the burnt and unburnt bulkhead (see arrow).

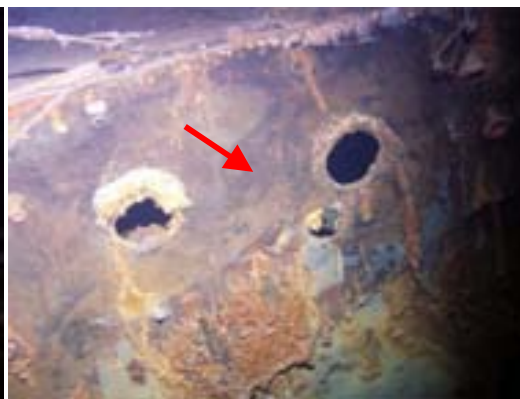
Canteen / dispensary, upper deck (forward - starboard). Note the blackened paint and the corrosion where the paint has been removed.
