## HMAS Sydney II Commission of Inquiry

### Report on Technical Aspects of the Sinking of HMAS *Sydney* and HSK *Kormoran*

DSTO-GD-0559

This report describes the technical findings of the battle and sinking of HMAS Sydney and HSK Kormoran based on historical and archeological evidence. The battle occurred on the 19<sup>th</sup> of November, 1941 off the West Australian coast. The wrecks of the two ships were discovered in March 2008 and their subsequent underwater exploration has shed light on the events that took place during and after the battle.

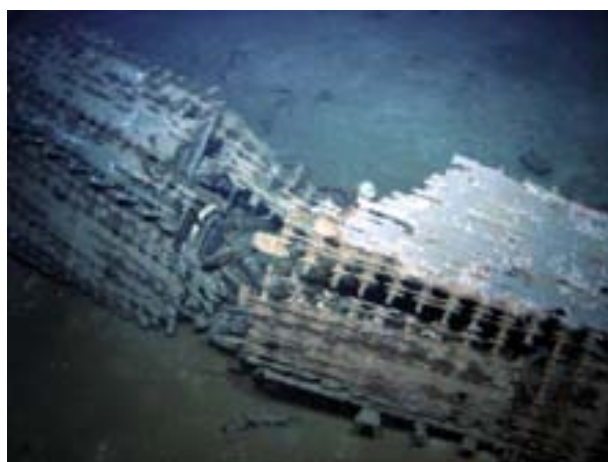
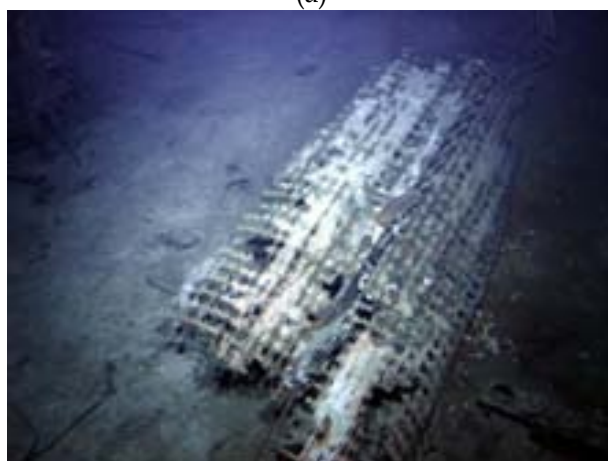
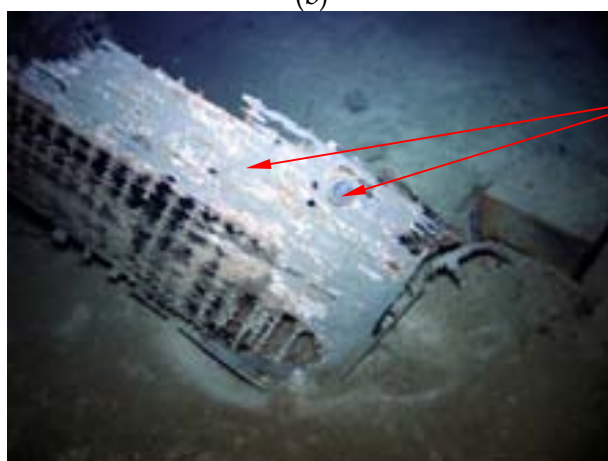
Figure 147: Photographs of a 35' Motor Boat on the seabed [228-230]

The figures below contain photographs that were taken using the ROV. Figure 147 shows the remains of one of the carvel built 35' Motor Boats partly lying on its side and partly upside down. Some of the planking is still intact but much of it has deteriorated, exposing the ribbed frame.

Figure 147(a) shows the mid section with significant damage. It appears that the boat has almost broken in two. In the middle of the boat there are metal parts and the remains of equipment. Figure 147(b) shows the bottom of the boat and that there is little of the planking intact and the stern is missing. Figure 147(c) shows the bow of the boat with a large percentage of the planking intact and several holes, which are believed to be due to fragment impacts. Note that the paint is largely intact in several areas and that there does not appear to be evidence of fire damage.

possible fragment  
impacts

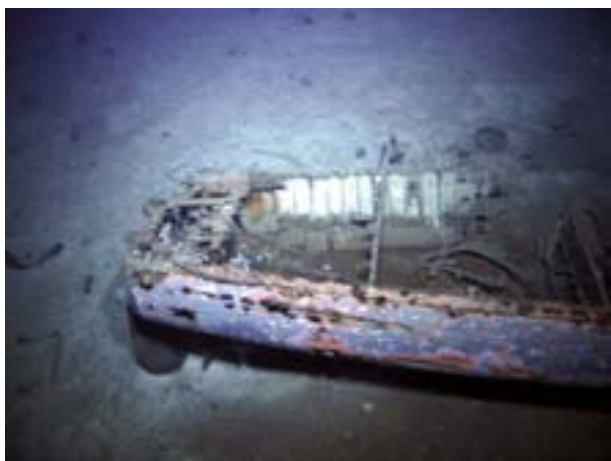
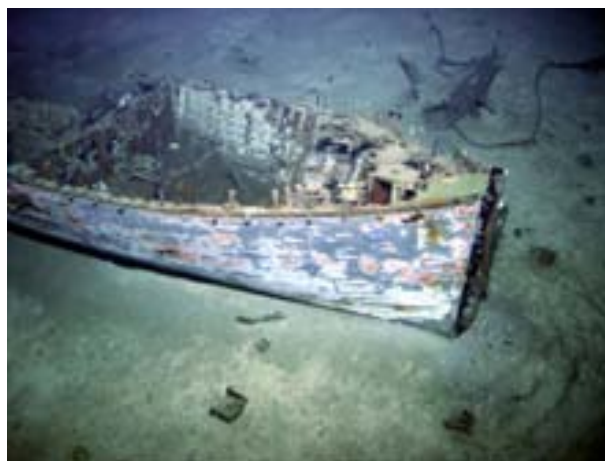
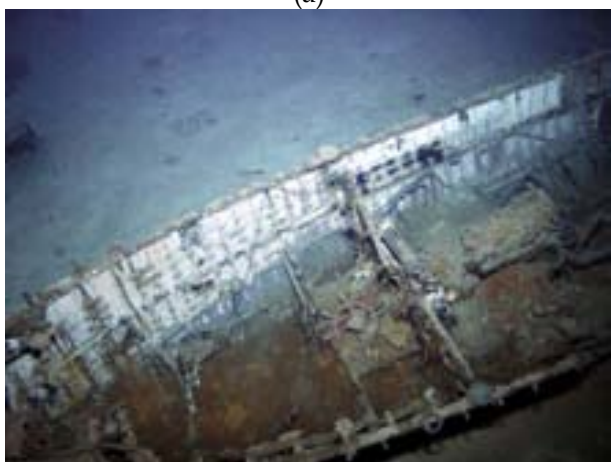
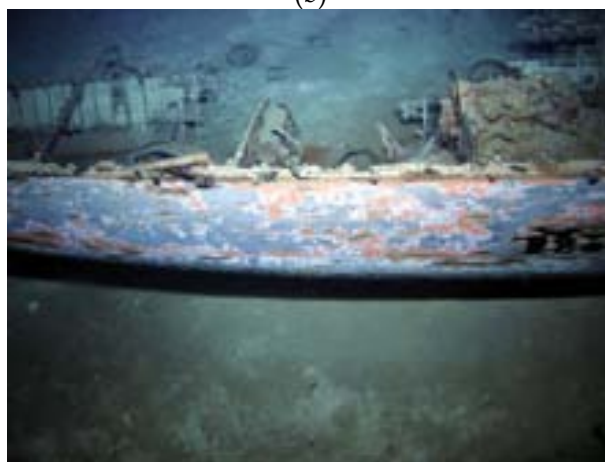
Figure 148: Photographs of a 35' Motor Boat on the seabed [231-234]

Figure 148 shows the second carvel built 35' Motor Boat sitting upright on the seabed. Figure 148(a) and Figure 148(b) show the stern and the bow of the boat, which are both relatively intact and show only limited damage to the planking from fragments and/or natural deterioration. Figure 148(c) is a plan view and shows the remains of the helm

and the interior equipment. Figure 148(d) shows the remnants of the motor and assorted pipe-work. It would appear that this boat is in very good condition with only limited decay of the wooden planking and the frame; the outer planking is clearly in better overall condition than the Motor Boat in Figure 147. The equipment inside (including the motor) is missing and has presumably fallen out during the sinking. The paint on the outside of the boat is in good condition and again there is little evidence of any fire damage.

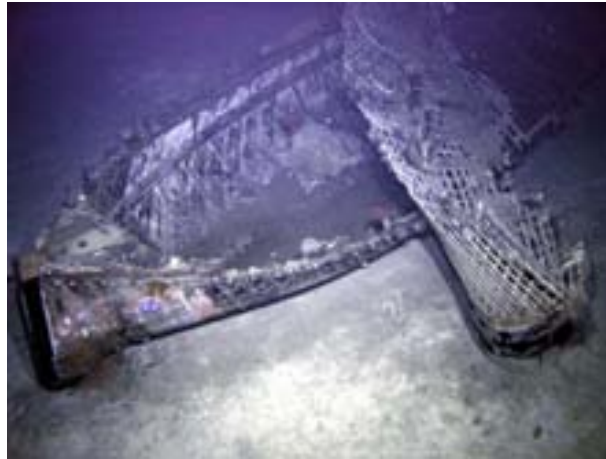
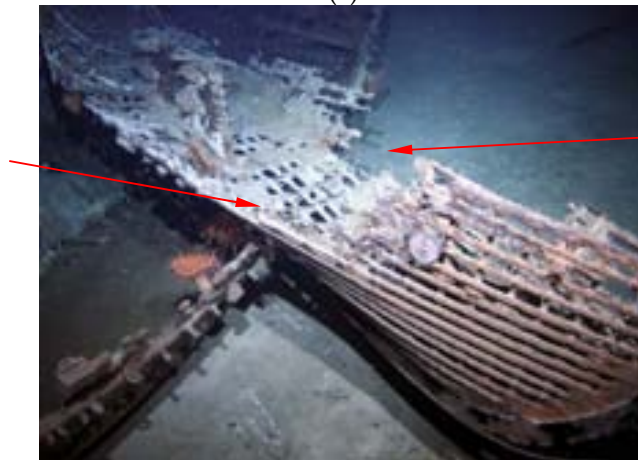
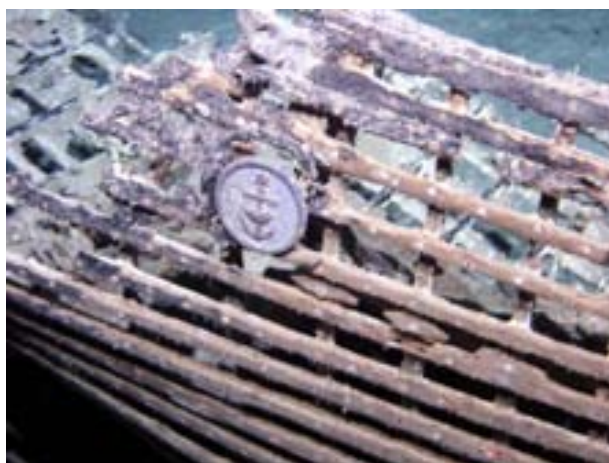
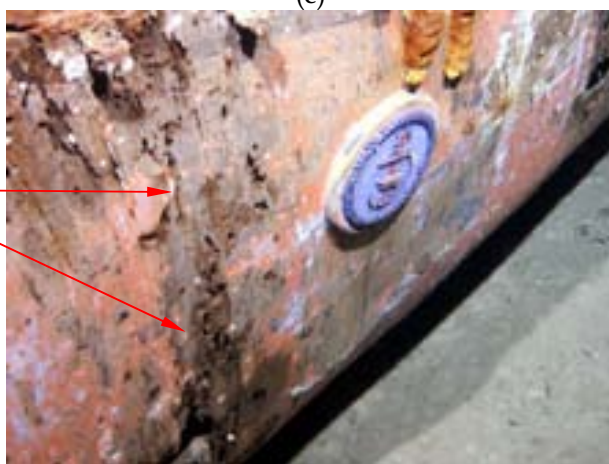
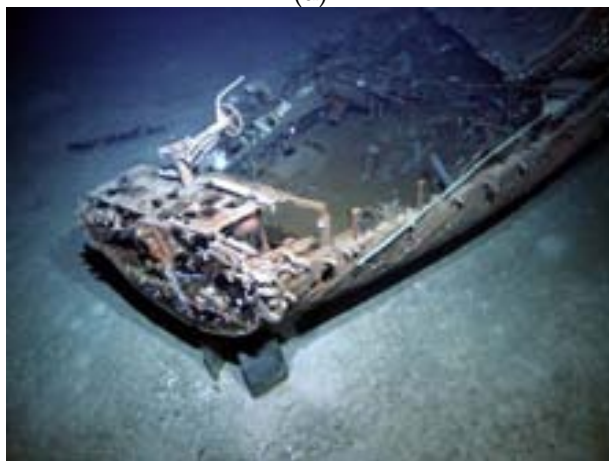
Figure 149: Photographs of a 36' Motor Pinnace and a 27' Whaler on the seabed [237-241]

Figure 149 shows the remains of two boats, one lying on the seabed and the second one on top of the other. The boat on the seabed is the carvel built 36' Motor and Sailing Pinnace which is identified by its distinctive tiller and rudder. The boat on top is a 27' Whaler which can be identified by the curved bow and stern (the Whaler is the only boat on board *Sydney* that had this characteristic shape). Since the Pinnace was on the port side of *Sydney*, it is highly likely that the Whaler is also from the port side. Figure 149 (a) shows how the two boats are positioned on the seabed and shows that the Pinnace exhibits significantly less deterioration compared to the Whaler. The fact that the Whaler is a clinker built boat [235] may explain the extensive deterioration of the boat's planking. Figure 149 (b) shows that the planking on the Whaler has rotted away leaving

only the frame behind. Figure 149 (b) also shows that a large section of the bow is missing on both the port and starboard sides. Figure 149 (c) is an enlargement of the bow section of the Whaler and shows evidence of fire damage to the frame timber which is observed in the blackening of the timber around the ship's boat badge. Figure 149 (d) is one side of the bow of the Pinnace and shows what appears to be damage to the planking caused by fragments; there are multiple penetrations to the outer timber consistent with fragments from weapons. It also shows the presence of rusticles consistent with the use of steel in the construction of this boat [236]. Figure 149(e) shows the stern of the Pinnace and that much of the interior of the boat is missing.

Possible multiple  
fragment hits

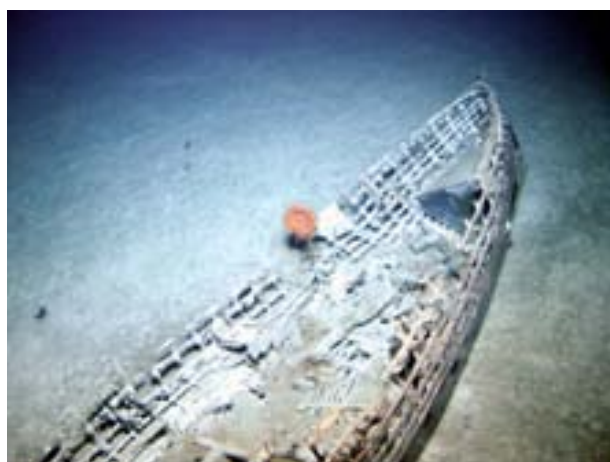
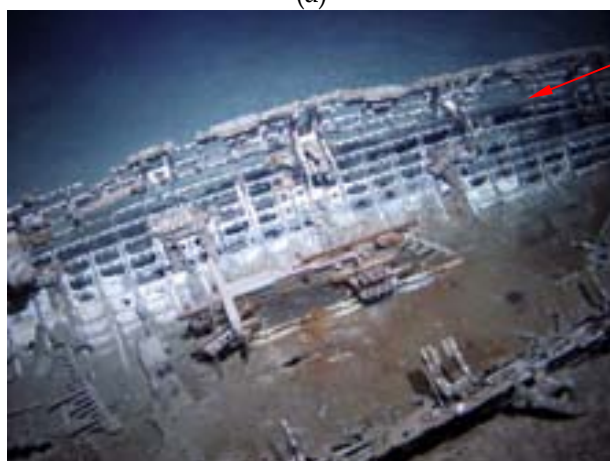
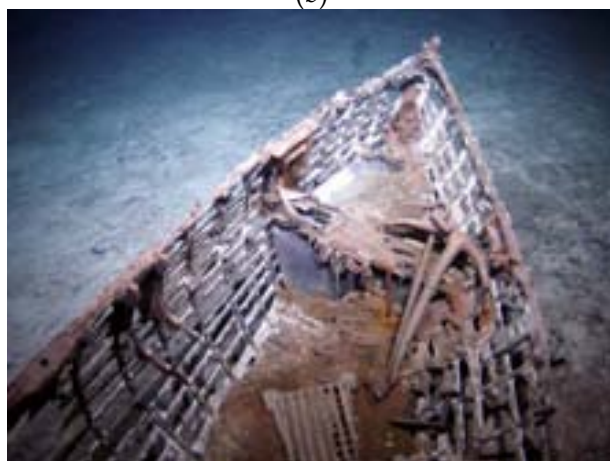
Figure 150: Photographs of a 27' Whaler on the seabed [242-244]

Figure 150 shows a 27' Whaler on the seabed. Although the images do not clearly show the characteristic shape of the bow and the stern, the frame construction is identical to the Whaler in Figure 149 (a) and Figure 149 (b). Given that Figure 149 is believed to be the port Whaler, it is probable that this is the Whaler from the starboard side. The photograph shows almost complete rotting of the boat planking but the frame is still

intact (this is very similar to the other Whaler). There is some evidence of shell damage to the boat as seen by the round hole through the frame shown in Figure 150(b). There are other small sections of the boat frame that are missing but whether this is due to weapons effects, rotting or being damaged by other parts of the ship during the encounter or the sinking is difficult to determine. However, given that the boat is intact as a whole it is highly likely that the localised damage is due to weapons effects. Figure 150(c) shows the forward part of the boat with the anchor still intact.

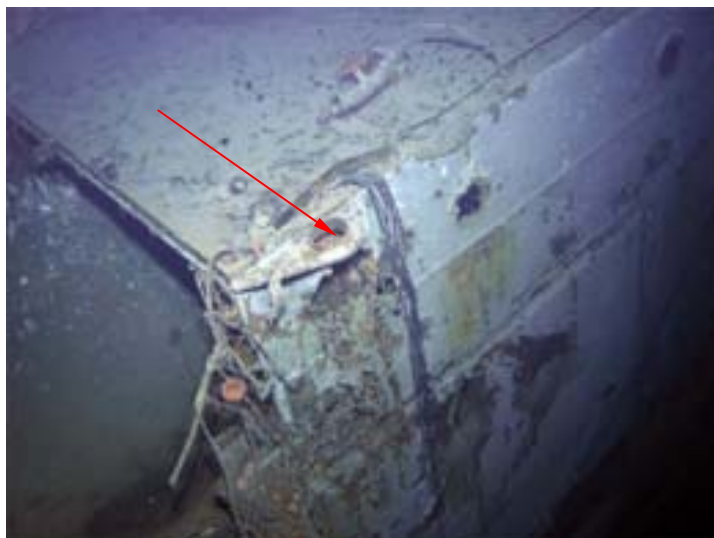
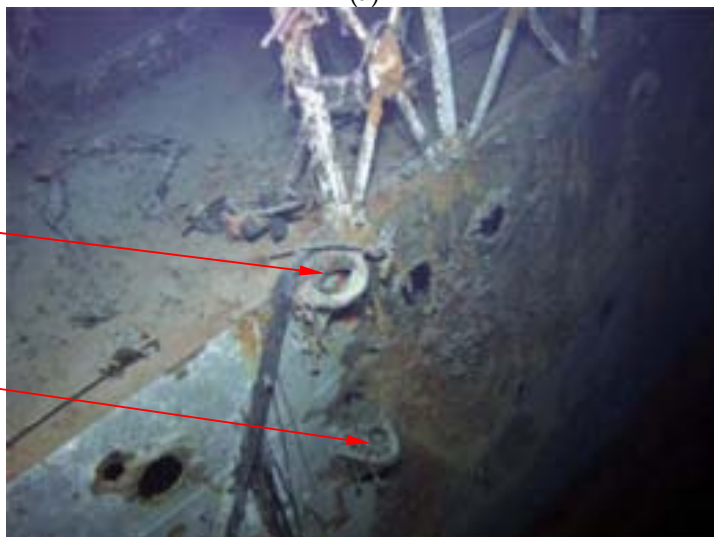
Figure 151: Locating holes for davits for starboard Cutter (a) aft (b) forward [185, 245]

Examination of the ROV images of the hull of *Sydney* on the seabed show the remains of where the davits for the Cutters should be. Figure 151(a) shows an empty aft locating hole for the davit on the starboard side for the Cutter. Also clearly visible is the shell damage to the hull possibly inflicted by a 15 cm shell which would have resulted in

significant fragment damage to the 32' Cutter. Figure 151(b) shows the empty forward locating hole for the davit slightly further along the hull. This figure also shows fire damage to the hull forward of the davit holder holes. Figure 152 shows the end of the 27' Whaler cradle on the starboard side. There is fragment damage to the front of the cradle frame and also extensive shell damage to the hull below the cradle. Figure 150, which is believed to be the starboard Whaler, shows some damage to the boat that may be consistent with this weapons damage. Figure 153 shows the port side 27' Whaler cradle. Although showing signs of deterioration, there is little evidence of weapons or fragment damage. It is known that parts of the superstructure nearby were fire damaged but there does not appear to be fire damage to the cradle. Figure 154 shows the port cradle for the Gig where the two Pattern No. 20 Carley floats were located. There is clearly structural damage to the vertical support beam and also fragment damage to the horizontal top of the cradle. Figure 155 shows the forward and aft remains of the davit locating holes for the port Cutter. The figure shows significant weapons damage to this area and that the davits are missing. The fragment damage to the nearby lifeboats would have been extensive. There is also evidence of significant fire damage to this area. Composite images of the relevant locations are shown in Figure 134 to Figure 144.

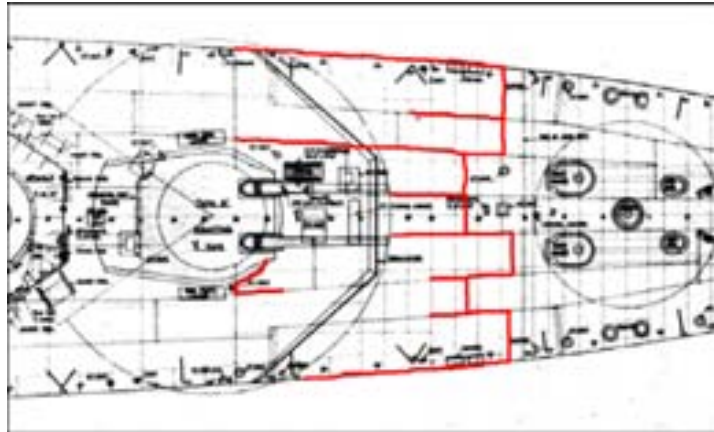
The extent of the torpedo hole has already been described. Upon reviewing the wreck images it is apparent that a significant part of the ship's forward structure is missing. The break in the Forecastle deck can be identified and its approximate location is shown in Figure 156. The break lies approximately where the timber deck planking ended at frame 20. The bow section lies in the debris field upside down, but there is a considerable amount of other shell and deck structure also lying in the debris field. One piece of torn and twisted side shell from the forward part of the ship is shown in Figure 157. These sections appear to have been torn away from the ship as she sank.

Figure 156: Approximate extent of splits in the Forecastle deck

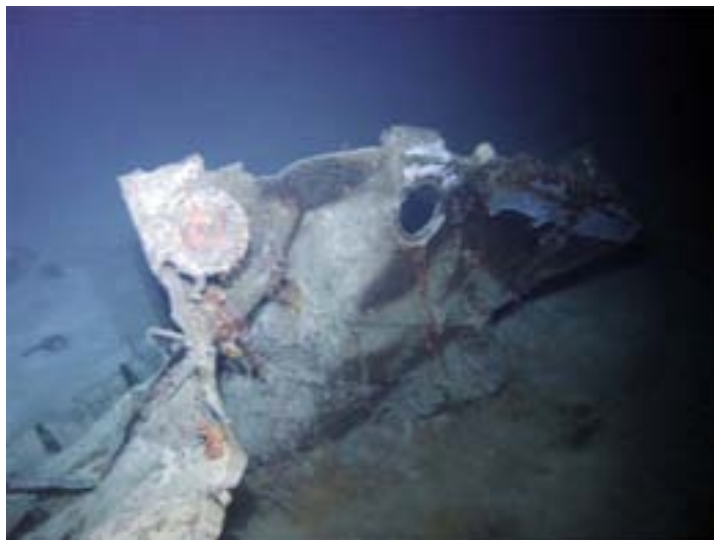
Figure 157: A section of side shell plating torn from the ship as she sank. The section includes two side scuttles, one of which had been blanked. [250]

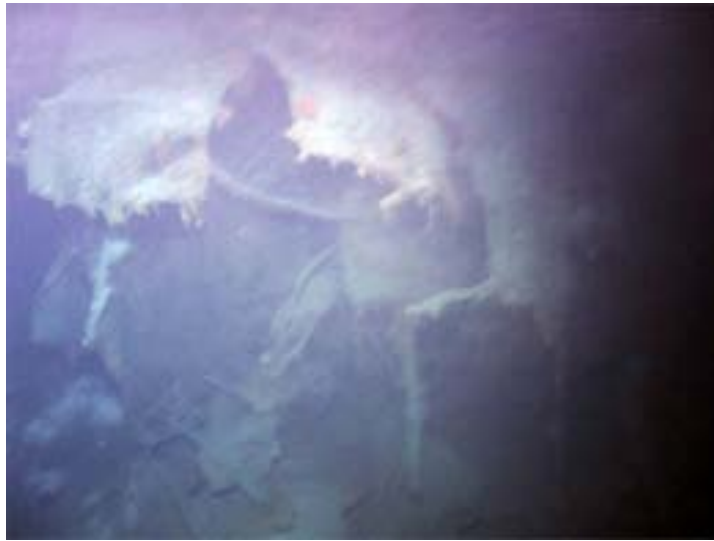
The break in the Forecastle deck, which can be seen in Figure 158, shows that the deck plates are torn along the seams and possibly the butt joints. The lower part of the hull structure and the aft end of the upturned bow appears to be torn rather than crushed. This indicates that the bow was torn off and pulled away from the hull rather than falling off.

Figure 158: The break in the Fore-castle Deck looking down towards the ship's keel [251]

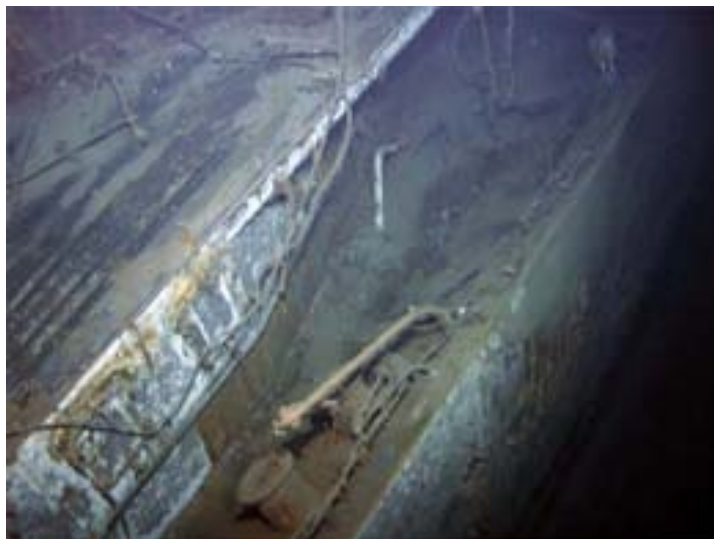
Implosion damage is caused when an airtight container has pressure applied externally to a level at which the container collapses. The failure is associated with excessive buckling of the structure. Implosion damage occurs to many ships during sinking, particularly those which sink rapidly before all spaces within the ship have filled with water. For example, the wreck of the cruiser USS *Quincy*, lost during the battle of Savo Island, shows very similar implosion damage to that evident on the wreck of *Sydney* [252]. Figure 159 shows the forward section of the ship's upper Deck on the starboard side. The upper Deck has collapsed downwards and the side shell bent inwards over an extensive length, possibly as far forward as the watertight bulkhead at frame 154.

Figure 159: *Sydney's* upper Deck on the starboard side between frames 157 and 151, looking forward [253]

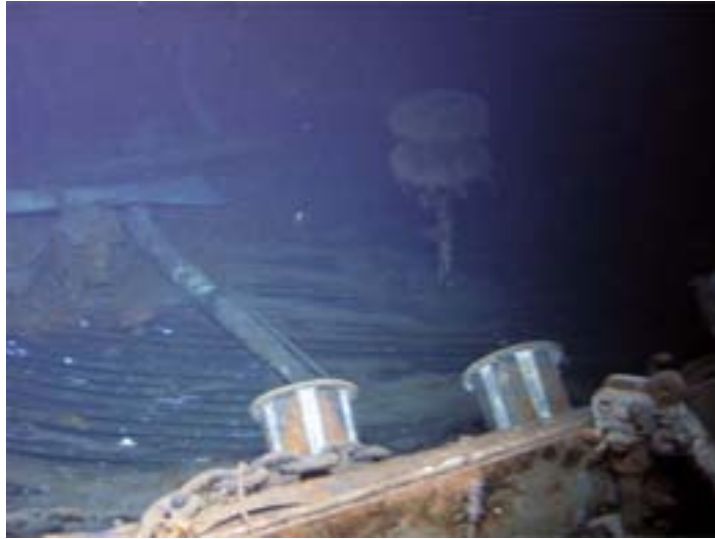
The quarterdeck bollards on the port side of the upper Deck at frame 196 aft are shown in Figure 160. The deck has been forced down several feet, exposing the capstan shaft on the ship's centreline and bending the ship's side slightly inwards.

*Figure 160: Quarterdeck bollards on the port side of the upper Deck aft [254]*

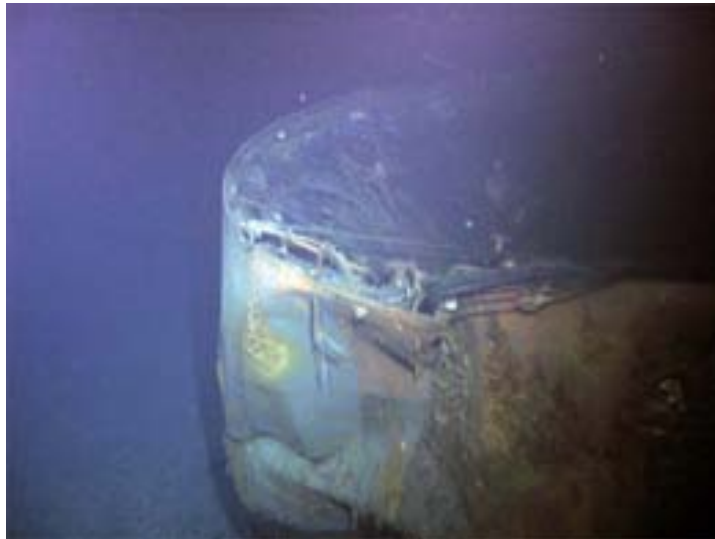
Moving further aft, as shown in Figure 161, there is significant collapse around the stern section.

*Figure 161: Collapsed structure at the stern of Sydney [255]*

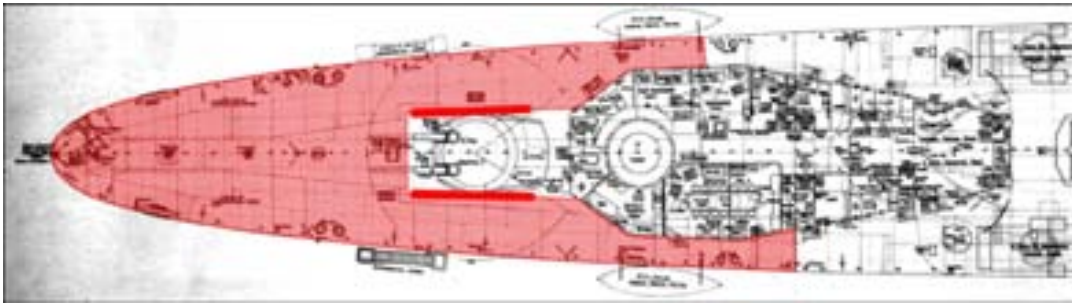
The extent of this buckling and collapsing damage therefore extends from the stern through to about frame 154. The damage is evident on both sides of the ship. Figure 162 shows a plan of the upper deck marked with the extent of the collapsed region. Also shown in the diagram are two thick red lines indicating where there are splits between the upper deck and the Y turret barbette.

Figure 162: Upper deck plan showing the extent of the collapsed region

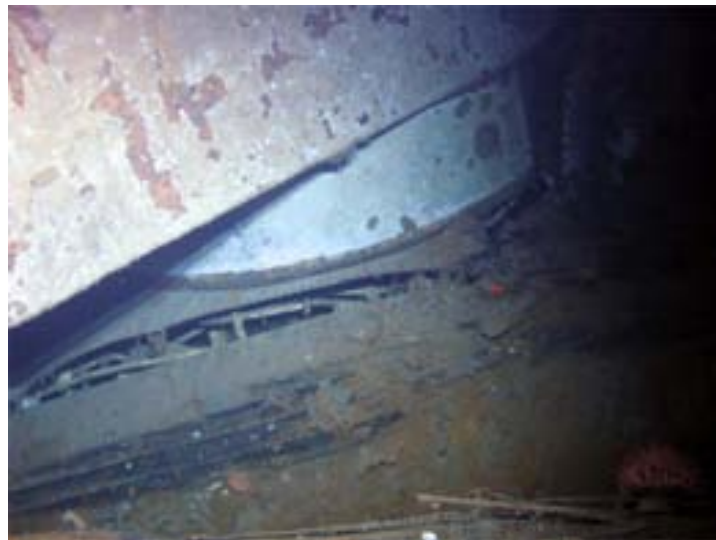
The split between the upper deck abreast of the Y turret is shown in Figure 163. The plate on the forward part of the barbette is also detached.

Figure 163: Split in the deck abreast of Y Turret on starboard side. [256]

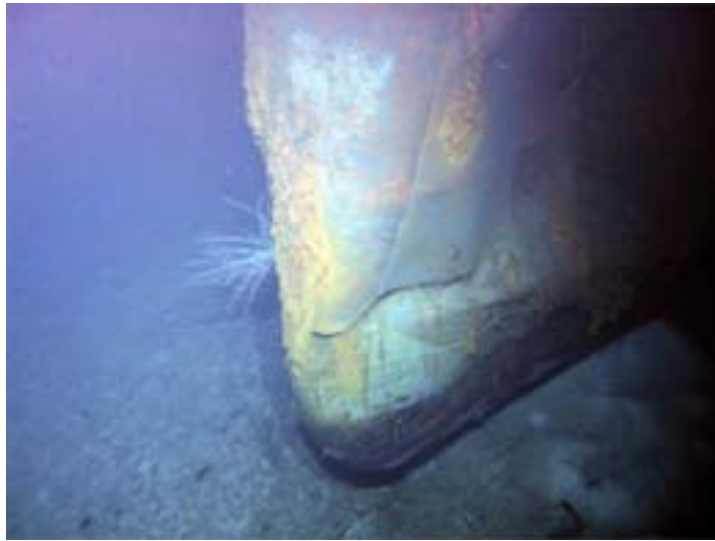
The main hull of *Sydney* shows some evidence of damage caused when the ship impacted with the seabed. The stern section shows some signs of collapse where it has come to rest on the seabed, shown in Figure 164, although some of this damage is likely to be caused by implosion.

*Figure 164: The stern of Sydney on the seabed [257]*

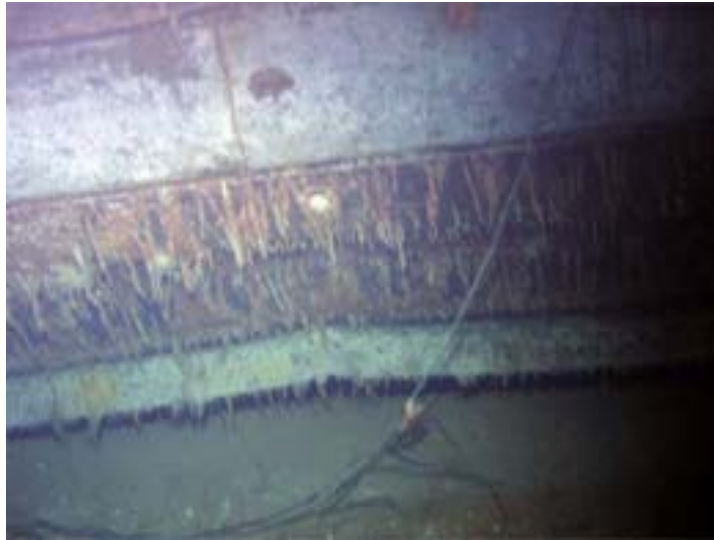
Further forward along the ship it becomes evident that the seabed is solid rock and there is not much silt. The impact with the seabed would have caused significant damage to the lower sections of the ship. Figure 166 shows the ship's bent starboard bilge keel resting on the seabed. The bilge keel is buckled and a section of the side shell plating below the armour plating appears to be imploded. The length of the imploded section

*Figure 166: Sydney's bent starboard bilge keel. The hull penetration may be the bilge ejector discharge around frame 128. [259]*

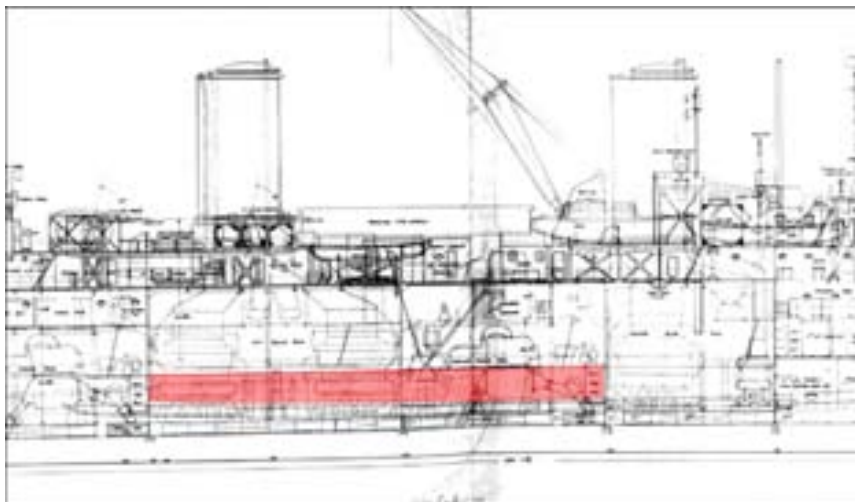
appears to begin around the forward end of the A engine room and continues aft some distance probably to end around the bulkhead at frame 135. The extent of the missing plate is shown in Figure 167 and Figure 168.

*Figure 167: Sketch showing the extent of imploded or collapsed shell plating*

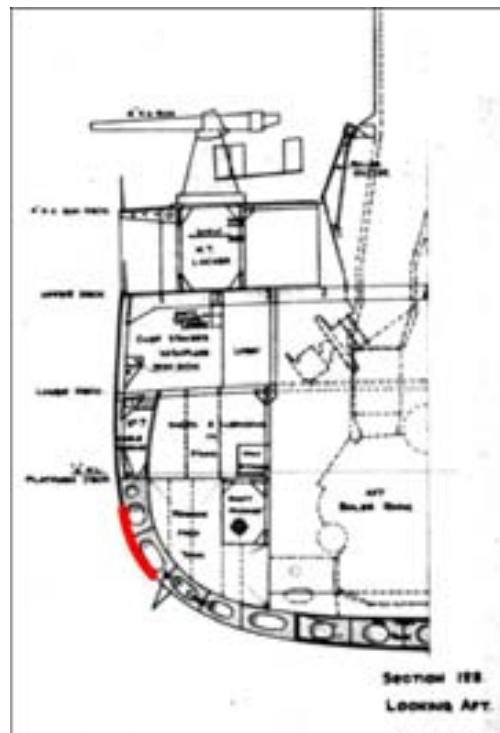
Figure 168: A section showing the extent of imploded or collapsed shell plating on the starboard side

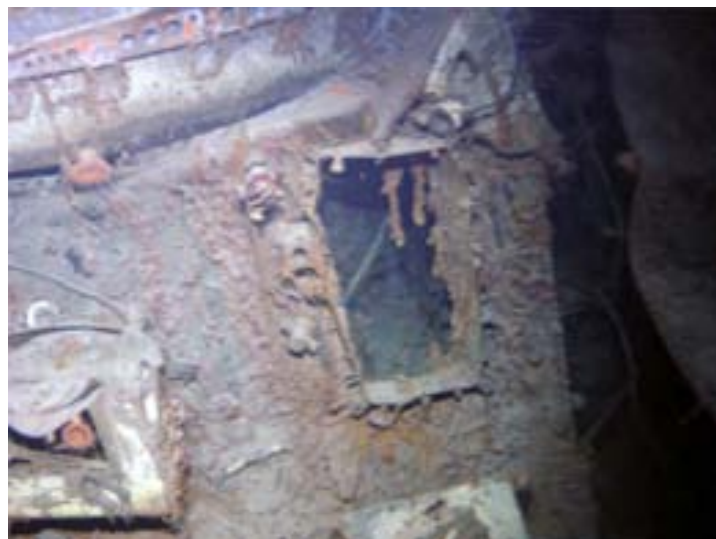
Towards the forward section of the main part of the wreckage the Forecastle deck has been bent down almost 90°. This could have occurred during the sinking process, but was most likely to occur when the hull stopped on the seabed. Figure 169 shows the WT hatch forward of the A turret barbette on the Forecastle deck. The deck is clearly bent and this type of damage does not seem to be consistent with other parts of the torn bow structure identified earlier in this section.

Figure 169: WT hatch immediately forward of the A Turret barbette [260]

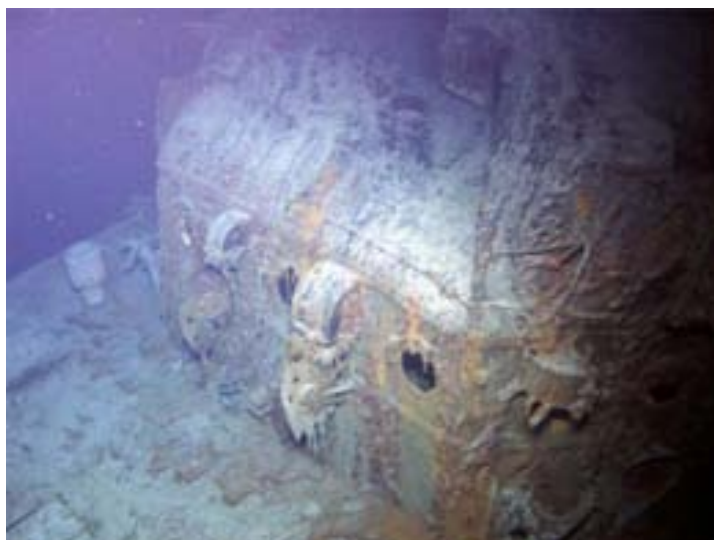
Figure 170: The forward screen of Sydney’s bridge superstructure [261]

The front of the bridge structure is collapsed and crushed above the Captain’s Sea Cabin and the Navigating Officer’s Cabin. It is evident that the Bridge has been crushed. The starboard side of the bridge has been torn away and the port side bent in. This severe damage almost certainly occurred as the ship sank, since the bullet-proof roof over the compass platform on the upper bridge deck is lying intact in the debris field resting against the DCT. It is unlikely to have survived intact if it had not left the ship before the damage to the bridge and the upper bridge deck occurred. It is possible that some large piece of wreckage hit the bridge as the ship sank.

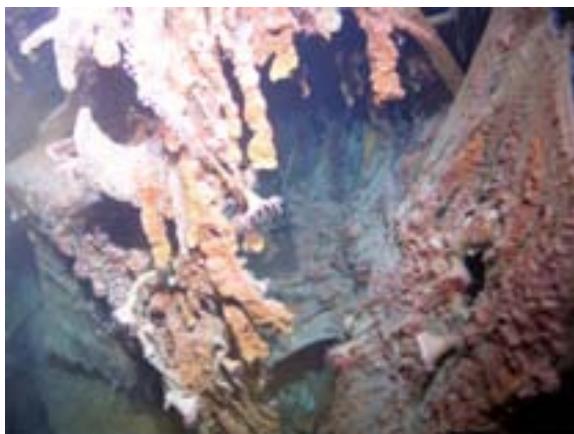
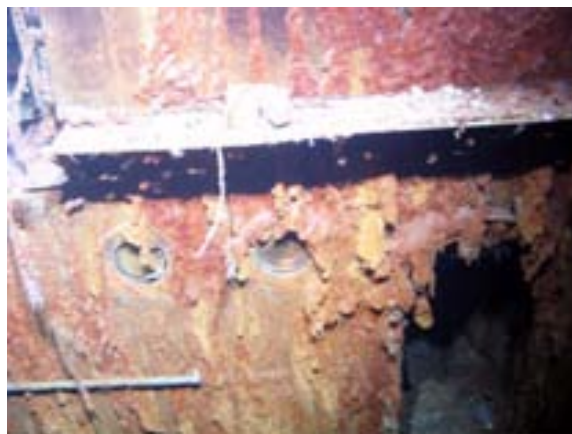
Figure 171 shows the presence of rusticles associated with the degradation of the steel of *Sydney*. Similar rusticles were found on the Titanic, which was 30 years older, as shown in Figure 27.

*Figure 171: Rusticle formations on Sydney [262, 263]*

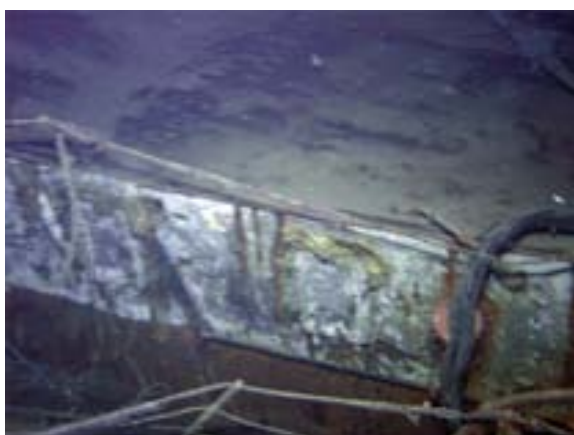
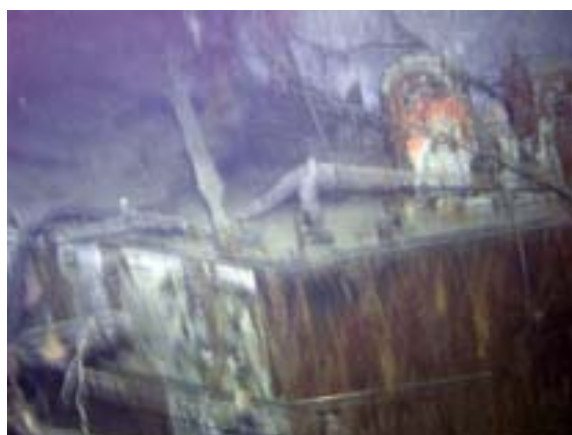
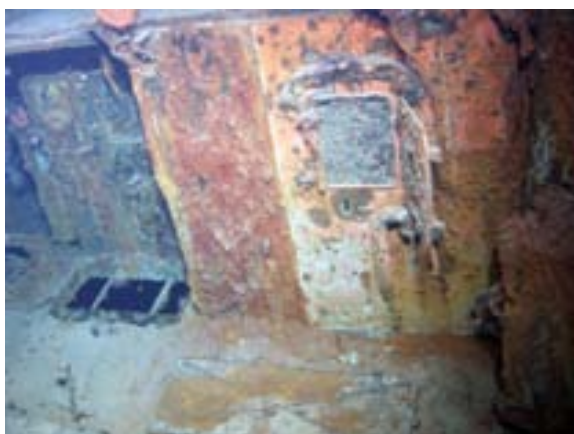
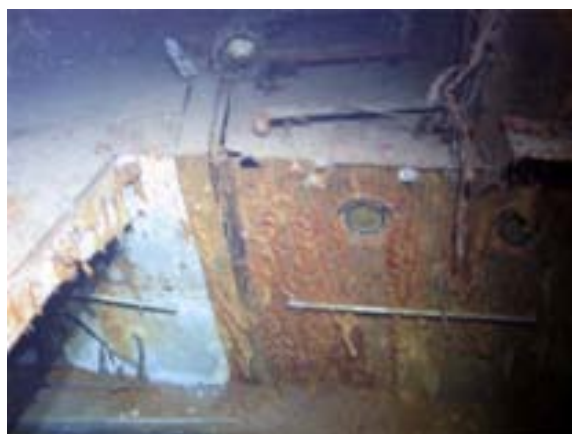
There are some cases where steel plating on the ship has deteriorated at a greater rate than adjacent plating. Examples of this deterioration are shown in Figure 172.

*Upper deck, adjacent X turret*

*Smith's Shop, port side Forecastle deck*

*Upper deck, aft of 4 inch gun deck*

*Figure 172: Deterioration of the steel plating on Sydney. [202, 221, 223, 224]*

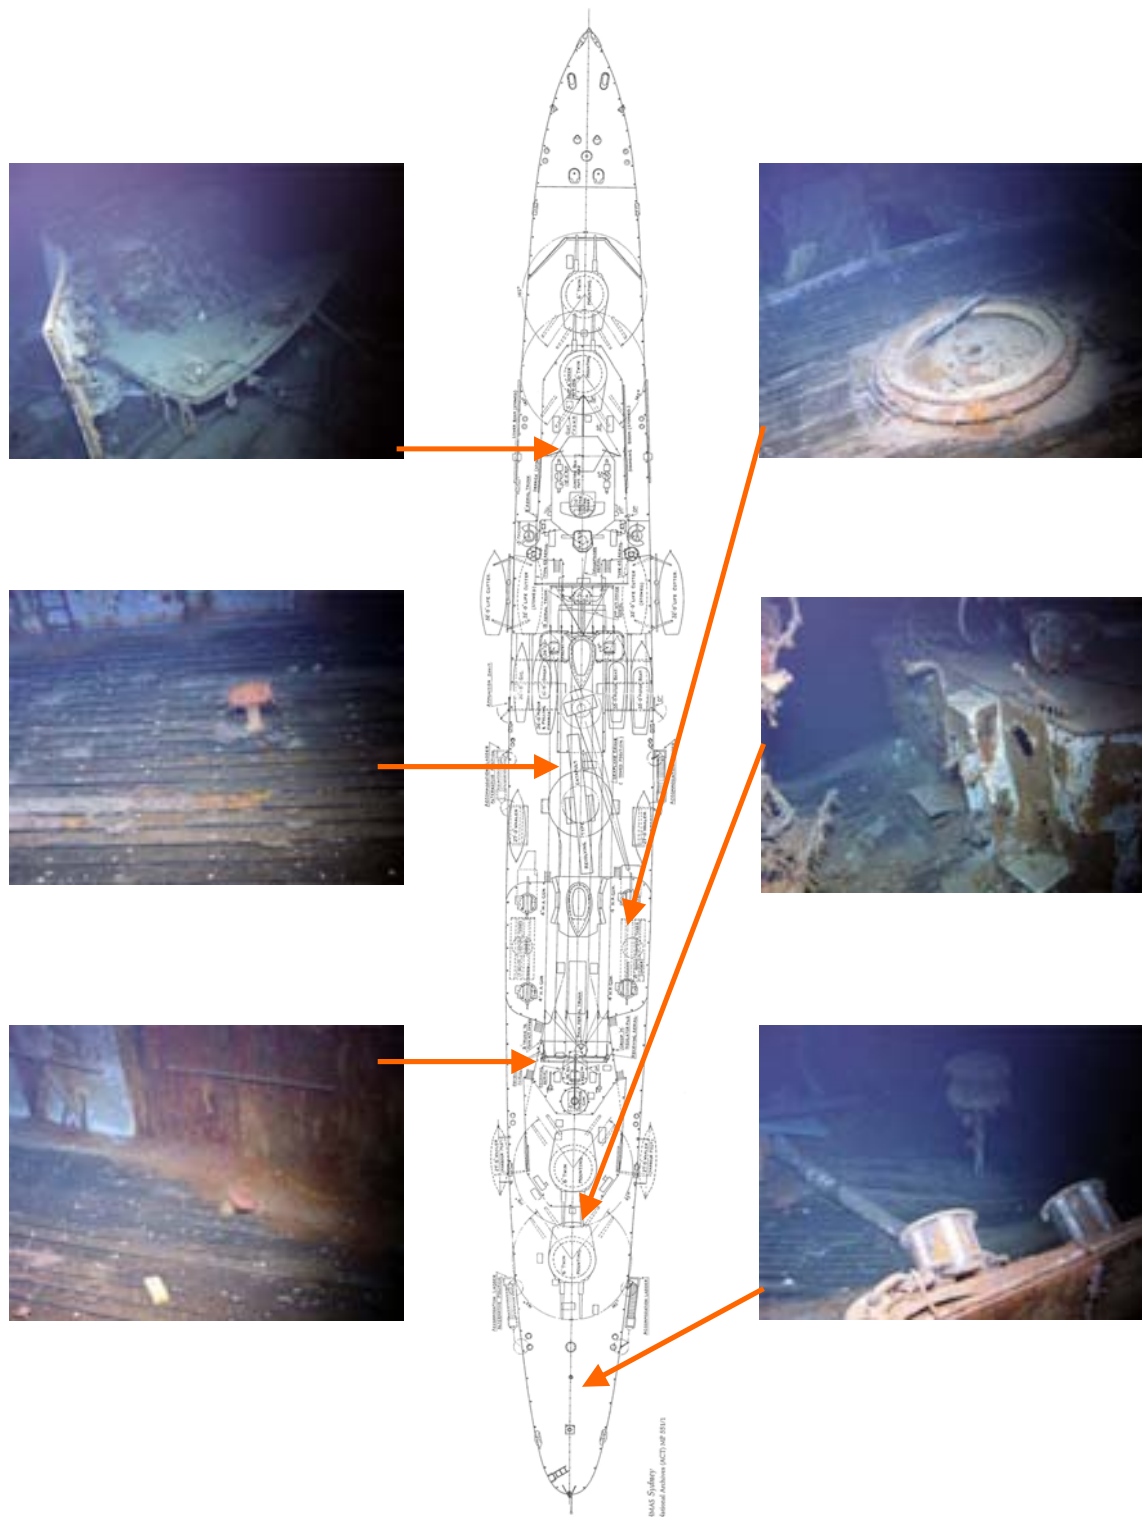
*Sydney* was fitted with a timber deck as per the ship specifications [98]. The timber on *Sydney* appears blackish in colour and is reduced in thickness. The studs securing the timber to the steel deck can be seen protruding through the remains of the timber in several areas. The caulking material appears undamaged.

Figure 173: Condition of the decking timber on *Sydney*. [214, 264-268]

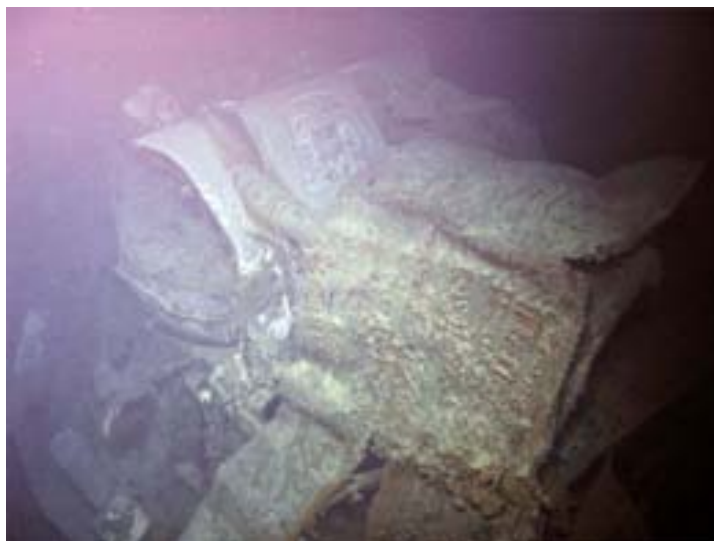
Little reliable information can be obtained because of the uncertain nature of the damage done due to the sinking. Figure 174 is a reconstruction of the approximate final locations of all guns on *Sydney*. Figure 175 shows the approximate elevation of the gun barrels on A and B Turret. Figure 176 shows a photograph of A turret. This turret has part of the deck wrapped around the guns. A photograph of B Turret is shown in Figure 177 and this turret is bearing on approximately 90° with an elevation of approximately 15°-20°. B turrets barrels also appear to be on different elevations. B Turret received a single non-penetrating shell hit to the front of the turret, and also a shell hit to the base on the port side.

Figure 176: Final orientation of A Turret

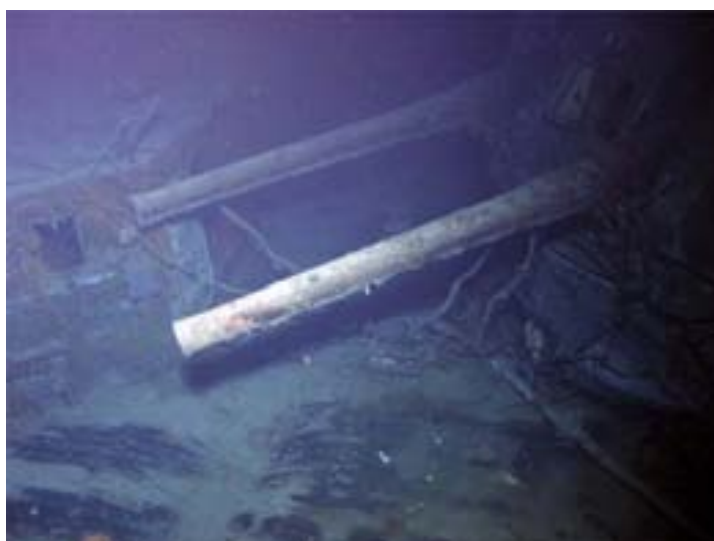
Figure 178 shows the approximate final orientation of X and Y Turret. These turrets are both bearing on approximately  $45^\circ$  to port (also see Figure 174). Figure 179 shows that X Turret is elevated at approximately  $-5^\circ$ . Figure 180 shows the elevation of the Y Turret barrels, which are approximately at  $0^\circ$  and  $-5^\circ$  respectively. Y Turret appears to be essentially undamaged.

*Figure 179: Final orientation of X Turret*

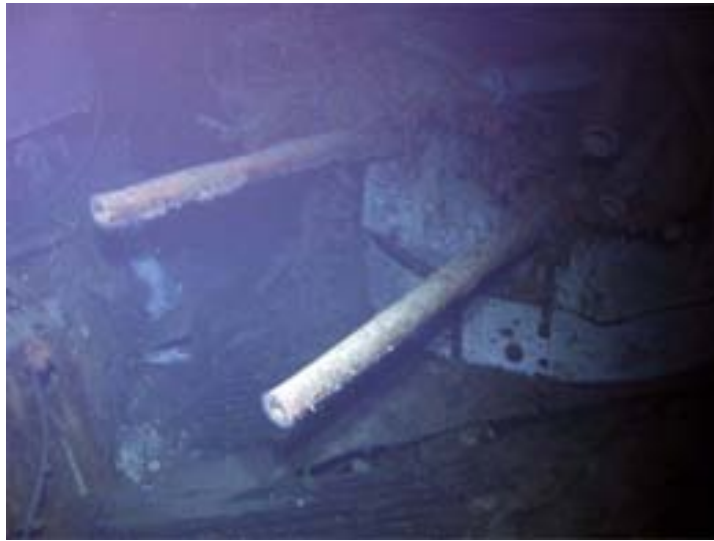
*Figure 180: Final orientation of Y Turret*

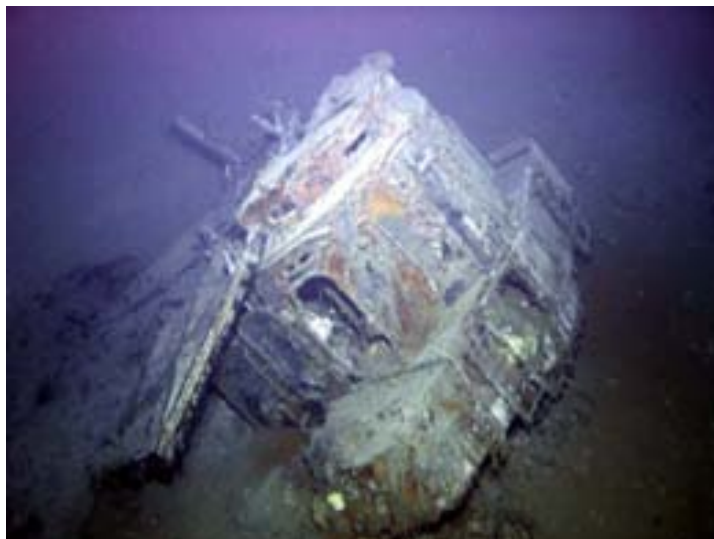
The fire control for the 6" guns was carried out by the DCT. The DCT has been located in the debris field and is shown in Figure 181. Holding up the DCT is the bridge roof. As the DCT and bridge roof are both located in close proximity to the ship, and with the rest of the equipment found in the debris field, it is suggested that the DCT fell from the ship as a result of the sinking. The forward section of the bridge is shown in Figure 182 and is extensively crushed. It is possible that the DCT has caused some of this damage as it left the ship, taking the bridge roof with it. Based on this evidence, the DCT would not have fallen from the ship as a direct result of a weapons hit prior to the sinking.

*Figure 181: DCT in debris field*

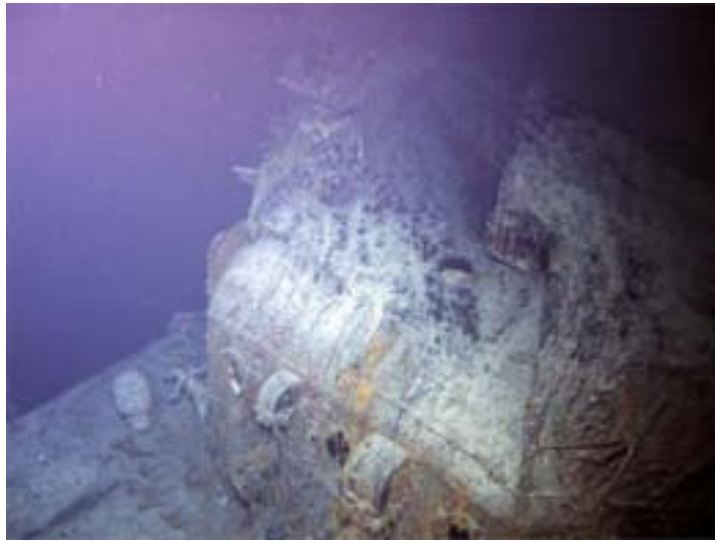
Figure 182: Front of the bridge crushed

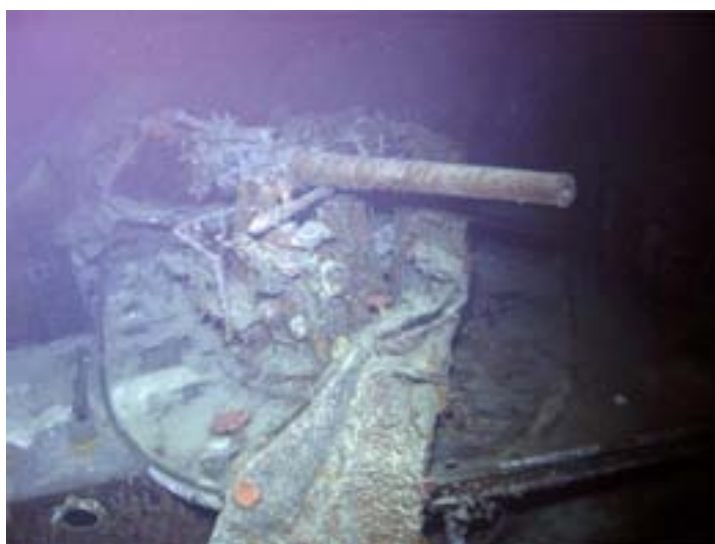
The approximate final positions of the 4" guns are shown in Figure 183. Three of *Sydney's* 4" guns (P1, P2, & S2) are still fixed to their mounts on the gun deck (as shown in Figure 184, Figure 185 and Figure 186 respectively). The forward port side 4" (P1) gun has material wrapped around its mount which is thought to be part of the aft funnel. P1 is also bearing approximately 135° port with an elevation of approximately 15°. The aft port side 4" gun (P2) is shown to be at an elevation of approximately 80° and on a bearing of around 125°. The aft starboard 4" gun (Figure 187) is bearing on approximately 135° to starboard with an elevation of approximately 15°. The fourth 4" gun (S1) can be found in the debris field.

Figure 184: Forward Port side 4" Gun (P1) [210]

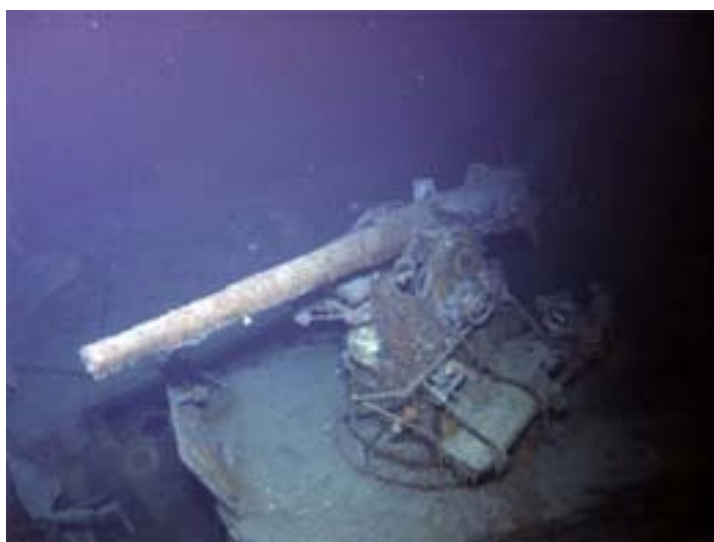
*Figure 187: Aft Starboard side 4" Gun (S2) [271]*

Protective plating was fitted to the guardrails around the *Sydney's* 4" gun deck. There is one piece of what appears to be side plating on the aft end of the Starboard side deck (as shown on the left hand side of Figure 187).

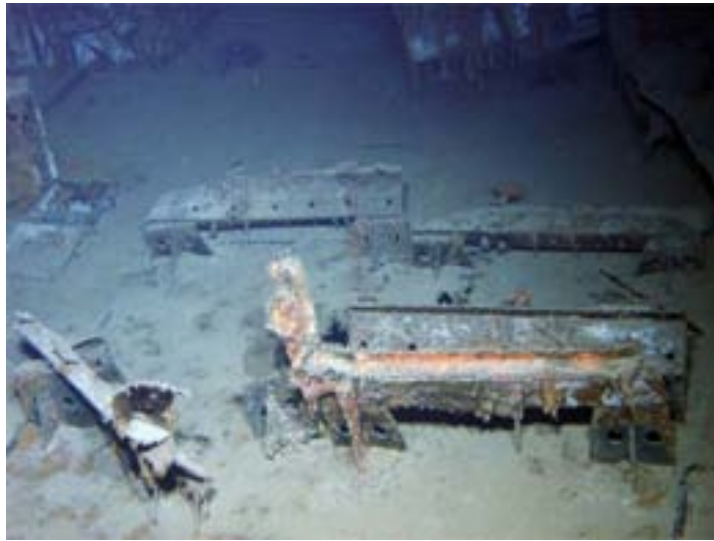
Four of the 'ready-use' lockers are missing from the starboard side, (see Figure 188), one of which lies in the debris field. It would appear that this locker has sustained weapons damage, or fragment damage.

Figure 188: Missing 'ready use' lockers on starboard side of 4" gun deck [272]

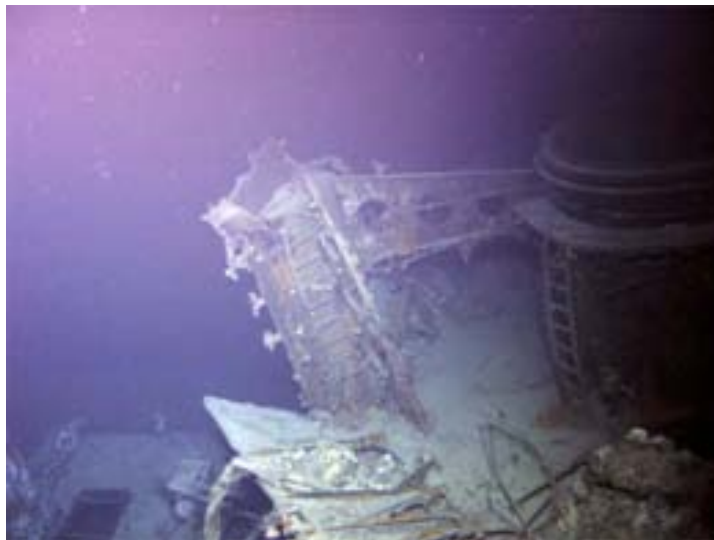
The fire control for the 4" guns was controlled by the HACS. The HACS can be found in the debris field (see Figure 189) and was likely lost early on in the battle due to a direct hit to the base of the HACS tower. This would have affected the accuracy of any fire from the 4" guns. There is evidence of significant damage to the starboard side superstructure below the HACS which could be attributed to the HACS falling shortly after being hit.

Figure 189: Damage to the HACS tower [273]

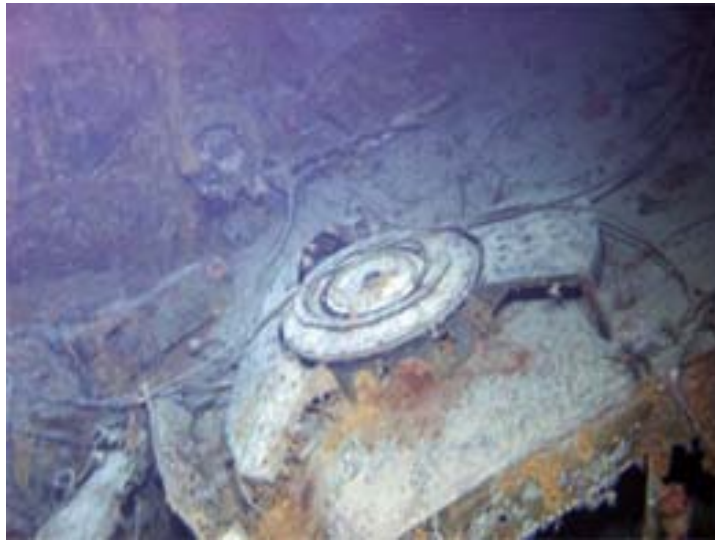
*Sydney's* quad machine guns are no longer on the decks (for example see Figure 190). It is likely that these guns were washed off the deck during the sinking.

Figure 190: Mounting for 0.5" quad machine gun [274]
