## HMAS Sydney II Commission of Inquiry

### Report on Technical Aspects of the Sinking of HMAS *Sydney* and HSK *Kormoran*

DSTO-GD-0559

This report describes the technical findings of the battle and sinking of HMAS Sydney and HSK Kormoran based on historical and archeological evidence. The battle occurred on the 19<sup>th</sup> of November, 1941 off the West Australian coast. The wrecks of the two ships were discovered in March 2008 and their subsequent underwater exploration has shed light on the events that took place during and after the battle.

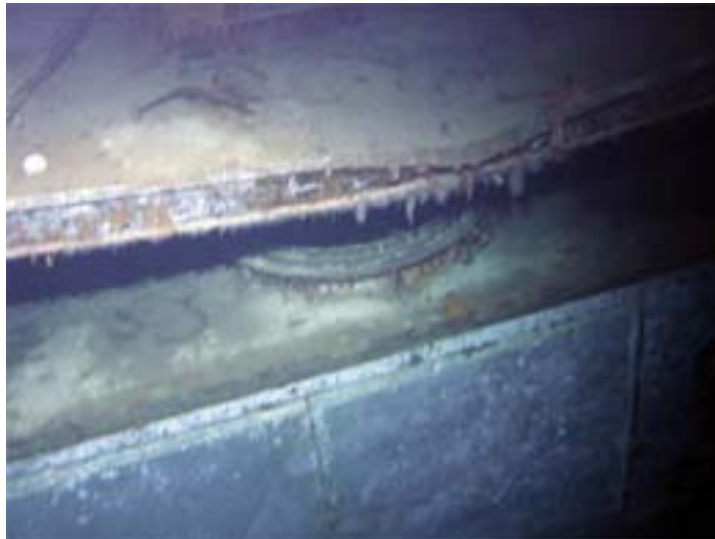
Figure 191 shows that the 4" HA gun deck above the port side tubes has been deformed downwards. This damage is possibly from secondary damage and is probably not a direct result of weapons damage. The aft strut supporting this deck has collapsed.

Figure 191: Collapsed deck over portside torpedo mount [275]

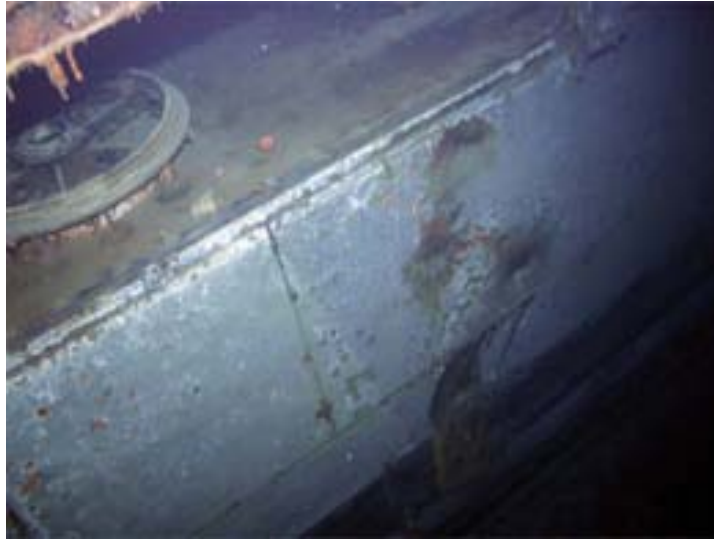
Below the starboard torpedo tubes there are four non-penetrating 15 cm shell hits (Figure 192) and it is possible that the torpedo tubes were damaged from fragments generated by these detonations.

Figure 192: 15 cm shell hits below starboard torpedo mounting ring [276]

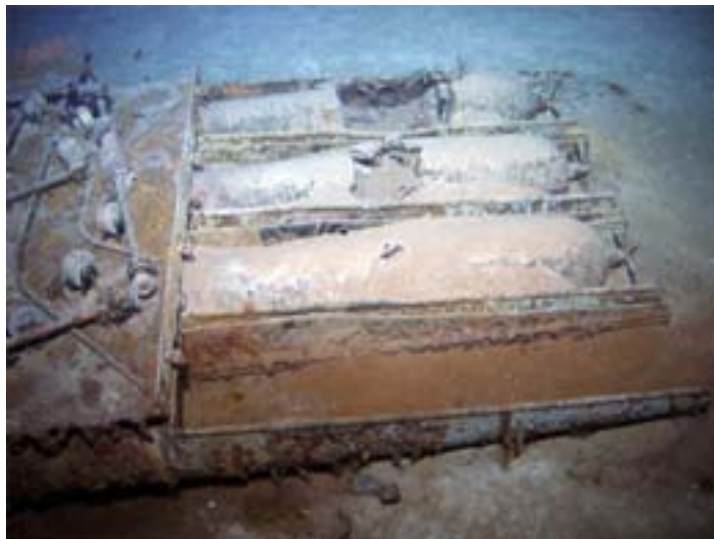
Figure 193 shows the torpedo tubes containing three torpedoes. The torpedoes in these tubes have suffered damage, with the outermost torpedo showing the most damage.

Figure 193: Starboard torpedo quad tubes showing damage to its three remaining torpedoes [277]

Figure 194 shows a diagram of the internal details of a 21" torpedo. This shows that the damage to the torpedoes has occurred between the warhead and the air cylinder of the torpedo. If a shell had damaged the warhead of the torpedo, a sympathetic detonation

would have occurred. This is obviously not the case as the torpedoes and tubes are still relatively in one piece.

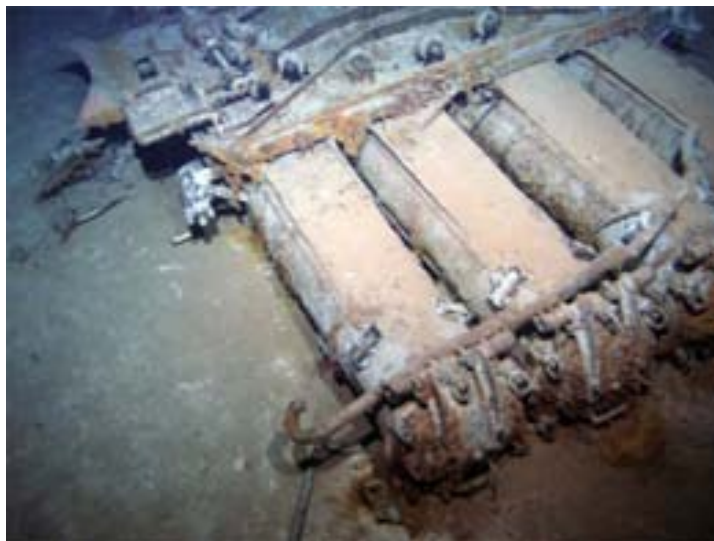
The original location of the torpedo tubes has been identified by two means. The initial method was from the general arrangement drawings [3] which show the tubes arrangement. Figure 195 shows the presence of the torpedo tube platform and manoeuvring gear on the inner side of the torpedo tube. This identifies the tube as coming from the starboard side.

Figure 195: Starboard quad tube identified by the platform on the upper left hand corner of the photograph [278]

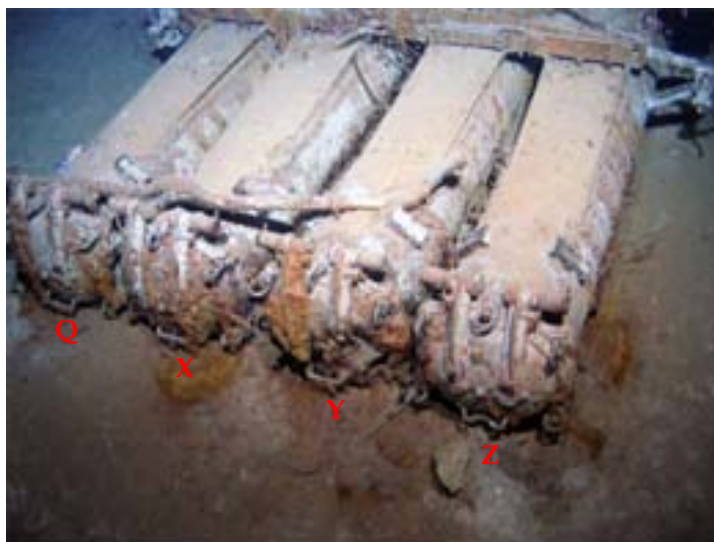
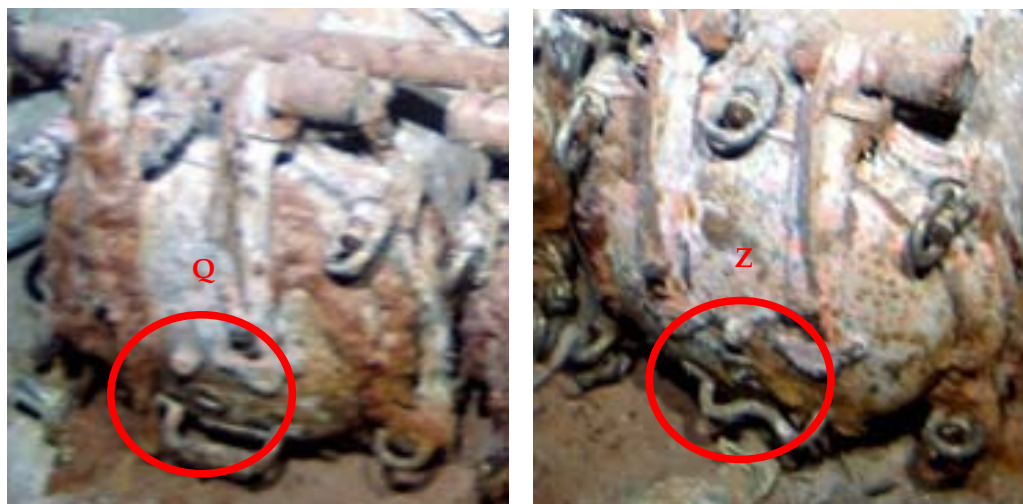
Another indicator used in identifying the original location of the tubes was the presence of letters embossed on the end caps of the tubes, which were originally used to indicate the firing sequence of the torpedoes. Figure 196 shows the presence of embossed letters labelling the tubes with the letters 'Q' and 'Z' on the two outer tubes for a more detailed view, see enlarged views in Figure 197. This identifies the quad tubes as starboard. This means that the starboard torpedo tubes still contain 3 torpedoes. It can be deduced that

the 3 remaining torpedoes fill the first three positions (Q-X-Y) of the Starboard firing sequence, with the last torpedo (Z) missing.

Figure 196: End caps of starboard quad tubes showing embossed lettering [279]

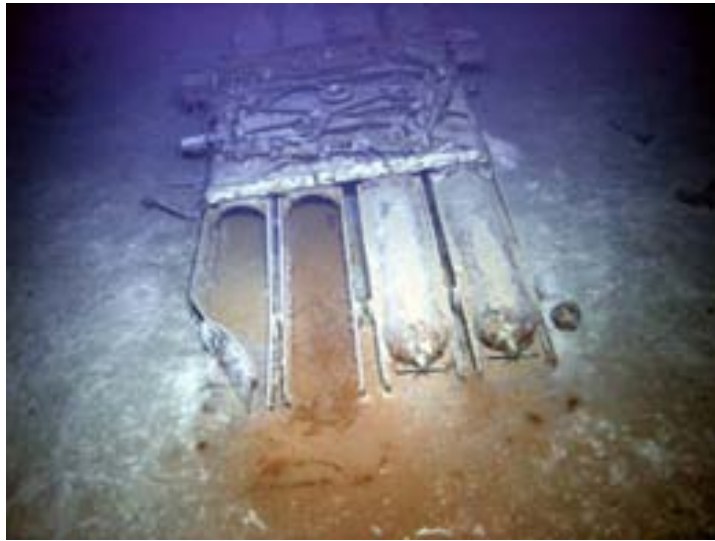
The torpedo tube containing two torpedoes is shown in Figure 198. The side of the left most tube in Figure 198 has been bent inwards on its forward end. This is probably a result of damage sustained as the tubes hit the seabed. The platform and the manual manoeuvring gear are missing.

Figure 198: Port torpedo quad tubes containing two torpedoes [280]

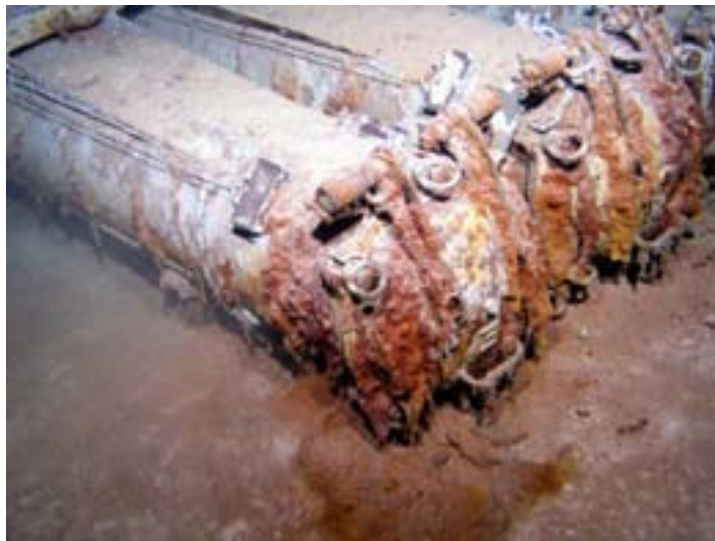
Figure 199 shows the end caps of the torpedo tubes containing the two torpedoes, the outer end cap has an embossed inverted letter 'E' clearly visible along with what appears to be the letter 'R'. These are the last two tubes in the Port firing sequence (F-I-R-E) mentioned previously.

Figure 199: End cap of port quad tube has the letter E embossed on outer tube [281]

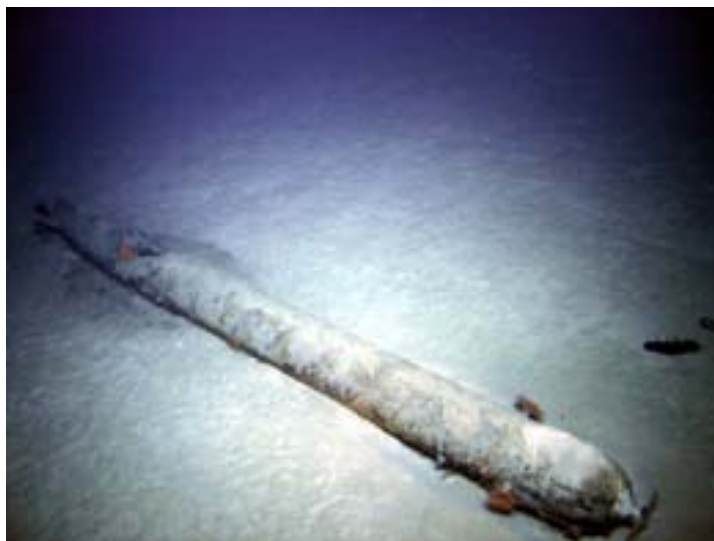
Figure 200 shows a lone torpedo that has been located in the debris field. This torpedo has been damaged towards the rear, it is possible that this torpedo could have been damaged by the sinking process. This is supported by the fact that the portion that is damaged would have been protected by the tubes. It is not possible to determine which torpedo tube this torpedo is from.

Figure 200: A torpedo in the debris field [282]

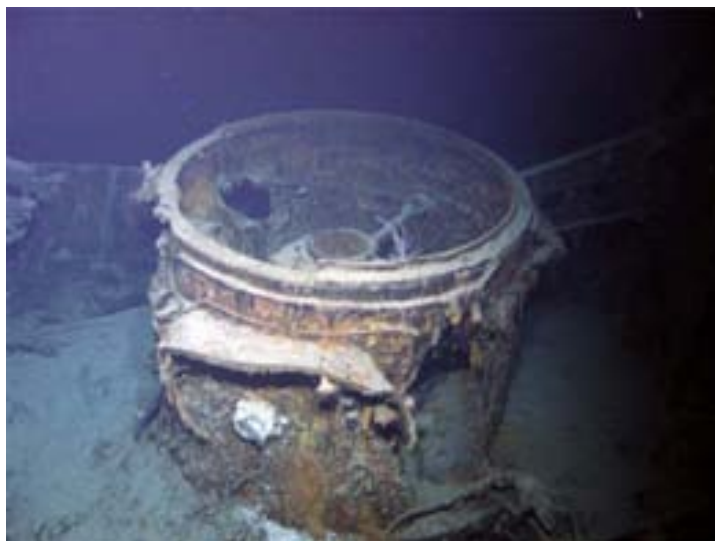
The bridge area of *Sydney* received multiple hits on the port side. Two of the most significant weapons hits in this area were to the Director Control Tower (DCT) and the High Angle Control Station (HACS). The damage to the base of the DCT is shown in Figure 210. This is a likely to have been caused by the detonation of a 15 cm shell fired by *Kormoran* and is likely to have put the DCT out of commission for the rest of the battle. Figure 211 shows a reconstruction of the DCT as it was attached to the bridge so that the original configuration of the ship in this area can be understood. It should be noted that the DCT is not likely to have been removed from its mountings by the damage received and that the DCT is likely to have separated from its mounting as a result of the sinking. All crew in the DCT would have sustained injuries from the weapons damage.

*Figure 210: Damage to DCT support [288]*

The starboard side of the ship has also received a considerable amount of damage from weapon hits. On the DCT there is at least one, but possibly two additional hits to the support structure (see Figure 210) and another penetrating hit to the main DCT (Figure

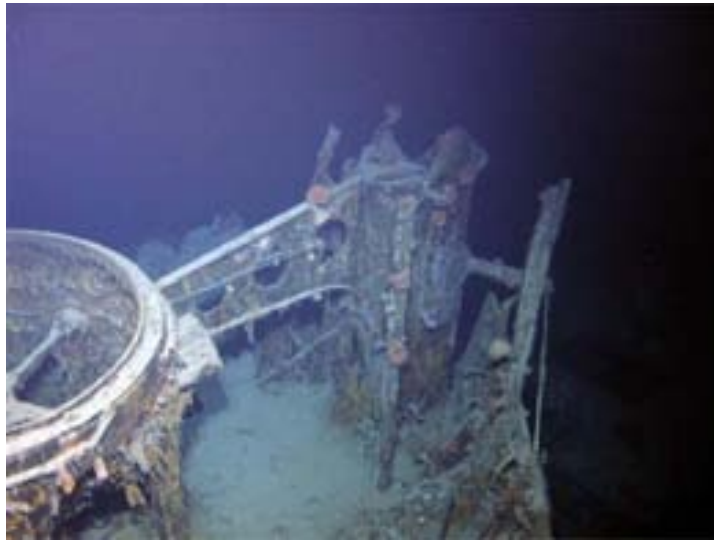
The HACS also received a very significant hit on the tower support, as shown in Figure 212. The original configuration of the HACS is shown in Figure 213, and shows that there was a considerable structure above where the HACS has broken off after the shell damage. Examination of the damage to the support and damage to the surrounding structure has led to the conclusion that this hit came in from the port side and led to the HACS buckling over towards the starboard side of the ship. The damage to these two structures would have left *Sydney* with seriously diminished fire control capabilities.

Figure 212: High Angle Control Station support [289]

This damage is likely due to a shell hit and subsequent detonation to the HACS support. The base of this support is shown in Figure 293 and this figure shows that the metal on the back edge of the hole has buckled backwards. This suggests that the tower has fallen backwards on to the aft end of the upper superstructure. This is supported by damage to the deck in this region. It is not obvious from Figure 293 that the damage to the tower support is due to a shell hit, but the damage to the upper section of the tower support shown in Figure 294 leaves no doubt that the damage is due to a 15 cm HE Shell detonation with obvious fragment damage and metal petalling due to the detonation. This detonation would have caused the HACS tower to collapse. A reconstruction of the HACS position is provided in Figure 213 showing that a large amount of the HACS structure has been removed by this hit.

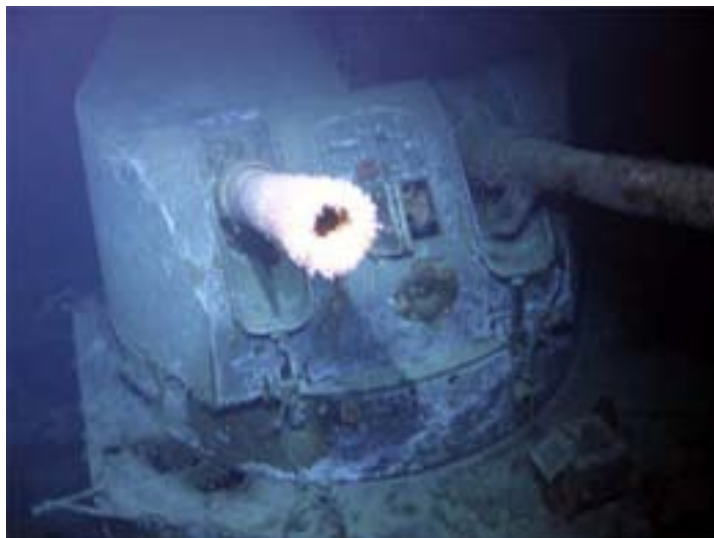
Moving forward of the bridge there are two significant points of damage on B Turret (Figure 214) that are evident from the port side. The hit between the barrels of B Turret indicates that the shell did not fully penetrate the armour plate as the hole is less than 15 cm in diameter. However, lack of fragment damage around this hole indicates that the shell may not have exploded at this location; it either failed to explode or the damage at the base of B Turret may be the result of the shell falling down onto the deck from this

shot. Another significant observation is the missing roof section on B Turret which may have been thrown off the turret due to the shock of the shell hitting the armour plating. The hit between the barrels shows that this turret was aimed at *Kormoran* at the time of the hit. It is likely that damage to the turret base jammed the turret mechanism.

Figure 214: Hits to B Turret [291]

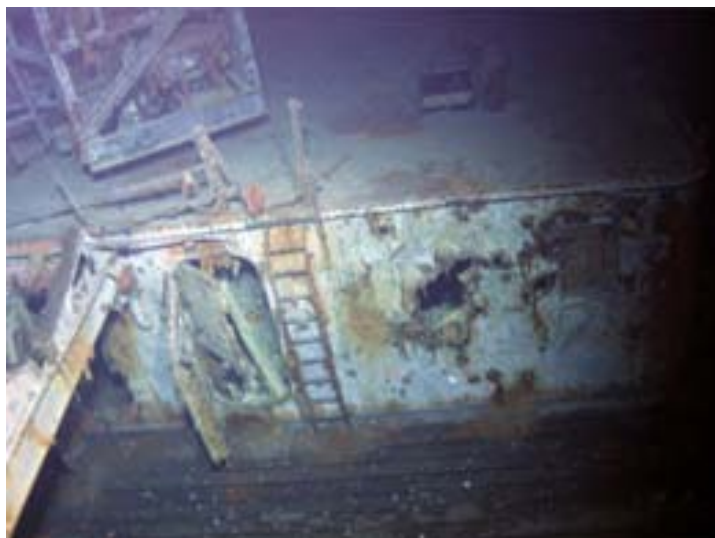
Figure 215 also shows extensive shell damage to the bakery which would have resulted in extensive fragment damage to the surrounding area which includes the port side Pinnacle and the two Carley floats.

Figure 215: Damage to port side of Bakery [292]

The bakery also shows evidence of significant damage on the port side due to both shell hits and fragments (see Figure 215). The sea-plane catapult has also received two shells hits that would have sprayed hot fragments over the aircraft and surrounding structure. Again, the potential for collateral damage is not evident until considering a reconstruction of this area of the ship as in Figure 216.

The bakery has received extensive damage from shells. P2FA28 is likely due to a contact detonation of a 15 cm HE Shell and has led to a 3' x 2' 6" (900 x 450 mm) hole on the port side. Note that there is extensive debris visible within the bakery, indicating extensive internal damage to this compartment. It is also likely that the aircraft and boats in this vicinity received fragment damage. The equipment originally in this area is shown in the reconstruction in Figure 216.

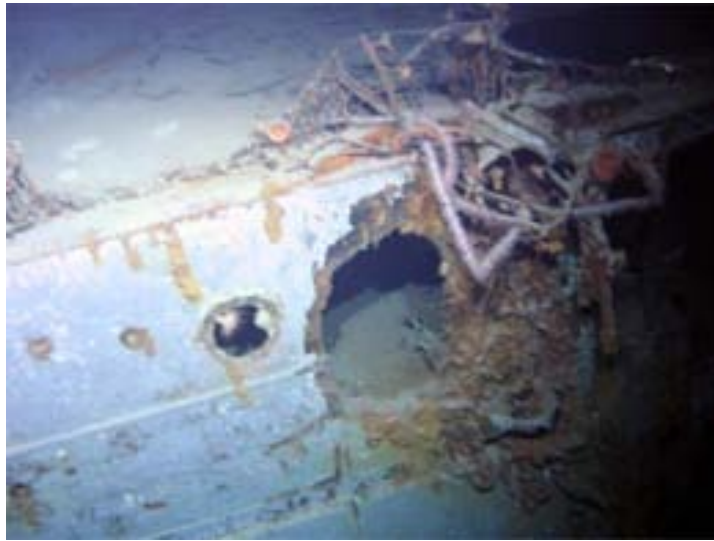
Figure 219: Contact detonation around the 32' Cutter davits [293]

The shells which detonated on contact would have generated a large number of fragments. The hit to the area surrounding the davits supporting the 32' Cutter, shown in Figure 219, are likely to have caused significant damage to this boat. Although the collateral damage may not be obvious from the ROV footage, when considering a reconstruction of the ship in this region (as shown in Figure 220), the potential for fragment damage to the 32' Cutter and surrounding structure is obvious.

The davits for the Cutter are missing and were most likely damaged/ destroyed during the engagement. They are located slightly aft of the bridge and this was where extensive weapons damage is seen. It is highly likely that the Cutter was also possibly blown or fell into the water during the engagement. Whilst at sea the Cutter was swung outboard on the davits. If the davits were damaged the boat would not have fallen onto the deck but into the ocean. Thus, it is not likely that any remains of the Cutter would be found in the debris field but more likely at the location of the engagement.

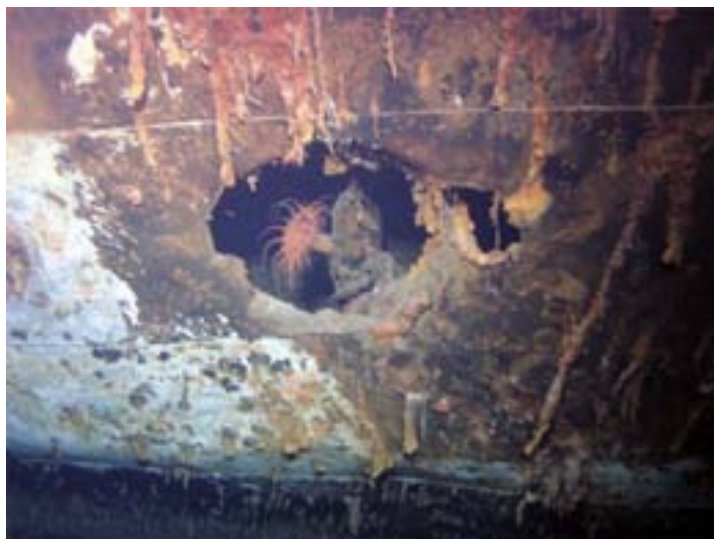
The hull under B Turret has also received a number of hits and there is evidence that multiple shells have penetrated the upper and Lower Mess areas on the port side. One significant region of damage has breached the water tight bulkhead between No. 3 and No. 2 Lower Mess's, as shown in Figure 221. This damage is likely to have been caused by a contact detonating shell. There are also numerous holes from shells that have penetrated the hull (for example Figure 222). These shells are likely to have been AP shells and although the damage on the hull appears non-lethal, the internal detonation of these shells would have caused significant internal damage to structures, equipment and crew and had a major effect on the function of the ship. These hits would have had a major effect on the damage control effort in controlling damage from the torpedo hit. As DC1 was based in this location heavy casualties would have occurred from these hits.

Figure 221: Example of contact detonating shell [294]

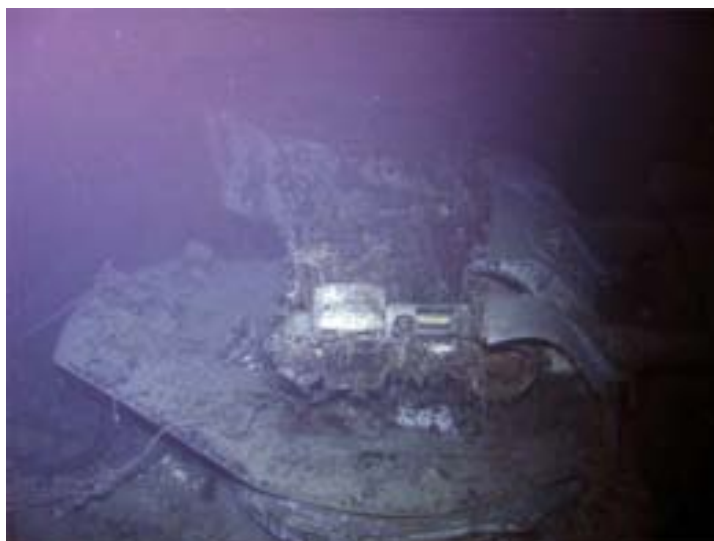
A turret has received considerable damage from hits to the starboard side (Figure 230). The starboard side armour shows that A turret received four separate hits (Figure 233), two of which detonated on contact and the other two penetrated the armour plating. These hits would have destroyed this turret. These hits would have occurred with A turret pointed to port, possibly indicating that the hits occurred as *Sydney* swung around the aft of *Kormoran*.

Figure 230: Damage to A Turret [301]

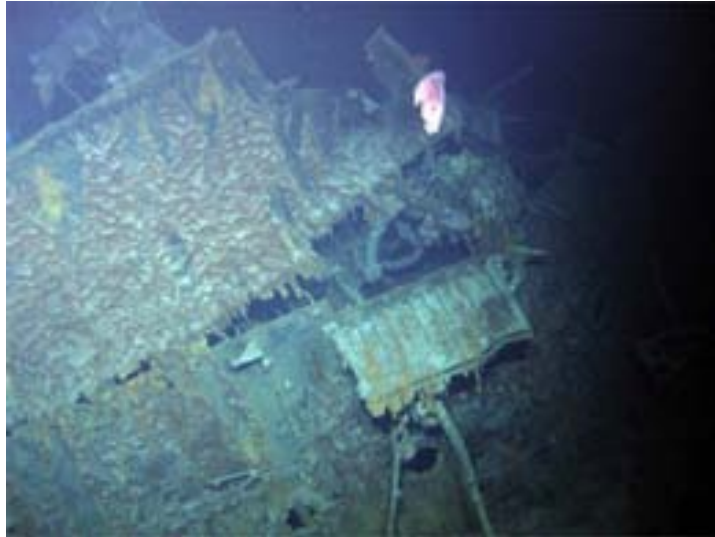
The bridge superstructure has also received additional hits on the starboard side, but again fire and sinking damage makes it difficult to categorically state that all the weapons hits have been identified (Figure 231).

Figure 231: Damage to bridge

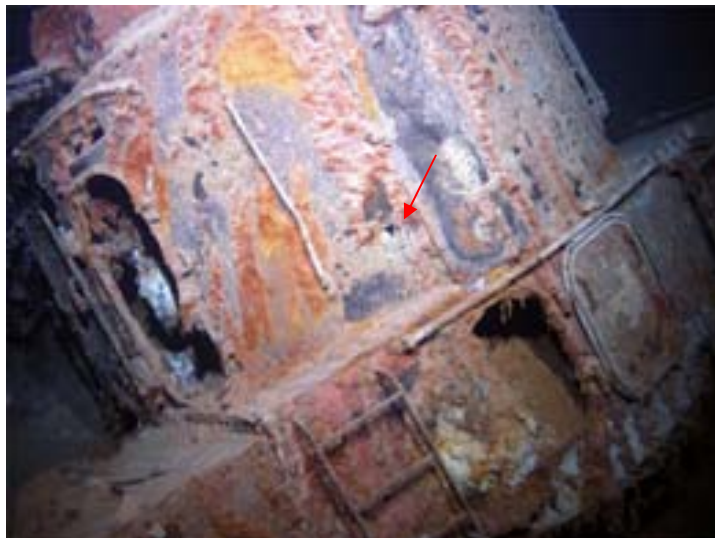
232). If any function in the DCT had remained operational after the hit to the port side, which is highly unlikely, the additional hits on the starboard side would have definitely put the DCT firing control permanently out of operation.

Figure 232: Hit to DCT [302]

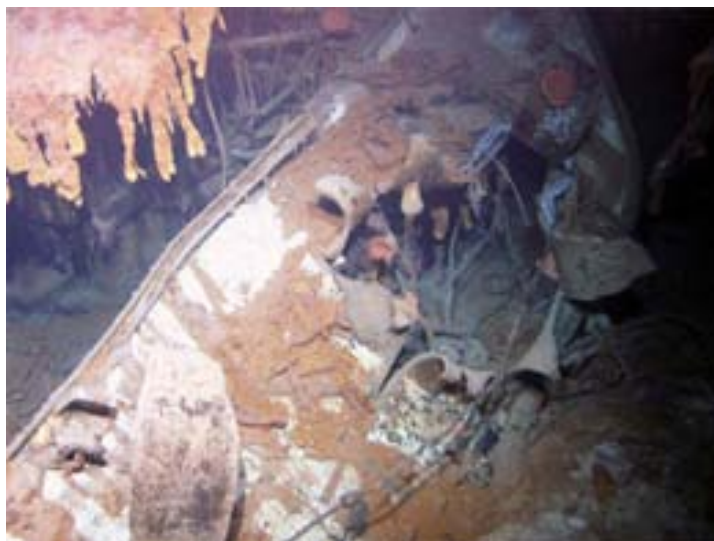
*Figure 233: Starboard side armour of A Turret [303]*

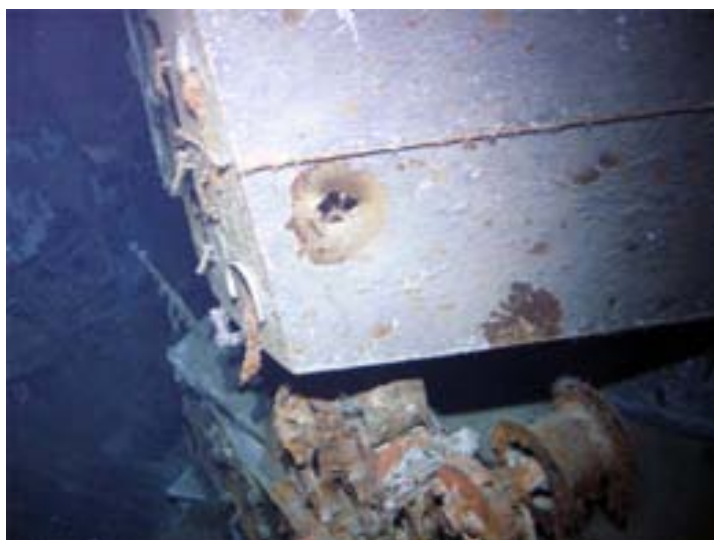
Although, X Turret has received a hit on its port side armour, it is likely due to the port bearing of the gun that this hit came in from the starboard side (Figure 234). This shell has penetrated the gun turret and there is evidence that it has detonated inside removing the rear port hatch [304].

*Figure 234: Hit to X turret [305]*

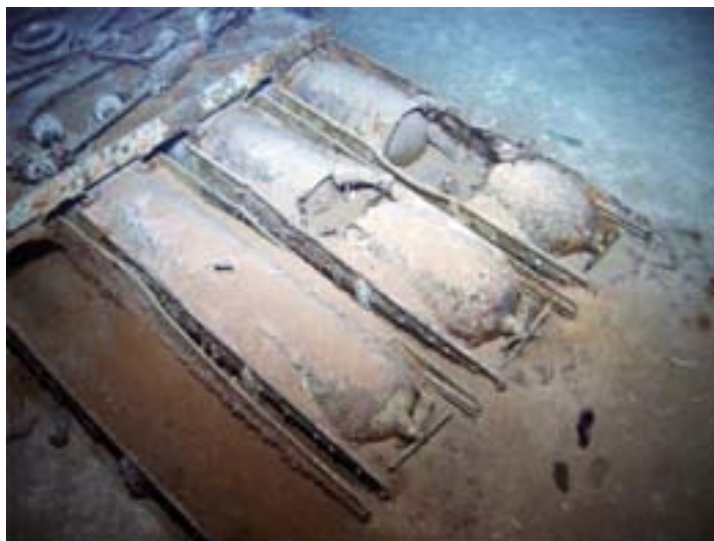
There is also damage to the starboard side torpedo tubes which is either a result of a shell hit, or due to fragment damage (Figure 235). This hit would have essentially disabled these torpedo tubes preventing them from being fired.

Figure 235: Damage to starboard side torpedo tube [306]

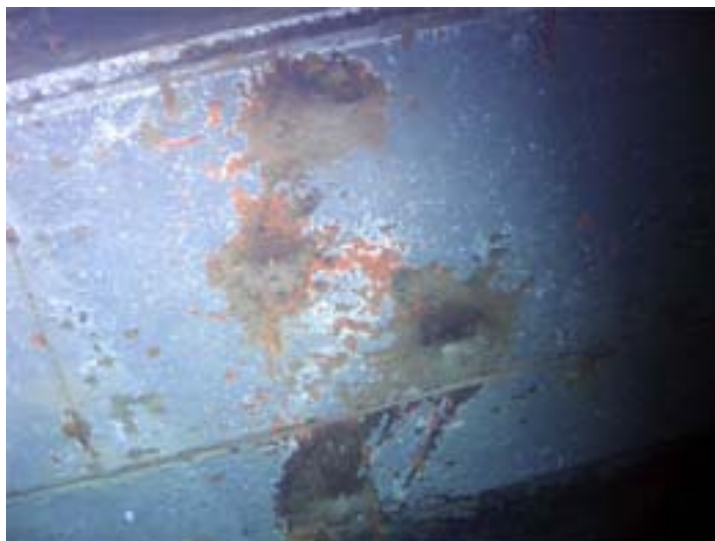
The starboard side of Sydney has also received multiple hits along the hull, particularly around the armour plating protecting the engine room. The value of the armour plating around the engine space is demonstrated by a number of these hits, where there is obvious shell impact, but it has not penetrated the hull (Figure 236). A number of hits have penetrated the armour plating and Figure 237 shows a hit that has probably penetrated the armour and possibly detonated inside *Sydney*. Figure 238 and Figure 239 show hits that have probably detonated on the outside of *Sydney*, but the fragments from the detonation have penetrated the armour. The hits in Figure 238 and Figure 239 would have caused some internal damage to *Sydney*, but this damage would be much less than if the shell had detonated on the inside of the ship. It is also interesting to note that a number of the hits on the armour plating appear to have impacted at an angle. For example the hit shown in Figure 238 is likely to have been fired from a position somewhere forward of *Sydney*. This is evident from the direction of the fragment markings on the hull. It is not possible from the evidence available to predict the angle at which this shell hit *Sydney* with any accuracy. Shell detonations in general would have been responsible to spraying fragments over the deck; this may have damaged the surrounding structure such as the boats and aircraft on the deck of *Sydney*. Figure 240 is a good example of a hit that is likely to have sprayed numerous fragments over the surrounding deck.

*Figure 236: Non-penetrating shell damage to the armour plating [307]*

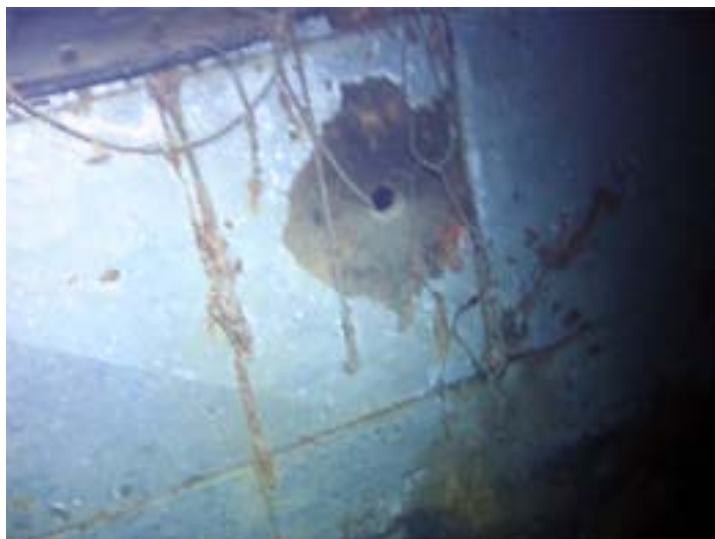
*Figure 237: Penetration to armour plating [308]*

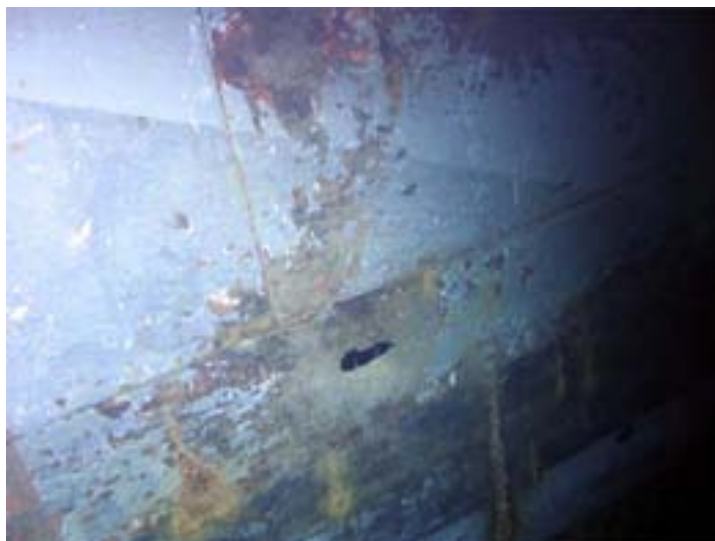
*Figure 238: Example of a shell that has probably hit Sydney on an angle [309]*

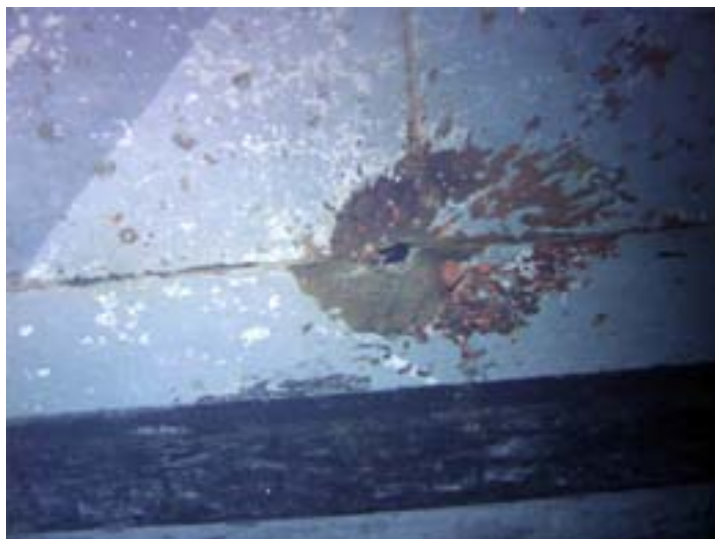
*Figure 239: Example of shell that has hit the armour with fragments causing the penetration  
(Note: Port side hit) [310]*

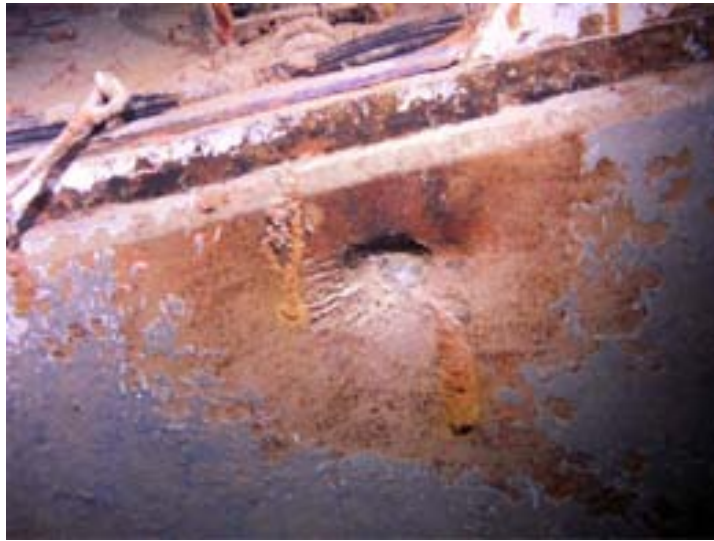
*Figure 240: Example of shell damage that probably sprayed hot fragments over the surrounding deck [311]*

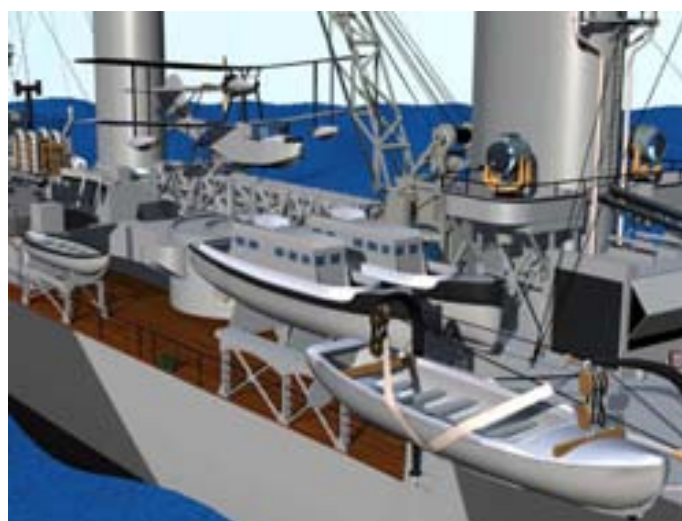
There is some evidence of fragment damage to the boats but the extent is difficult to determine for the reasons outlined in Chapter 4. All the boats show some degree of physical deterioration but they do not tend to show any significant fire damage. One of the Motor boats also shows extensive physical damage possibly due to an impact by a large object that has crushed a large section and almost broken the boat in two. Interestingly, next to this boat in the debris field is the remains of the seaplane catapult that may have hit the boat during the action or during the sinking. Given the difference in the physical state of the two 35' Motor boats, and knowing that they were next to each other on the starboard side, they could be expected to have similar damage. The fact that one shows far greater damage could be due to factors other than the weapons effects. The Whaler does show a single large shell hole in the frame indicative of weapon damage. The reconstruction of the starboard area showing the boats that would have been damaged by fragments sprayed onto the deck is shown in Figure 241.

*Figure 241: Reconstruction of midships*

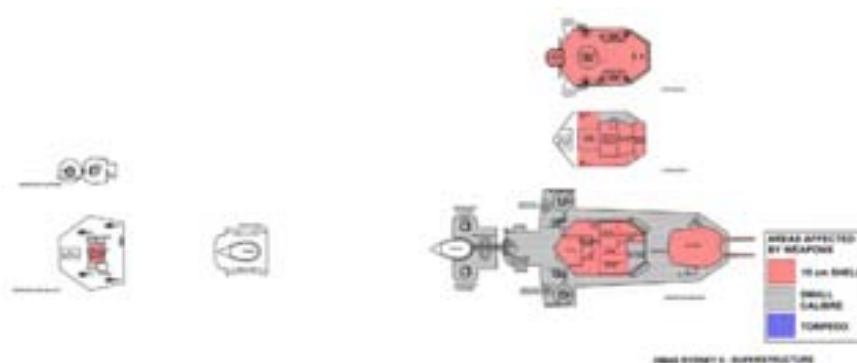
Figure 243: Predicted extent of weapon damage to superstructure and bridge compartments

Most of the superstructure and bridge compartments have been assessed as being affected by fragment damage and the exposed spaces on the Superstructure deck would have been highly likely to have sustained damage due to small calibre weapons and fragments. All equipment and personnel in these areas are deemed as incapacitated.

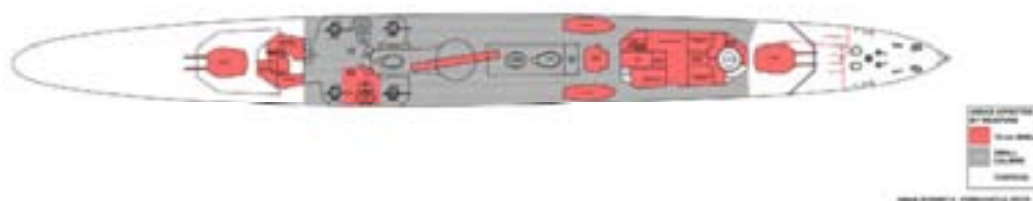
The Forecastle deck (Figure 244) was very exposed to small calibre weapons and the effects of thousands of fragments generated from hits to the forward superstructure region and the hits on the catapult and similar regions. The boats, Carley floats and personnel on this deck would be assumed to have been severely affected.

Figure 244: Predicted extent of weapon damage to Forecastle deck compartments

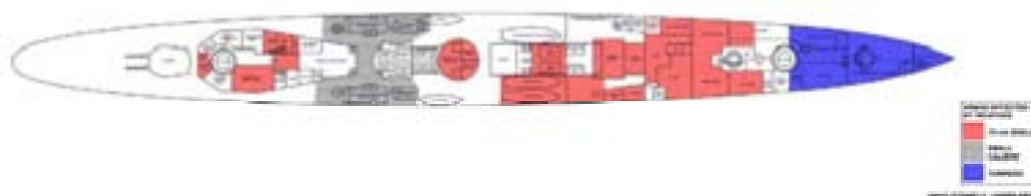
The extent of damage to the forward upper deck region (Figure 245) is significant. The number of hits identified would have severely limited the access and passage to the damage control crews in not only repairing the damage from the torpedo, but fighting the fires and repairing the associated damage from the shell hits in this region, the superstructure and bridge compartments.

Figure 245: Predicted extent of weapon damage to upper deck compartments

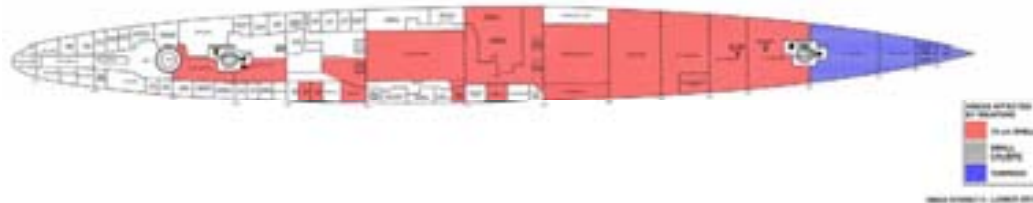
There is extensive damage to the lower deck mess compartment (Figure 246) from shell fragments and debris. The extremely important Damage Control Stations 1 and 2 have been showered with fragments which would have led to a large number of casualties from crew involved in repairing the ship and controlling the flooding and fires.

Figure 246: Predicted extent of weapon damage to lower deck compartments

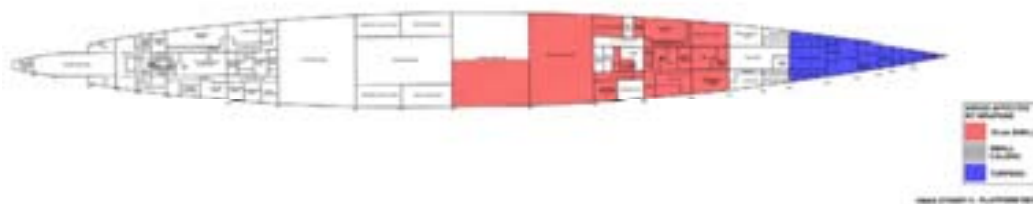
Damage to the forward section of the platform deck (Figure 247) indicates important areas such as the forward steering room, switchboard room and breaker rooms being hit by weapon fragments. It is important to note that the aft compartments of this platform are free of any weapon damage.

Figure 247: Predicted weapon damage to platform deck compartments

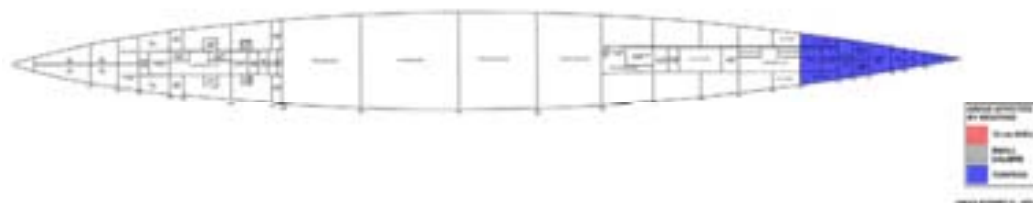
Apart from the torpedo damage, the hold (Figure 248) is intact from weapons damage. However there would be limited access to these areas due to the weapon effects in the upper decks, especially in the forward part of the structure.

Figure 248: Predicted extent of weapon damage to hold

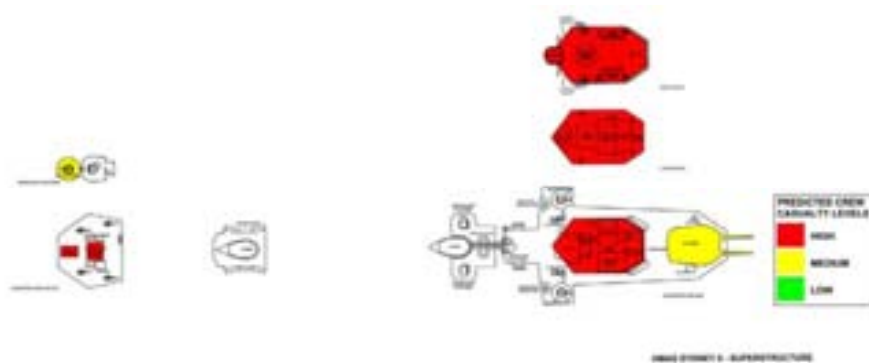
Figure 249 is purely the casualty level expected in the compartments from the identified shell hits. Exposed personnel and equipment would have had high casualty levels in all areas due to fragments and smaller calibre weapons. Kormoran survivors mention that the 3.7 cm gun was trained on the bridge region.

Figure 249: Probability of crew casualties in the Superstructure deck compartments resulting from 15 cm shell hits

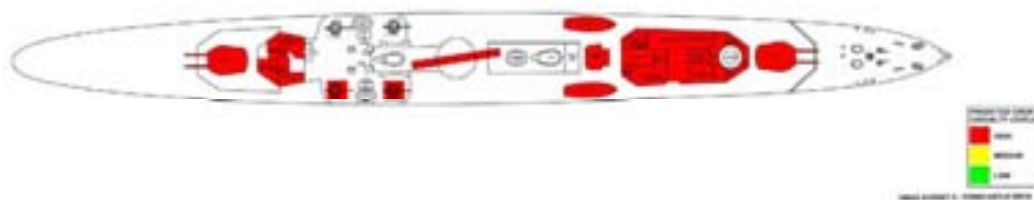
Figure 250 show the probability of casualties in spaces defined by the analysis. Again extensive damage from the smaller calibre weapons would result in high casualty levels to both the exposed crew and equipment on this deck.

Figure 250: Probability of crew casualties on the Forecastle deck resulting from 15 cm shell hits.

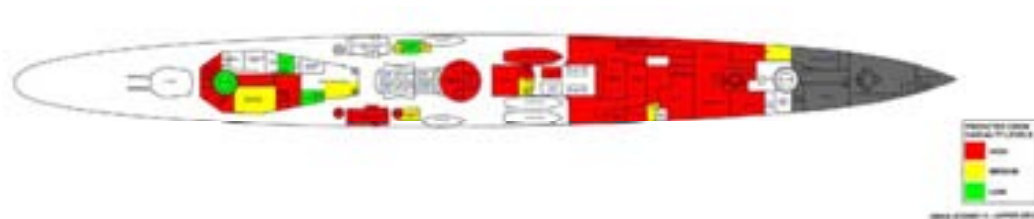
Figure 251 shows casualties in spaces on the upper Deck. Extensive damage to the forward spaces is shown. The torpedo damage highlighted is purely the structural damage. Personnel and equipment in Turret A zones would have high rates of casualties due to the torpedo effects on this zone.

Figure 251: Probability of crew casualties resulting from a 15 cm shell into the upper deck

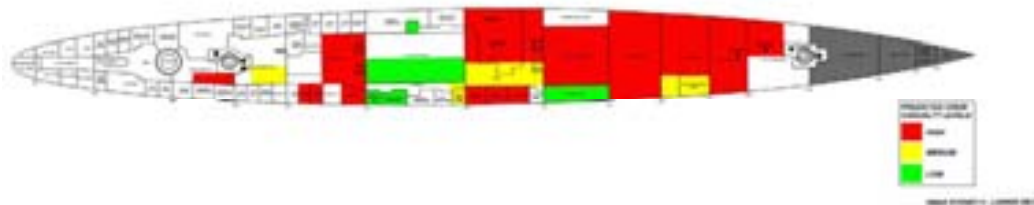
Figure 252 illustrates that the main Damage Control Stations in the engineering workshop and lower mess 2 have high rates of casualties. The torpedo damage shown is purely structural.

Figure 252: Probability of crew casualties resulting from a 15 cm shell into the lower deck

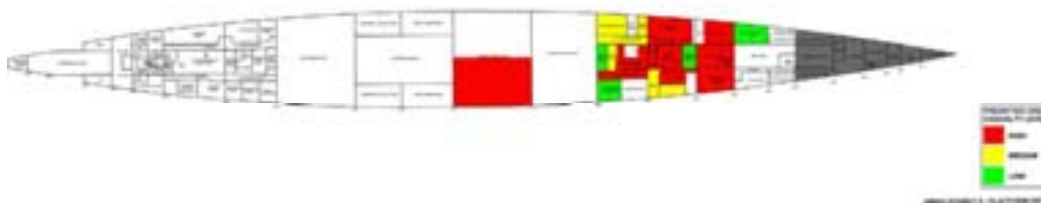
Major compartments of interest in Figure 253 are the switchboard room, lower steering room, and breaker rooms. Each has been estimated to have received a certain amount of damage.

Figure 253: Probability of crew casualties resulting from a 15 cm shell into the platform deck

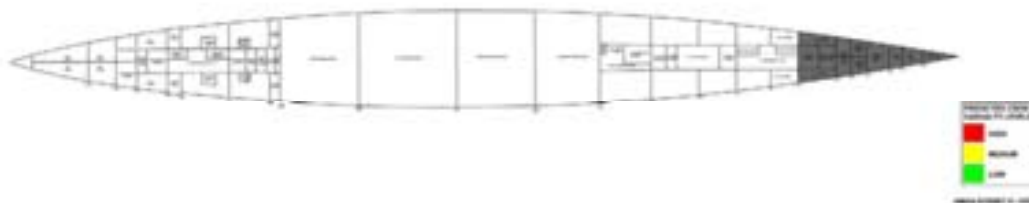
Figure 254 indicates that no crew casualties from direct weapons effects were expected in the hold.

Figure 254: Probability of crew casualties resulting from a 15 cm shell into the hold

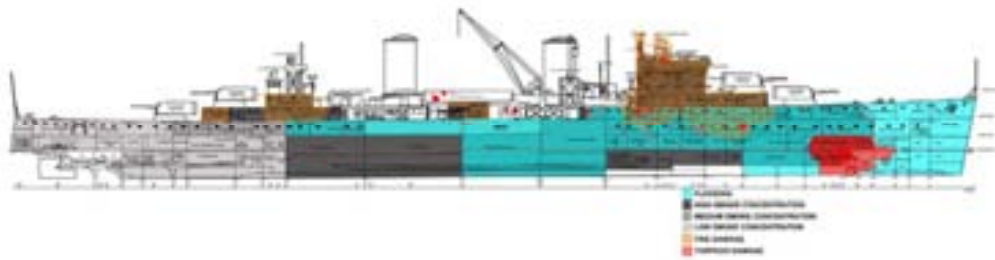
Figure 255: Port side total damage profile prior to sinking

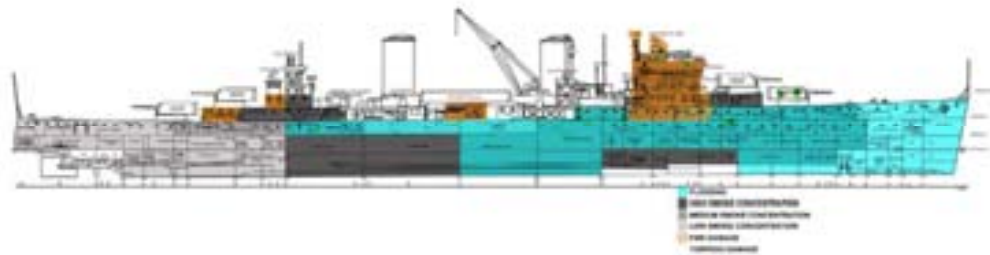
Figure 256: Starboard side total damage profile prior to sinking

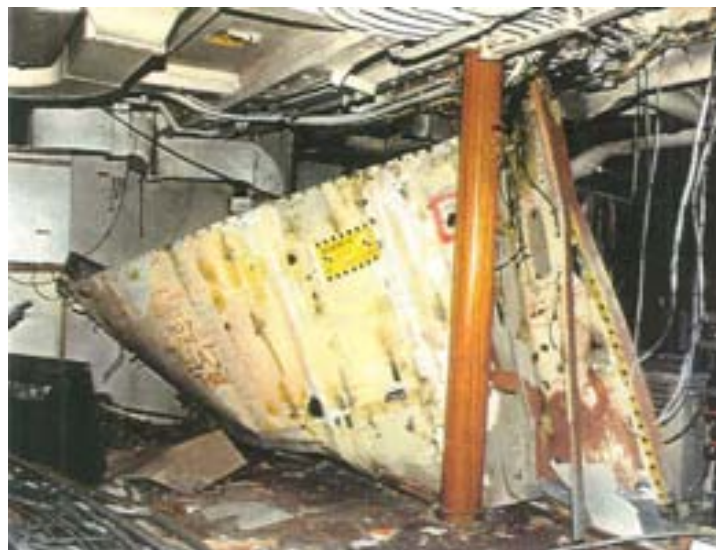
Weapon damage would have caused considerable difficulty for the crew to move about the ship to escape from internal areas or to conduct damage control activities. As an example of damage, Figure 257 shows the damage caused to a partition bulkhead from the internal blast from a 4.75 kg cased charge during an experiment on ex - HMAS Derwent [285]. The bulkhead is joined by bolts or rivets. Such internal damage can occur to doors, hatches, ladders, and provides obstructions to movement; particularly where lighting is lost due to damage or when smoke is present.

Figure 257: Damage to a bulkhead from the internal blast from a 4.75 kg cased charge [285]

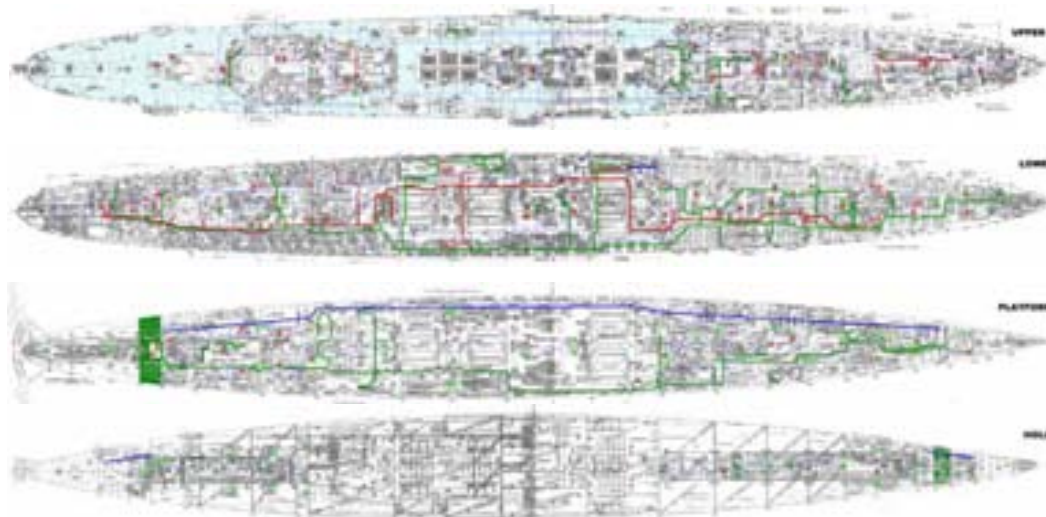
The area of the ship shaded in light grey in Figure 259 was structurally intact. However the services in this area would have been deleteriously affected by the damage sustained in the remainder of the ship. The impacted systems in the light grey area probably included the electrical branch lines and equipment, which could have caused disruptions to the main electrical supply, requiring the isolation of some of the branch lines. It is possible that emergency leads were run to some equipment, or used as the main supply if damage to permanent cabling was too severe.

As can be seen from an examination of Figure 259 it is highly unlikely that any damage control was carried out in the forward section of *Sydney*.

*Figure 259: Systems and composite damage extents after the battle*

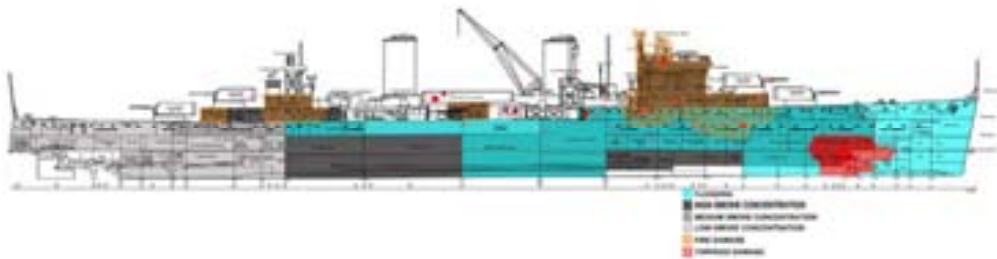
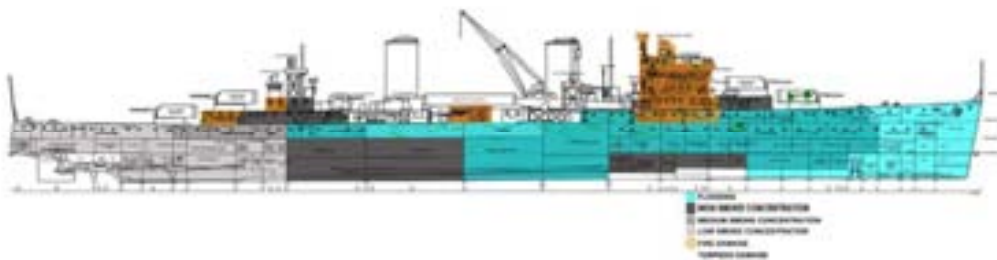
*Port side total damage profile prior to sinking.*

*Starboard side total damage profile prior to sinking.*
