## HMAS Sydney II Commission of Inquiry

### Report on Technical Aspects of the Sinking of HMAS *Sydney* and HSK *Kormoran*

DSTO-GD-0559

This report describes the technical findings of the battle and sinking of HMAS Sydney and HSK Kormoran based on historical and archeological evidence. The battle occurred on the 19<sup>th</sup> of November, 1941 off the West Australian coast. The wrecks of the two ships were discovered in March 2008 and their subsequent underwater exploration has shed light on the events that took place during and after the battle.

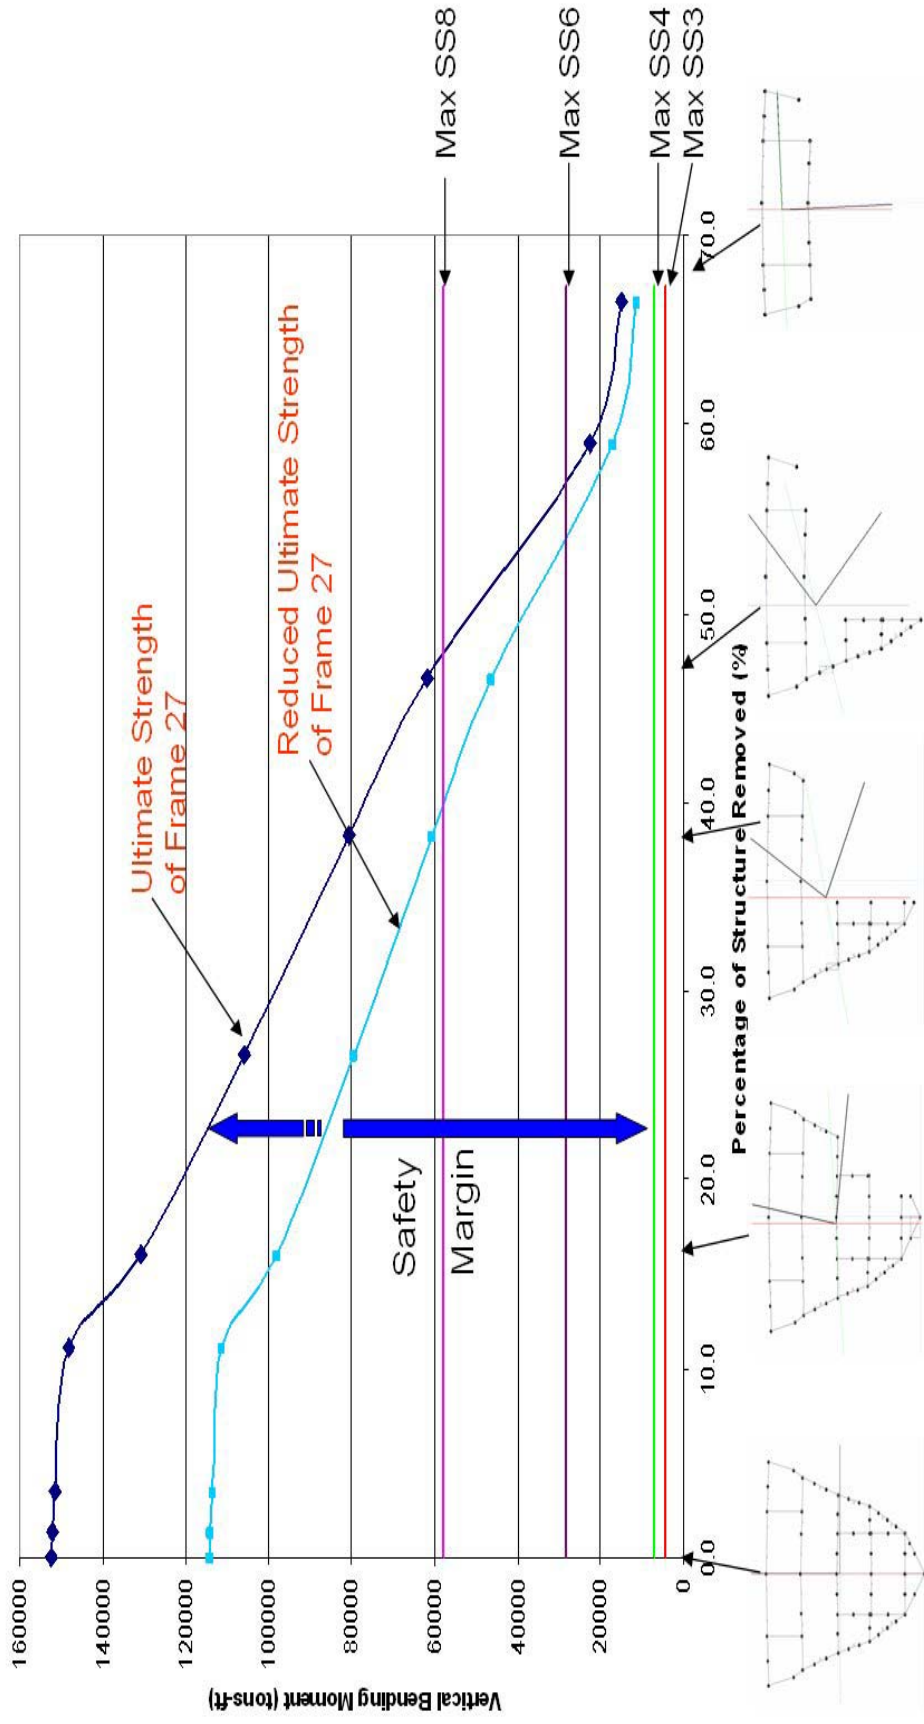
Figure 261: Comparison of Ultimate Bending Strength and Bending Moments due to Sea Loads at Frame 27 for Asymmetric Damage

From the plots in Figure 261 and Figure 262, it can be seen that for both the asymmetric and symmetric damage cases, the ultimate strength of the section remains greater than the sea loads in sea states three and four, for even the most extensive damage. The bending moments for sea states six and eight have been included as a guide to the level of residual ultimate strength of the section at frame 27.

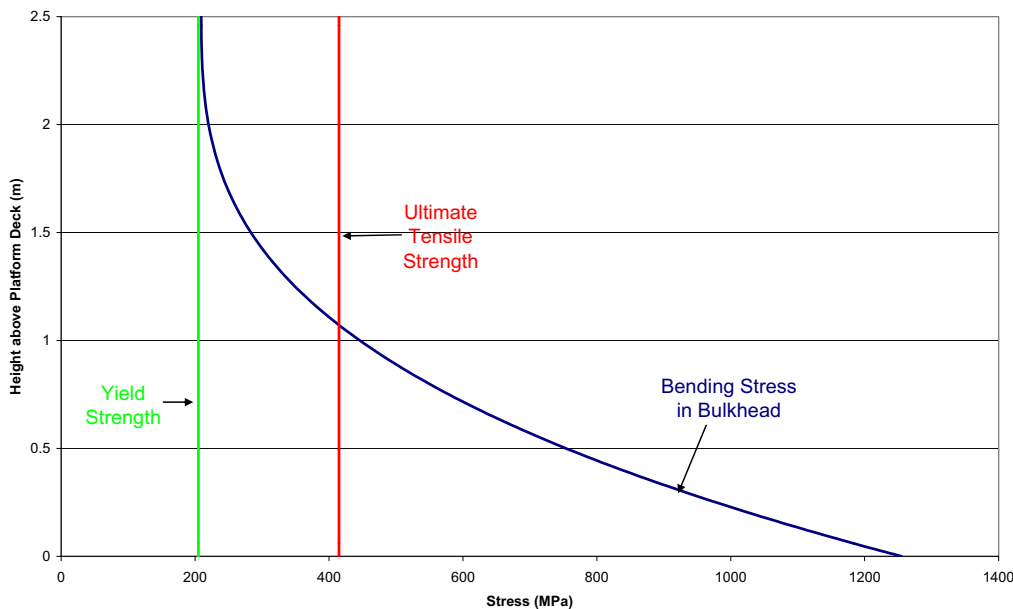
Figure 264: Bending Stress along Height of Bulkhead at Frame 53 along with Ultimate and Yield Strengths of D grade Steel

From Figure 264 it can be seen that the bending stress in the bulkhead is greater than the yield strength of the steel over the entire height of the bulkhead panel analysed. It should be noted however, that this simplified approach tends to overestimate the stress in the bulkhead at the upper and lower edges, and that it is likely that the maximum stress in the bulkhead will be at approximately mid height [314]. At the midpoint of the bulkhead panel, from Figure 264 it can be seen that the bending stress is well into the plastic region of the steel material. This is consistent with the literature that was reviewed in the previous section.

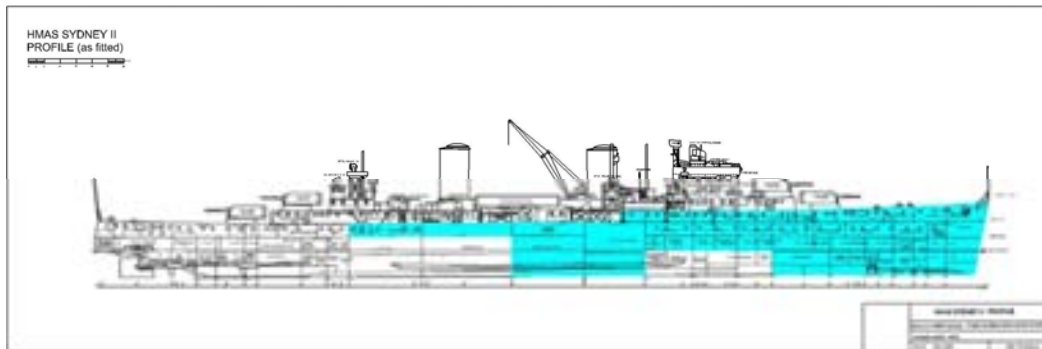
Figure 265 Profile of Sydney showing potentially flooded compartments due to weapons damage

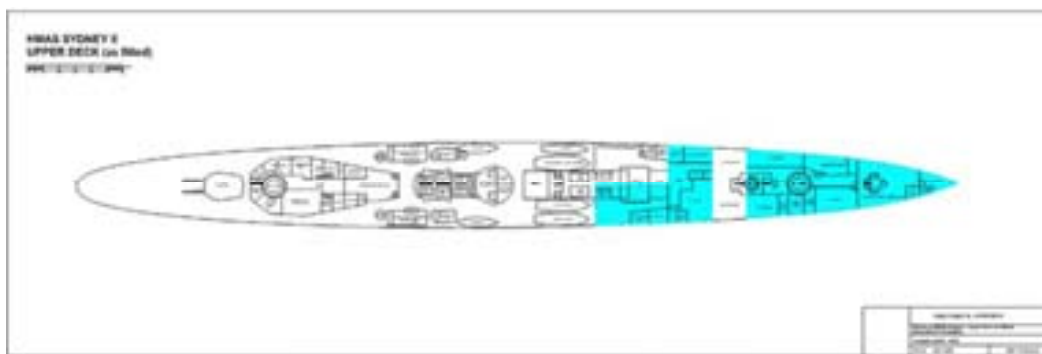
Figure 266 Upper Deck of Sydney showing potentially flooded compartments due to weapons damage

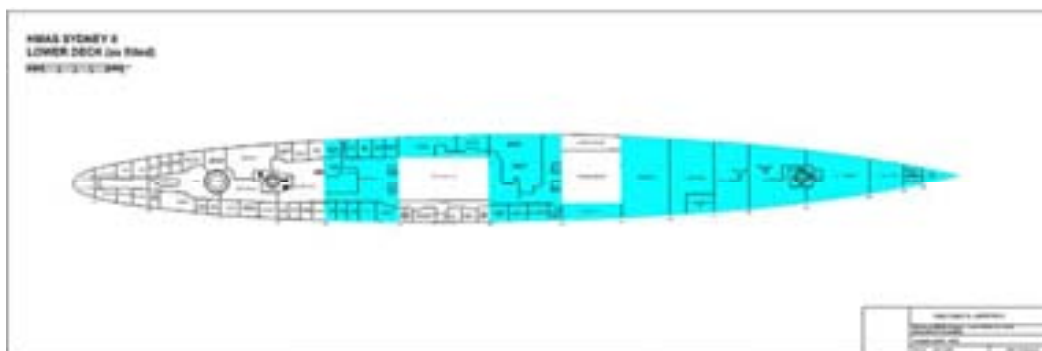
Figure 267 Lower Deck of Sydney showing potentially flooded compartments due to weapons damage

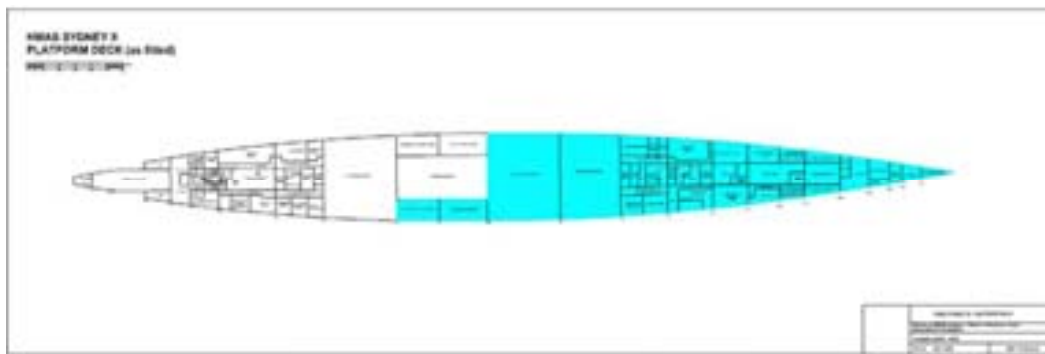
Figure 268 Platform Deck of Sydney showing potentially flooded compartments due to weapons damage

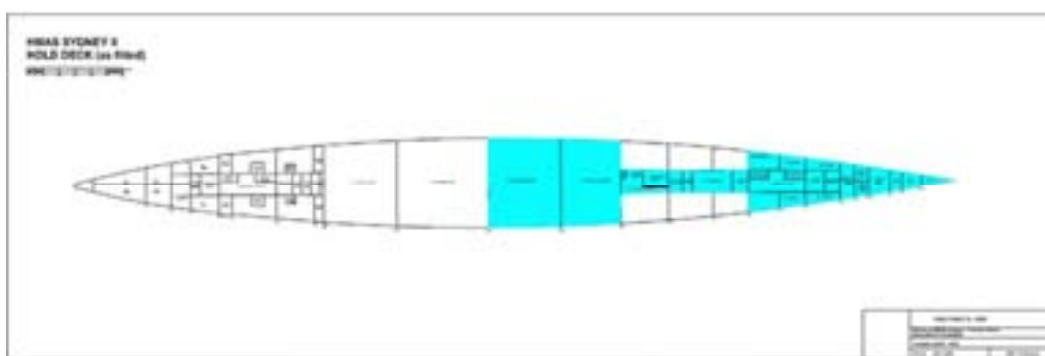
Figure 269 Hold of Sydney showing potentially flooded compartments due to weapons damage

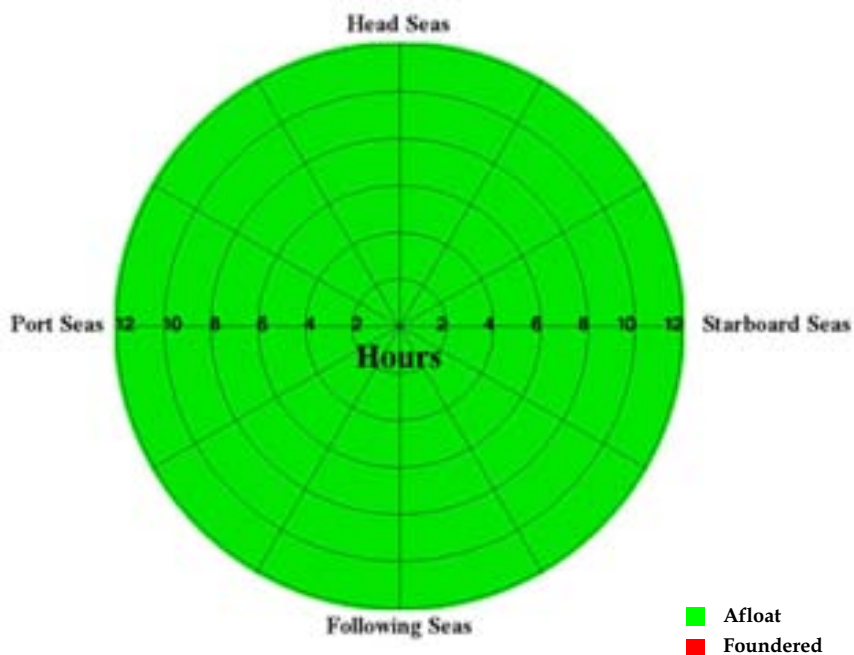
Figure 270 shows a polar plot indicating that with the damage extents described above *Sydney* potentially could have remained afloat for at least 12 hours independent of the headings she sailed. These results are based on the assumptions that the wave environment was sea state 3 and that *Sydney* was sailing at a speed of 5 knots.

Figure 270 Polar plot indicating time Sydney remained afloat in Sea State 3 considering flooding through hull penetrations and torpedo damage only

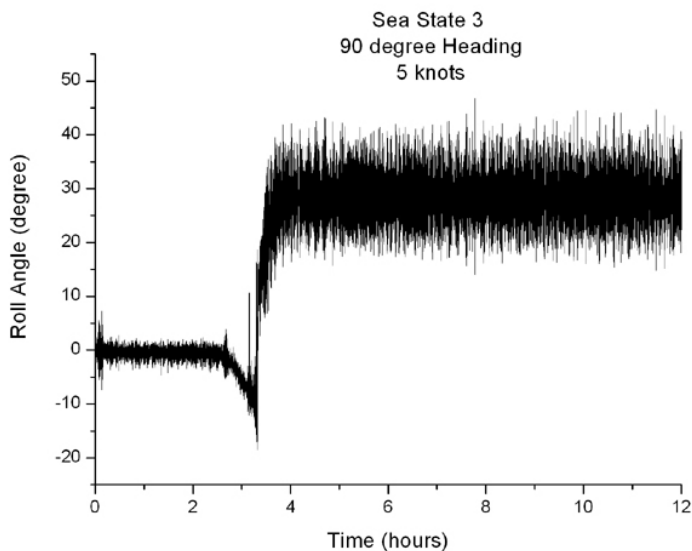
Although remaining afloat, the time history for the roll of the vessel sailing in beam seas, as shown in Figure 271, indicates that after approximately 4 hours from the battle the vessel may have been constantly rolling between approximately 15° and 40° to port. Any attempt at damage control and/or evacuation at these large roll angles would have been virtually impossible.

Figure 271 Time record for the roll motion of Sydney in Sea State 3 considering flooding through hull penetrations and torpedo damage only

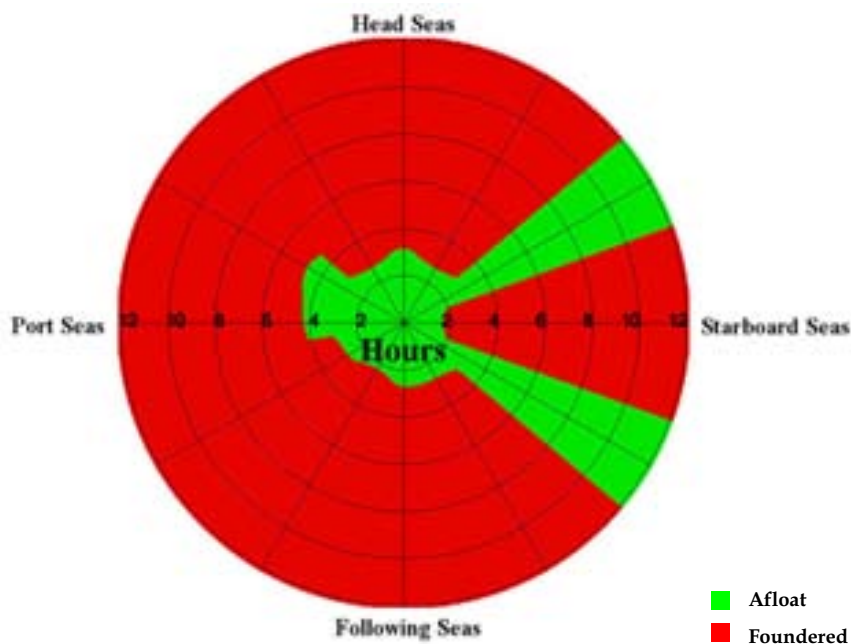
It was reported that when *Kormoran* launched their lifeboats that the sea state was increasing to sea state 4 and getting worse [283]. Figure 273 shows that even with a worse sea state, if *Sydney* was sailing in a 60° or 120° heading then potentially she may have remained afloat for at least 12 hours. It is believed that after the battle *Sydney* sailed off in approximately beam seas (90° heading). Any slight deviation in heading from 60° or 120° would have significantly changed the time the vessel remained afloat. For the damage extents considered, the analysis indicates that for all other headings considered, the time after the battle that *Sydney* could potentially remain afloat was somewhere between 2 to 4.5 hours. This is consistent with reports that the glow on the horizon from the fires onboard *Sydney* disappeared approximately 4.5 hours after the battle [283]. If Figure 270 and Figure 273 are compared it is evident that the change in sea state alone had a significant effect upon the survival time of *Sydney*.

Figure 273 Polar plot indicating time Sydney remained afloat in Sea State 4 considering flooding through hull penetrations and torpedo damage only

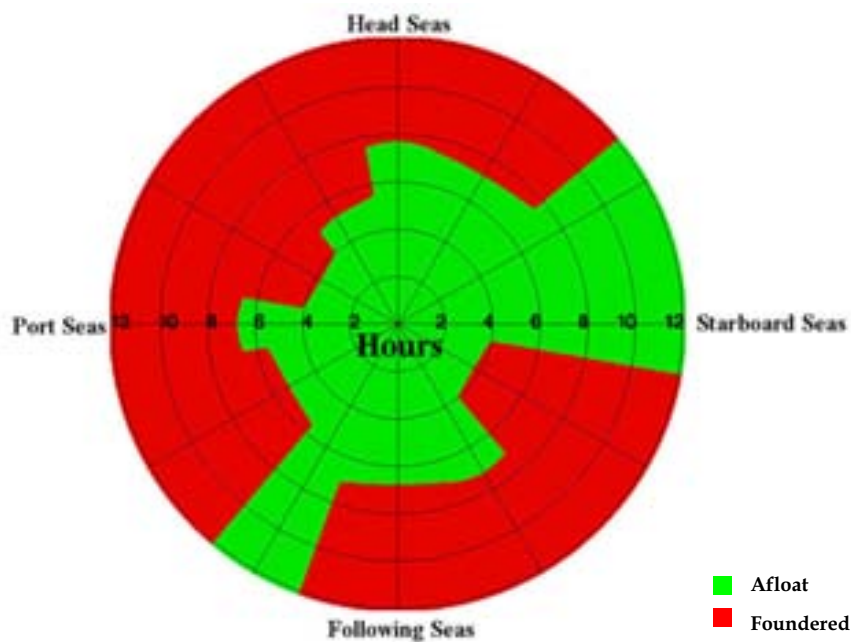
Figure 274 shows the predicted times that *Sydney* remained afloat in sea state 3 when the internal damage was considered. It can be seen, depending upon the heading that *Sydney* was sailing, that the survival time of the vessel varies. If Figure 270 and Figure 274 are compared it is evident that this additional damage significantly effects the duration which *Sydney* remained afloat.

Figure 274 Polar plot indicating time Sydney remained afloat in Sea State 3 considering flooding through hull penetrations, torpedo damage and predicted internal damage.

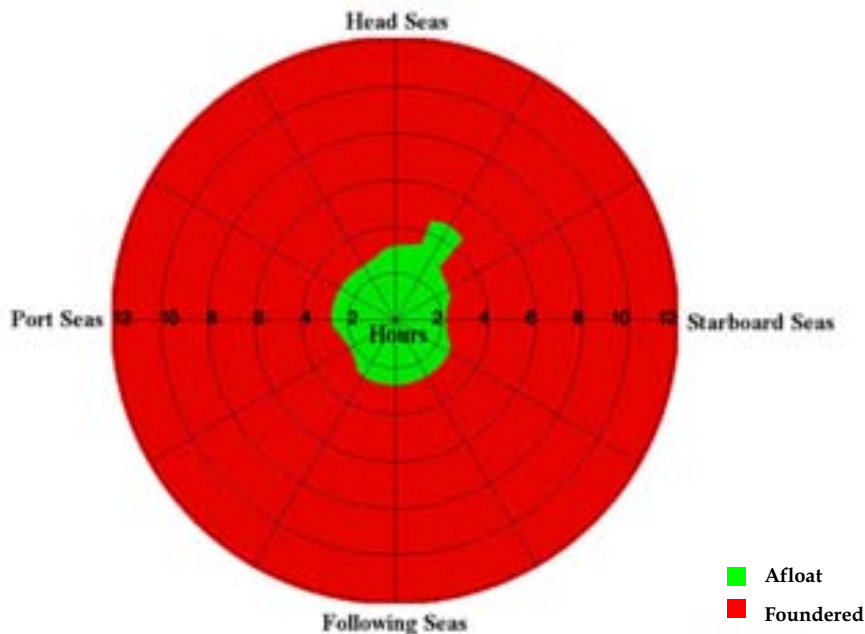
Figure 275 shows the predicted time that Sydney remained afloat as the seas increased to sea state 4. It is evident that regardless of the heading of Sydney the vessel potentially would have sunk after 2 to 4 hours.

Figure 275. Polar plot indicating time Sydney remained afloat in Sea State 4 considering flooding through hull penetrations, torpedo damage and predicted internal damage.

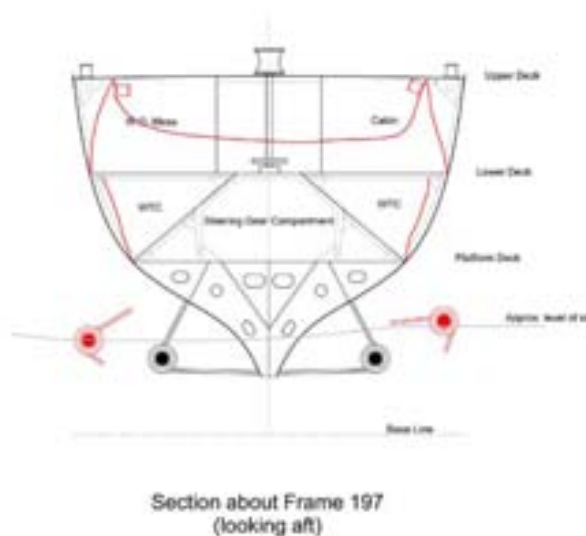
As stated above, it is not known exactly what happened in the last few minutes before *Sydney* sank. Some parts of the ship would still have been full of air when she left the surface. These could have included the relatively-undamaged after part of the ship, approximately from Y turret to the stern, partly filled or empty tanks, watertight compartments like those in the double-bottom spaces around the engine and boiler rooms and other intact internal spaces. Whilst all spaces would have rapidly started to flood through ventilation trunks and air escapes, the ship would have been sinking so fast that the external water pressure would have caused the intact compartments to implode. As shown in Chapter 6, there is extensive evidence of this implosion on the wreck e.g. the upper deck aft has been compressed down almost to the lower deck (Figure 277). The hull can be seen to be crushed in the vicinity of a number of tanks aft. Most of this damage would have occurred within about 30 m of the surface.

Figure 277 - A section through Sydney as she lies on the sea floor showing the implosion of her structure

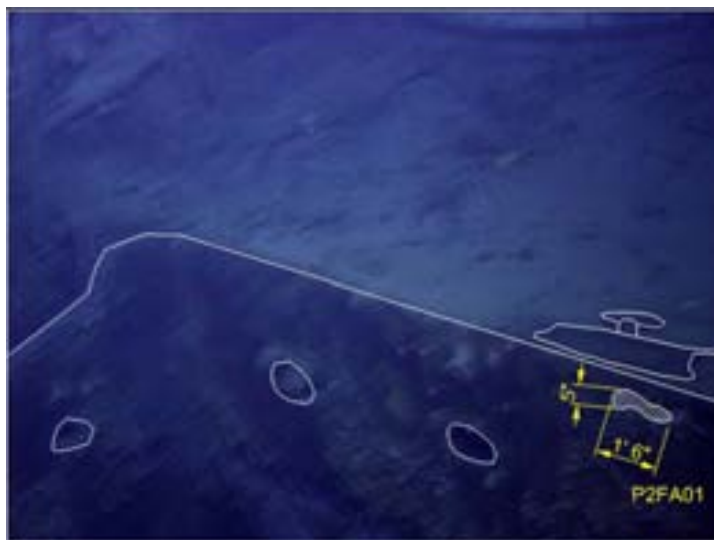
Image : FSF.001.0074 (see Figure 286)  
 Location : Upper deck, CPO's Mess (see Figure 125)  
 Side : Port  
 Probable Cause : Shell Penetration  
 Probable Weapon : 15 cm HE Shell  
 Hull Thickness : 20 lbs (12.7 mm)

The shell possibly came from an angle, leading to an elongated shaped hole. There is also a hole in the deck near this penetration that is probably associated with this shell detonating inside *Sydney*. This damage to the deck can be found in the video footage. This penetration is also just aft of the section of the hull plate that has been bent back at 90° as a result of the bow breaking off. The bend in the hull plate is visible on the left hand side of Figure 286.

Figure 286: In vicinity of CPO's Mess, Upper deck on port side [339]

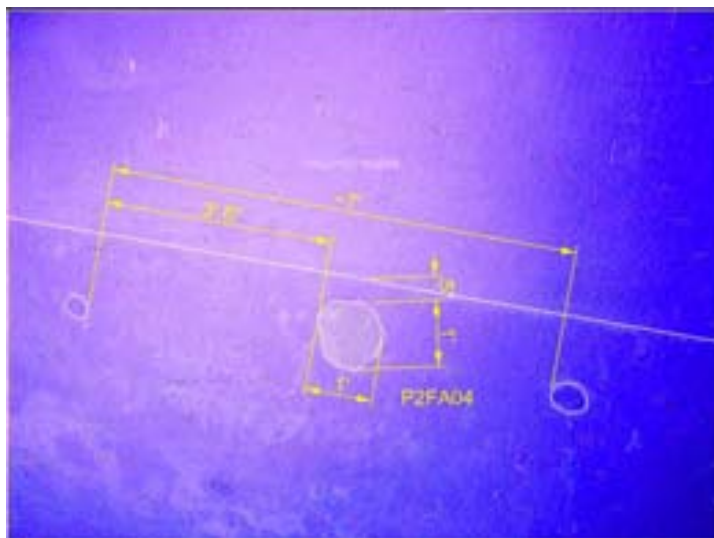
##### P2FA04

Image : Screen capture from FSF Dive 2 File 101 (see Figure 287)  
 Location : Upper deck, CPO's Mess (see Figure 125)  
 Side : Port  
 Probable Cause : External shell contact detonation  
 Probable Weapon : 15 cm HE Shell  
 Hull Thickness : 25 lbs (15.9 mm)

This hole has a diameter of at least 1' (300 mm) (approx.) and is possibly due to the contact detonation of a 15 cm HE Shell on the hull. This damage has opened the hull at the CPO's Mess on upper deck. Figure 287 was captured from the ROV dive video footage. This detonation would have thrown a lot of fragments into the CPO's mess.

Figure 287: In vicinity of CPO's Mess, upper deck on port side. [340]

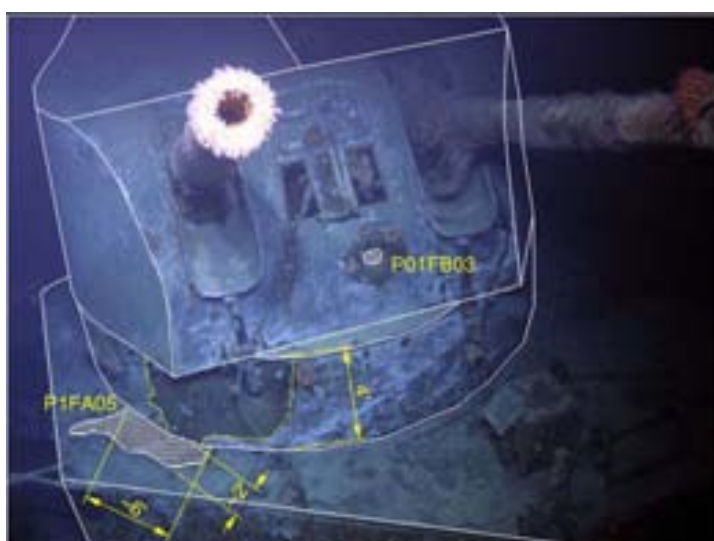
#### P1FA05

Image : FSF.002.0092 (see Figure 288)  
 Location : Forecastle deck, Seaman's Urinals (see Figure 125)  
 Side : Port  
 Probable Cause : External shell contact detonation  
 Probable Weapon : 15 cm HE Shell

This is a 6' x 2' (1800 x 600 mm) (approx.) hole into the deck below B turret. It is possible that this hole was caused by the hit at P01FB03 by a 15 cm HE Shell that did not penetrate the B turret, which subsequently fell to the deck before detonating. As this damage is in the vicinity of the roller bearing path it is possible that this damage resulted in the turret jamming. The damage associated with this hole would have been caused by fragments from the detonation of a 15 cm HE Shell. It is worth noting that the view ports on B turret are open.

Figure 288: From port side showing B Turret [341]

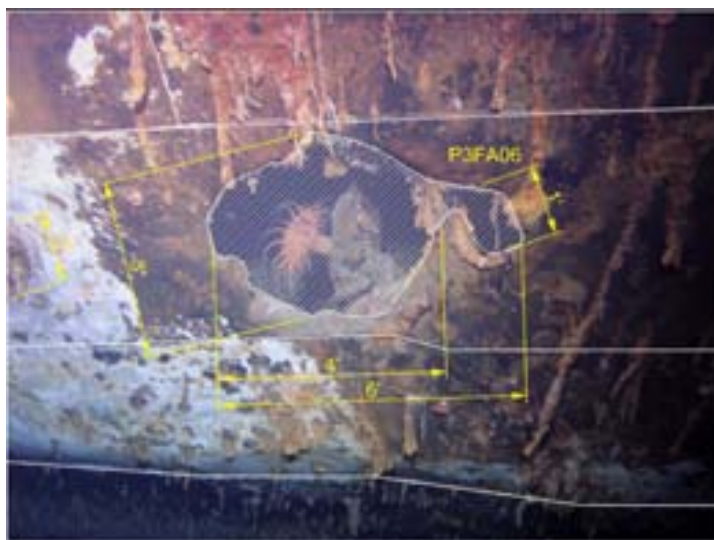
Figure 289: In vicinity of No. 2 and No. 3 Lower Mess, Lower deck [342]

Image : FSF.002.0218 (see Figure 289)  
 Location : Lower deck, No. 2 and No. 3 Lower Mess (see Figure 125)  
 Side : Port  
 Probable Cause : External shell contact detonation  
 Probable Weapon : 15 cm HE Shell  
 Hull Thickness : 25 lbs (15.9 mm)

This is a 6' x 3' (1800 x 900 mm) hole into the port side of the ship at Lower deck level. This is likely to be a surface contact detonation of a 15 cm HE Shell, and has opened a hole in the No. 2 and No. 3 Lower Mess areas. This damage has also resulted in the breach of WTB 53 at this level; this bulkhead is clearly visible inside the hole. The odd shape of the hole on the left hand side is due to the damage meeting up with a scuttle into the No. 3 Mess. There would have been considerable fragment damage inside the No. 2 and No. 3 Mess areas from this detonation.

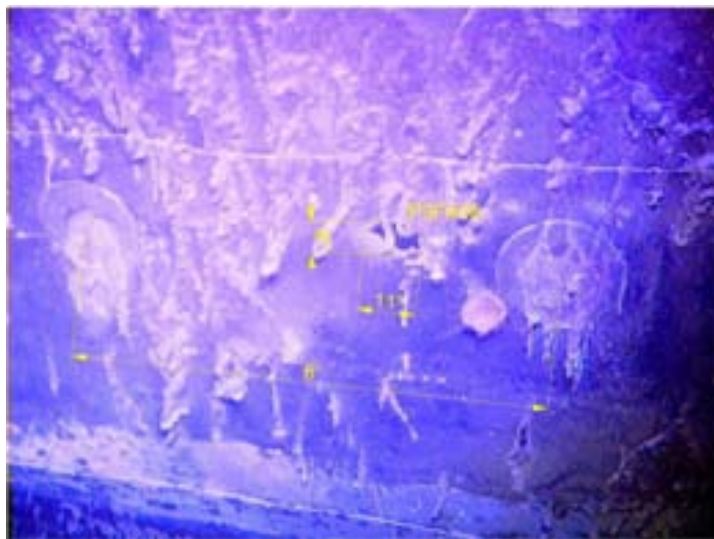
Figure 290: In vicinity of Lower No. 3 Mess, Lower deck. [343]

Image : Screen capture from FSF Dive 2 File 100 (see Figure 290)  
 Location : Lower deck, Lower No. 3 Mess (see Figure 125)  
 Side : Port  
 Probable Cause : Shell Penetration  
 Probable Weapon : 15 cm HE Shell  
 Hull Thickness : 25 lbs (15.9 mm)

This hole is likely to be due to a shell penetrating the hull at an angle.

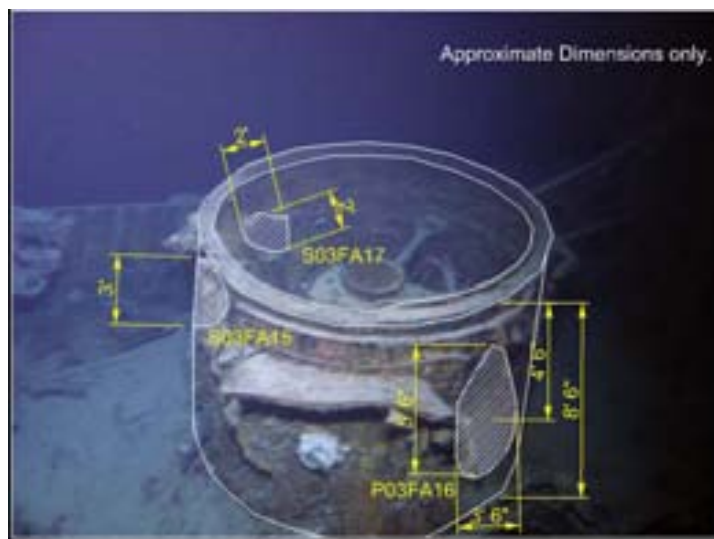
Figure 292: Director Control Tower Support, upper deck [345]

Image : FSF.002.0112 (see Figure 292)  
 Location : Upper Bridge, Director Control Tower (DCT) Support (see Figure 126)  
 Side : Port  
 Probable Cause : Contact detonation of shell  
 Probable Weapon : 15 cm HE Shell

The most notable feature in Figure 292 is that the DCT is missing from the support. There is also extensive damage to the DCT support, with P03FA16 likely to be due to the contact detonation of a 15 cm HE Shell on the port side. This detonation would have generated a lot of fragments inside the DCT support, and would have also sprayed fragments around the upper bridge area. It is likely that this hit would have permanently disabled the DCT, but the detonation is unlikely to have been responsible for dislodging the DCT from the support. It is likely that the DCT was dislodged as part of the sinking process.

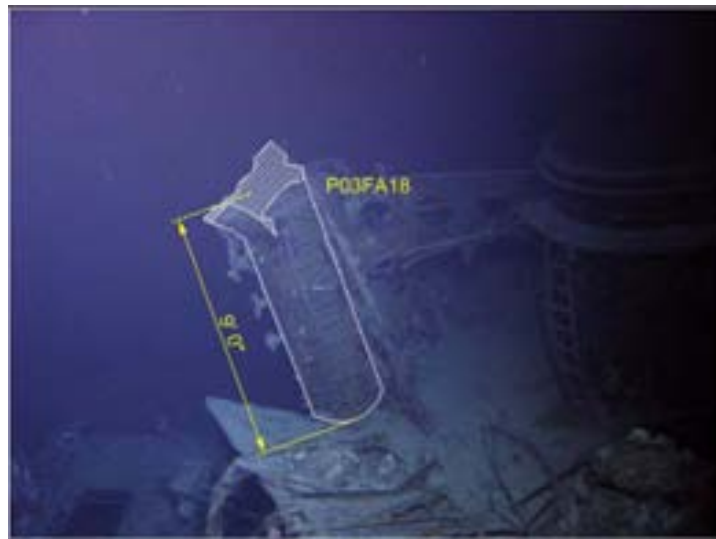
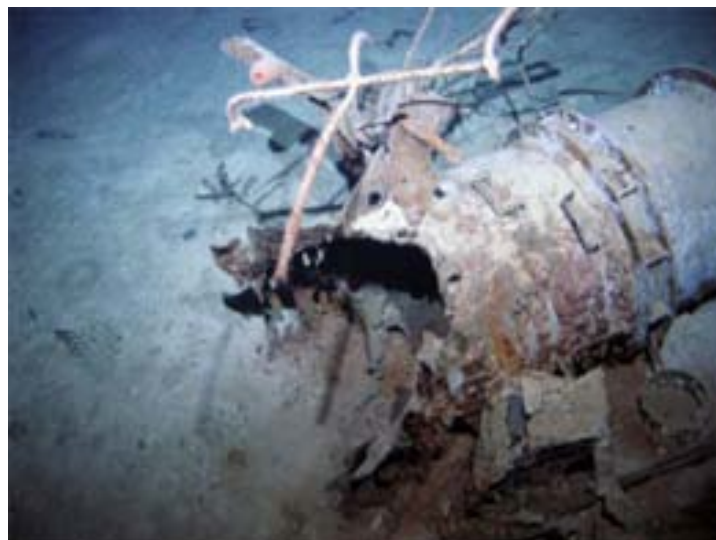
Image : FSF.002.0318 (see Figure 293), FSF.002.0206 (see Figure 294)  
 Location : Upper Bridge, High Angle Calculating Station (HACS) support (see Figure 130)  
 Side : Hit from port side  
 Probable Cause : Shell penetration/detonation  
 Probable Weapon : 15 cm HE Shell

This damage is likely due to a shell hit and subsequent detonation to the HACS support. The base of this support is shown in Figure 293 and this figure shows that the metal on the back edge of the hole has buckled backwards. This suggests that the tower has fallen backwards on to the aft end of the upper superstructure. This is supported by damage to the deck in this region. It is not obvious from Figure 293 that the damage to the tower support is due to a shell hit, but the damage to the upper section of the tower support shown in Figure 294 leaves no doubt that the damage is due to a 15 cm HE Shell detonation with obvious fragment damage and metal petalling due to the detonation. This detonation would have caused the HACS tower to collapse. A reconstruction of the HACS position is provided in Figure 213 showing that a large amount of the HACS structure has been removed by this hit.

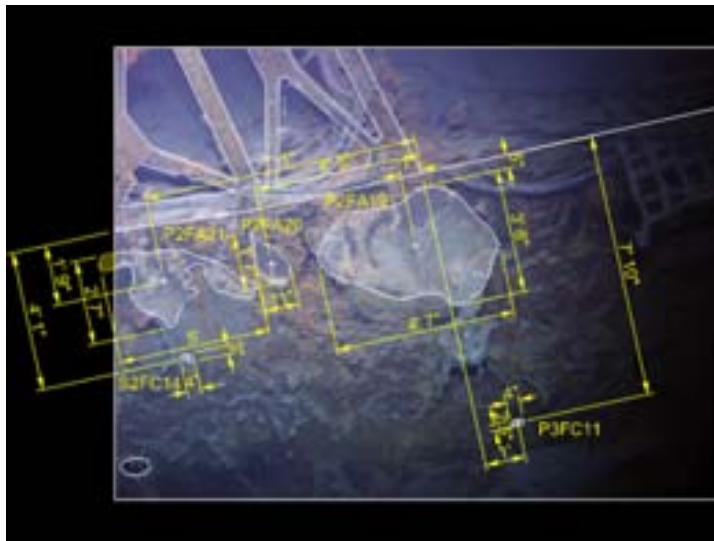
Figure 295: In vicinity of Diving Gear Store, upper deck [347]

Image : FSF.002.0124 (see Figure 295)  
 Location : Upper deck, Central Store Office (see Figure 126)  
 Side : Port  
 Probable Cause : Contact Detonation  
 Probable Weapon : 15 cm HE Shell  
 Hull Thickness : 35 lbs (22.2 mm)

This damage and that associated with P2FA20 and P2FA21 is probably due to the contact explosion of one or more shells.

The hole size possibly indicates a partial shell penetration or a very large fragment. It is difficult to take measurements or get a clear view of this damage from the available footage.

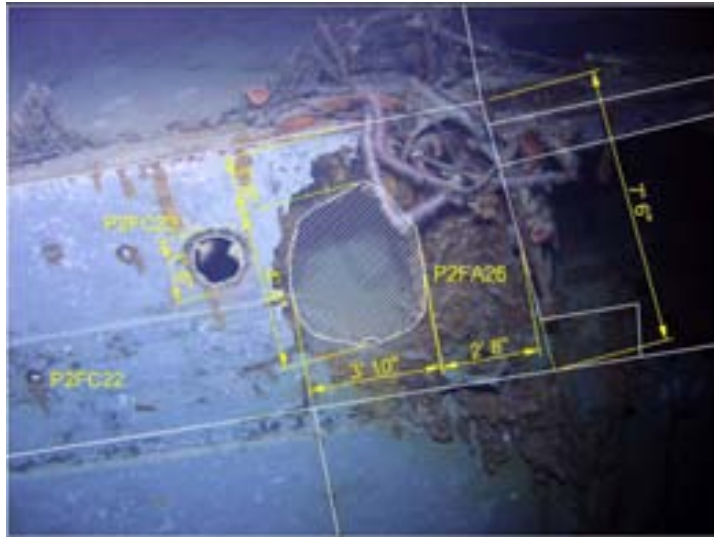
Figure 296: In vicinity of Abandon Ship Store Lockers, upper deck [249]

Image : FSF.002.0135 (see Figure 296)  
 Location : Upper deck, in vicinity of Abandon Ship Store Lockers  
 (see Figure 126)  
 Side : Port  
 Probable Cause : Contact detonation  
 Probable Weapon : 15 cm HE Shell  
 Hull Thickness : 30 lbs (19.1 mm)

This damage is to the upper deck is in the vicinity of the Abandon Ship Store Lockers. The contents of the Abandon Ship Locker would have been damaged by this detonation. This detonation was also in the vicinity of the port side 36' Motor Pinnacle and Carley

float, which would have also received fragment damage. This hit would also have severely damaged the 32' Cutter davit. Figure 220 is a reconstruction of the boats and davits in the vicinity of these hits.

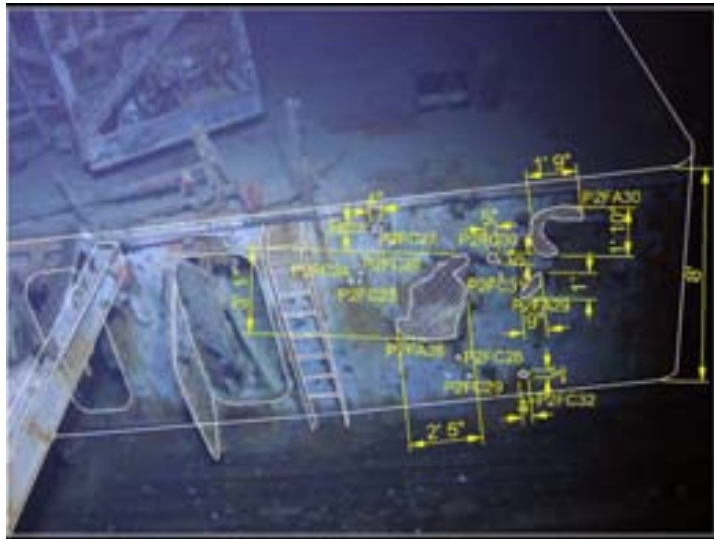
Figure 297: Port side of Bakery, upper deck [292]

Image : FSF.002.0153 (see Figure 297)  
 Location : Upper deck, Bakery (see Figure 127)  
 Side : Port  
 Probable Cause : Contact detonation  
 Probable Weapon : 15 cm HE Shell

The bakery has received extensive damage from shells. P2FA28 is likely due to a contact detonation of a 15 cm HE Shell and has led to a 3' x 2' 6" (900 x 450 mm) hole on the port side. Note that there is extensive debris visible within the bakery, indicating extensive internal damage to this compartment. It is also likely that the aircraft and boats in this vicinity received fragment damage. The equipment originally in this area is shown in the reconstruction in Figure 216.

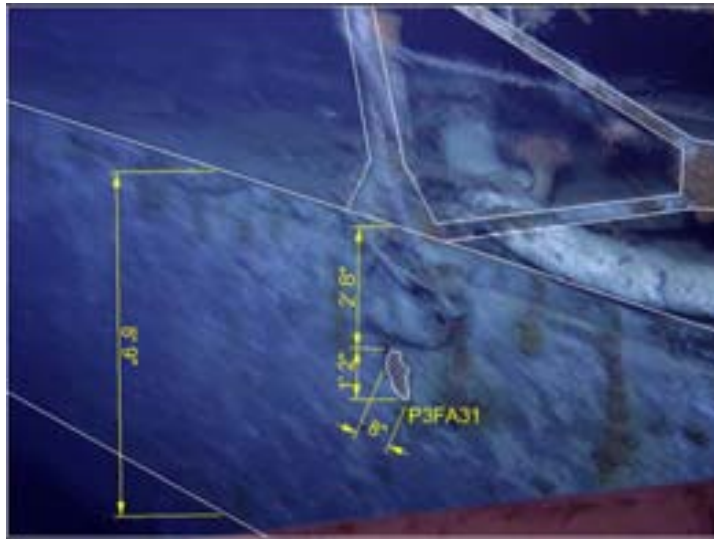
Figure 298: In vicinity of Engineers Fitting Shop, Lower deck [348]

Image : FSF.001.0044 (see Figure 298)  
 Location : Lower deck, Engineers Fitting Shop (see Figure 127)  
 Side : Port  
 Probable Cause : Shell penetration or damage due to sinking  
 Probable Weapon : Uncertain

The cause of this damage is unclear, but is possibly due to a shell penetration.

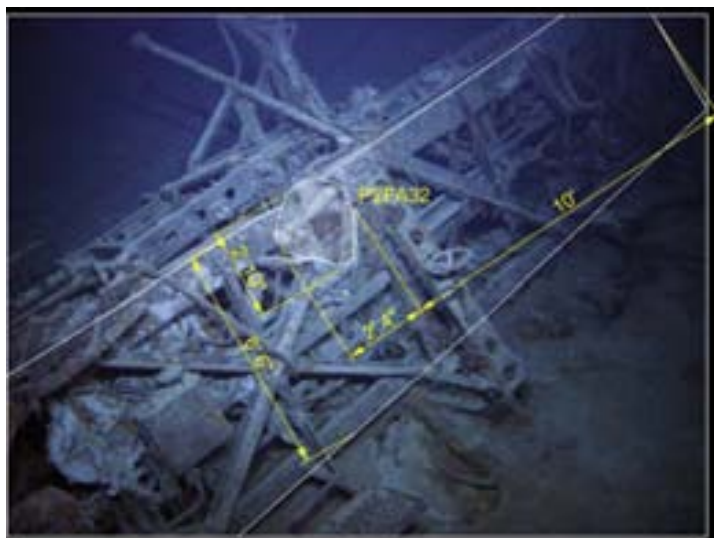
Figure 299: Damage to Catapult [349]

Image : FSF.004.0078 (see Figure 299)  
 Location : Upper deck, Catapult structure (see Figure 127)  
 Side : Port  
 Probable Cause : Shell detonation  
 Probable Weapon : 15 cm HE Shell

The catapult on *Sydney* was able to be rotated to launch the aircraft. It is not clear which direction the catapult was facing when it was hit, but for this analysis it will be assumed to have been in the stowed position. This hit to the catapult would have thrown a lot of fragments over the open decks around the catapult, including the boat. Hot fragments from shell hits to the catapult may have caused the Walrus aircraft to catch fire. Figure 216 shows the equipment surrounding the catapult, and it is easy to see how these hits would have sprayed hot fragments onto the aircraft.

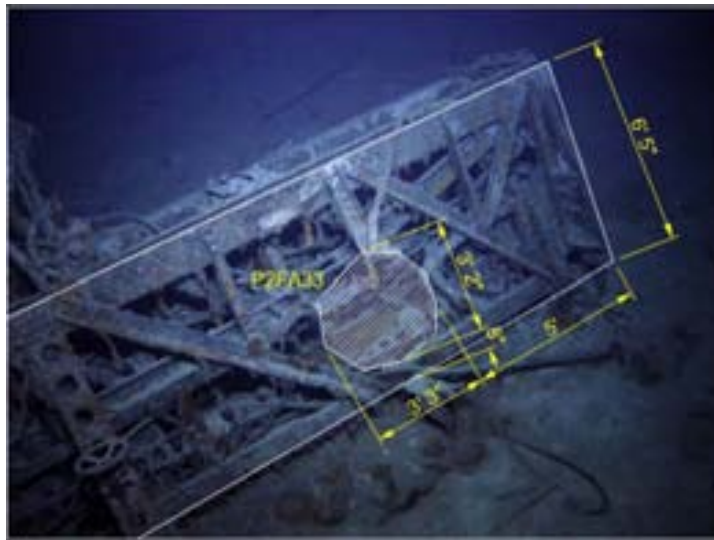
Figure 300: Damage to Catapult [350]

Image : FSF.004.0079 (see Figure 300)  
 Location : Upper deck, Catapult structure (see Figure 127)  
 Side : Port  
 Probable Cause : Shell detonation  
 Probable Weapon : 15 cm HE Shell

As per P2FA32.

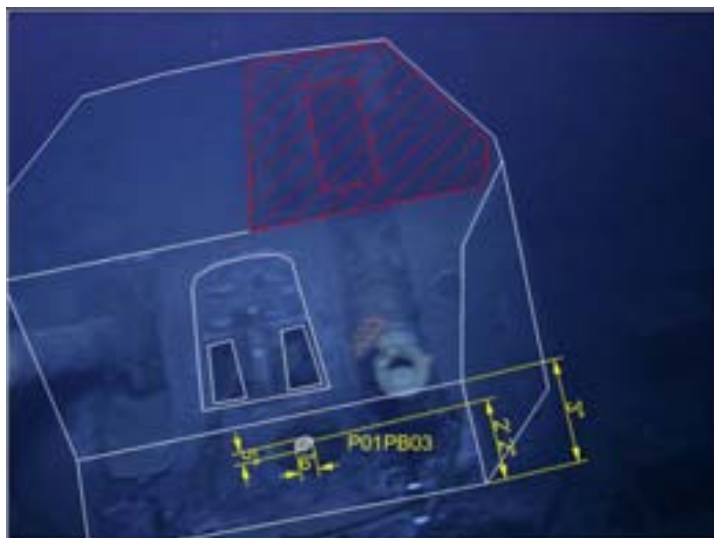
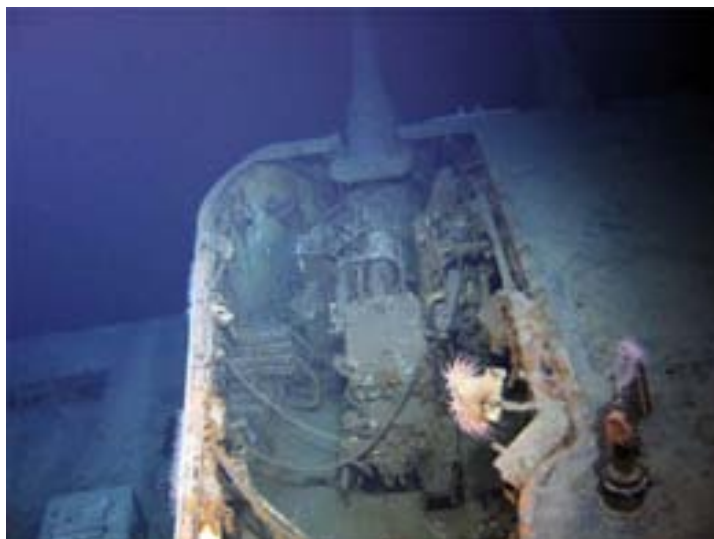
Image : FSF.001.0077 (see Figure 301)  
 Location : Front of B Turret (see Figure 125)  
 Side : Port  
 Probable Cause : Partial shell penetration  
 Probable Weapon : 15 cm HE Shell  
 Armour Thickness: 1" (25 mm)

The hole size indicates that the shell failed to fully penetrate the armour plating. The shell may have possibly fallen to the deck and exploded causing the damage at P1FA05. This hit has also likely caused the roof of B Turret to be removed (see red hashing in Figure 301). Figure 302 indicates that internals of B turret are largely intact suggesting that there has not been an internal detonation inside B Turret, though the impact which created this hole would have resulted in metal fragments from the armour plating entering the turret at high speed.

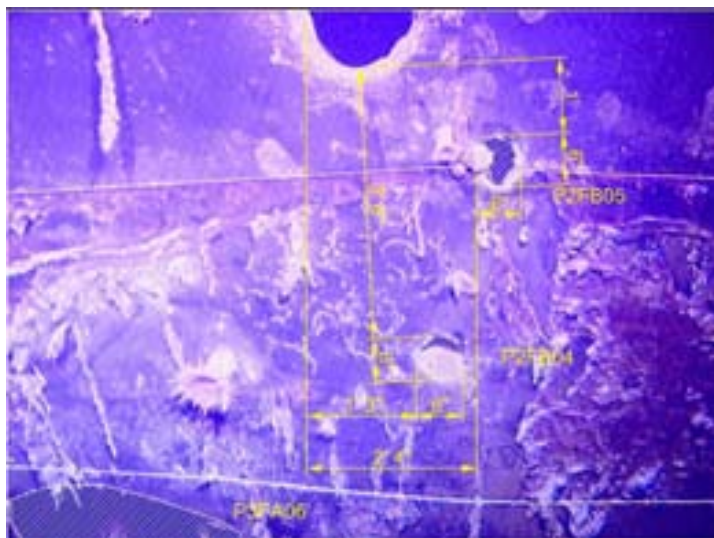
Figure 303: In vicinity of Musician's Mess, upper deck [343]

Image : Screen capture from FSF Dive 2 File 101 (see Figure 303)  
 Location : Upper deck, Musician's Mess (see Figure 125)  
 Side : Port  
 Probable Cause : Shell Penetration  
 Probable Weapon : 15 cm HE Shell  
 Hull Thickness : 25 lbs (15.9 mm)

This hole is likely due to a 15 cm HE Shell penetrating the Upper deck hull into the Musician's Mess. This shell would have detonated inside this mess area causing considerable internal damage if the shell detonated.

This hole is likely due to a 15 cm HE Shell penetrating the upper deck hull into the Musician's Mess. Again, there would have been considerable internal damage.

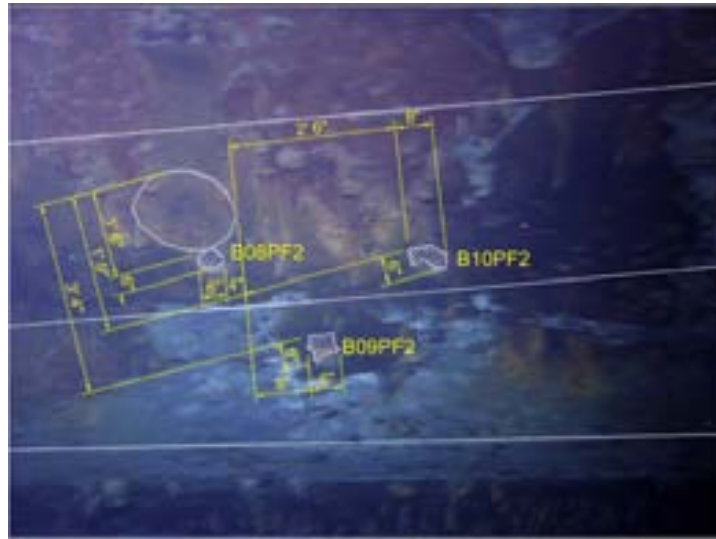
Figure 304: In vicinity of No. 4 Lower Mess, Lower deck [295]

Image : FSF.002.0214 (see Figure 304)  
 Location : Lower deck, No. 4 Lower Mess (see Figure 126)  
 Side : Port  
 Probable Cause : Shell Penetration  
 Probable Weapon : 15 cm HE Shell  
 Hull Thickness : 30 lbs (19.1 mm)

This is a clean penetration into the No. 4 Lower Mess area on Lower deck and is likely due to a 15 cm HE Shell. This shell would have detonated inside the No.4 Lower Mess. There are multiple clean penetrations in to the No. 4 Lower Mess area, and significant internal damage would be expected in this compartment.

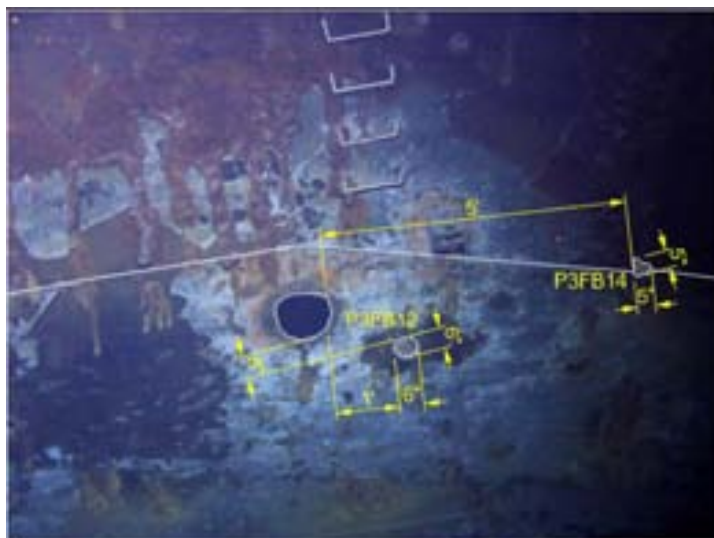
Figure 305: In vicinity of No. 4 Lower Mess, Lower deck [353]

Image : FSF.002.0213 (see Figure 305)  
 Location : Lower deck, No. 4 Lower Mess (see Figure 126)  
 Side : Port  
 Probable Cause : Shell penetration  
 Probable Weapon : 15 cm HE Shell  
 Hull Thickness : 30 lbs (19.1 mm)

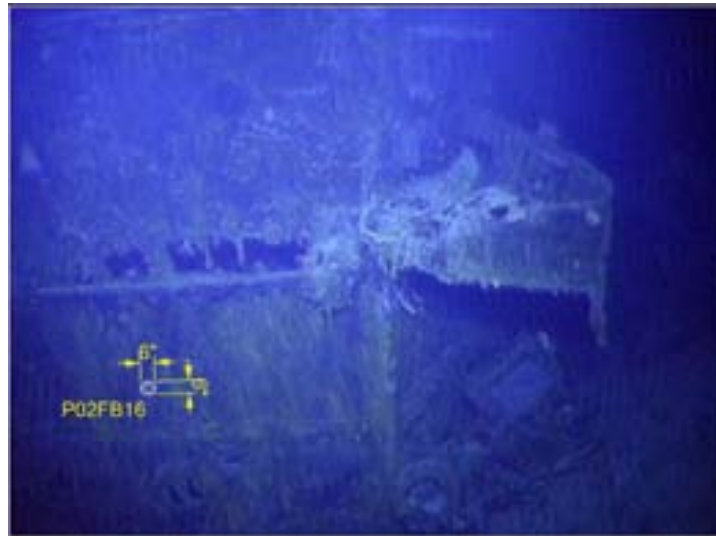
Figure 306: Port side of Bridge [340]

Image : Screen capture from FSF Dive 1 File 52 (see Figure 306)  
 Location : Lower Bridge, Lobby Area (see Figure 126)  
 Side : Port  
 Probable Cause : Shell penetration  
 Probable Weapon : 15 cm HE Shell

This is a clean penetration into the port side of the bridge. This hit probably detonated inside the bridge causing considerable damage.

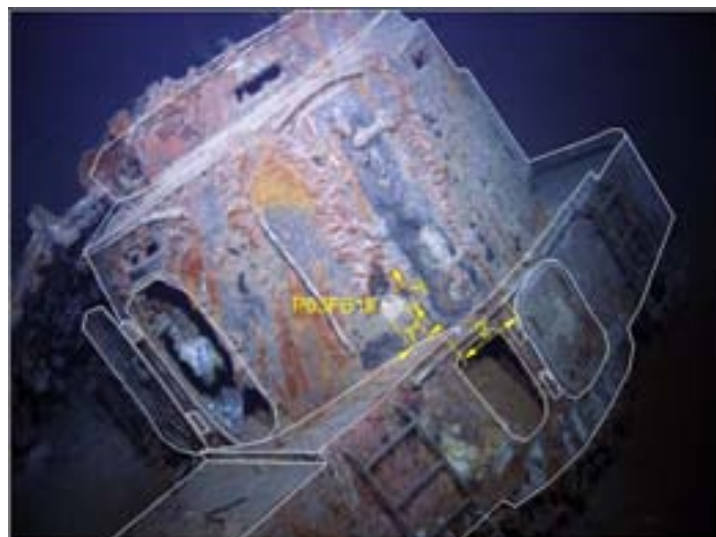
Figure 307: Director Control Tower [354]

Image : FSF.006.0012 (see Figure 307)  
 Location : Upper Bridge, DCT (see Figure 130)  
 Side : Port  
 Probable Cause : Shell Penetration  
 Probable Weapon : 15 cm HE Shell

This hit to the DCT is on the port side of the DCT. The DCT was probably facing to port when hit, so the hit was caused by a shell fired at the starboard side of *Sydney*. This shell hit appears to have detonated internally, and would have caused considerable damage inside the DCT.

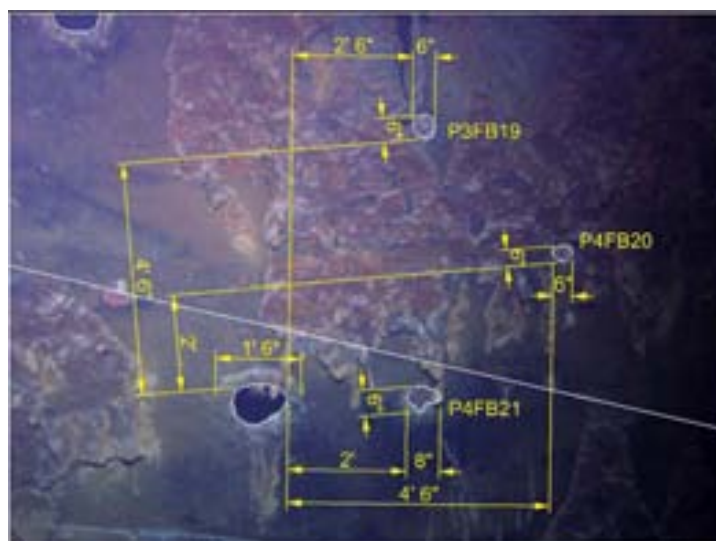
Figure 308: In vicinity of Stoker's Mess Lower deck [355]

Image : FSF.002.0212 (see Figure 308)  
 Location : Lower deck, Stoker's Mess (see Figure 126)  
 Side : Port  
 Probable Cause : Shell Penetration  
 Probable Weapon : 15 cm Shell  
 Hull Thickness : 30lbs (19.1 mm)

This hole is probably due to 15 cm cleanly penetrating the hull. This shell would have entered the Stoker's Mess on Lower deck and detonated internally. There are multiple hits to the Stoker's Mess and it is likely that this compartment received extensive internal damage.

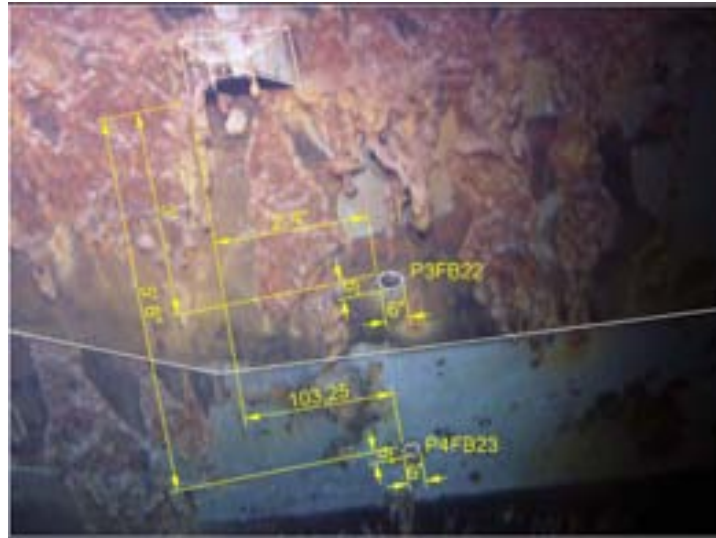
Figure 309: In vicinity of Stoker's Mess, Lower deck [356]

Image : FSF.002.0128 (see Figure 309)  
 Location : Platform deck, Switchboard Room (see Figure 126)  
 Side : Port  
 Probable Cause : Shell Penetration  
 Probable Weapon : 15 cm HE Shell  
 Hull Thickness : 30 lbs (19.1 mm)

This hole is likely to be due to a shell cleanly penetrating the hull protecting the Switchboard room. This shell would have detonated internally causing damage to the Platform deck around the Switchboard room and Breaker rooms.

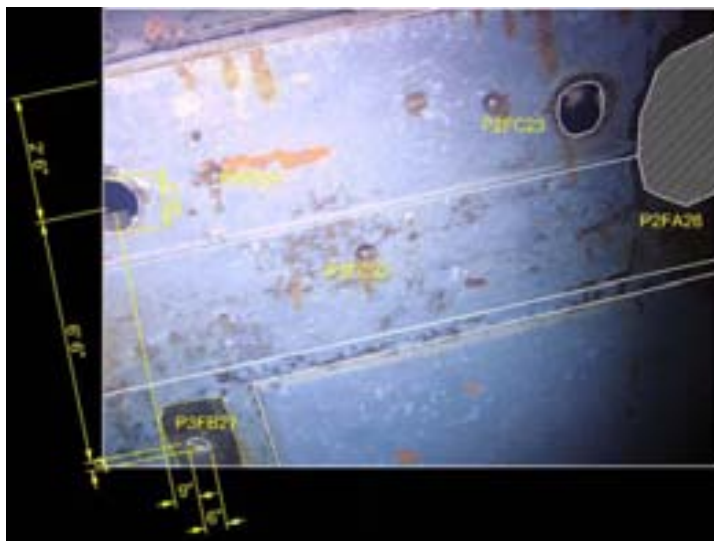
Figure 310: In vicinity of Stoker's Mess [357]

Image : FSF.002.0131 (see Figure 310)  
 Location : Lower deck, Stoker's Mess (see Figure 126)  
 Side : Port  
 Probable Cause : Shell penetration  
 Probable Weapon : 15 cm HE Shell  
 Hull Thickness : 30 lbs (19.1 mm)

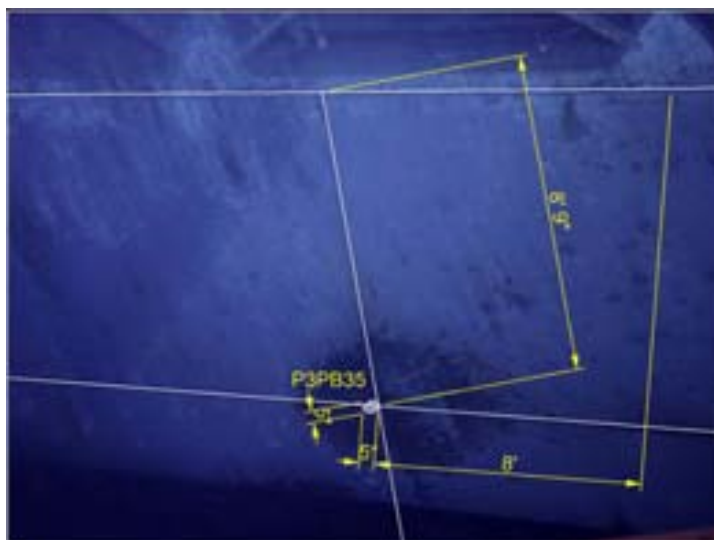
Figure 311: In vicinity of Electric Light room, Lower deck and below 31 ft whaler [358]

Image : FSF.001.0053 (see Figure 311)  
 Location : Lower deck, Electric Light Room (see Figure 127)  
 Side : Port  
 Probable Cause : Partially penetrating contact detonation  
 Armour Thickness : 164 lbs (104.1 mm)

This hit has occurred on the seam edge of the armour plate and it appears that the detonation has occurred external. Partial penetration has occurred with limited damage to the internal compartment.
