## HMAS Sydney II Commission of Inquiry

### Report on Technical Aspects of the Sinking of HMAS *Sydney* and HSK *Kormoran*

DSTO-GD-0559

This report describes the technical findings of the battle and sinking of HMAS Sydney and HSK Kormoran based on historical and archeological evidence. The battle occurred on the 19<sup>th</sup> of November, 1941 off the West Australian coast. The wrecks of the two ships were discovered in March 2008 and their subsequent underwater exploration has shed light on the events that took place during and after the battle.

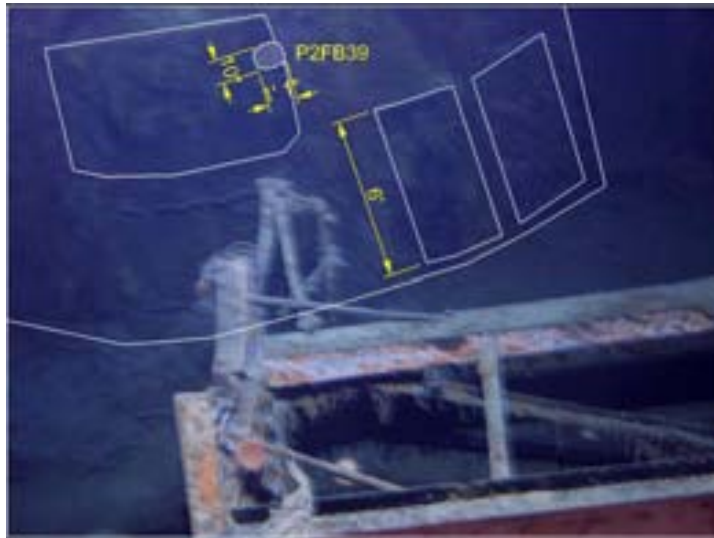
Figure 312: Shipwright's Workshop below Catapult. [208]

Image : FSF.001.0046 (see Figure 312)  
 Location : Upper deck, Shipwright's Workshop, (see Figure 127)  
 Side : Port  
 Probable Cause : Shell penetration  
 Probable Weapon : 15 cm HE Shell

A shell has penetrated into the Shipwright's Workshop. Due to the location of this shell hit, it is also likely that the boat next to the Shipwright's Workshop has also been hit. Damage can be identified on this boat that aligns with this penetration.

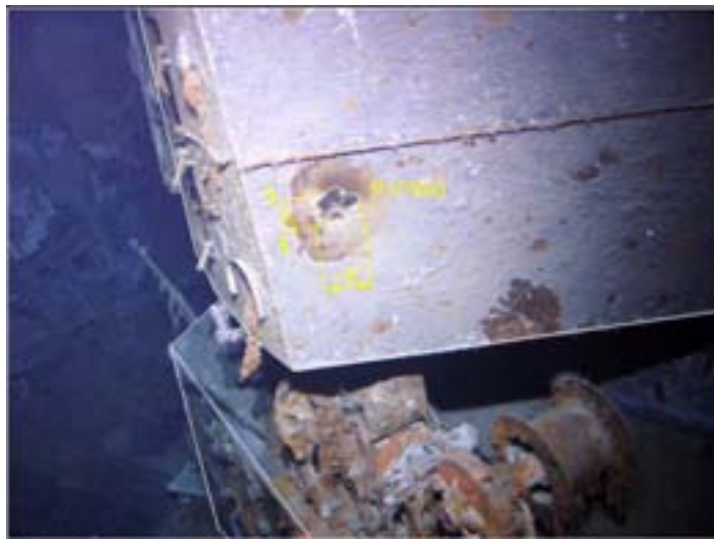
Figure 313: Hit into side of X Turret [359]

Image : FSF.002.0263 (see Figure 313)  
 Location : Aft of X Turret (see Figure 128)  
 Side : Port  
 Probable Cause : Shell Penetration  
 Probable Weapon : 15 cm HE Shell

This shell has cleanly penetrated X turret on the port side. It is not clear which direction X turret was facing when this damage occurred. This shell hit may have also been associated with damage at P1FA38. Assuming that the turret has not moved since being hit, it is likely that the shell that created this damage was fired at *Sydney's* starboard side.

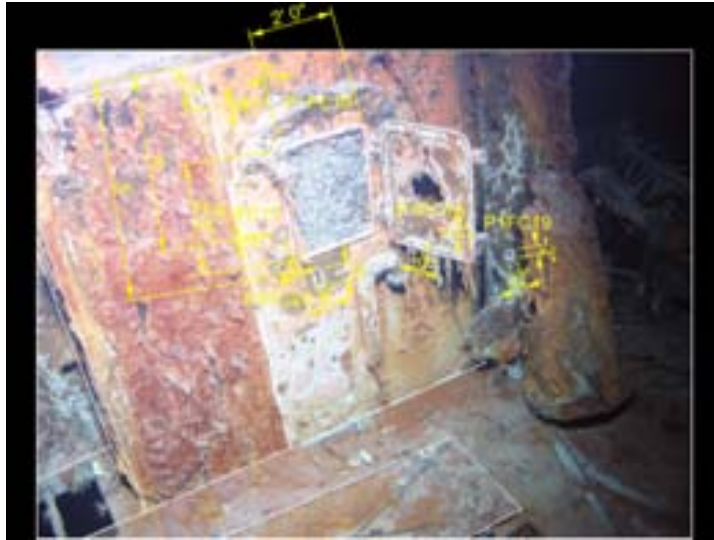
Figure 314: Port side of Smith's Shop [360]

Image : FSF.002.0137 (see Figure 314)  
 Location : Forecastle deck, Smith's Shop (see Figure 126)  
 Side : Port  
 Probable Cause : Fragment damage due to external detonation  
 Probable Weapon : Likely to be a 15 cm HE Shell

There is significant fragment damage to the Smith's shop and the Secondary Wireless Transmission trunk. The origin of these fragments is unclear, but the hole size is

consistent with a 15 cm HE Shell. What ever has generated these fragments would also have likely damaged the 32' Cutter that was stowed in the vicinity. Due to the number of penetrations in Figure 126, not all of the holes have been highlighted.

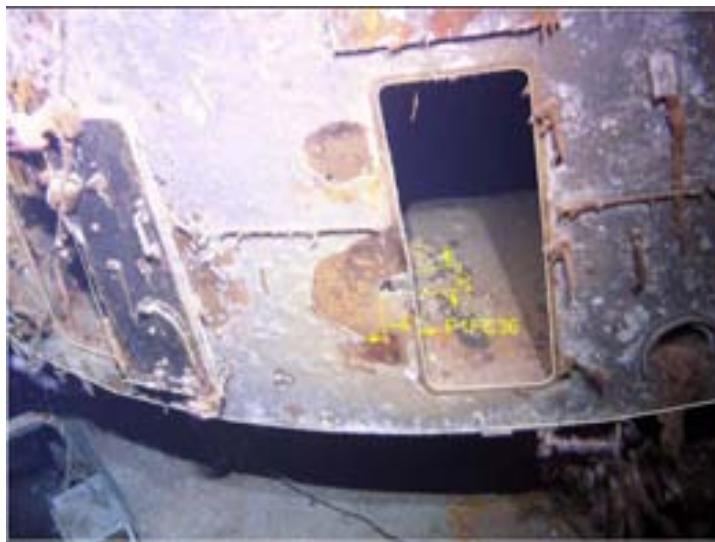
Figure 315: Aft of X Turret [304]

Image : FSF.002.0264 (see Figure 315)  
 Location : Rear of X Turret (see Figure 128)  
 Side : Port  
 Probable Cause : Fragment penetration from shell  
 Probable Weapon : 15 cm HE Shell

This damage is likely due to a shell entering X Turret at P1FB50 and detonating inside the turret. This detonation appears to have blown out the door. See P1FB50.

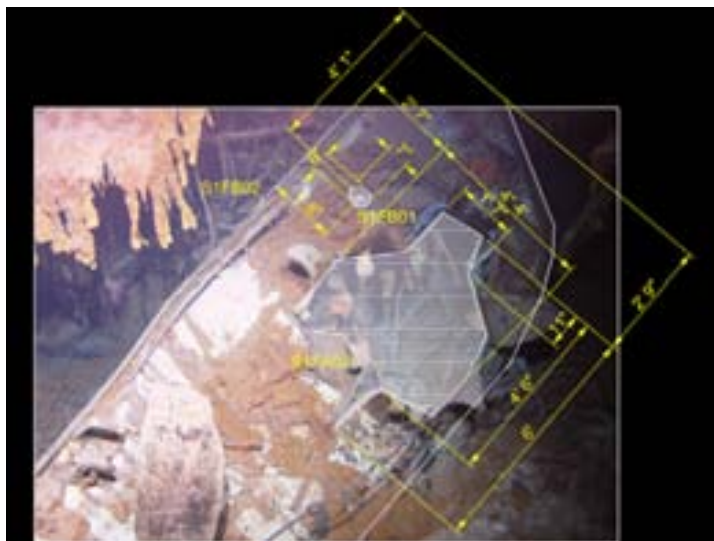
Figure 316: Forward section of starboard side of A turret [303]

destroyed the capability of this turret, let alone the three other hits that will subsequently be described.

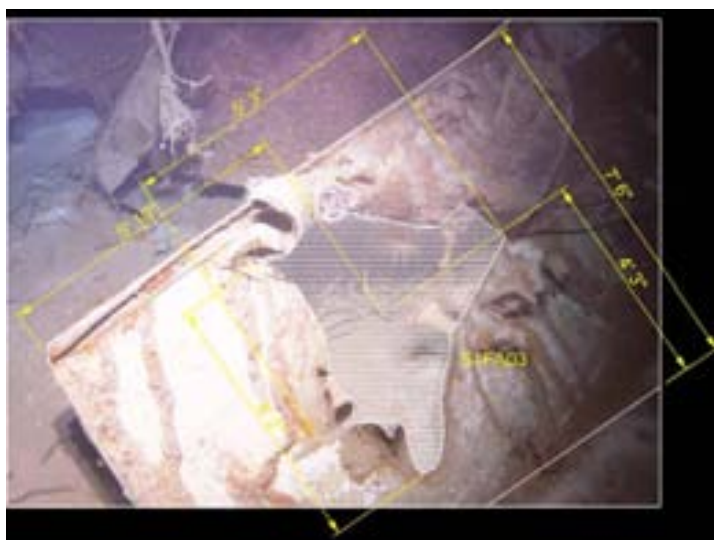
Figure 317: Aft section of starboard side of A turret [361]

Image : FSF.002.0034 (see Figure 317)  
 Location : Starboard armour plating of A Turret (see Figure 129)  
 Side : Starboard  
 Probable Cause : External shell contact detonation  
 Probable Weapon : 15 cm HE Shell  
 Armour Thickness : 1" (25 mm)

As per S1FA02, except a 5' 3" x 5' 2" (1600 x 1600 mm) hole.

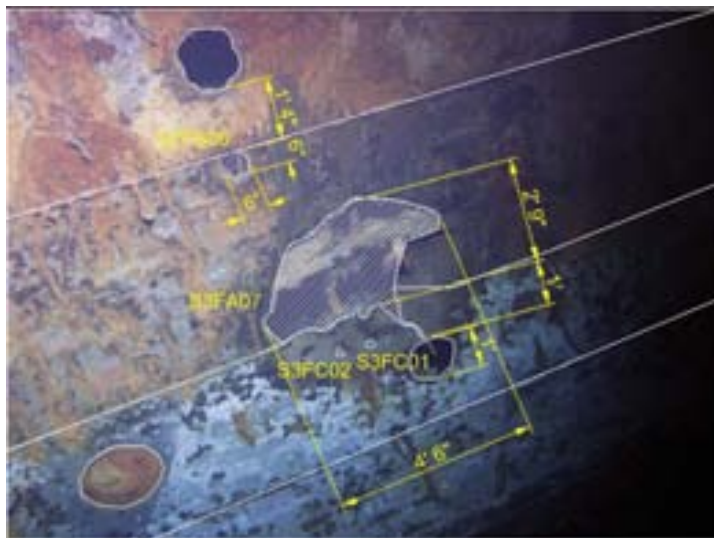
Figure 318: In vicinity of No. 3 Lower Mess, Lower deck and Seaman's Mess, upper deck [193]

Image : FSF.002.0324 (see Figure 318)  
 Location : Lower deck, No. 3 Lower Mess and upper deck, Seaman's Mess  
 (see Figure 129)  
 Side : Starboard  
 Probable Cause : External shell contact detonation  
 Probable Weapon : 15 cm HE Shell  
 Hull Thickness : 25 lbs (15.9 mm)

This hole is likely caused by a contact detonation of a 15 cm HE Shell. This hole has opened up the starboard side of the ship between upper and Lower deck. The deck level is visible through this hole, and the hole has opened up the No. 3 Lower Mess and the Seaman's Mess on upper deck. A large number of fragments would have entered No. 3 Lower Mess area. This is a large hole with dimensions 4' 6" x 2' 9" (1400 x 850 mm).

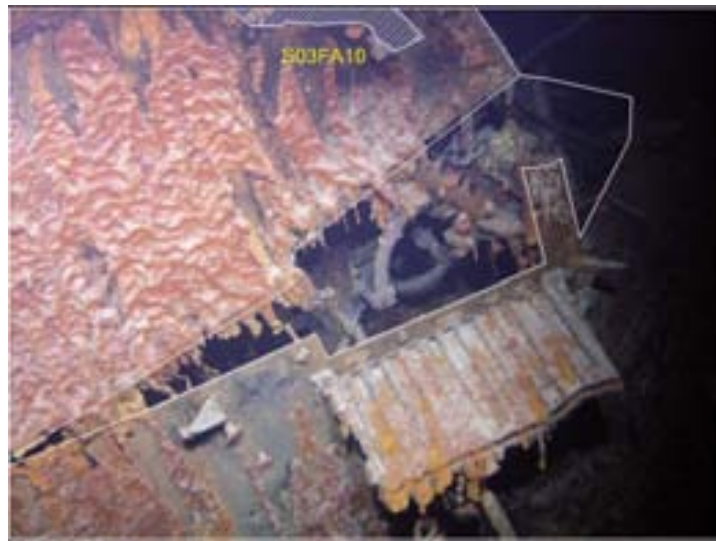
Figure 319: Starboard side of upper Bridge [362]

The shape of the missing material from the structure around the upper bridge is likely to have been caused by a contact detonation of a 15 cm HE Shell. It is difficult to tell the full extent of the damage in this region due to the extensive damage to the forward bridge superstructure, but the damage in this region is consistent with a shell hit. This shell hit would have extensively damaged the starboard rangefinder. Other damage in this region is associated with the break up of the upper superstructure on sinking. A reconstruction of the bridge is shown in Figure 320 to help understand where this damage is located.

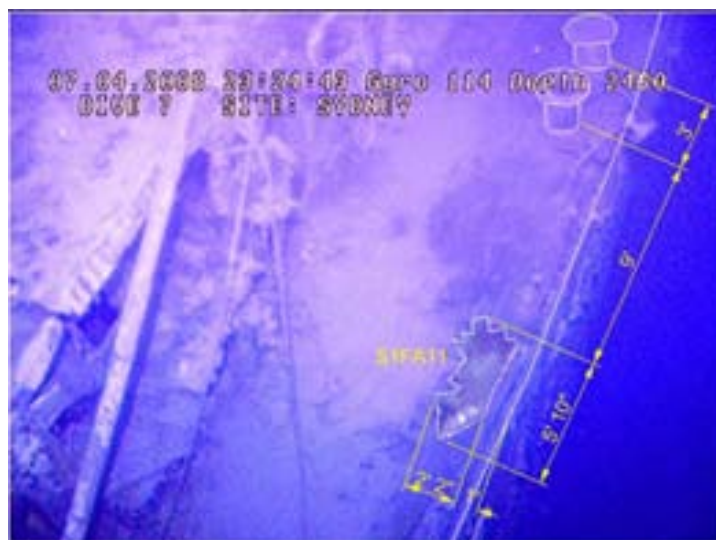
Figure 321: Damage to Forecastle deck. Into Sick Bay, upper deck [363]

between these damage locations. This hole has opened up the deck above the sick bay area on the upper deck.

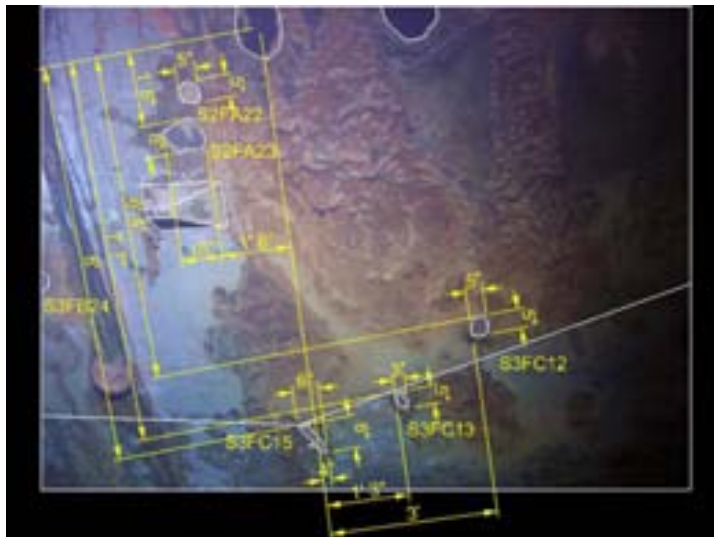
Figure 322: In vicinity of Butcher's Shop, upper deck [191]

This damage is probably due to a hit on the davit from a shell, which would have severely damaged the davit and made it impossible to launch any associated boats. This hit would have also damaged the Butcher's Shop. Figure 323 is a reconstruction of the boats and davits in the vicinity of these hits and the area shown in Figure 322 is highlighted in red.

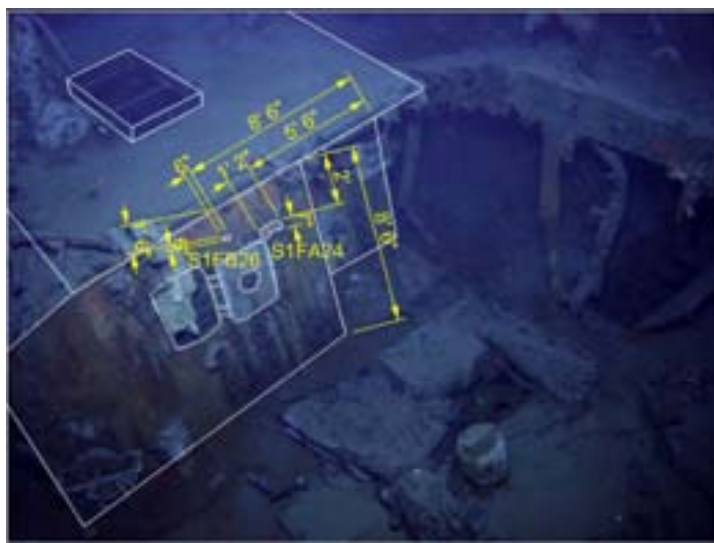
Figure 324: starboard side of Smith's Shop, Forecastle deck [201]

Image : FSF.003.0012 (see Figure 324)  
 Location : Forecastle deck, Smith's Shop (see Figure 130)  
 Side : Starboard  
 Probable Cause : Shell penetration  
 Probable Weapon : 15 cm HE Shell

This damage is likely to be caused by a shell penetrating the Smith's Shop at an angle. There is not enough information to determine the precise trajectory of this shell.

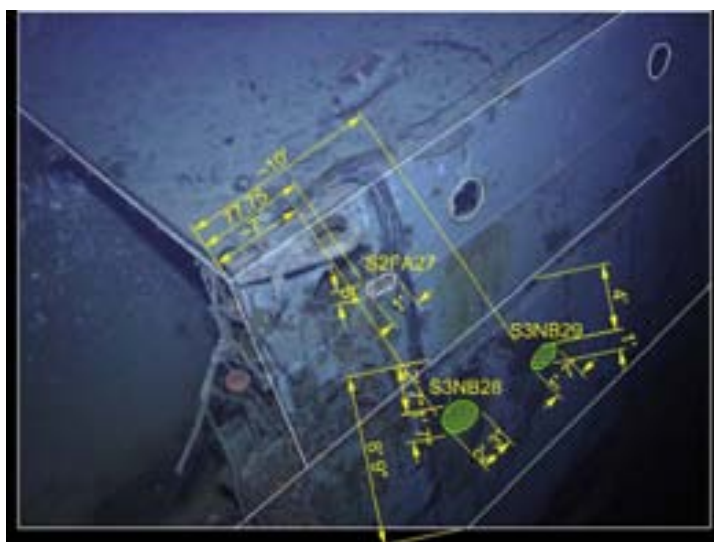
Figure 326: Enclosed walkway on upper deck [365]

Image : FSF.003.0008 (see Figure 326)  
 Location : Upper deck, Enclosed Walkway (see Figure 130)  
 Side : Starboard  
 Probable Cause : Detonation on the davit  
 Probable Weapon : 15 cm HE Shell  
 Hull Thickness : 30 lbs (19.1 mm)

This damage is probably due to a shell hitting the davit and detonating causing this hole in the exterior bulkhead. This damage would also mean that the davits would not be able to be used to get the 32' boat off the ship. Figure 323 is a reconstruction of the boats and davits in the vicinity of these hits with the region shown in Figure 326 highlighted in green.

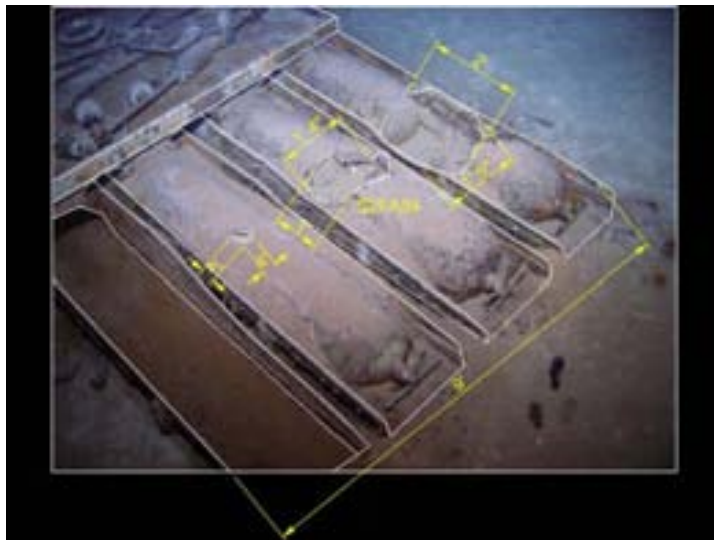
Figure 327: Starboard Torpedo Tubes [366]

Location : Upper deck, starboard side Torpedo Tubes (see Figure 132)  
 Side : Starboard  
 Probable Cause : Shell penetration  
 Probable Weapon : 15 cm HE Shell

This damage to the torpedoes is possibly due to a glancing shell hit. Note that this hit is on the bottom of the torpedo when stowed. The most damaged torpedo is stowed inboard of the torpedo had not been rotated ready to fire. It is possible that this torpedo was hit when the torpedo tubes were pointed outboard.

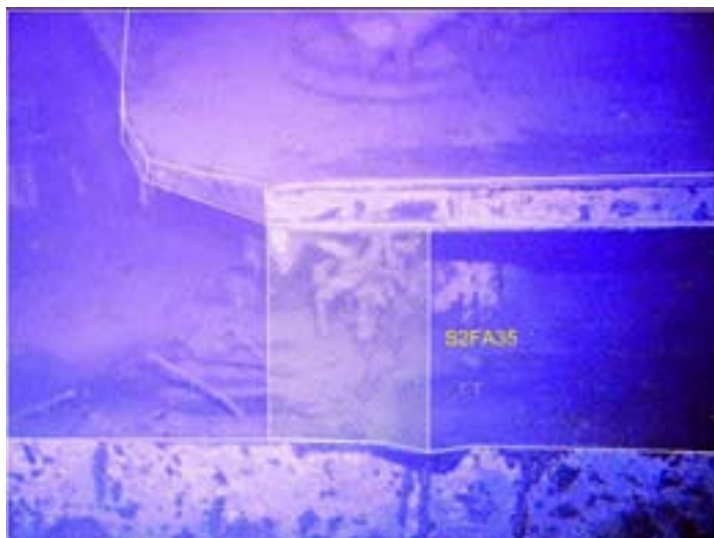
Figure 328: Starboard Side Aft 4" Gun deck Support missing [343]

Image : Screen capture from FSF Dive 2 File 147 (see Figure 328)  
 Location : Upper deck, starboard Aft 4" Gun deck support (see Figure 132)  
 Side : Starboard  
 Probable Cause : Shell detonation  
 Probable Weapon : 15 cm HE Shell

This damage was likely to have been caused by a direct shell hit to this support.

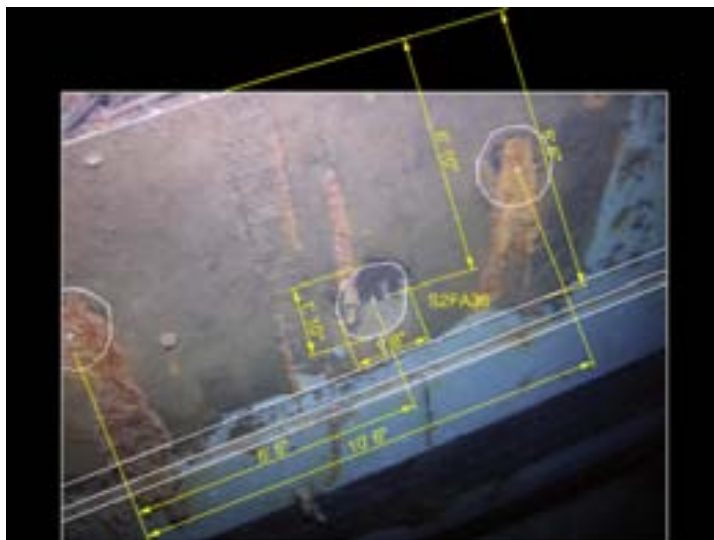
Figure 329: In vicinity of Cabins No. 5 and No. 7, Lower deck [218]

Image : FSF.003.0034 (see Figure 329)  
 Location : Lower deck, Cabin No. 5 or No. 7 (See Figure 132)  
 Side : Starboard  
 Probable Cause : Possibly contact detonation  
 Probable Weapon : Possibly 15 cm HE Shell  
 Hull Thickness : 35 lbs (22.2 mm)

This is a large hole in the side of the ship. It has likely been caused by the contact detonation of a 15 cm HE Shell. This hole is into Cabin No. 7 or No. 5 on the Lower deck.

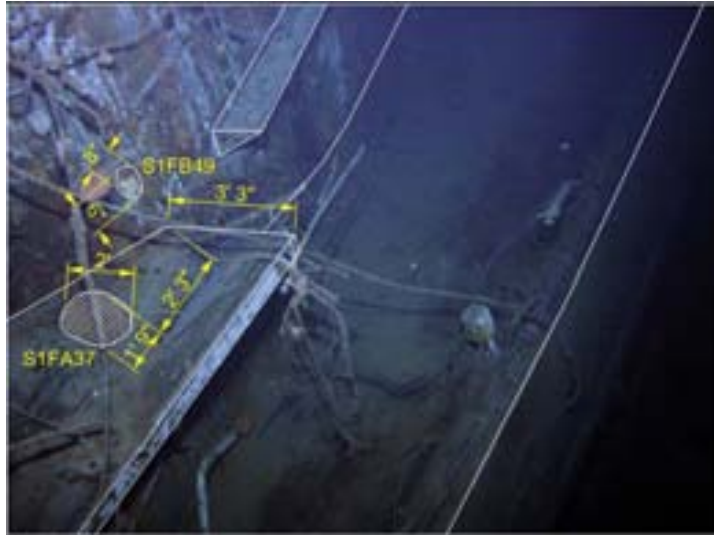
Figure 330: Starboard side of aft superstructure [219]

Location : Into Forecastle deck, Captain's Day Dining Cabin(see Figure 132)  
 Probable Cause : Possibly contact detonation  
 Probable Weapon : Possibly 15 cm HE Shell

This is a 2' (600 mm) hole in the Forecastle deck. The surrounding debris makes it difficult to positively identify the cause of this hole.

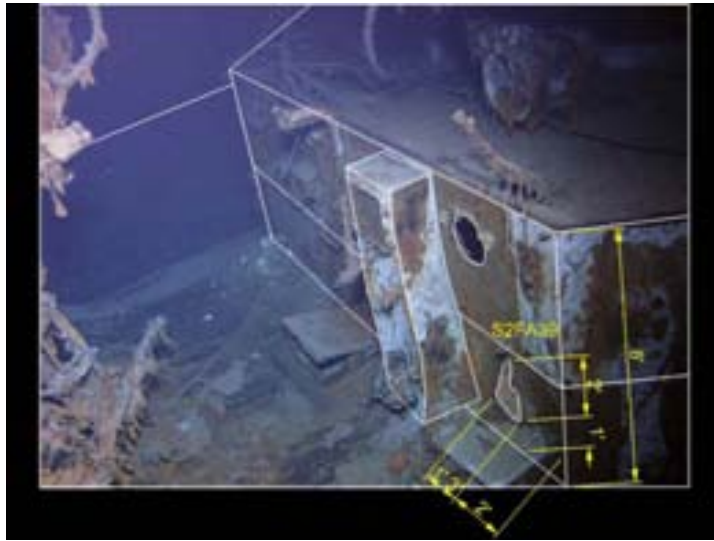
Figure 331: Superstructure forward of X turret [214]

Image : FSF.002.0258 (see Figure 331)  
 Location : Upper deck, Captain's bath (see Figure 133)  
 Side : Starboard  
 Probable Cause : Fragments from internal detonation  
 Probable Weapon : 15 cm HE Shell

This damage is consistent with damage due to a shell detonation inside the Captains bath area. This damage is likely to be associated with the 15 cm HE Shell penetration at S2FB51.

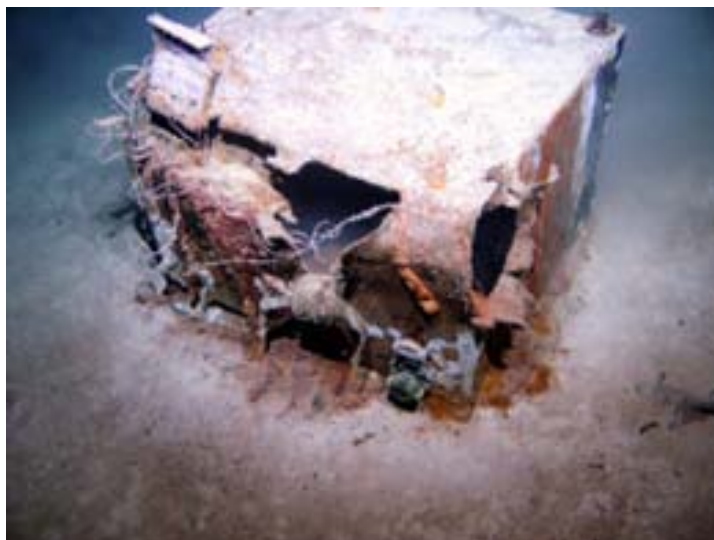
Image : FSF.004.0031 (see Figure 332)  
 Location : Hinged container/possibly disinfectant on Lower deck  
 (see Figure 130)  
 Side : Starboard  
 Probable Cause : Shell penetration  
 Probable Weapon : 15 cm HE Shell

It has not been possible to positively identify this piece of debris, but it does have a clear penetration from a shell. This debris may be associated with the disinfectant and there are a number of shell penetrations into the hull in this region that would have allowed this damage to occur.

Figure 332: Shell penetration to what is possibly the Disinfectant [367]

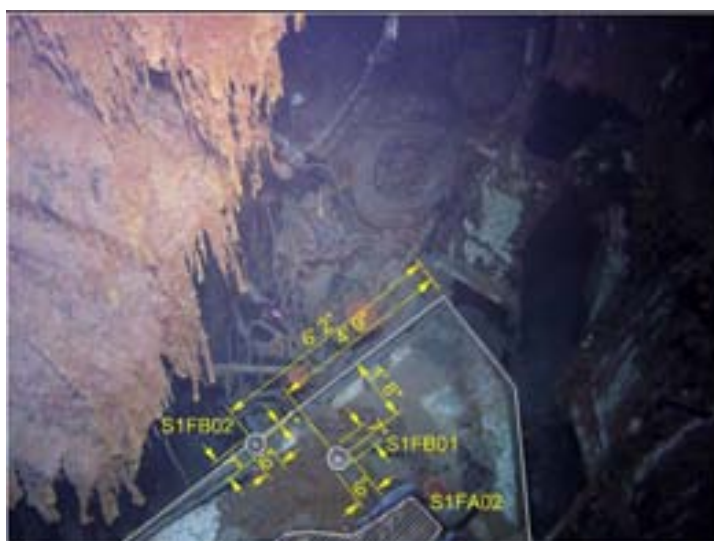
Figure 333: Starboard side of A Turret [368]

Image : FSF.002.0029 (see Figure 333)  
 Location : Starboard side of A Turret (see Figure 129)  
 Side : Starboard  
 Probable Cause : Shell penetration  
 Probable Weapon : 15 cm HE Shell  
 Armour Thickness: 1" (25 mm)

This is a clean hole, suggesting that an AP shell has been used. This hole is into the starboard side of the A turret, indicating that the turret was not facing *Kormoran* when hit. The internal damage from the internal shell detonation of this shell would have put this turret out of action.

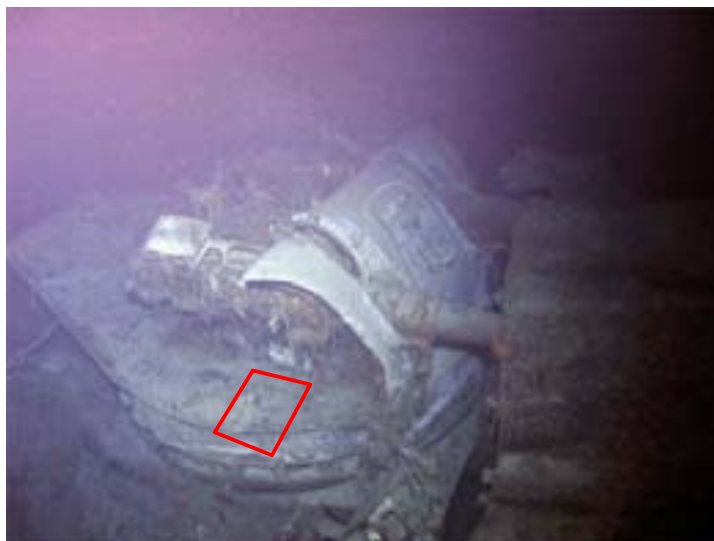
This shell has penetrated the armour plating of A turret. A marking on the floor of A Turret from this shell is visible in Figure 334. The internal damage to A Turret is extensive (when compared to the condition on B Turret) and it is certain that the damage to this turret put it completely out of action.

Figure 334: Damage to side of A Turret marks from shell penetration are highlighted in red [369]

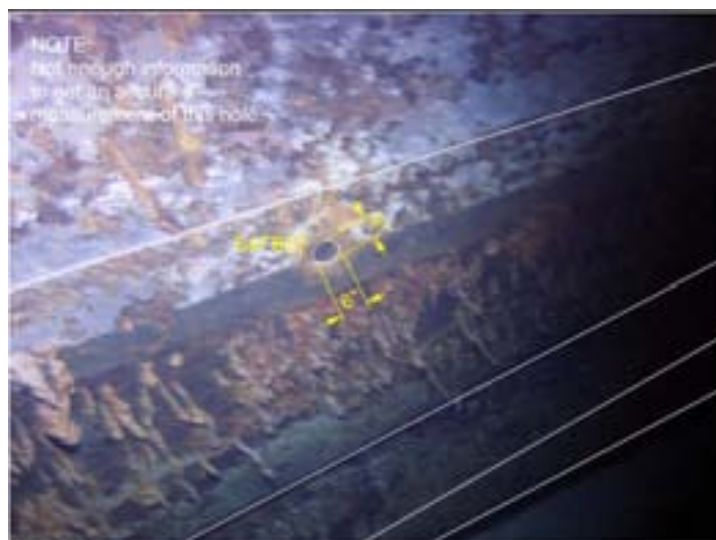
Figure 335: In vicinity of Refrigerating Machinery Compartment, Platform deck [370]

Image : FSF.002.0325 (see Figure 335)  
 Location : Platform deck, Refrigerating Machinery Compartment (see Figure 129)  
 Side : Starboard  
 Probable Cause : Shell penetration  
 Probable Weapon : 15 cm HE Shell  
 Hull Thickness : 20 lbs (12.7 mm)

This hole is close to the original waterline of the ship.

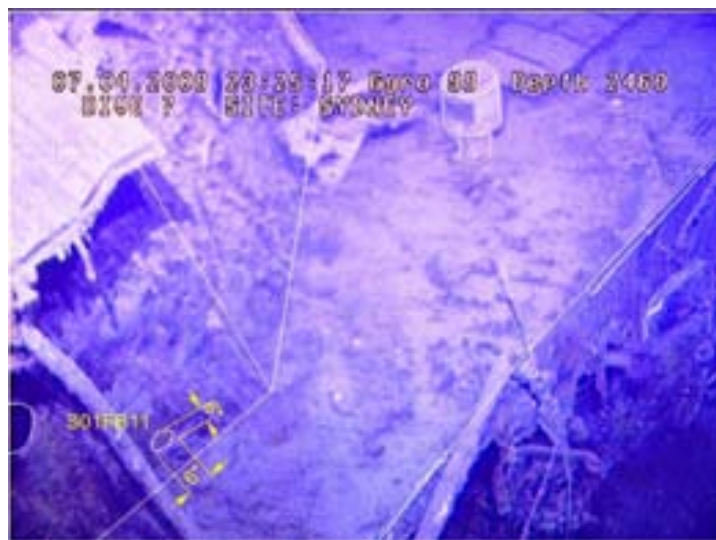
Figure 336: Starboard side of bridge superstructure [295]

Image : FSF.002.0214 (see Figure 336)  
 Location : Superstructure deck, Armament Office (see Figure 130)  
 Side : Starboard  
 Probable Cause : Shell penetration  
 Probable Weapon : 15 cm HE Shell

This appears to be a clean hole, possibly detonating inside the superstructure.

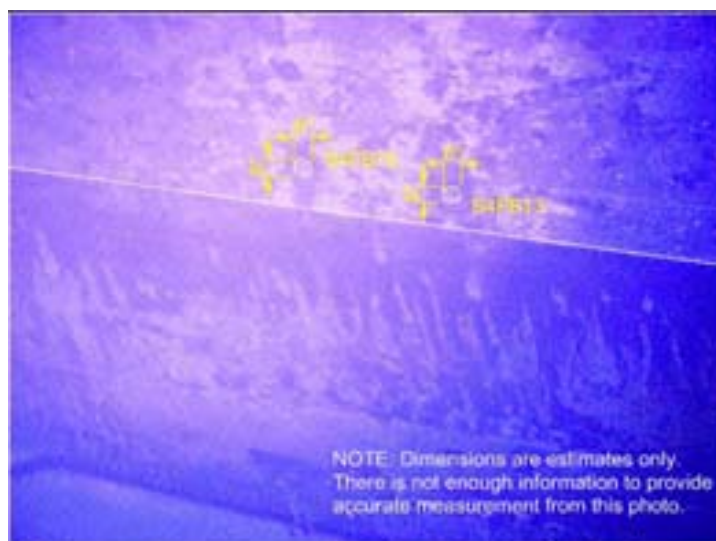
Figure 337: In vicinity of Cold Room, Platform deck [340]

Image : Screen capture from FSF Dive 2 File 159 (see Figure 337)  
 Location : Platform deck, Cold Room (see Figure 130)  
 Side : Starboard  
 Probable Cause : Shell penetration  
 Probable Weapon : 15 cm HE Shell  
 Hull Thickness : 20lbs (12.7 mm)

This hit is likely to be due to a 15 cm HE Shell cleanly penetrating the hull and possibly detonating internal on the platform deck.

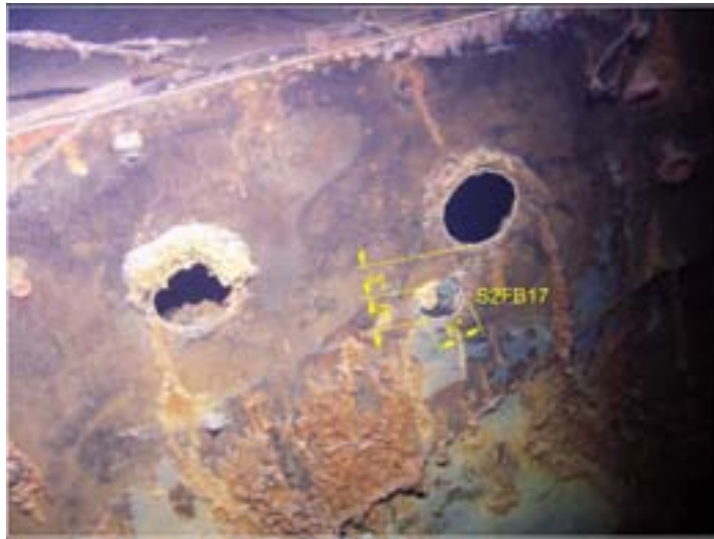
Figure 338: In vicinity of Canteen, Upper deck [192]

Image : FSF.002.0311 (see Figure 338)  
 Location : Upper deck, Canteen (see Figure 130)  
 Side : Starboard  
 Probable Cause : Shell Penetration  
 Probable Weapon : 15 cm HE Shell  
 Hull Thickness : 35 lbs (22.2 mm)

This damage appears to be due to a 15 cm HE Shell cleanly penetrating and possibly detonating internally on the Upper deck.

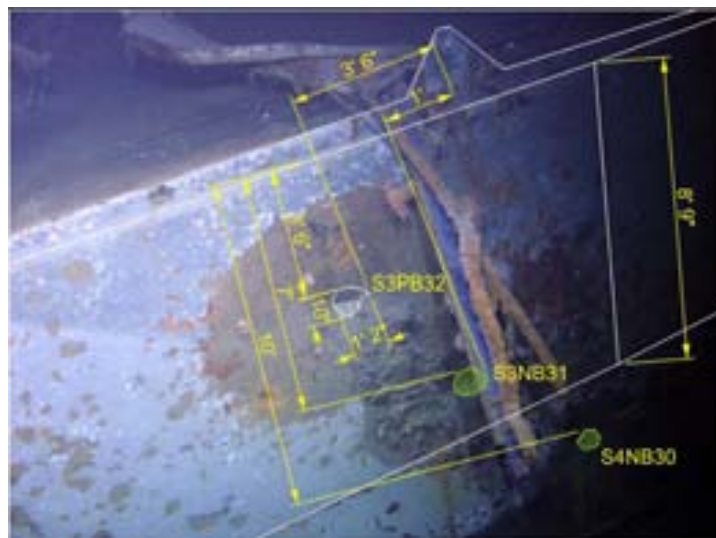
Figure 339: In vicinity of Kit Locker Flat, Lower deck [371]

Image : FSF.002.0306 (see Figure 339)  
 Location : Lower deck, Kit Locker Flat (see Figure 131)  
 Side : Starboard  
 Probable Cause : Non-penetrating contact detonation  
 Probable Weapon : 15 cm HE Shell  
 Armour Thickness: 164 lbs (104.1 mm)

This damage is on the armour plating and has failed to penetrate. No damage would have occurred behind the armour plating.

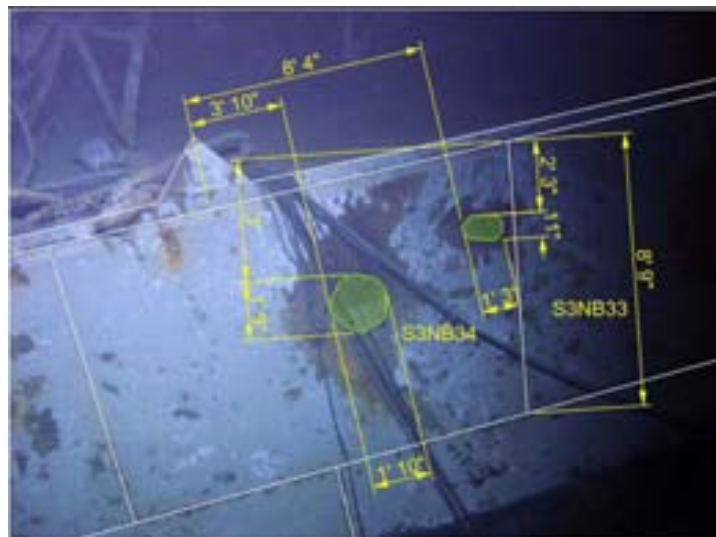
Figure 340: In vicinity of Kit Locker Flat, Lower deck [372]

Image : FSF.002.0304 (see Figure 340)  
 Location : Lower deck, Kit Locker Flat (see Figure 131)  
 Side : Starboard  
 Probable Cause : Non-penetrating contact detonation  
 Probable Weapon : 15 cm HE Shell  
 Armour Thickness: 164 lbs (104.1 mm)

This was a non-penetrating detonation. The fragment pattern suggests that this hit came in from an angle, but it is difficult to determine what the angle was.

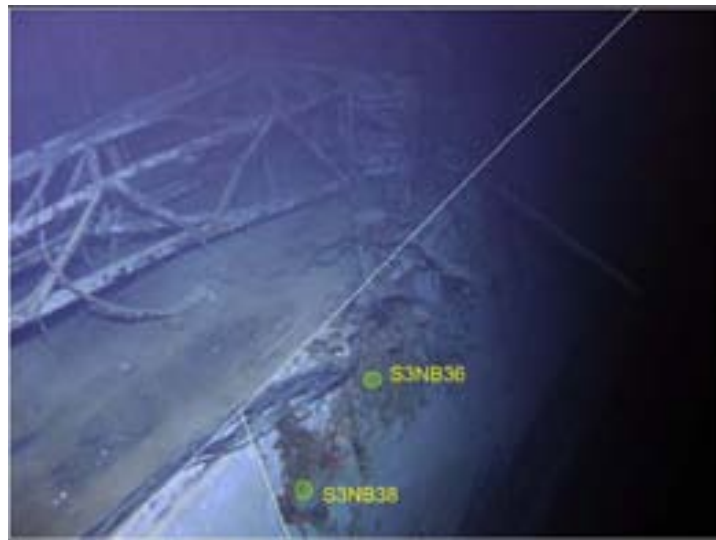
Figure 341: In vicinity of OA's Workshop, Lower deck [373]

Image : FSF.002.0301 (see Figure 341)  
 Location : OA's Workshop, Lower deck (see Figure 131)  
 Side : Starboard  
 Probable Cause : Non-penetrating contact detonation  
 Probable Weapon : 15 cm HE Shell  
 Armour Thickness: 164 lbs (104.1 mm)

This hit is a non-penetrating contact detonation and would not have caused damage to the compartments behind the armour plating.

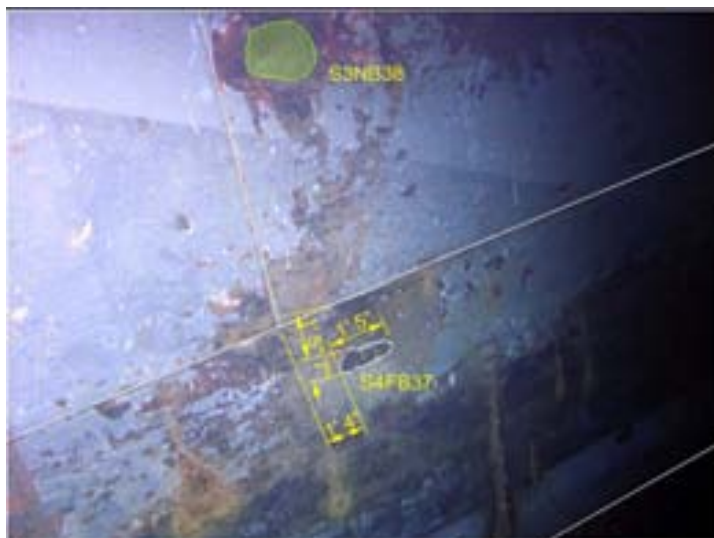
Figure 342: In vicinity of No. 1 Cable Passage, Platform deck [309]

Image : FSF.002.0303 (see Figure 342)  
 Location : Platform deck, No. 1 Cable Passage (see Figure 131)  
 Side : Starboard  
 Probable Cause : Shell penetration  
 Probable Weapon : 15 cm HE Shell  
 Armour Thickness: 164 lbs (104.1 mm)

This shell has contacted the hull at an acute angle from the forward direction and has detonated on the surface. This has resulted in a penetration to the armour plating. This hit would have resulted in many fragments being thrown into the No. 1 Cable Passage.

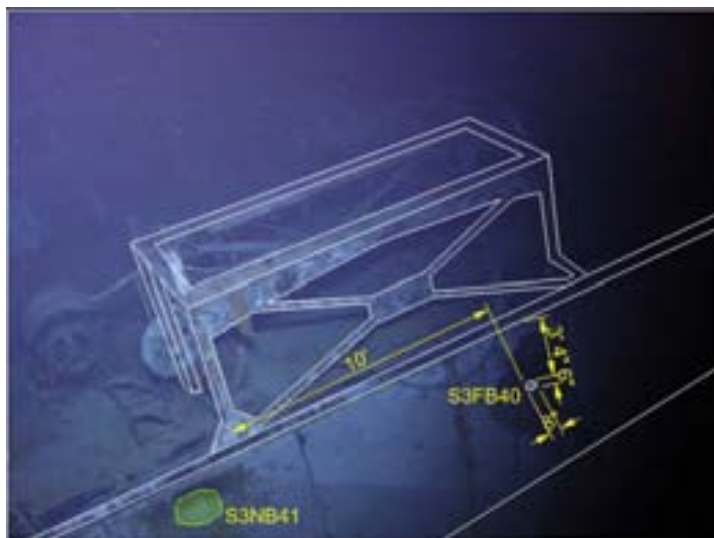
Figure 343: In vicinity of ERA's Dressing room, Lower deck and below 27 ft Whaler [374]

Image : FSF.002.0298 (see Figure 343)  
 Location : Lower deck, ERA's Dressing Room (see Figure 131)  
 Side : Starboard  
 Probable Cause : Shell penetration  
 Probable Weapon : 15 cm HE Shell  
 Armour Thickness: 164 lbs (104.1 mm)

This shell has penetrated into the ERA's Dressing Room and has possibly detonated internally.

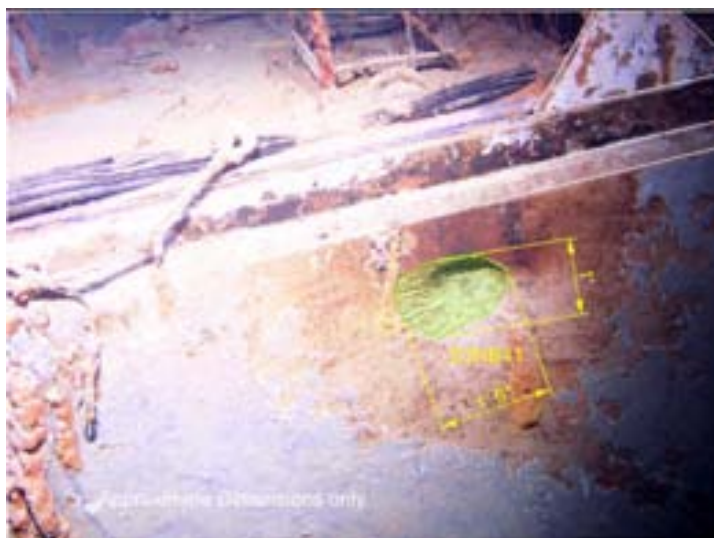
Figure 344: In vicinity of ERA's Wash Place and below starboard side 27 ft whaler [375]

Image : FSF.002.0291 (see Figure 344)  
 Location : Lower deck, ERA's Wash Place (see Figure 132)  
 Side : Starboard  
 Probable Cause : Non-penetrating contact detonation  
 Probable Weapon : 15 cm HE Shell  
 Armour Thickness : 164 lbs (104.1 mm)

This shell detonation would have sprayed fragments into the 27' Whaler.

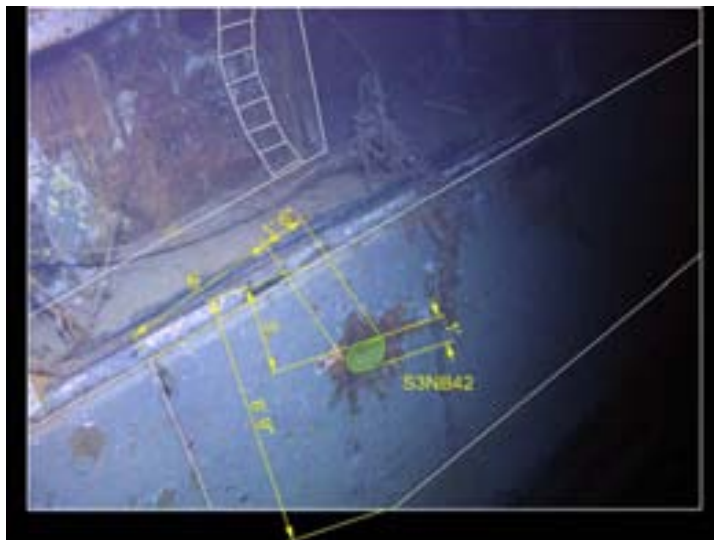
Figure 345: In vicinity of Day Man's Wash Place, Lower deck [376]

Probable Cause : Non-penetrating contact detonation  
 Probable Weapon : 15 cm HE Shell  
 Armour Thickness: 164 lbs (104.1 mm)

This shell hit would not have caused any internal damage.

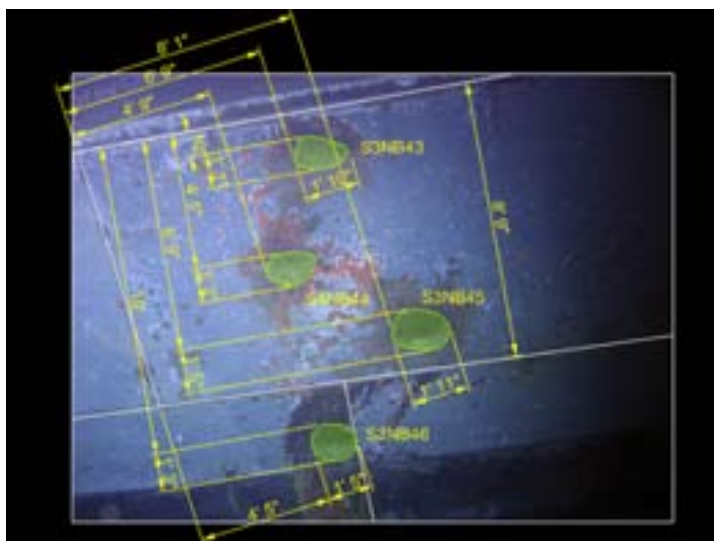
*Figure 346: In vicinity of Chief Stoker's Wash Place, Lower deck [377]*

Image : FSF.002.0284 (see Figure 346)  
 Location : Lower deck, Chief Stoker's Wash Place (see Figure 132)  
 Side : Starboard  
 Probable Cause : Non-penetrating contact detonation  
 Probable Weapon : 15 cm HE Shell  
 Armour Thickness: 164 lbs (104.1 mm)

This is a non-penetrating shell hit and would not have caused internal damage. Some fragments from this detonation may have damaged the superstructure above.

This is a non-penetrating shell hit and would not have caused internal damage.

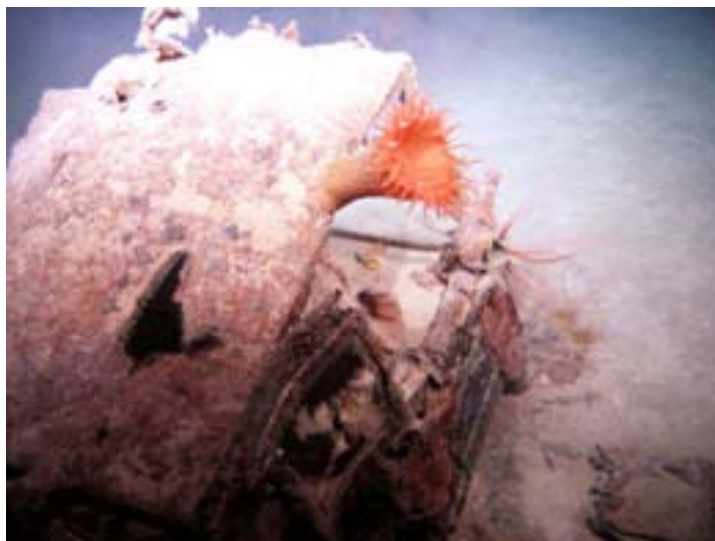
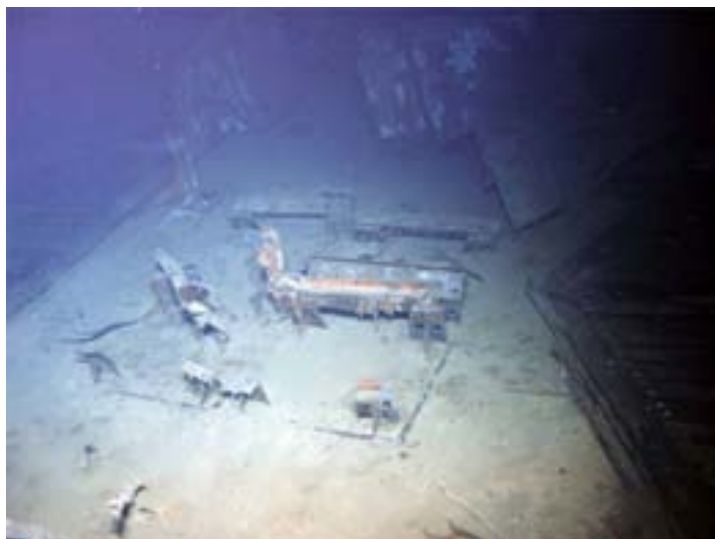
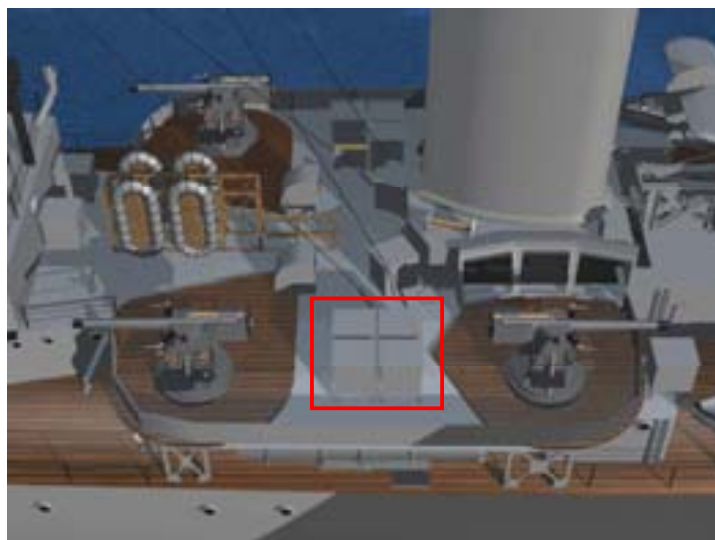
Image : FSF.004.0194 (see Figure 347)  
 Location : Upper deck, 4" HA Ammunition Locker (see Figure 132)  
 Side : Starboard  
 Probable Cause : Weapon damage  
 Probable Weapon : Unknown

The 4" Ammunition Locker has been either hit by a German shell, or hit by a fragment causing sympathetic detonation of a 4" shell within the locker. All of the 4" HA Ammunition Lockers in this area have become detached from the mounting brackets (see Figure 347). This is either due to the detonation or due to damage during sinking. There is potential for fragment damage to the equipment on the surrounding deck, including the Carley Floats on these decks (see Figure 349).

Figure 347: 4" HA Ammunition Locker in debris field [378]

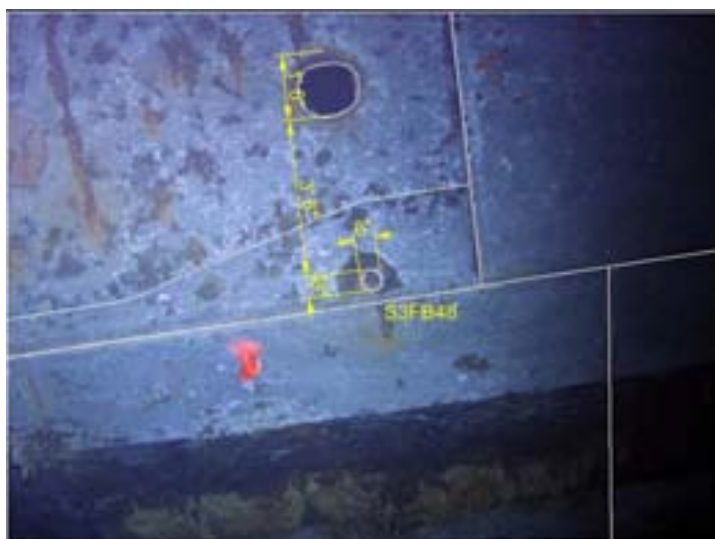
Figure 350: In vicinity of No. 1 Cabin, Lower deck [380]

Image : FSF.002.0272 (see Figure 350)  
 Location : Lower deck, No. 1 Cabin (see Figure 132)  
 Side : Starboard  
 Probable Cause : Shell penetration  
 Probable Weapon : 15 cm HE Shell  
 Hull Thickness : 35 lbs (22.2 mm)

This is a clean penetration in the No. 1 Cabin which would have detonated internally.

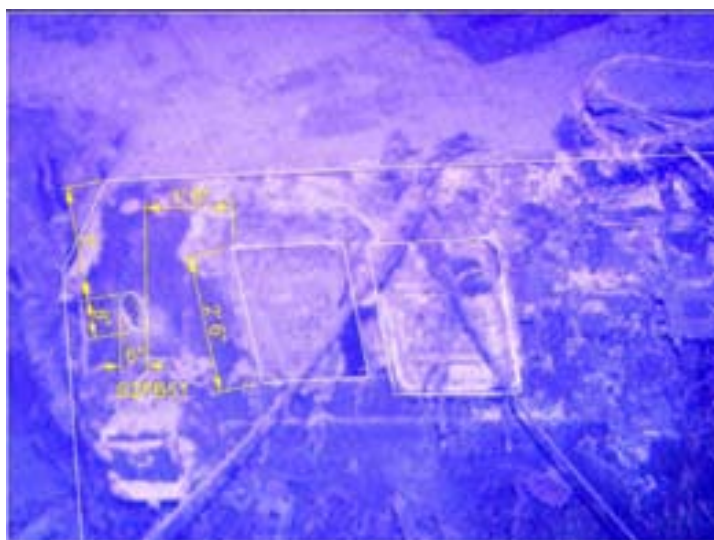
Figure 351: In vicinity of Captain's Bath, Upper deck [343]

Image : Screen capture from FSF Dive 2 File 145 (see Figure 351)  
 Location : Upper deck, Captain's Bath (see Figure 133)  
 Side : Starboard  
 Probable Cause : Shell penetration  
 Probable Weapon : 15 cm HE Shell

This is a shell penetration into the Captain's Bath area. This shell hit is also possibly associated with damage at S2FA39 where the shell may have detonated.

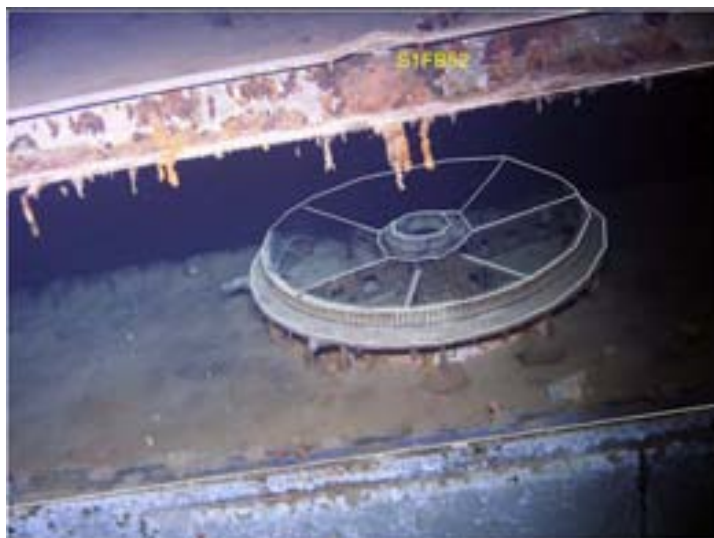
Figure 352: Starboard side torpedo tube mounting [381]

Image : FSF.002.0278 (see Figure 352)  
 Location : Above starboard side torpedo tube mount (see Figure 132)  
 Side : Starboard  
 Probable Cause : Contact Detonation  
 Probable Weapon : 15 cm HE Shell

This damage is possibly associated with the damage to the 4" HA Ammunition Lockers on the starboard side (S1FB47).

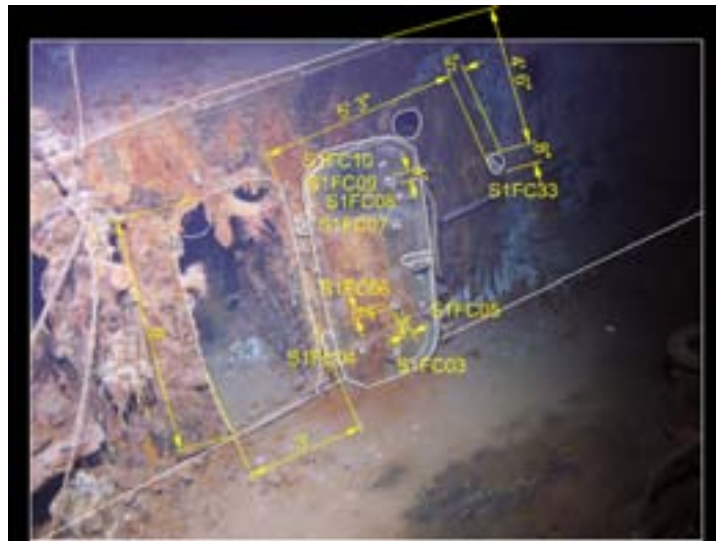
Figure 353: In vicinity of Recreation Space, Forecastle deck [187]

Image : FSF.002.0319 (see Figure 353)  
 Location : Forecastle deck, Recreation Space (see Figure 129)  
 Side : starboard  
 Probable Cause : Fragment damage due to external detonation\Shell Penetration  
 Probable Weapon : 15 cm HE Shell\3.7 cm Shell

This door has a number of penetrations. Assuming that the door was closed, this damage is a result of either externally generated fragments (i.e. a 15 cm HE Shell in the vicinity) or possibly due to a series of 3.7 cm shell holes. Due to the irregular shape of the holes suggests that the damage is due to fragments from a 15 cm HE Shell, but the linear pattern suggests that it could be the result of automatic weapons fire.

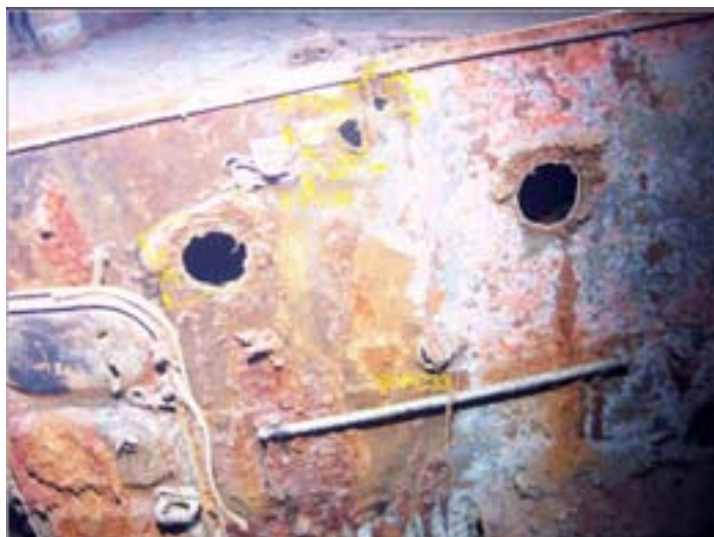
Figure 354: In vicinity of Seaman's Heads [188]

Image : FSF.002.0321 (see Figure 354)  
 Location : Forecastle deck, Seaman's Heads (see Figure 129)  
 Side : starboard  
 Probable Cause : Fragment damage  
 Probable Weapon : 15 cm HE Shell

See S1FC33.
