# In-flight engine malfunction – Boeing 747-438, VH-OJH

100 km south-east of Bali International Airport, Indonesia | 9 May 2011

**ATSB Transport Safety Report**  
Aviation Occurrence Investigation  
AO-2011-062  
Final

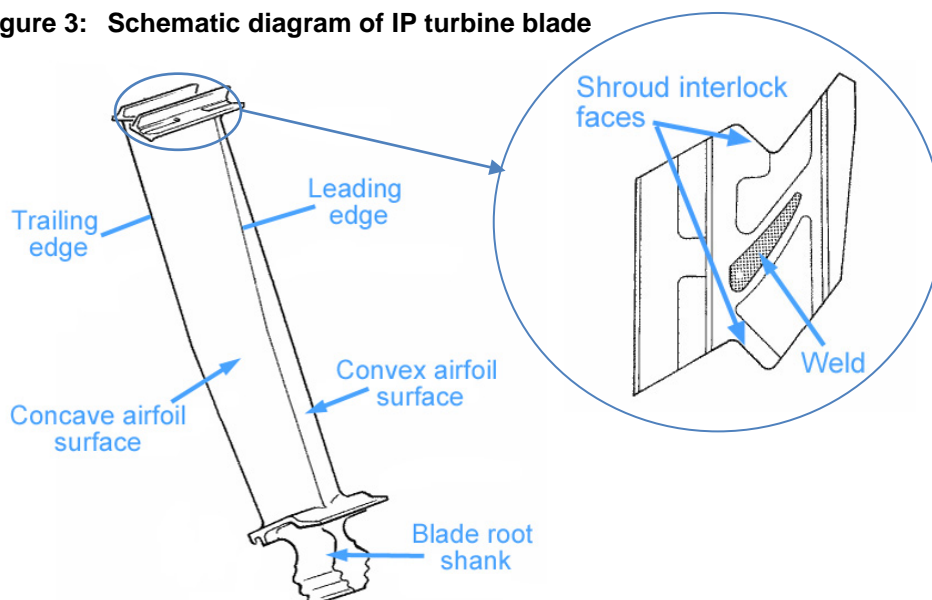
**Figure 3: Schematic diagram of IP turbine blade**

The fractured IP turbine blade, manufactured in May 1989, was identified as blade No.24 (disc post position), with serial number A01630-7 and part number UL21701. The blade had fractured approximately 5 mm (0.2 in) from the root platform.

Fractographic analysis showed that the blade had failed following the growth of a low stress/high cycle fatigue crack that had originated on the convex (suction) side of the aerofoil (Figure 3) and propagated across a significant portion of the cross section prior to final release in tensile rupture (Figure 4). There were no discontinuities or other localised stress-raising defects identified in the crack origin areas.
