Design of Safe Timber Structures - How Can we Learn from Structural Failures in Concrete, Steel and Timber?

Frühwald, Eva; Serrano, Erik; Toratti, Tomi; Emilsson, Arne; Thelandersson, Sven

2007

Report TVBK-3053
ISSN 0349-4969
ISNR:LUTVDG/TVBK-3053-SE (228)

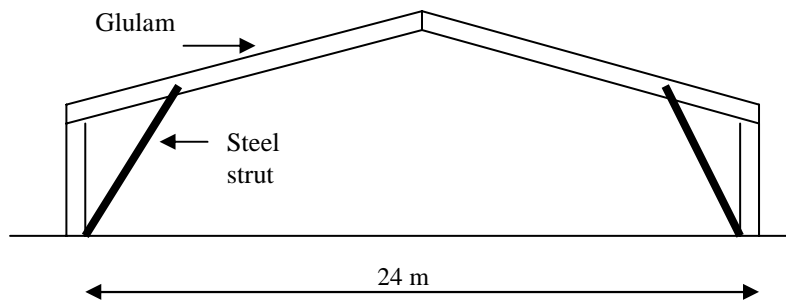
Figure 32-1. Schematic of frame structure

In 1993, a building that originally had served as a temporary exhibition hall in Trondheim since 1984, was erected in Oppdal as a sports hall. The structure consisted of three-hinged frames of glulam, placed at 6 m centres, with a span of 24 m. Inclined steel struts were placed between frame support and frame beam, see figure 32-1.

The building was not designed for snow load in Oppdal, however, extra wind bracing was provided.

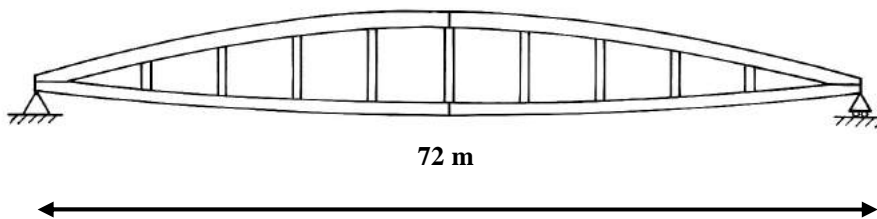
Figure 41-1. Design of glulam truss.

The roof structure of the cycle velodrome is a fish-shaped truss with double upper and lower rafters and single verticals (placed at 6.4 m centres), but no diagonals, built in 2001, see figure 41-1. The trusses span 72 m and are supported by concrete columns. One of the supports allows horizontal movements in the trusses direction. The verticals are connected to the rafters with two bolts including bulldog. The upper rafter has dimensions 2 times 160 mm x 900 mm (with 160 mm gap), the lower rafter has dimensions 2 times 160 mm x 533 mm (with 160 mm gap), and verticals are 160 mm x 160 mm (in between the rafters). The upper rafter is braced by purlins (220 mm x 440 mm) placed at 6.4 m centres (as the verticals). Diagonal bracing is also provided in the roof plane. The lower rafter is braced by boards (160 mm x 200 mm), placed at 12.8 m centres.

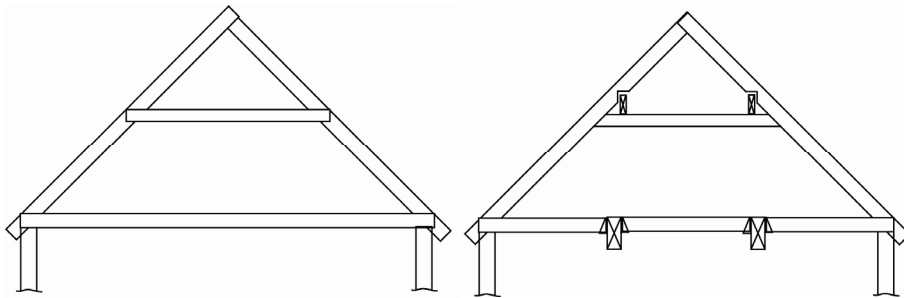
Figure 56-1: Designed roof structure (left) and executed roof structure (right).

Inclined exterior walls indicate problems with horizontal forces from the roof structure. The investigation showed that the roof structure of the log house was executed differently from the design. The design was made for a roof with collar beam, where the beams in the slab between ground floor and first floor should serve as tie beams, see figure 56-1 (left). However, the roof structure was executed with intermediate purlins above the collar beam that were not in contact with the rafters and thus not statically used at all. However, notches had been prepared, which weaken the cross-section (about 30% reduction) and load-bearing capacity of the rafter. The rafter dimensions were smaller than in the design. The smaller dimensions and notches imply that the stresses exceed the design stresses by 25%. Furthermore, due to the long span in the ground floor (living room), two binding beams are used and the tie beams were jointed with the binding beams via sheet metal joist hangers. However, the joist hangers were not properly nailed to neither binding beams or tie beams and were only supposed to transfer vertical loads. Horizontal loads cannot be transferred here, but have to be taken in the joint between rafters and exterior walls. This led to an outward compression on the exterior walls. Additionally, the tie beams were drawn out of the bag of joists (about 5 cm). Due to risk of collapse of the whole construction, the residents were evacuated and the structure had to be changed. The failure in this case was due to changes on the building site, compared to the design (on-site alterations).

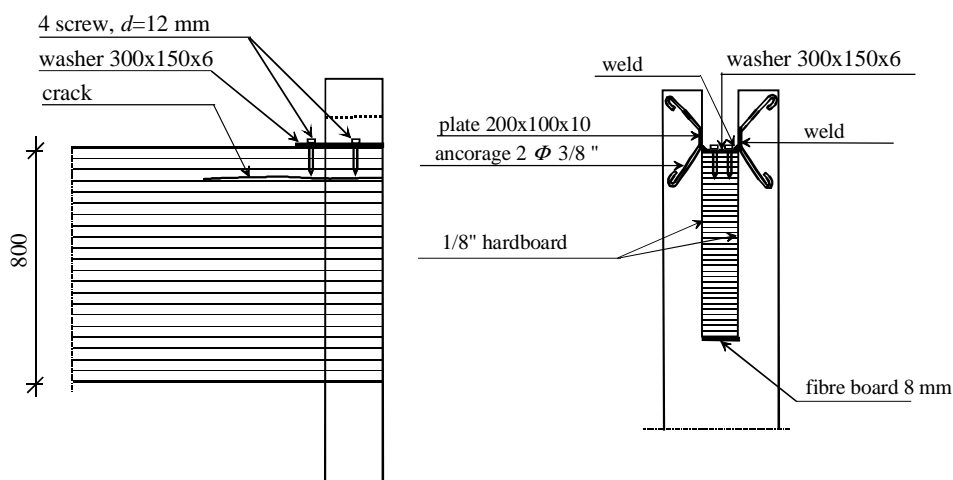
Figure 94-1: Support connection of glulam beam to concrete column.

This building is a school gymnasium built in the 1970's with a length of 24 m and width of 13.4 m. The damaged glulam beam is supported on a concrete column. The beam cross section is $b \times h = 140 \times 800 \text{ mm}^2$, the span is 13.4 m and the beam spacing 2.4 m. The support connection of the beam and column is as shown in figure 94-1 below.

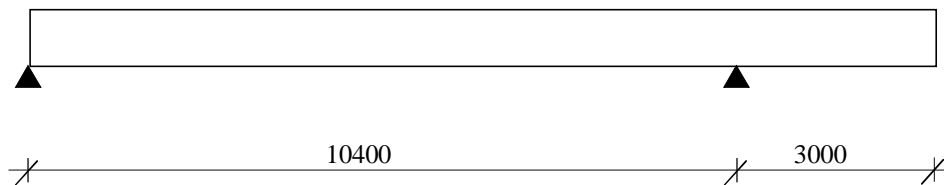
Figure 95-1: Beam in roof structure.

A commercial building, originally 40 to 45 years old, had been enlarged twice. The damaged beam was part of the old building part next to the newer enlargement. The beam was as shown in figure 95-1 below, a single span plus a cantilever. The cross section was $b \times h = 92 \times 845 \text{ mm}^2$ and it was loaded from a 4 m wide tributary area. The other beams were loaded from a 3.8 m wide area. The beams were supported on concrete columns.

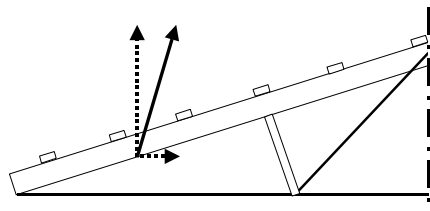
After finalising the roof structure with four trusses and purlins, a crane was used to raise it in place on top of supporting columns. The straps used during rising of the structure were placed according to figure 104-2. The forces in the straps lead to a compressive force in the glulam parts, as indicated below. In addition, the purlins are also subjected to compressive forces, see figure 104-3. Just before putting the roof structure down on its supports, the structure collapsed. According to witnesses, one of the outermost trusses tilted and the structure failed.

Figure 104-2. Strap placement.

Figure 104-3. Strap placement.

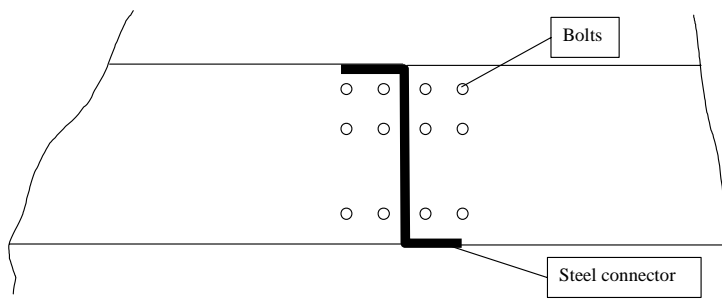
Figure 109-1. Schematic of beam connection.

The roof structure of this library and lecture hall consists of primary load bearing glulam beams of depth between 855 and 1350 mm. The beam width is 215 mm. The beams are connected at supports with a steel connector, schematically shown in figure 109-1. The structure was erected during March – April.

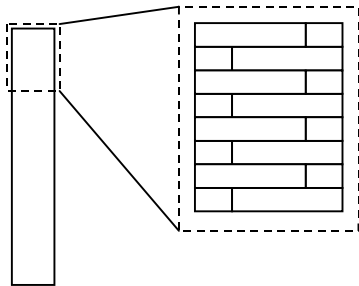
Each of the 190 mm wide roof beams was made up from two laminations, edgewise glued to each other. The two laminations had widths of 45 and 145 mm respectively. This is shown in figure 112-2.

Figure 112-2. Beam cross-section built up from edgewise glued laminations.

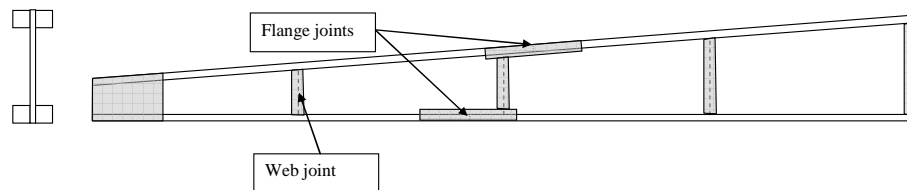
Figure 113-1. Beam with joint reinforcements.

The roof structure of the school building was made from single tapered beams, made from solid wood flanges glued to a plywood web. The flanges were glued-nailed to the web using a phenol or possibly a phenol-resorcinol adhesive. The flanges consisted of two timber members, one glued to each side of the web. The web had joints, which were reinforced by vertical wood members, also glued-nailed to the web. The flanges were also lengthwise joined by glued-nailed, overlapping wood members. The flange joint was located at the same section for both timber members in the flange. The roof beam is schematically depicted in figure 113-1. The span of the roof beams was approximately 7.9 m.

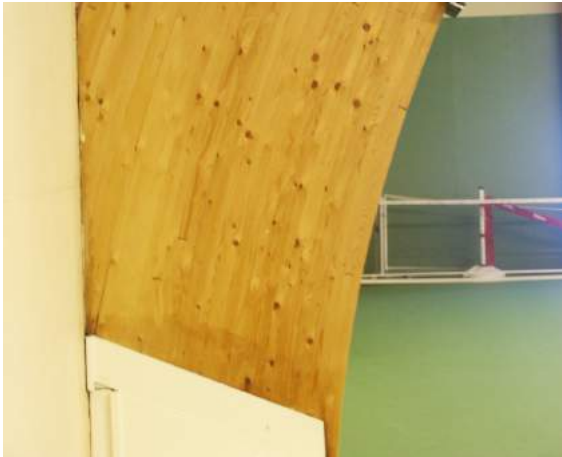
Figure 115-1. Arched column with steel parts (in white).

This structure is a tennis hall built from 3-hinged glulam frames, placed at 9 m distance. The columns are curved, and attached to the ground by steel parts, see figure 115-1.

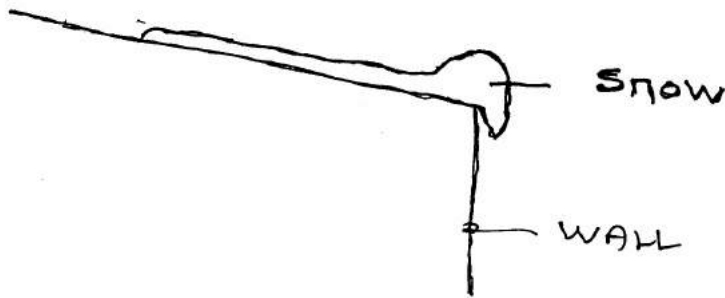
The investigation showed that the snow load on the roof moved downwards due to the pitch of the roof and melting. Extremely high snow load was present at the eaves, see figure 118-1, which led to overloading of the eaves purlin.

Figure 118-1: Snow load at time of failure.

Snow overhanging according to EC1 fig. 6.2 should have been considered.

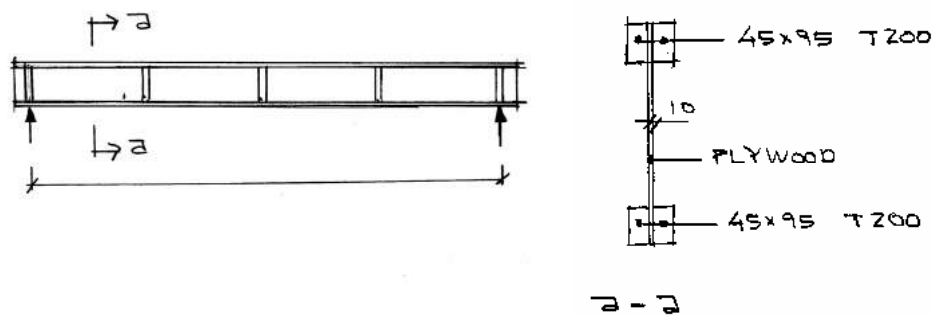
Figure 121-1: Light-weight I-beams.

A farm building (11 m x 24 m) was built in 1973 with light-weight plywood beams and timber columns. The beams had a depth of 630 mm and were placed at 3.5 m centres. The plywood web was butt jointed, see figure 121-1.
