Windowcraft – Part One

SONJA ALLBÄCK AND BERTIL FREDLUND

Abstract

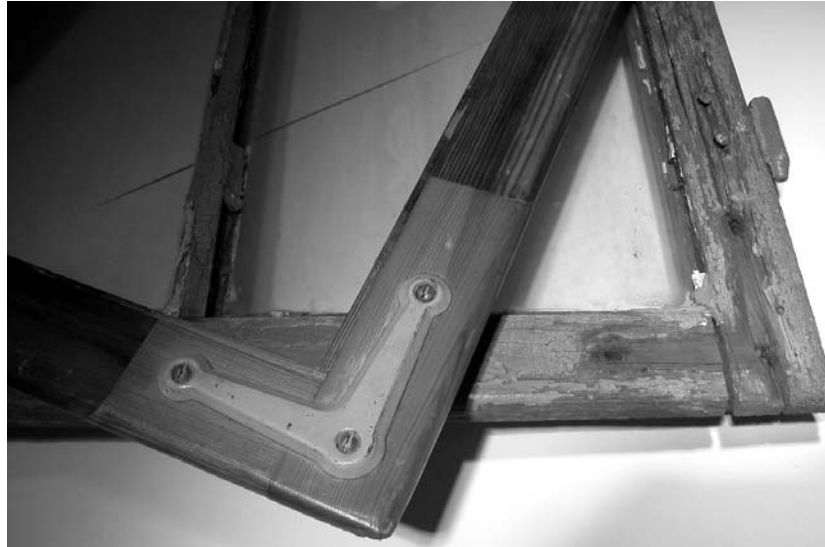
Figure 1 Windows from 1880, showing small-scale repairs.

We started our training school in Sweden in 1985. Since the Windowcraft artisan is a carpenter, glazier, painter, blacksmith, and bricklayer, all rolled into one, he or she will thus be an expert on the interactions between the various materials of a window – wood, glass, paint, putty, fittings, and plaster – and will assume responsibility for the end result. This new organizational form removes earlier technical and financial limitations on the renovation and maintenance of windows. The individual parts create the whole (Figure 1).

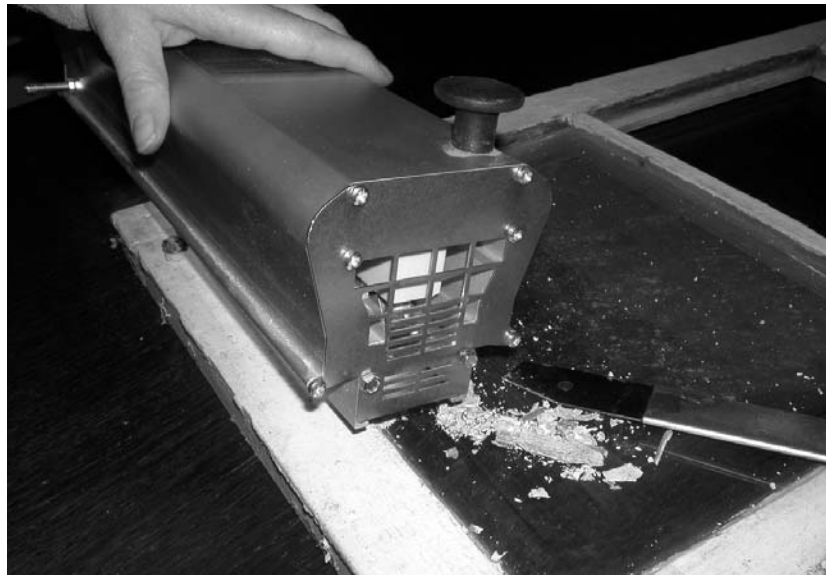
Figure 2 The putty lamp – an innovation by Sonja and Hans Allbäck.

Another difficult problem that we encountered was how to soften hard linseed-oil putty in order to remove glass. The putty needs to be heated to more than 100°C to soften (depending on the quality of the putty), but glass will crack long before that temperature. As we wanted to save the old blown glass in order to recycle all parts of the window, we carried out many trials before realizing that infrared radiation with a wavelength

below $2.6\ \mu\text{m}$ passed through the glass. At a wavelength of $2.0\ \mu\text{m}$, only 10–15 per cent of the energy is absorbed by the glass, depending on its thickness and iron oxide content. We knew that if we could regulate power to the lamp at a level where the infrared radiation was very high ($\sim 2.0\ \mu\text{m}$) and focus this energy, we might heat the surface without affecting the glass. This was the basis for the development of a new tool to soften hard putty without cracking the glass – the ‘putty lamp’ was born (Figure 2).² Infrared radiation passes through the glass, and softens the putty over and under it. Once the putty and pins are removed, the valuable, original glass can be lifted from the casement and recycled.
