## STANDARDS FOR RESTORATION & GUIDELINES FOR RESTORING HISTORIC BUILDINGS

# Restoration

## Standards for Restoration

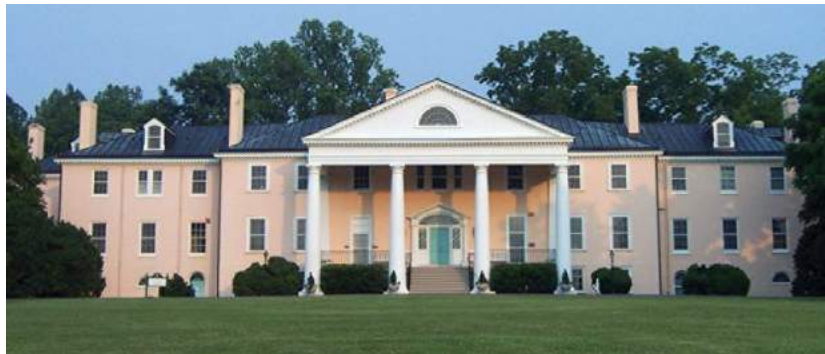
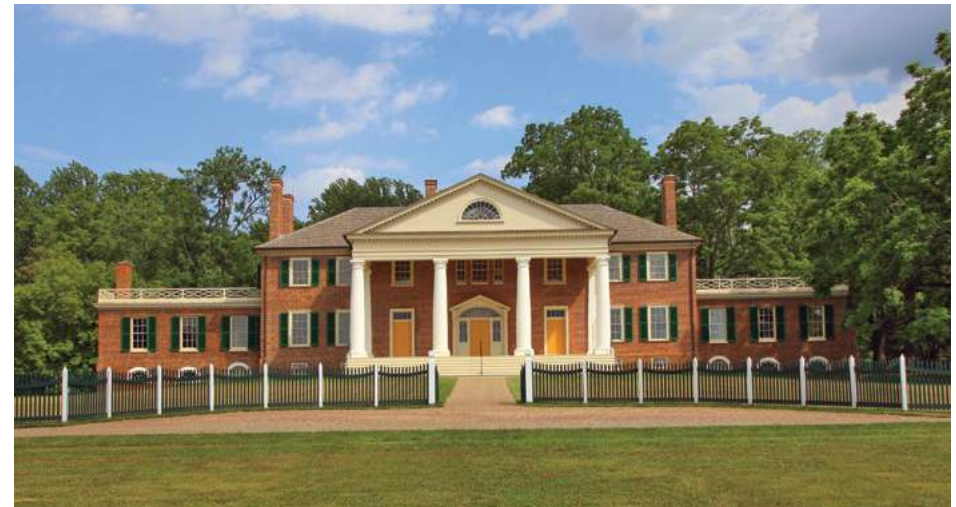
[1] (a) When it was acquired by the National Trust for Historic Preservation in the 1980s, Montpelier in Montpelier Station, VA, the home of James and Dolley Madison, had been much altered and enlarged since it was first constructed. Based on historical documentation and research, Montpelier was accurately restored to its 1820s appearance when the president and his wife lived there (b). *Photos: Courtesy of The Montpelier Foundation.*

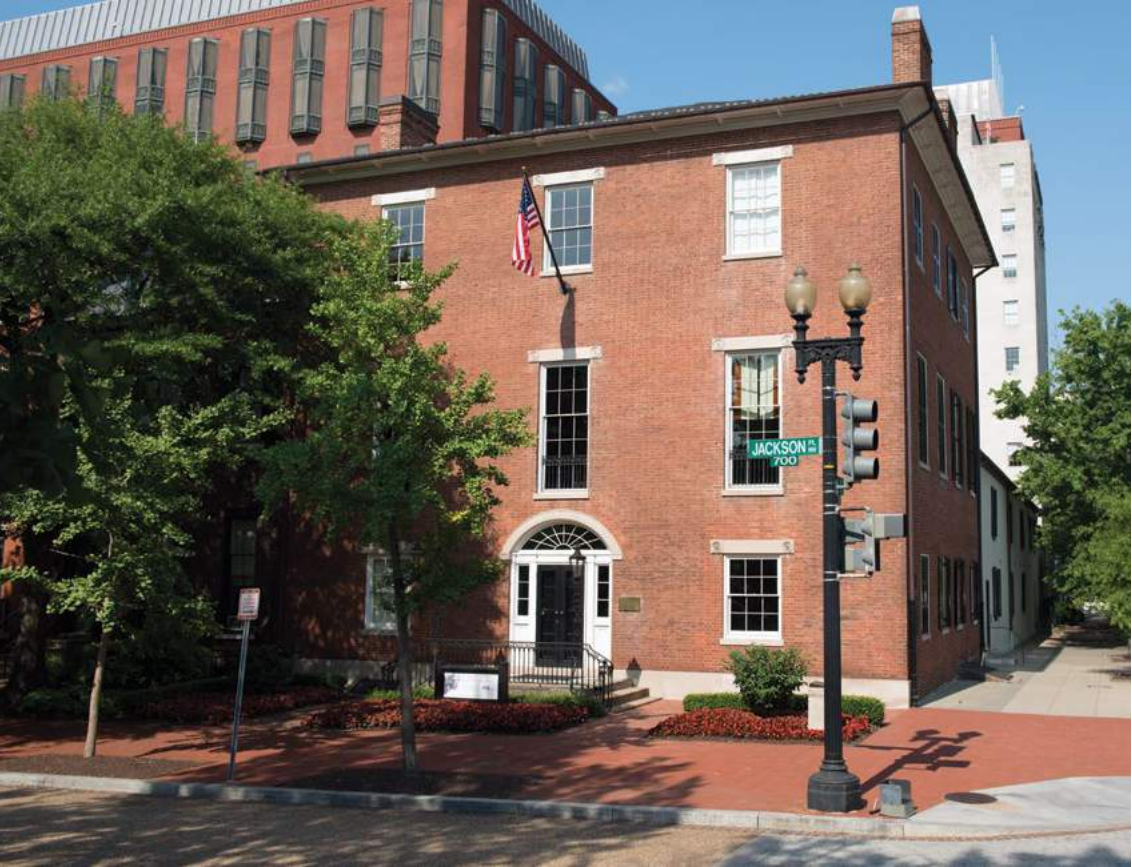
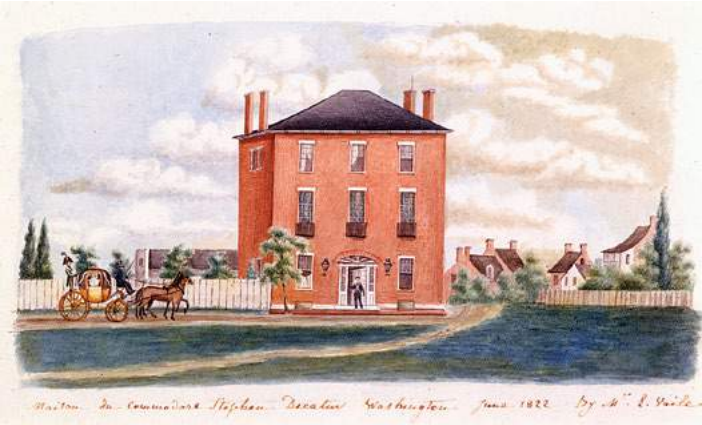
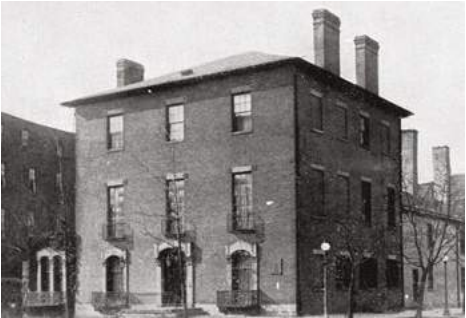
[2] (a) Decatur House in Washington, DC, was designed by William Henry Latrobe and constructed in 1816. (b) In the late-19th century, the façade was “modernized” by removing the limestone lintels on the first floor and replacing them with decorative sandstone lintels in the style of the period. (c) In the mid-20th century, the house was brought back to its original appearance based on historic documentation. Photos: The White House Historical Association and Decatur House, a National Trust Site.

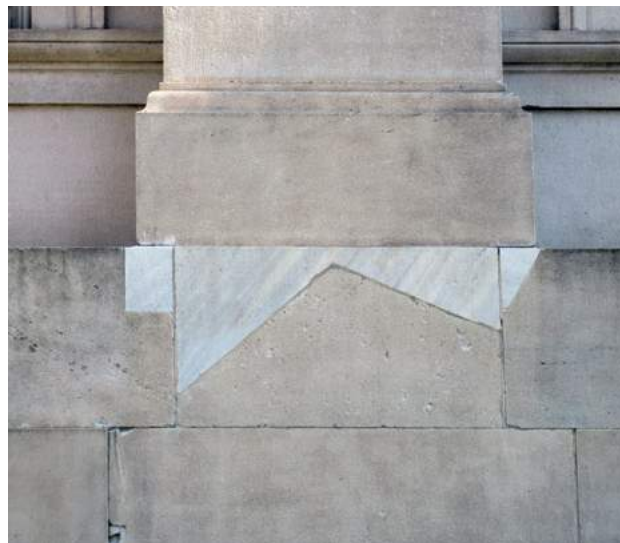
[3] **Not Recommended:** Although the Dutchman stone repair has been well executed, the replacement stone is not a good color match.

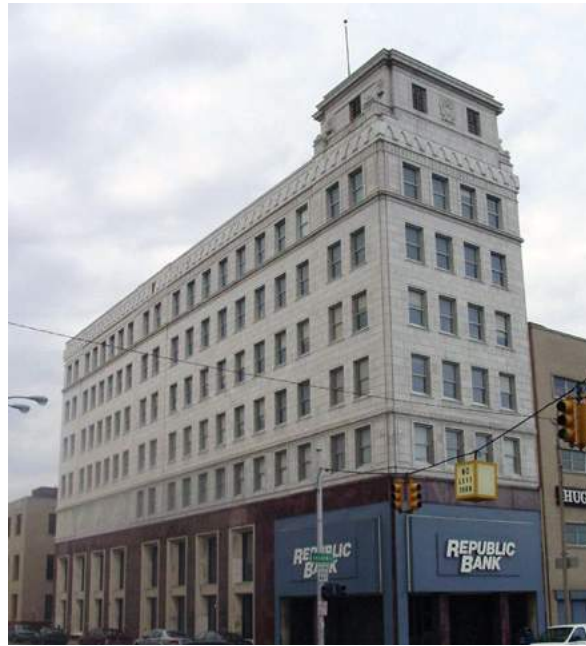
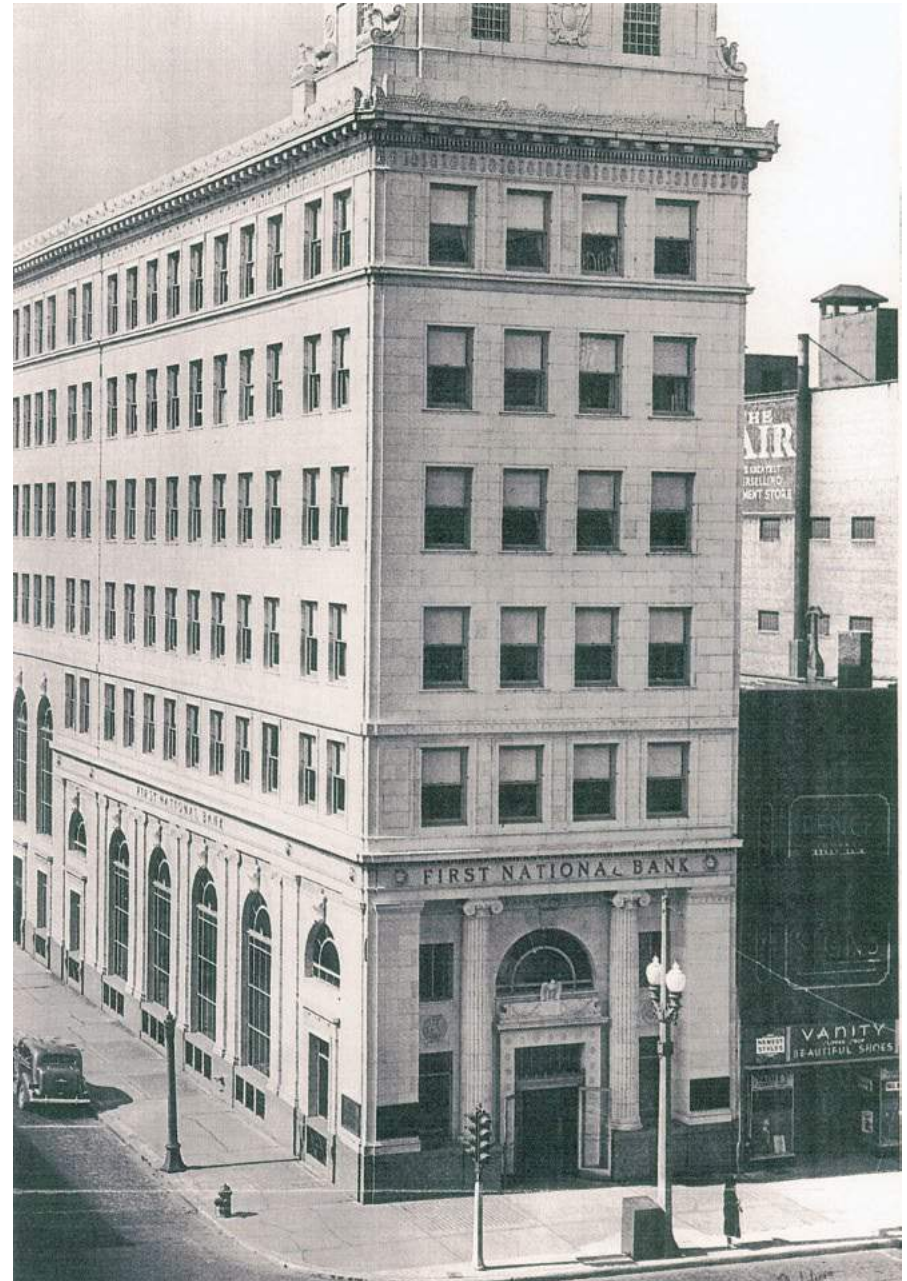
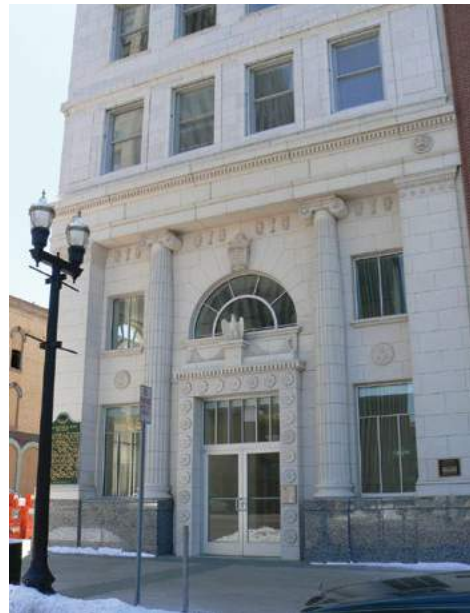
[4] (a) Over the years terra-cotta cladding had been replaced on the lower floors of this early-20<sup>th</sup> century bank building with a storefront and incompatible windows. (b) A 1936 photograph of the building provided the documentation to restore its historic appearance. (c) Glass fiber reinforced plastic (GFRP) was chosen as a substitute material, and samples were made in a variety of colors and textures to obtain the best match for the missing and damaged terra cotta. (d) This photo taken after restoration shows that the GFRP replacements successfully blend in with the original terra cotta. Photo (d): Blamonet at English Wikipedia.

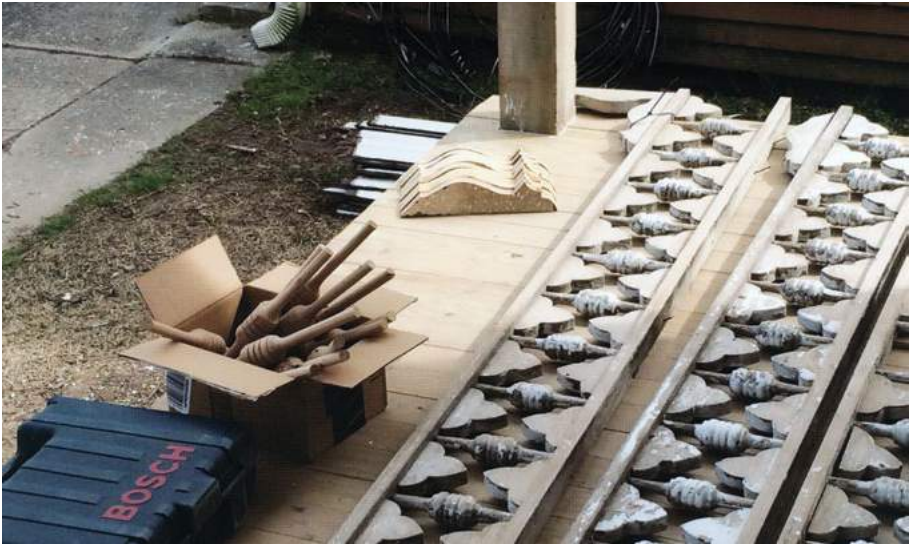
[5] New wood trim pieces were milled to match the few remaining historic features to replace those that were missing.

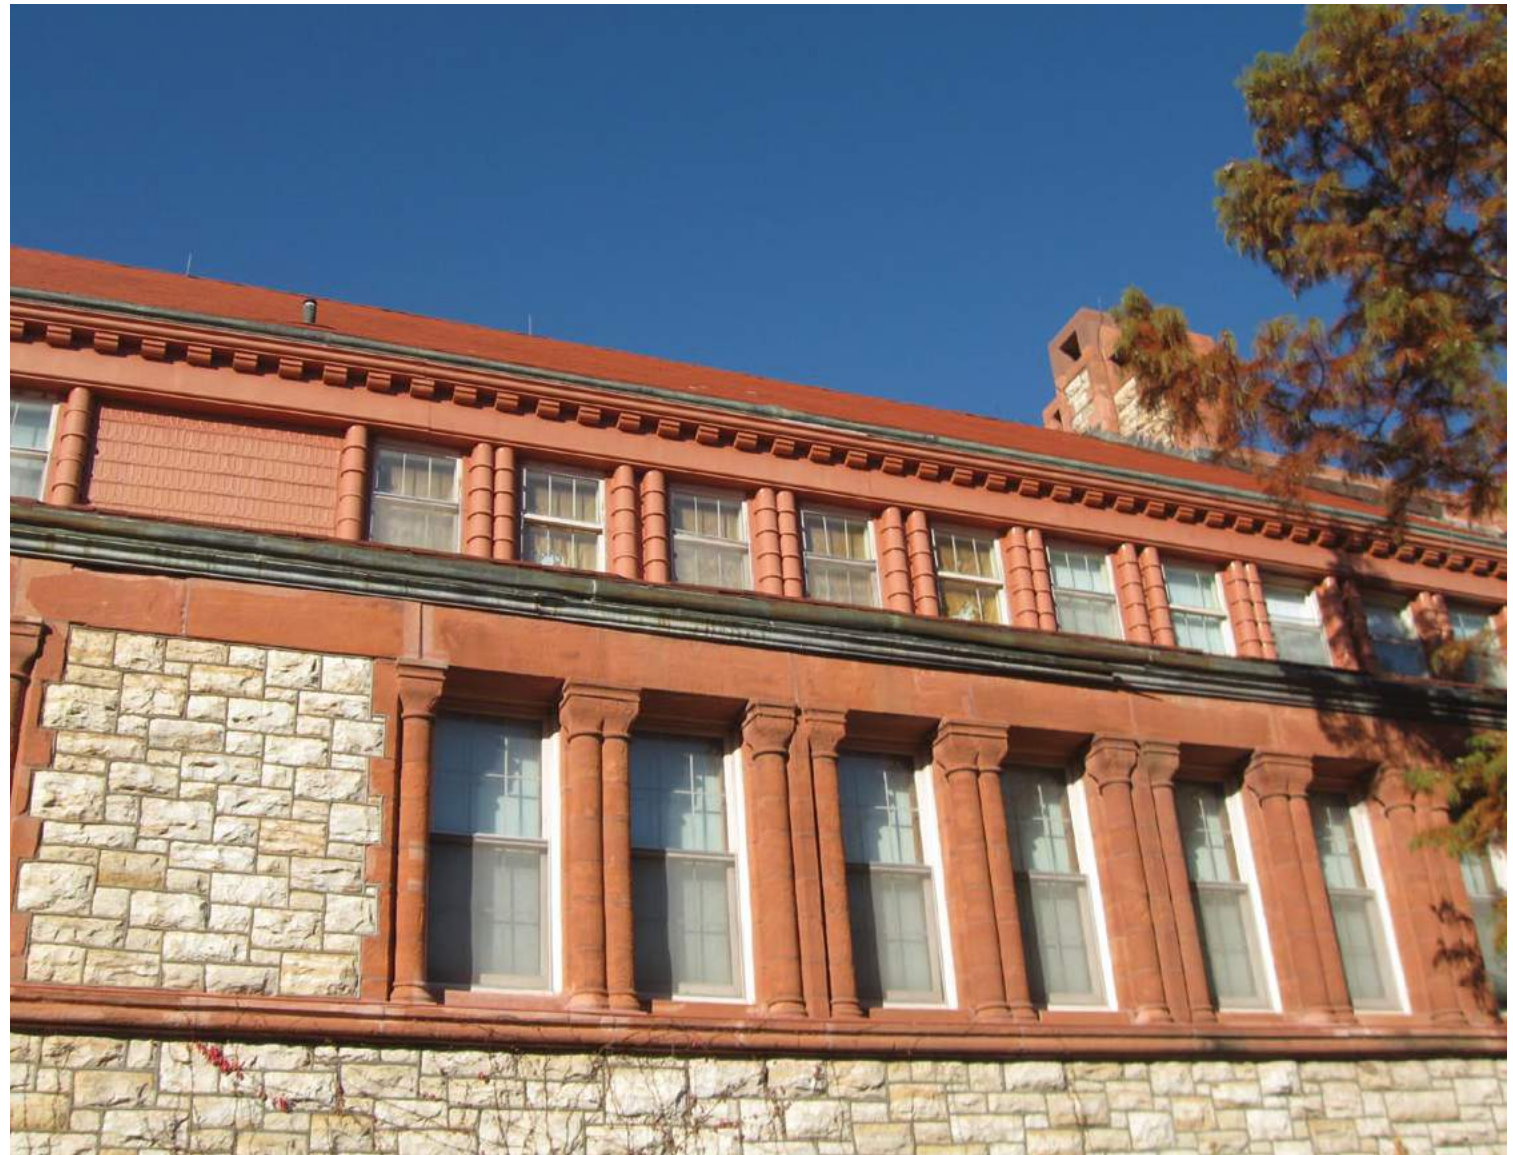
[6] Preliminary work before starting restoration revealed that the columns and the decorative shingles ornamenting the top floor of this historic building were fabricated of metal to imitate the red sandstone used elsewhere on the building.

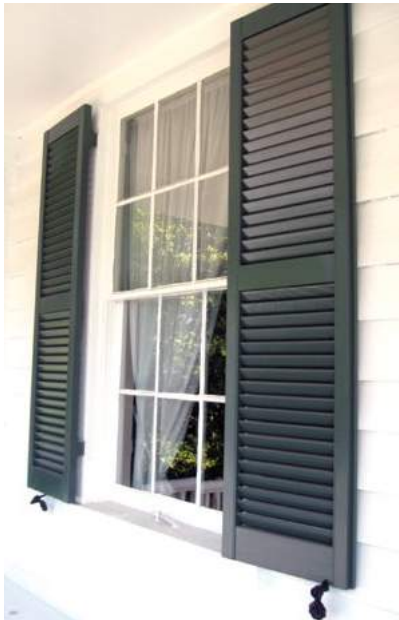
[9] Historic window and shutter hardware such as that shown here should be retained and repaired in a restoration project.

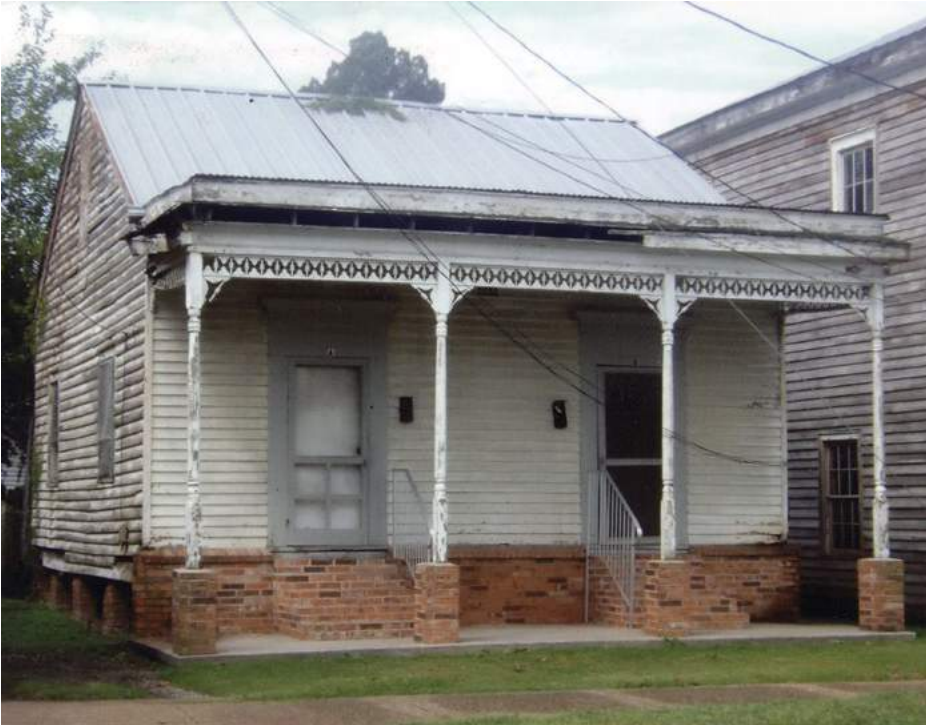
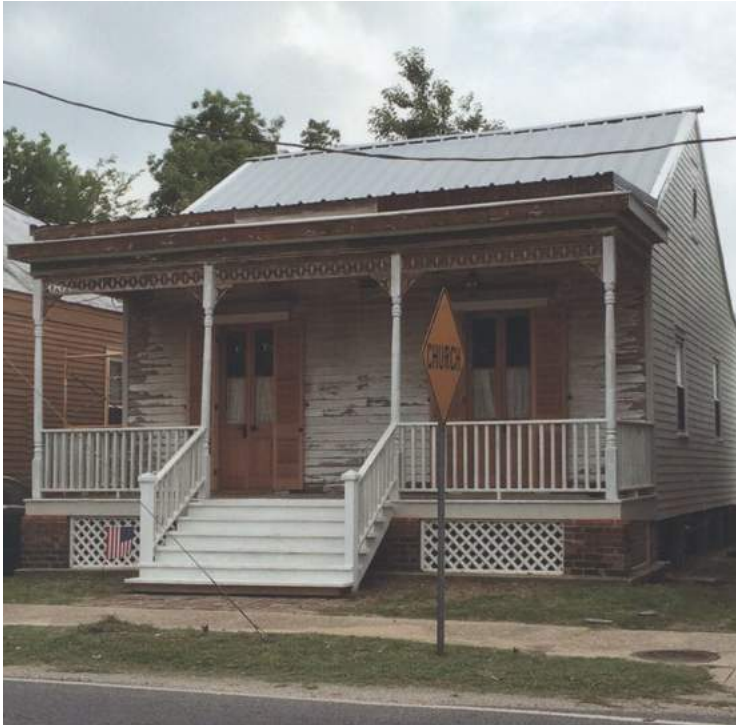
[10] (a) The entrance of this house had been altered over the years, including removal of the porch floor and steps. (b) This photograph shows the house after the porch and steps were restored to their historic appearance.

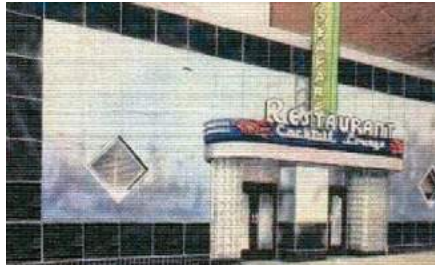
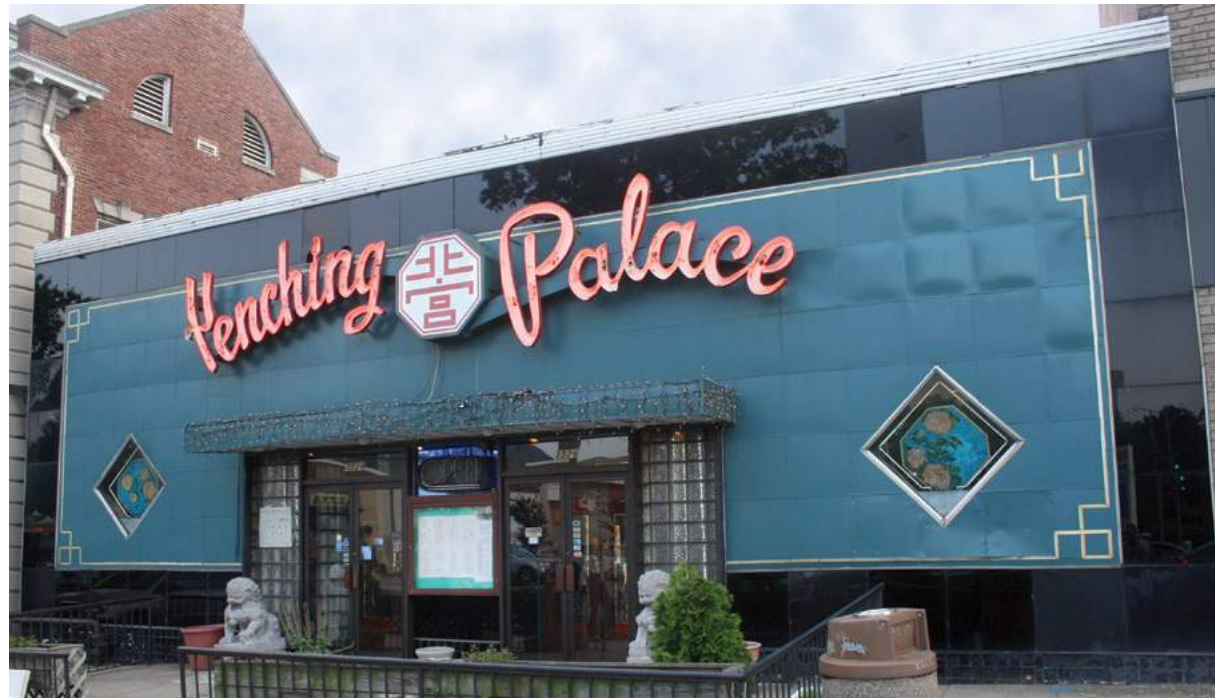
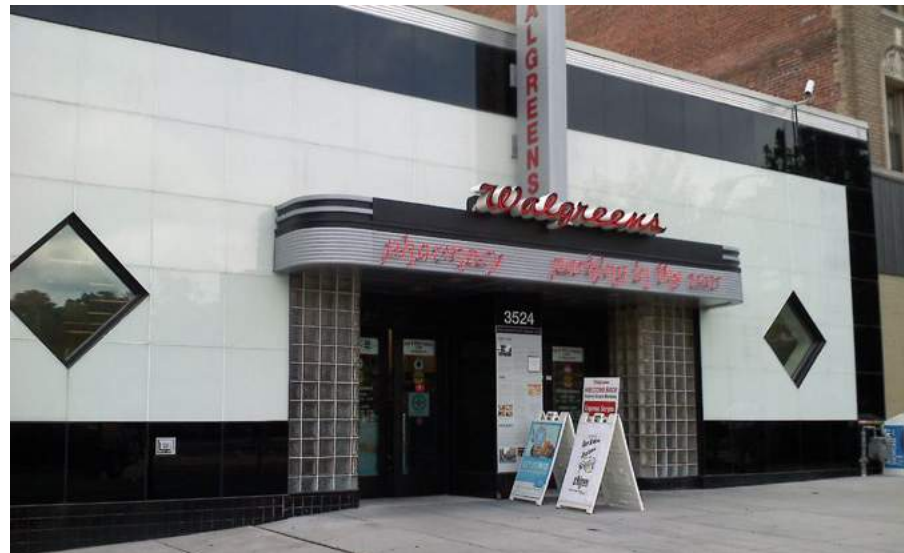
[11] (a) Some of the materials on the front of this historic building had been previously replaced, but the façade retained its essential distinctive features and design. (b) A vintage postcard of the building (far left) provided sufficient documentation to restore the façade to its historic 1945 appearance, using spandrel glass as a replacement for the original Carrara glass (c). *Photo (b): Courtesy Kelsey & Associates.*

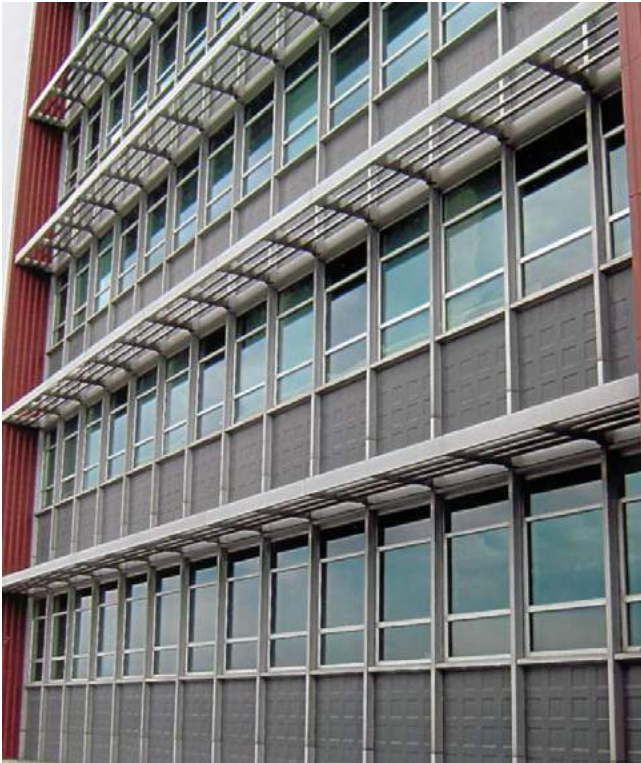
[12] This historic curtain wall features a distinctive variety of panel types which must be repaired or replicated in a restoration project if any are damaged or missing.

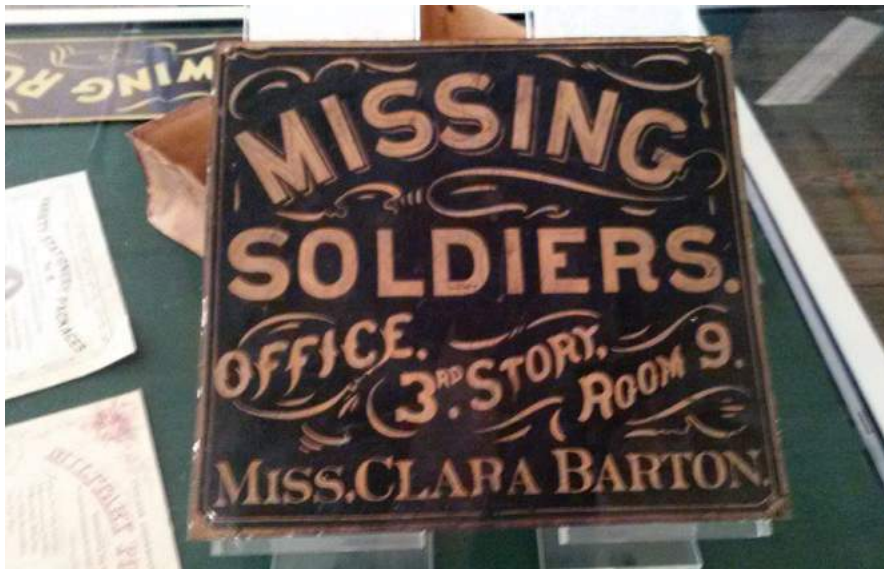
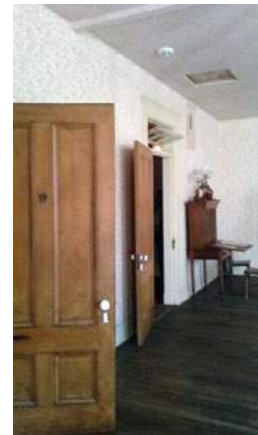
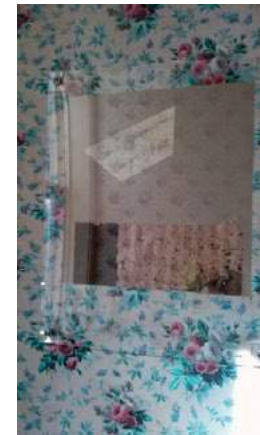
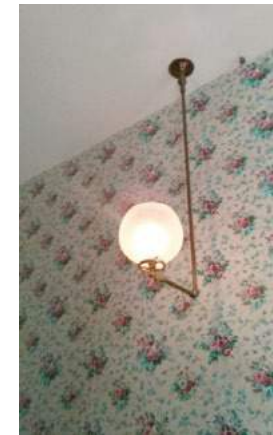
[13] (a) In the 1990s the Missing Soldier's Office—established by Clara Barton at the end of the Civil War—was discovered still extant on the third floor of a building in Washington, DC, that was slated for demolition. The office was restored to its historic appearance using physical and documentary evidence. The original numeral '9' is still on the door to the office, and wall paper was reproduced from scraps found on the walls (b-d).

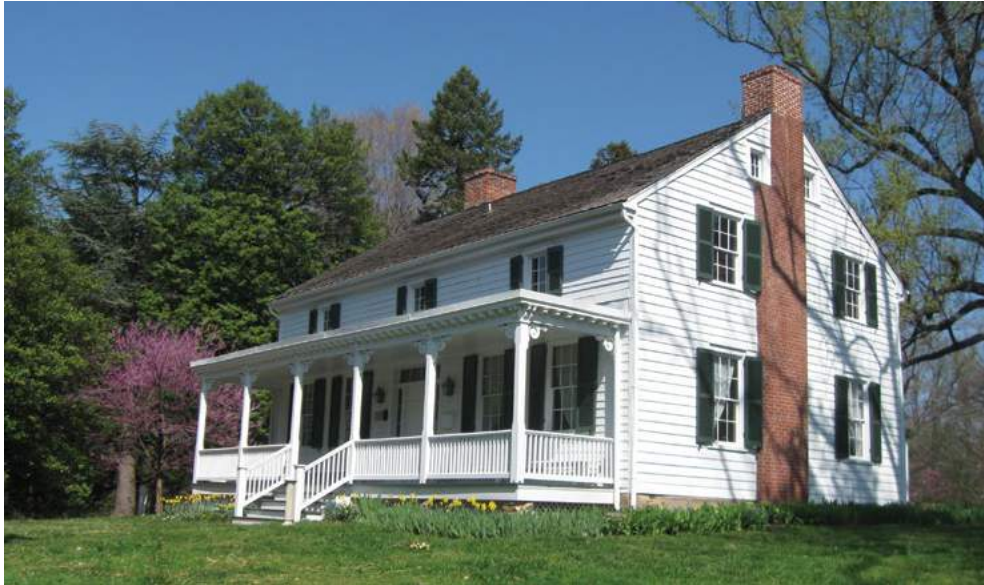
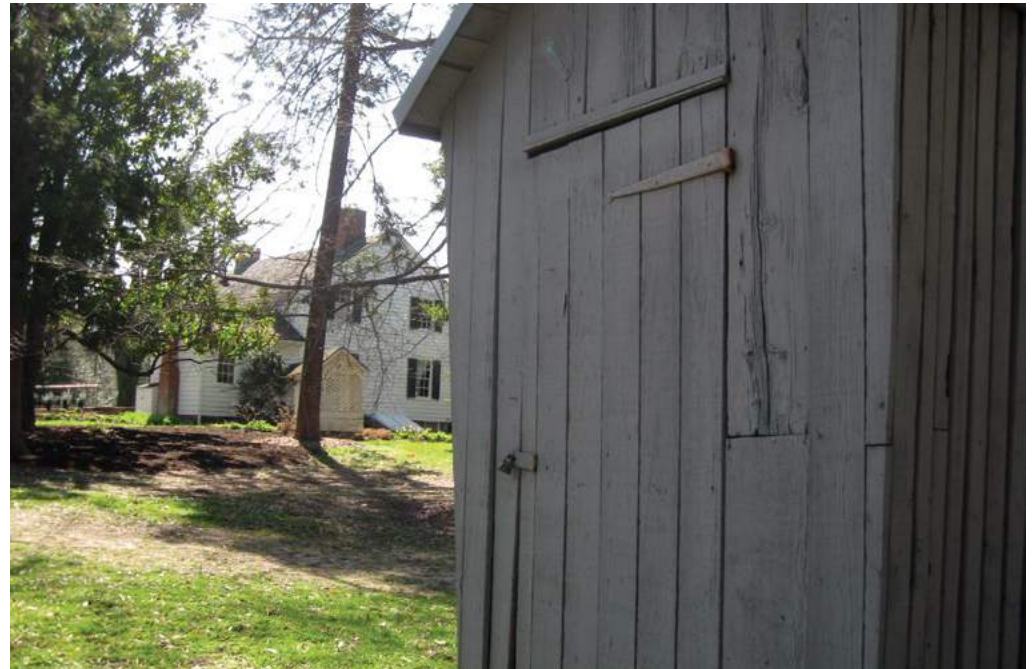
[15] (a) Cherry Hill House and Farm (c. 1845) in Falls Church, VA, was the site of encampments during the Civil War. Outbuildings on the property, such as the corn crib (b) in the foreground which was the source of provisions for the soldiers, are important in interpreting its role during the war.

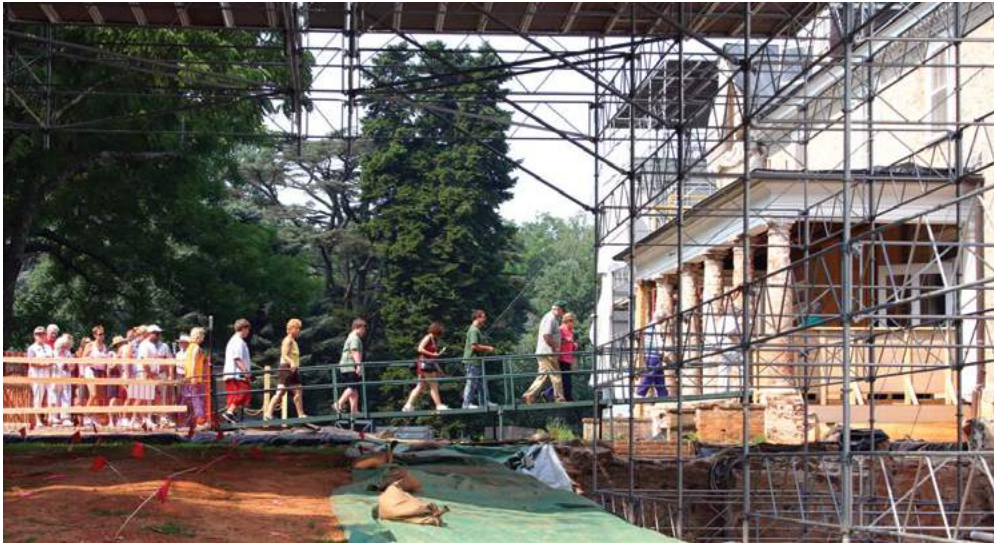
[16] Archeological investigation of the property was undertaken to ensure accuracy of the restoration of Montpelier. Photo: Courtesy of The Montpelier Foundation.

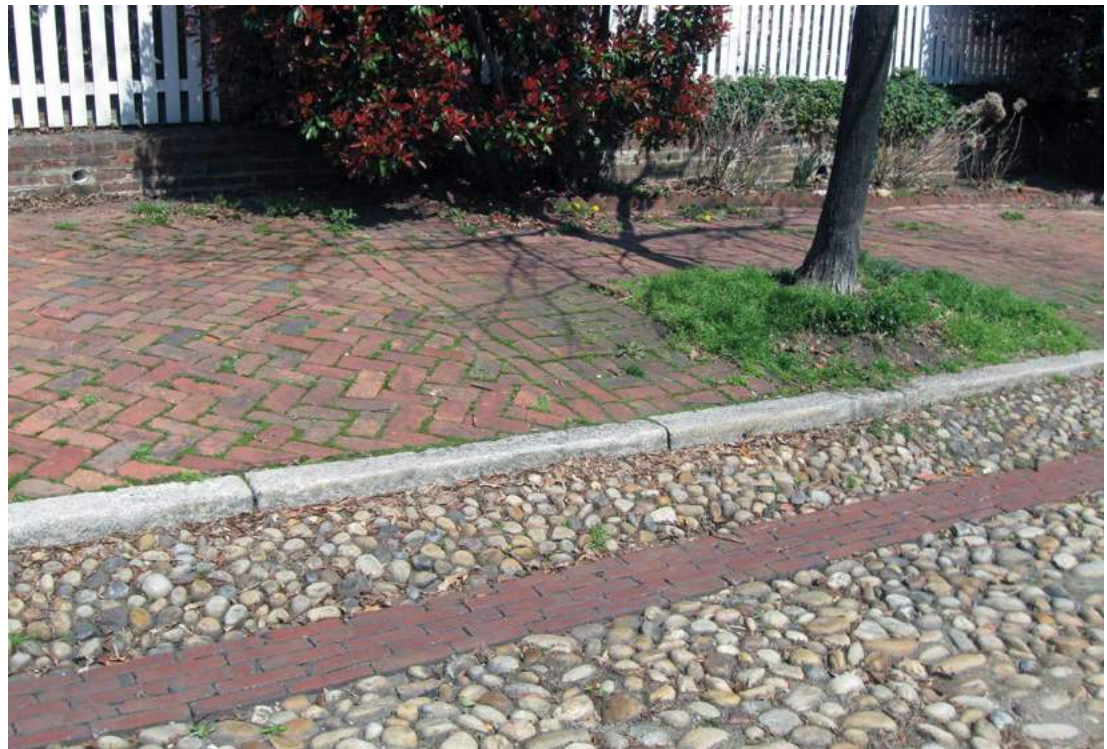
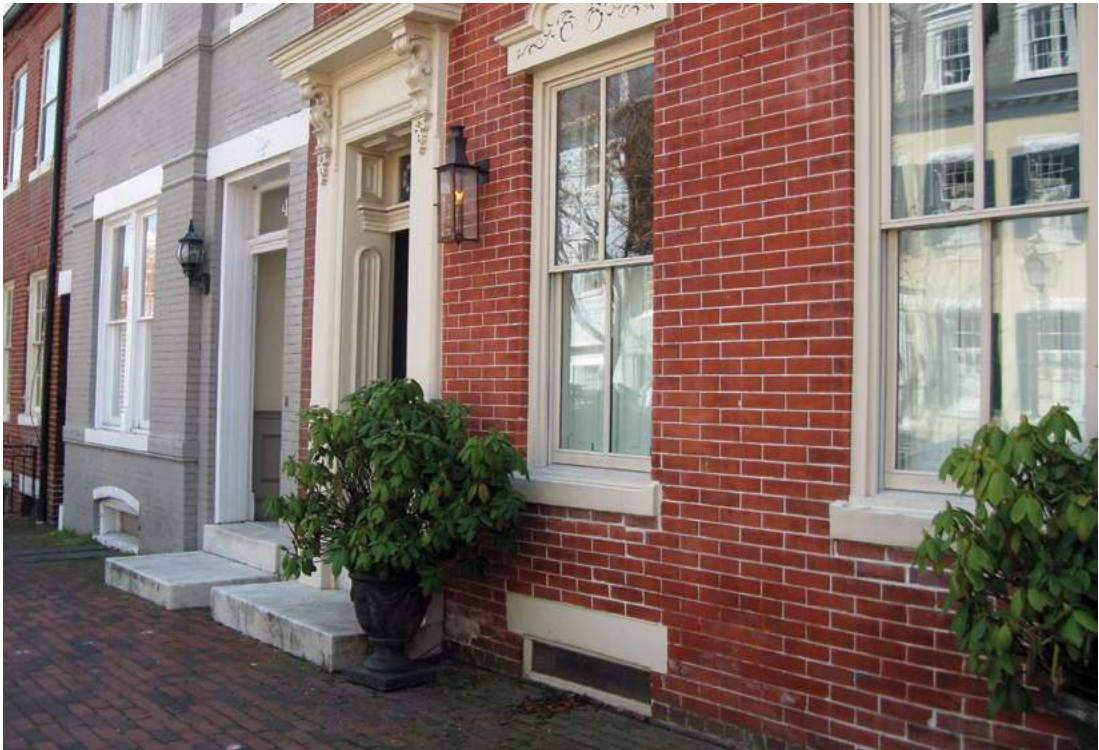
[17 a-b] The cobblestone street, brick sidewalks, and stone stoops of these houses are important restoration-period features of the late 18th-through the 19th-century restoration period of this historic district.

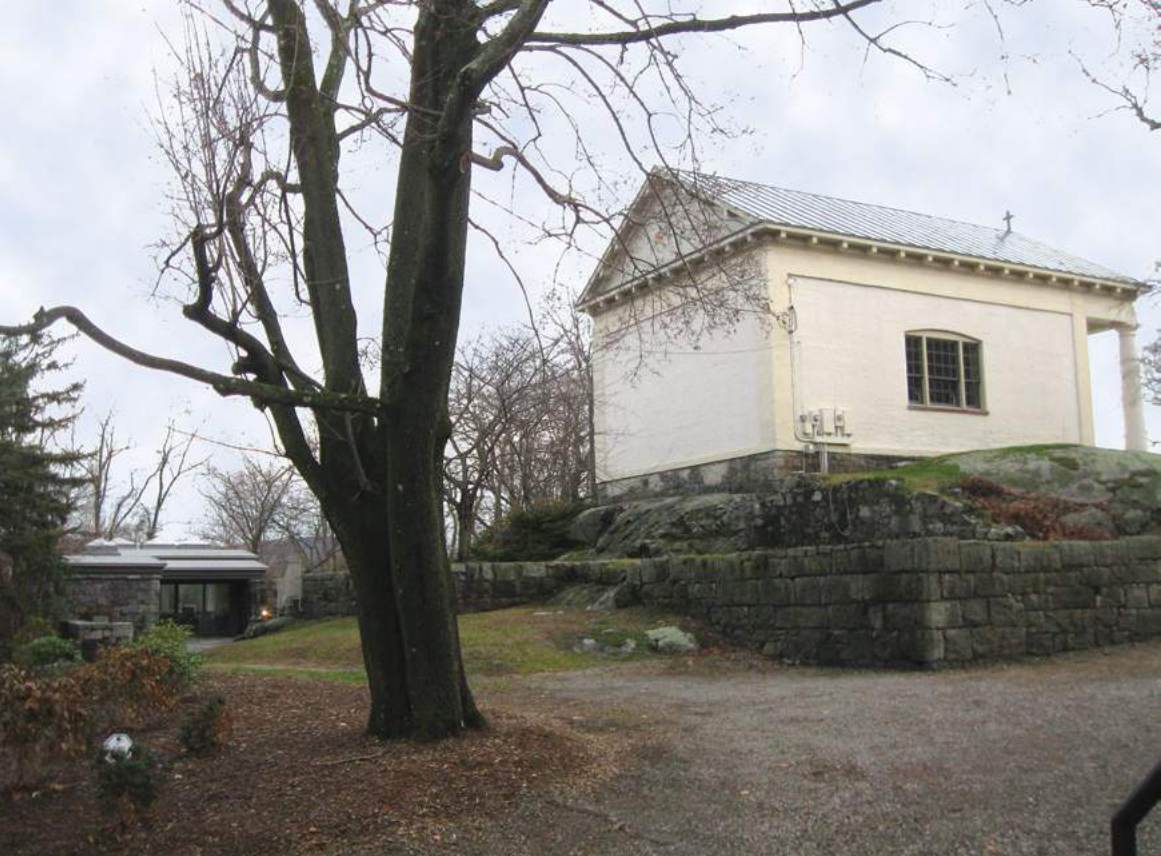
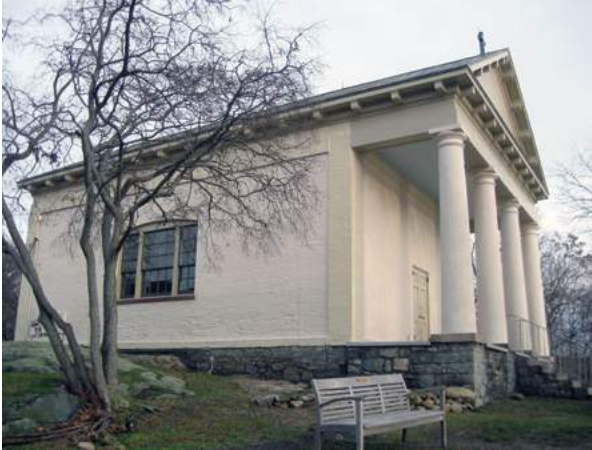
[18 a-b] The historic Chapel of Our Lady in Cold Spring, NY, is situated on a rocky promontory overlooking the Hudson River. Installing an accessible ramp would greatly compromise the character of the building and the site. However, an audio-visual program available in a separate building—located where it would not impact the character of the site, such as this small pavilion at the rear of the property—could provide visitors otherwise unable to access the Chapel an opportunity to experience the site.

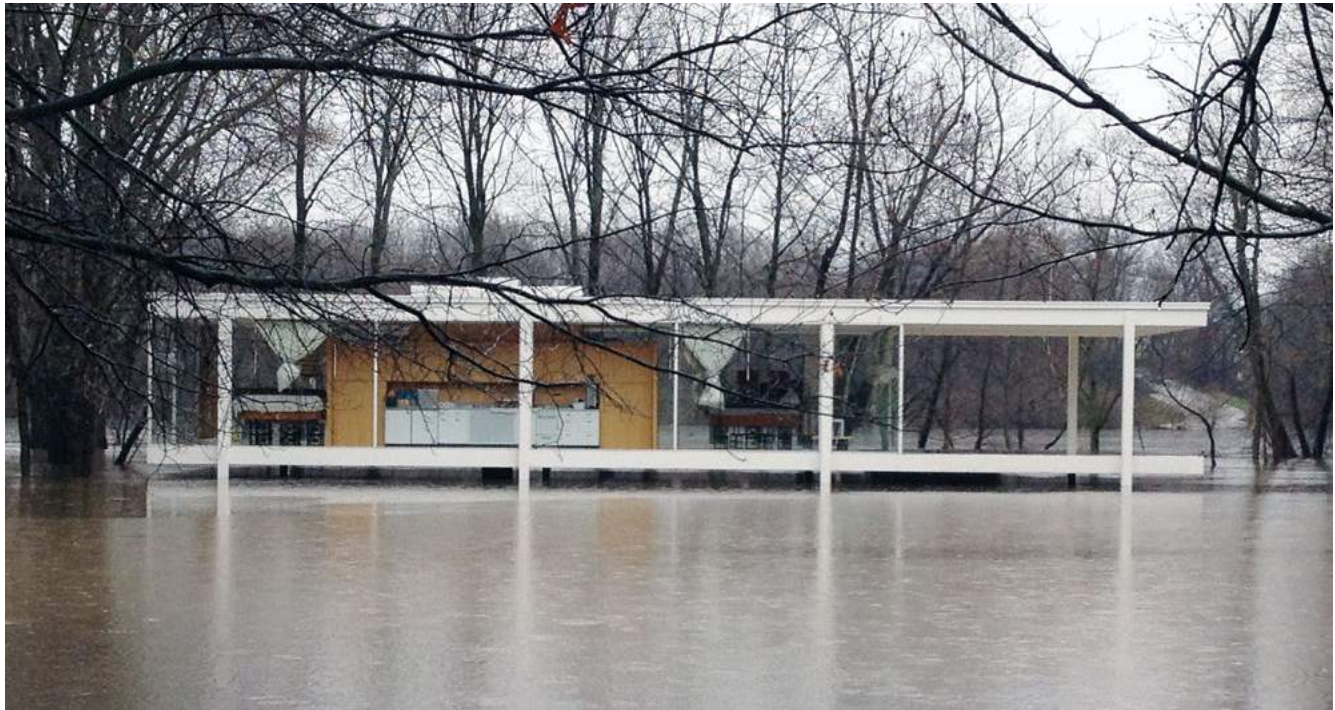
[19] The 1951 Mies van der Rohe-designed Farnsworth House, Plano, IL, was built close to the Fox River, which is increasingly prone to floods. To preserve the house in its original location, historic preservation architects and engineers continue to explore ways to protect it from the flooding, including a possible system that would lift the house above the flood waters and lower it back to the ground. *Photo: Courtesy Farnsworth, A Site of the National Trust for Historic Preservation.*

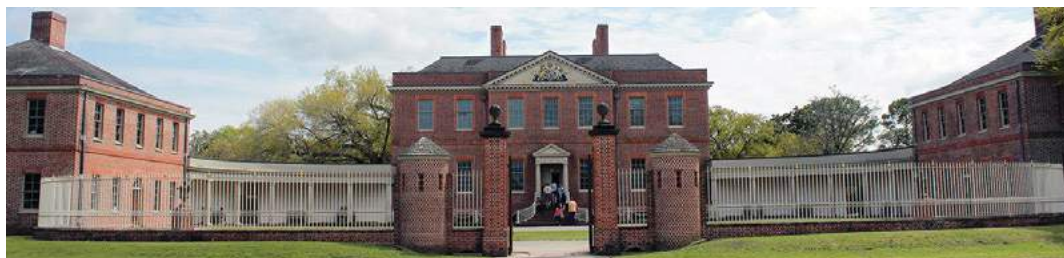
[1 a-b] Tyron Palace, New Bern, NC, was designed by John Hawks in 1767 for Governor William Tyron. It was completed in 1770, but destroyed by fire in 1798. The palace was reconstructed in 1959 based on the original plans, and on its original foundation, which was found 5 feet below the street, with the help of the 1767 drawing. *Photo: Courtesy Tyron Palace, New Bern, NC. Drawing: Courtesy of the State Archives of North Carolina.*

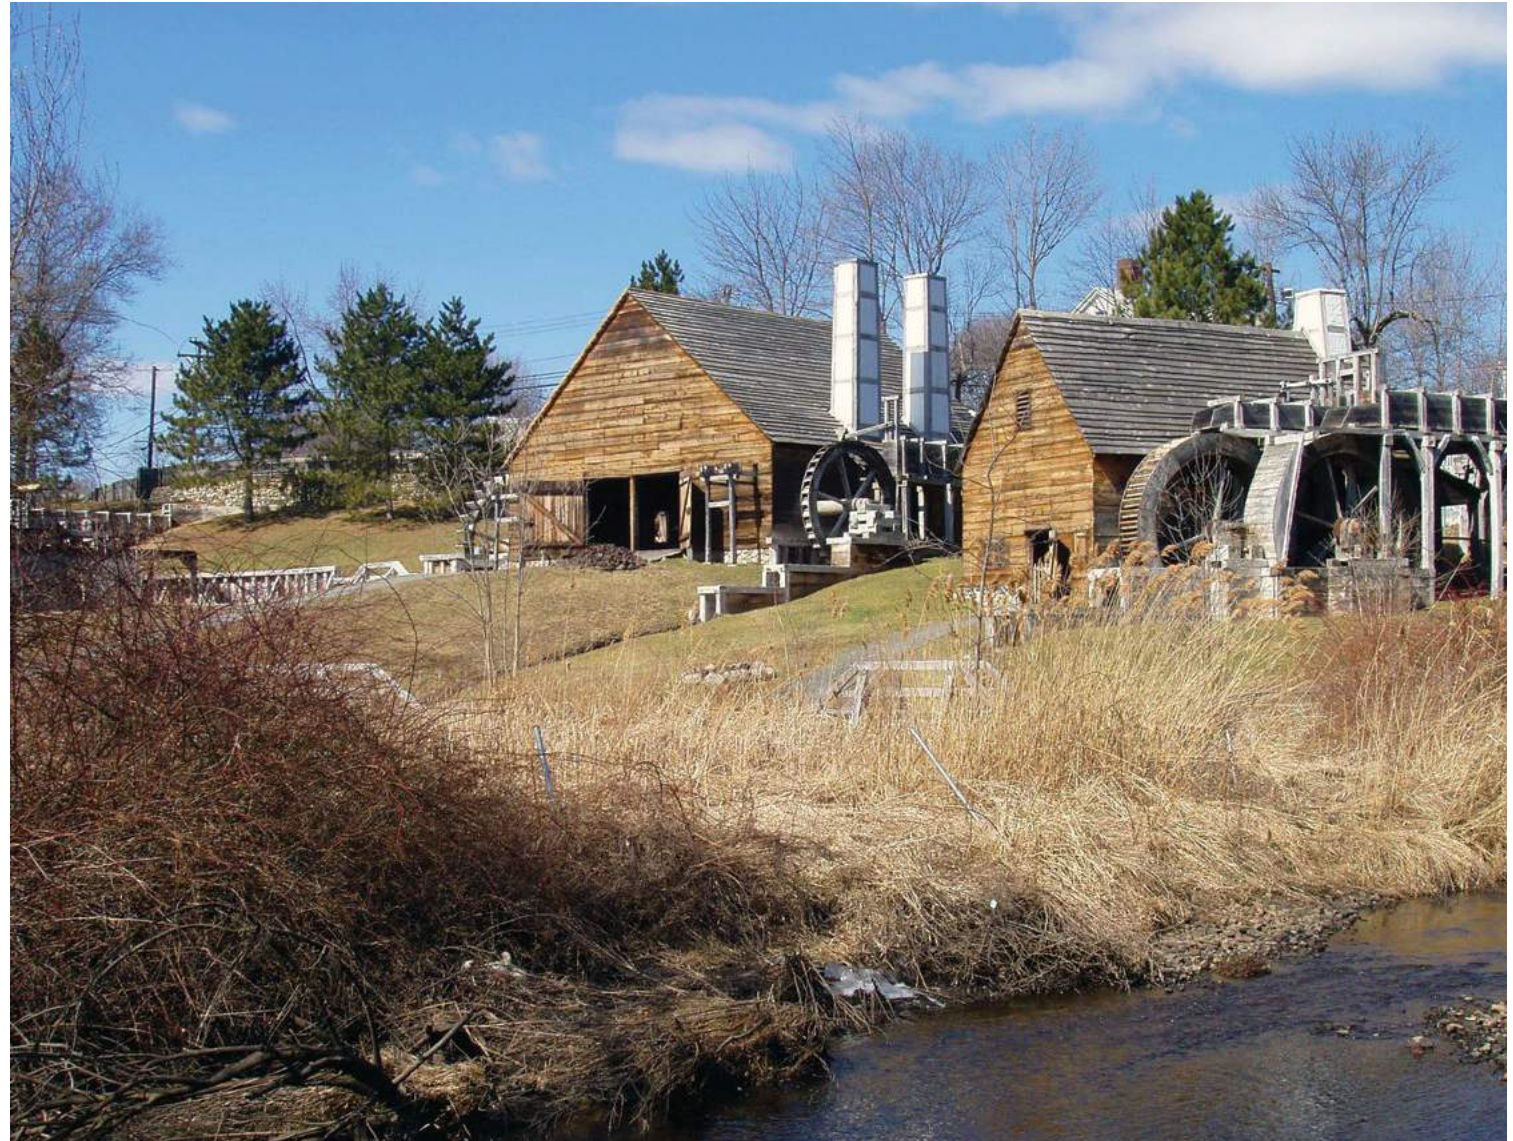
[2] The Saugus Iron Works, Saugus, MA, a National Historic Site, was active from 1646 to about 1670 and was the first integrated iron works in North America. The forge and mill (shown here) are part of the site which was reconstructed based on archeological research and historic documents and opened in 1954. *Photo: Daderot at the English language Wikipedia.*

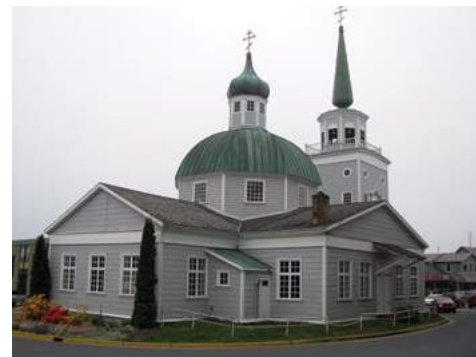
[3] The Cathedral of Saint Michael the Archangel, built in the early 1840s in Sitka, AK, was devastated by fire in 1966. It was reconstructed using measured drawings done in 1961 by the Historic American Buildings Survey (HABS). While the original cathedral was built of logs covered on the exterior with wood siding, its replacement is a fire-resistant structure with concrete and steel walls that replicates the historic building's appearance. *Photo: Berek at Wikimedia Commons.*

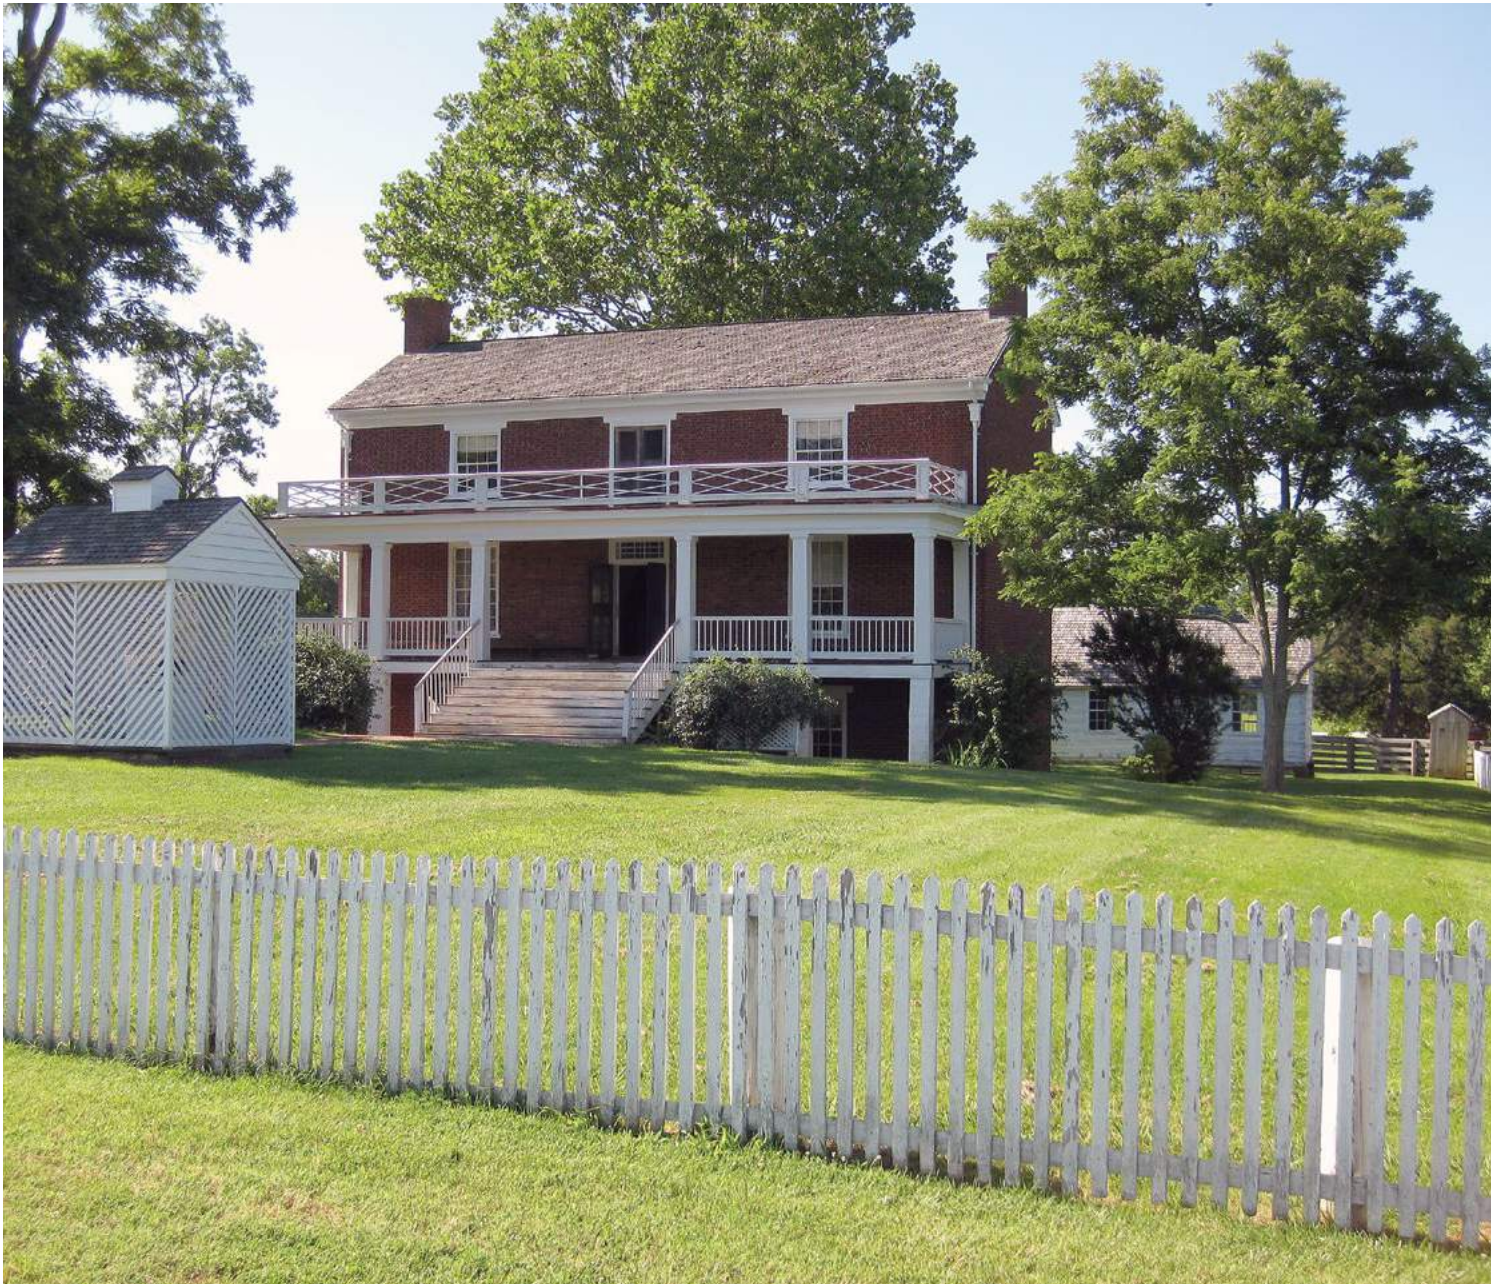
[4] The McLean House, where Robert E. Lee surrendered to Ulysses S. Grant, is located on the site of the battlefield—now part of Appomattox Courthouse National Historical Monument (VA). Several years after the end of the Civil War, measured drawings were made of the house before it was dismantled to be moved to Washington, DC, where it was to be reconstructed as a tourist attraction. This scheme never came to fruition, and the dismantled pieces gradually disappeared. The house was accurately reconstructed in 1949 on the original site based on the measured drawings.
