## STANDARDS FOR RESTORATION & GUIDELINES FOR RESTORING HISTORIC BUILDINGS

# Restoration

## Standards for Restoration

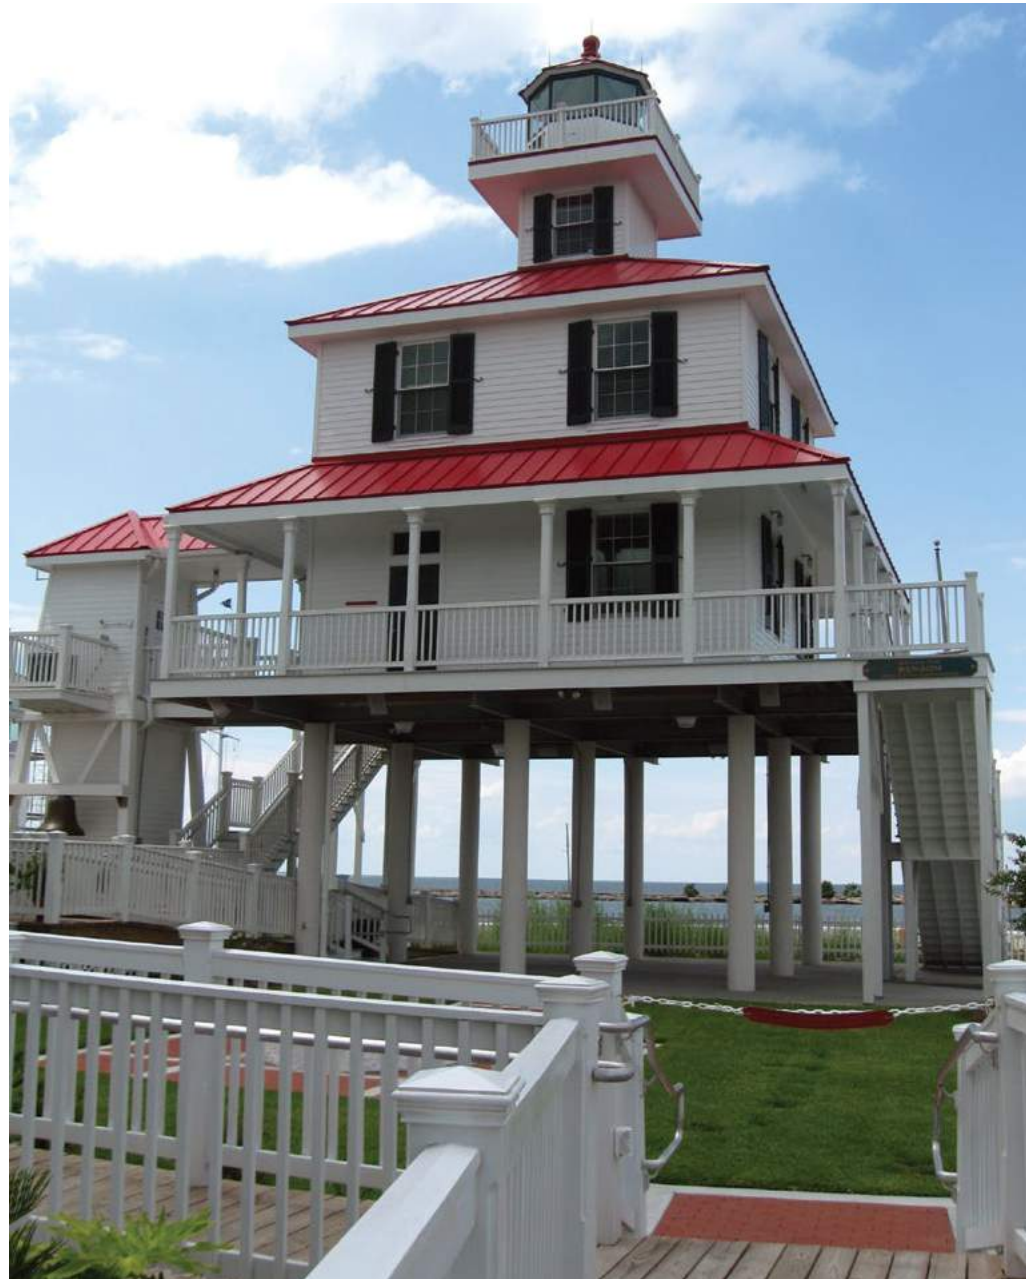
[6] This lighthouse on Lake Ponchartrain in New Orleans was reconstructed after the historic 1890 lighthouse was destroyed by Hurricane Katrina.

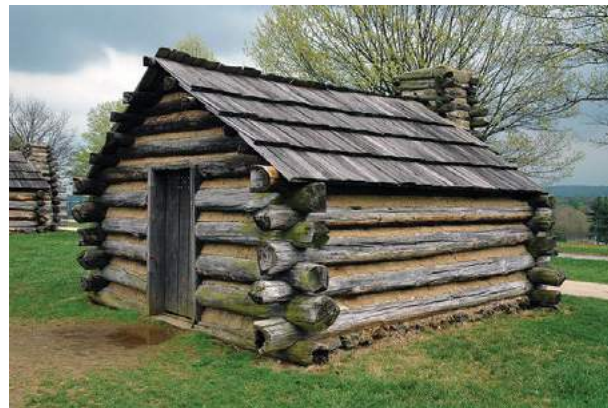
[7] The Muhlenberg Brigade Huts are reconstructions of nine log huts erected in 1777 at Valley Forge during the Revolutionary War. They have been reconstructed on the historic road with logs cut with modern power tools and finished with cement, unlike the original logs which were hand hewn and finished with traditional chinking. *Photo: Rdsmith4 at Wikimedia Commons.*

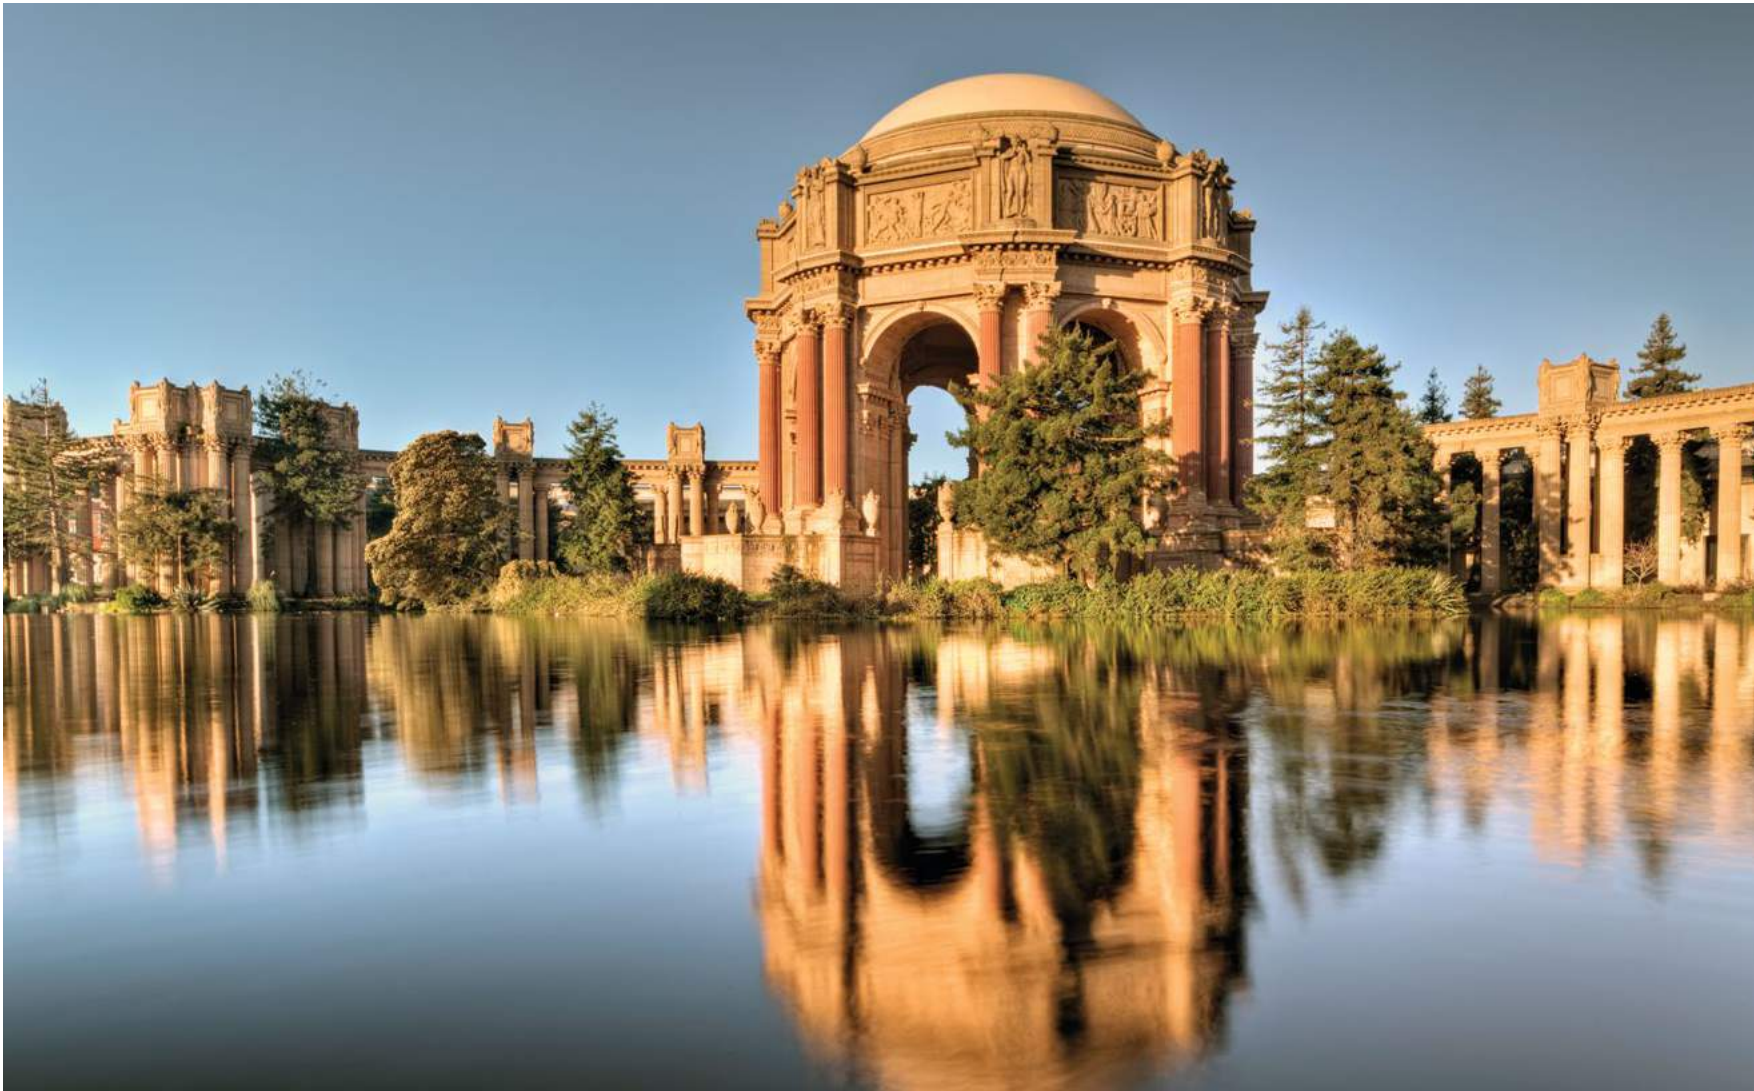
[8] The Palace of Fine Arts was designed by Bernard Maybeck and built for the 1915 Panama-Pacific Exposition in San Francisco. The pavilion was intended to be temporary and, although it had a steel structure, the exterior was finished only with stucco, an impermanent material composed of plaster and fiber. The building was not torn down after the exposition, and it eventually fell into ruin. In 1964, all but the steel structure was demolished, and the building was reconstructed with lightweight poured-in-place concrete. *Photo: KevinCole at Wikimedia Commons.*
