HYDROLOGY AND HYDRAULICS OF URBAN FLOODPLAINS

LAURA SUPPLE

MENTOR SCIENTIST: DR. ANDREW J. MILLER

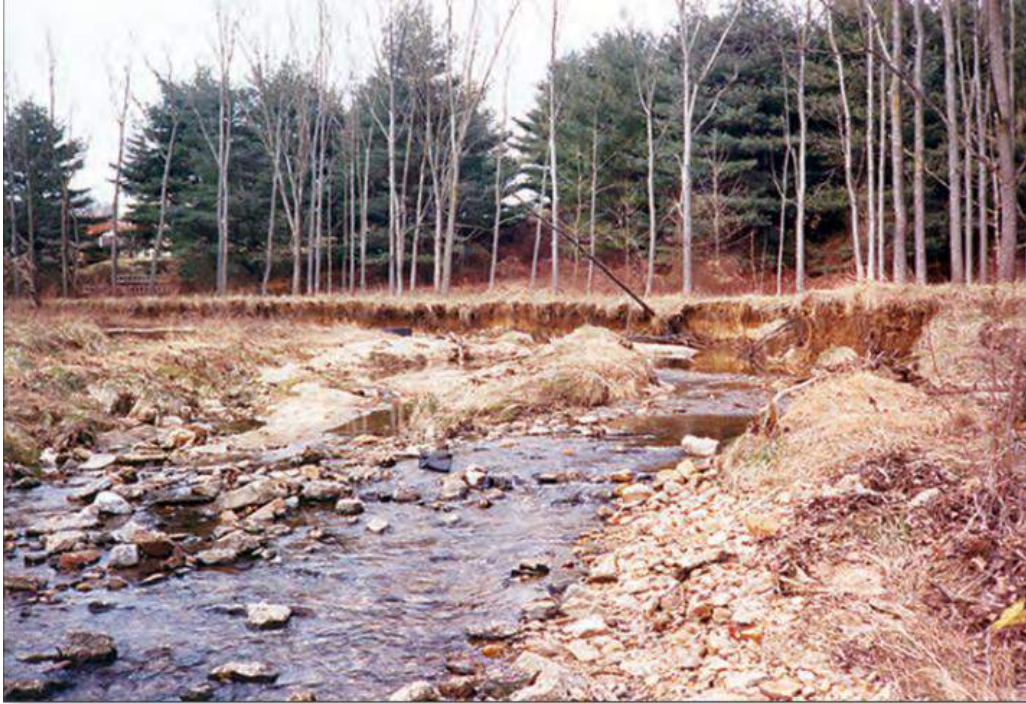
FIGURE 3. Pre-restoration photograph of Minebank Run (2003). View looking upstream from the confluence with the Harts Run tributary at the upstream end of the study reach. Image courtesy of U.S. Geological Survey Scientific Investigations Report 2012-5012.

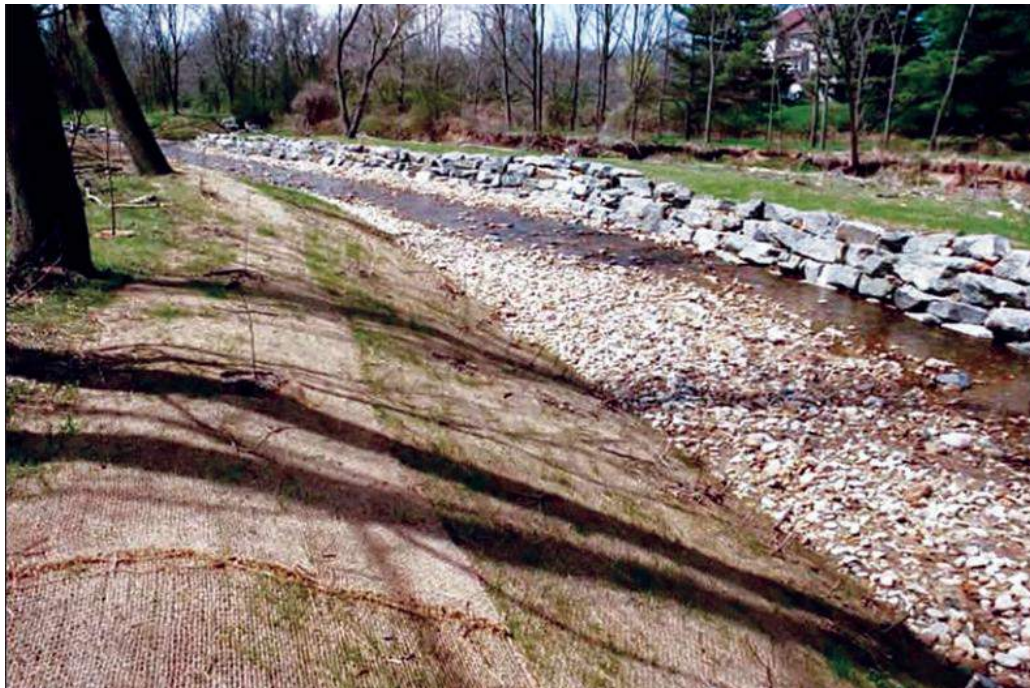
FIGURE 4. Restored section of Minebank Run (2005). View looking upstream from the confluence with the Harts Run tributary at the upstream end of the study reach with the original channel visible in the background. Image courtesy of U.S. Geological Survey Scientific Investigations Report 2012-5012.

The reach of Minebank Run captured by this study is contained in the lower portion of the watershed restored in 2004-05. Land use in the region is approximately 80.6 percent urban and 16.9 percent forested or open space, with the largest percentages of urban land use and impervious cover located in the headwaters of the watershed. Prior to restoration, much of the channel was incised and over-widened, with steep bank slopes and several large meanders corresponding to unstable banks and a mobile channel bed. Within this particular reach the channel bed was reconstructed with gravel and small cobbles, riprap walls and rock weirs were placed in sections, and the channel was redirected in two locations to control sinuosity and the original channel was left in place as an overflow channel and oxbow wetland, (Doheny *et al.*, 2012).

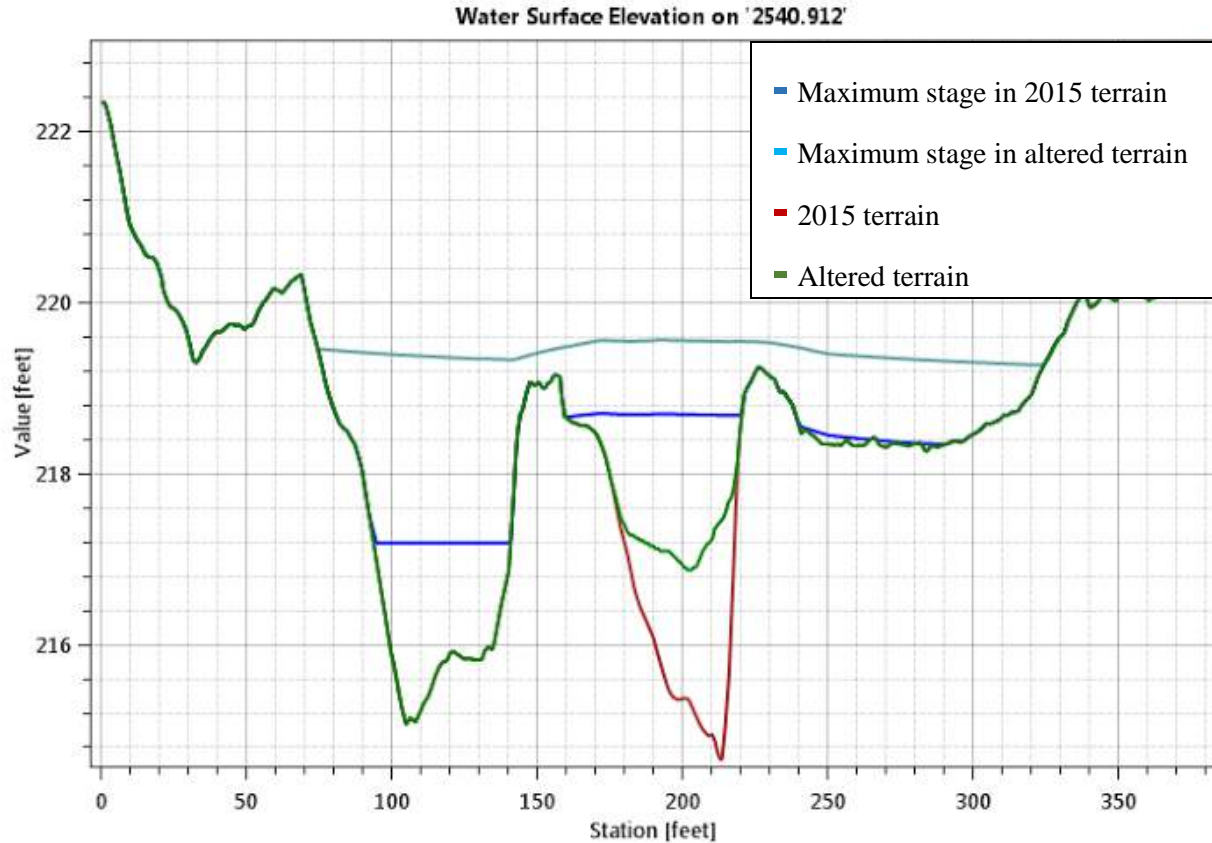
FIGURE 7. Maximum water surface elevation for an 1170 cfs flood event in the 2015 and altered terrain models at river station 2540.912. Maximum water surface elevation profiles for both the 2015 and altered terrain models as well as topographic profiles of the 2015 terrain and altered terrain plotted as elevation above the North American Vertical Datum of 1988 on the vertical axis and distance from the left extent of cross section 2540.912 facing downstream. Note the terrain models differ only in channel bed minimum elevation, approximately between cross sectional station markers 180 and 220. The left channel, located approximately between cross sectional station markers 80 and 150, is the remnant of the pre-restoration channel, left by the restoration project as one of three overflow oxbow wetlands. Plots generated in RAS Mapper, a feature of HEC-RAS 5.0 software.

Comparison of **Figure 5** and **Figure 6** indicates degree of floodplain inundation at maximum stage was notably increased in the altered region of terrain upstream of Sherwood Bridge. In **Figure 5** it appears overbank flow in the 2015 terrain model was mostly confined to the oxbow wetland channels, remnants of the pre-restoration channel intended to capture stream overflow. In contrast, **Figure 6** suggests the pattern of floodplain inundation at maximum stage differed markedly in the altered terrain for the same flood event, extending farther beyond the channel boundaries and more completely flooding the vegetated areas surrounding the oxbow channels, although the highest water velocities were still concentrated in the main channel (regions of red and orange in both figures). **Figure 7** provides another demonstration of the difference in pattern of floodplain inundation for the two terrain models, illustrating the profile plot of maximum water surface elevation at river station 2540.912, the oxbow wetland cross section in **Figures 5 & 6**, for each terrain.
